September 1, 2025

**Re: Follow-up Reports Spill #2025-315 and #2025-317 – Release of 50 L of Process Plant slurry at the Meliadine Gold Project**

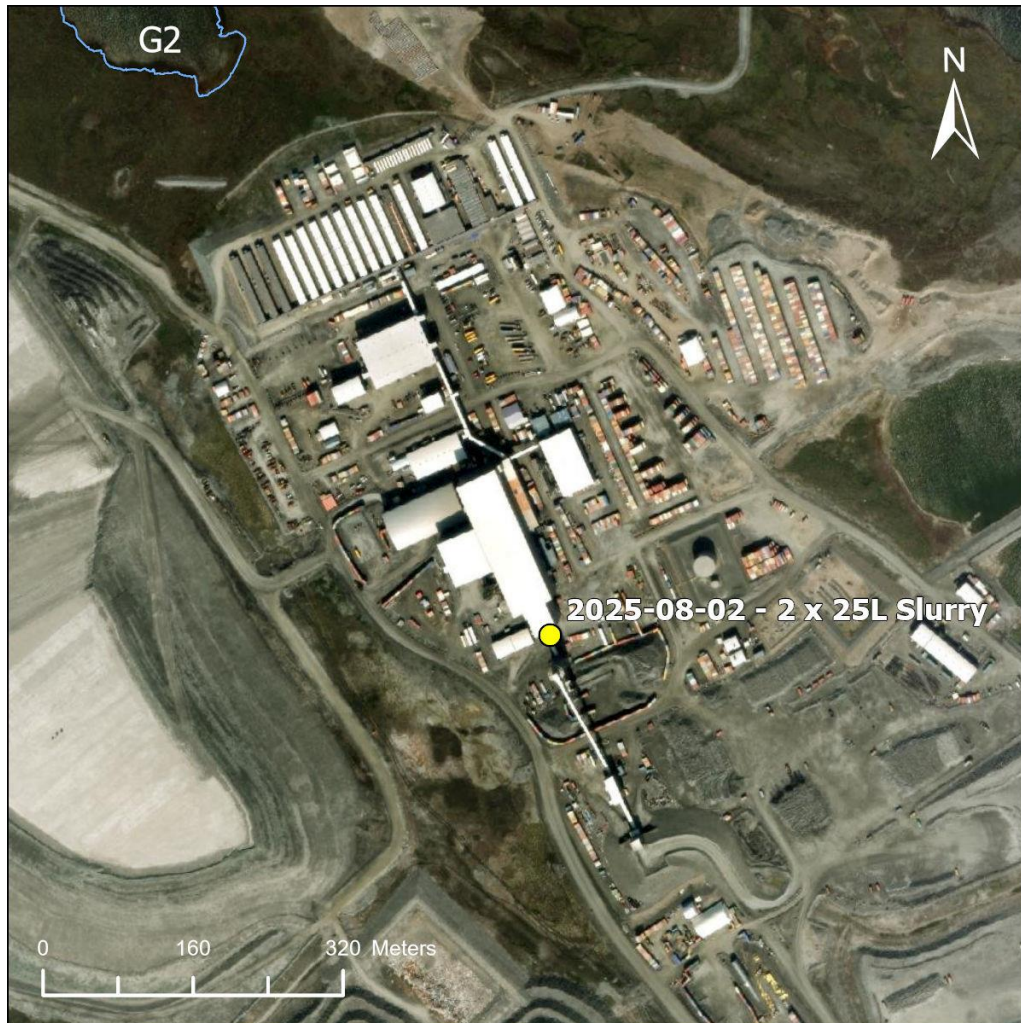
The spill occurred within the bounds of the site's runoff collection system; no water bodies being impacted or at risk of being impacted by the spill. The closest water body, Lake G2, is approximately 650 m northwest, as seen in Figure 1.

**Figure 1:** Location of the spill and proximity to waterbodies.

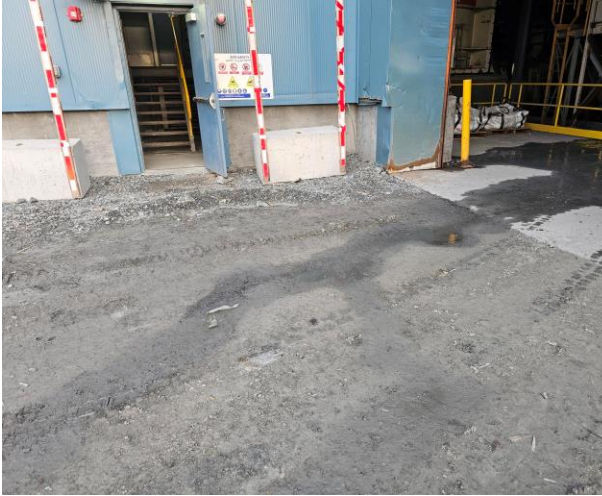
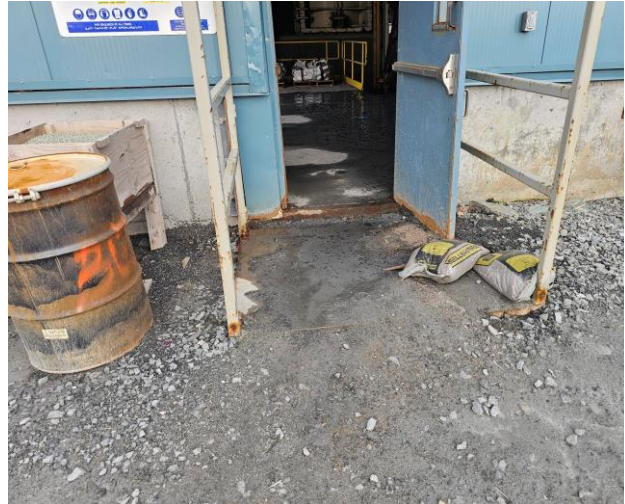
On August 2<sup>nd</sup>, 2025, at approximately 3:30AM and 7:00PM, water used in the cyclone for primary grinding at the Process Plant started accumulating in the Plant and eventually made its way outside through the garage door and the man door on the south side of the Plant. This resulted in two release events of approximately 25 L of slurry onto the industrial pad.

- The cyclone chute was plugged with ore during primary grinding, making the Process Water overflow from the cyclone into the Process Plant. The slurry spill eventually made its way outside, as the garage and man doors were open due to the high temperatures in the Process Plant that day.
- Even when closed, the garage and man doors would not prevent spills from going outside, as water can infiltrate through the bottom of these doors.

**Photos 1-2:** Spill location

Upon realizing that process water was overflowing from the cyclone, the operator shut the cyclone and notified his supervisor. Process Plant personnel then started cleaning inside and outside the Process Plant. The slurry that made its way outside was hand shoveled and brought back inside the Process Plant to be reintroduced into the recirculation system. Environment department personnel were then notified of the first spill and started the investigation process. Later that day, Process Plant personnel notified the Environment department of a similar spill, which was remediated in the same way.

- Spill containment berms were ordered and will be staged near the cyclone, so the operators can quickly act in the event of a spill. These berms will be made available by October 31<sup>st</sup>.
- Process Plant personnel will review the trash screen catch basin and explore possible modifications to prevent the cyclone from plugging, or any overflow from reaching the garage or man doors. This assessment and possible solutions will be explored before June 2026.

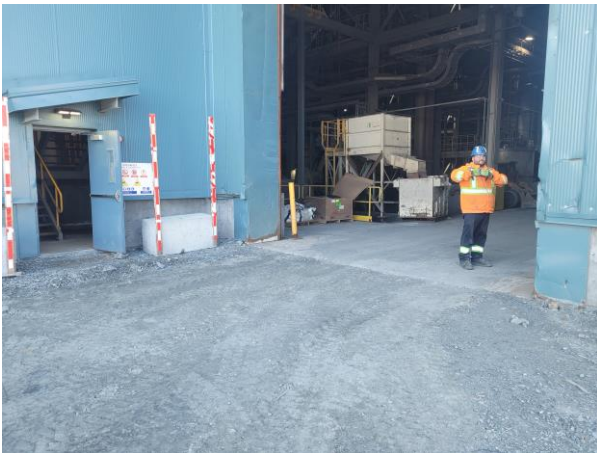
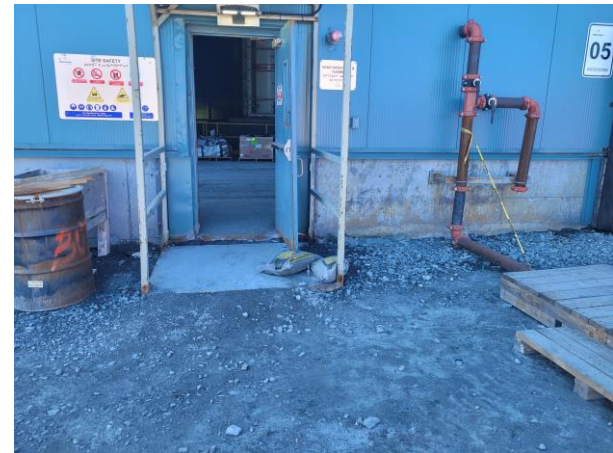
**Photos 3-4:** Spill location post-cleanup.
