September 19, 2025

Re: Follow-up Report Spill #2025-343 – Release of unknown amount of sediment at the Meliadine Gold Project

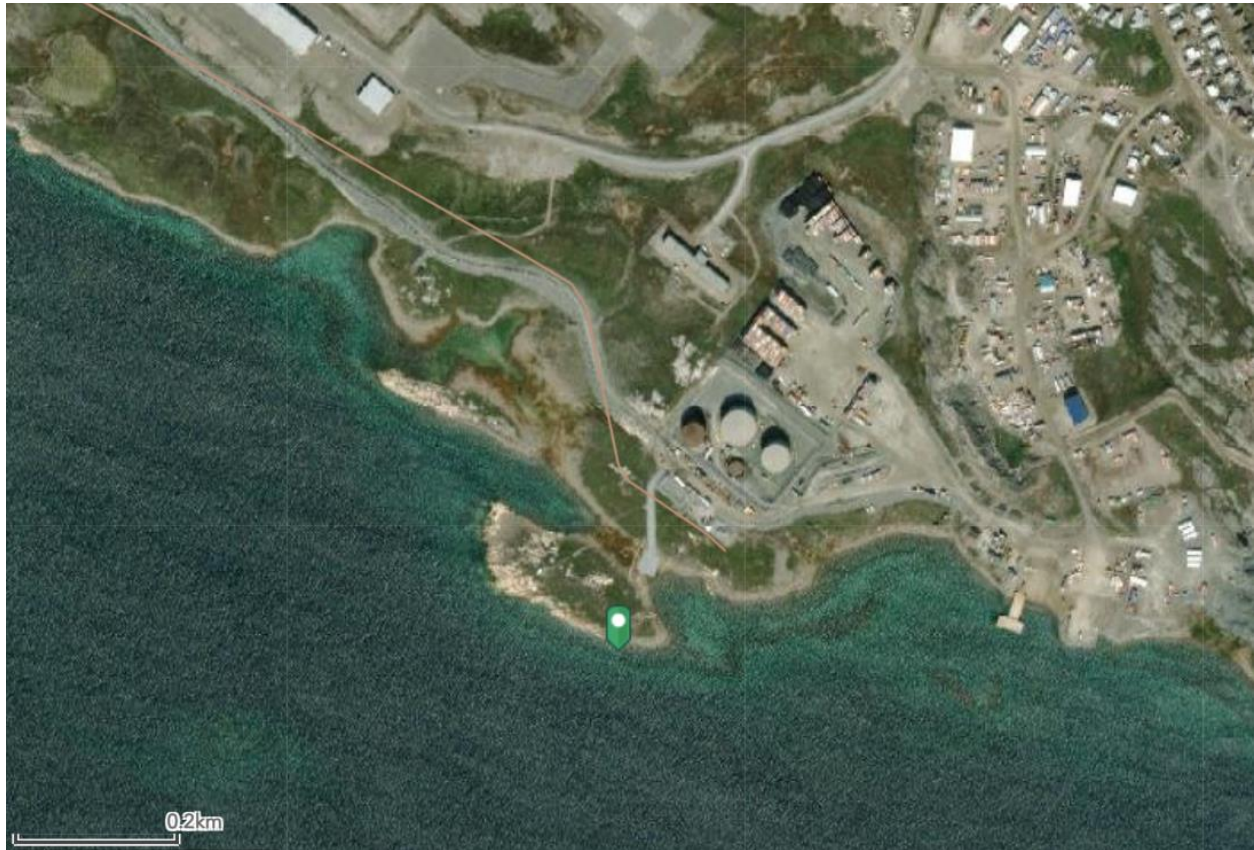
On August 20th, 2025, at approximately 2:30 PM, during the horizontal directional drilling (HDD) at Itivia Harbour a sediment plume was observed in Melvin Bay (Figure 1). As the drill penetrated the seabed, it exited the bedrock into an area of seabed debris. The compressed air used to stabilize the borehole escaped into the surrounding water, disturbing the fine sediments on the seabed. The release of energy caused particulates to become suspended in the water column, creating a plume that spread outward from the drilling site.

Figure 1: Location of the spill in Melvin Bay.

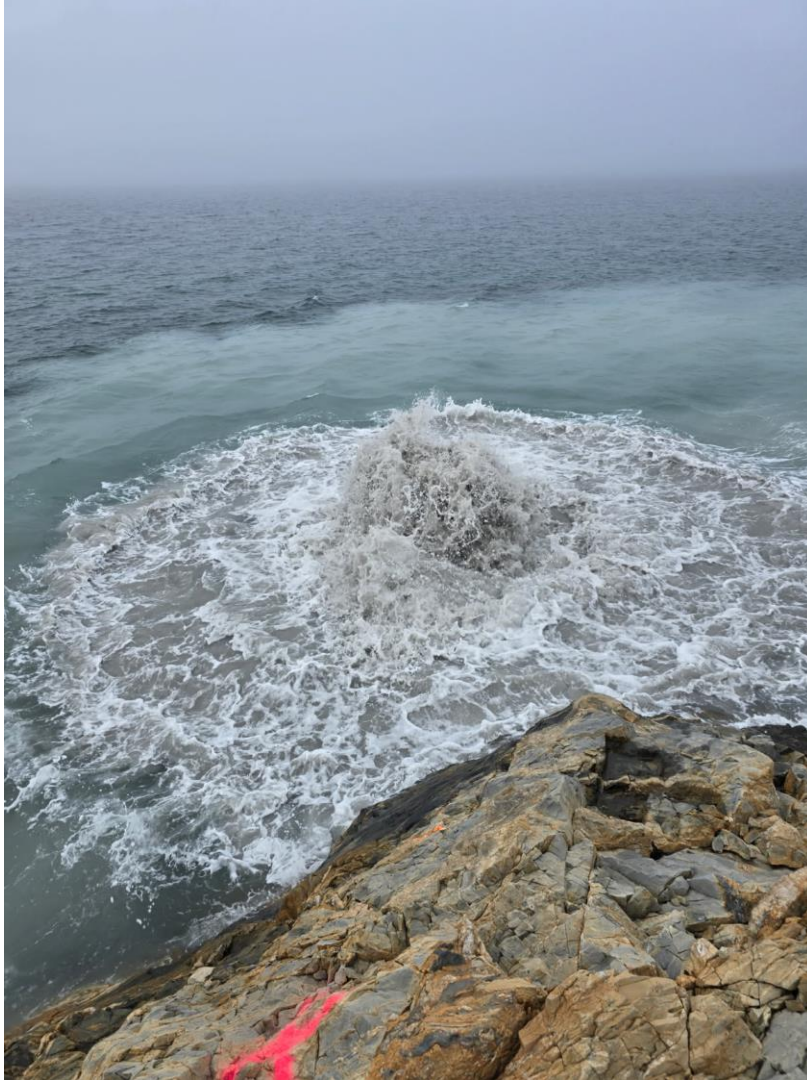
Photo 1: Location of sediment release in Melvin Bay.

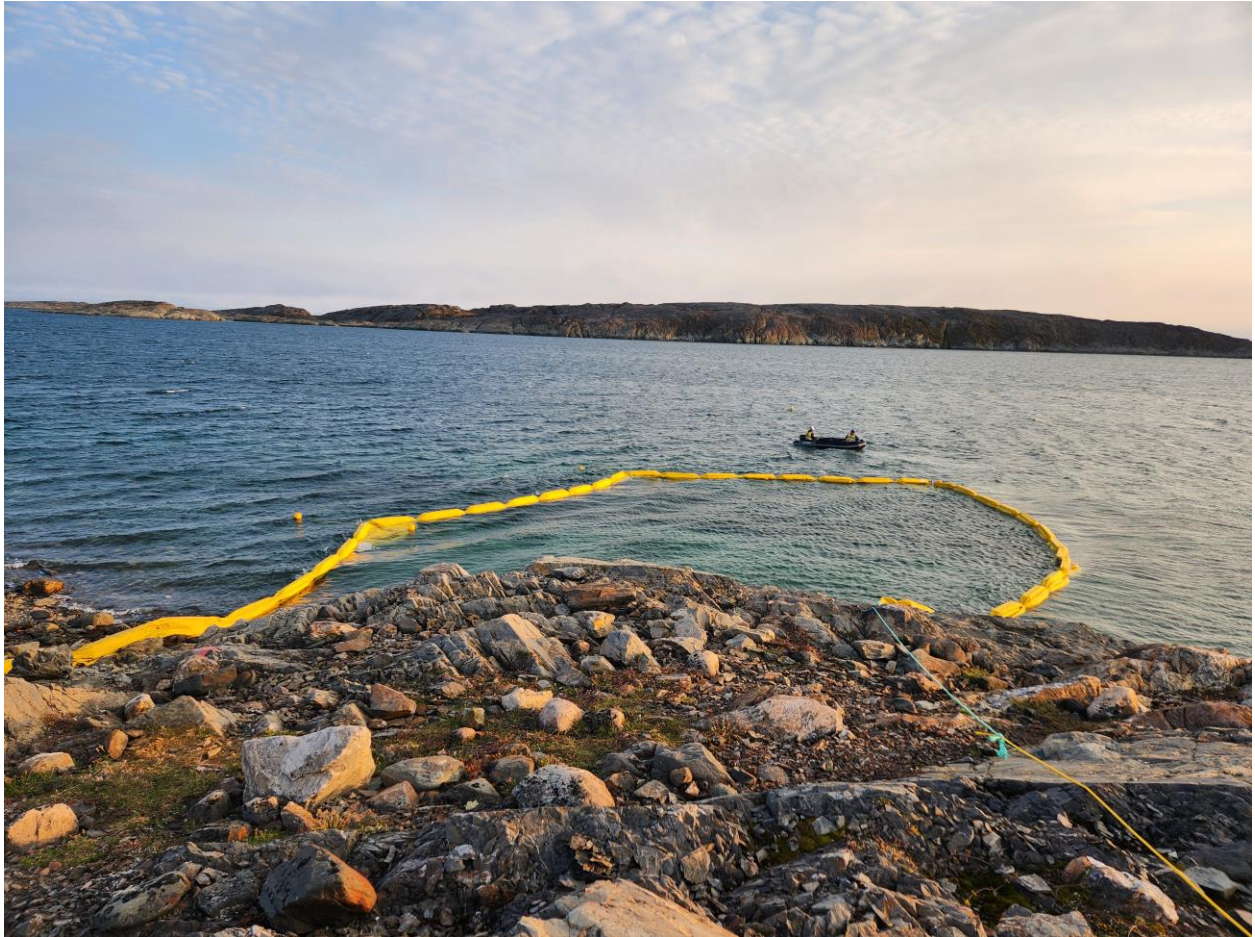
Photo 2: Turbidity curtains installed before resuming the drilling operation.

- As an immediate corrective measure, drilling was stopped.
- Turbidity curtains were installed around the source of the sediment release and along the planned HDD path to contain suspended sediments.
- Prior to any future underwater HDD work, silt curtains or booms will be deployed around the work area before drilling begins.
