Re: Follow-up Report Spill #2025-359 – Release of 10 L of sewage at the Meliadine Gold Project

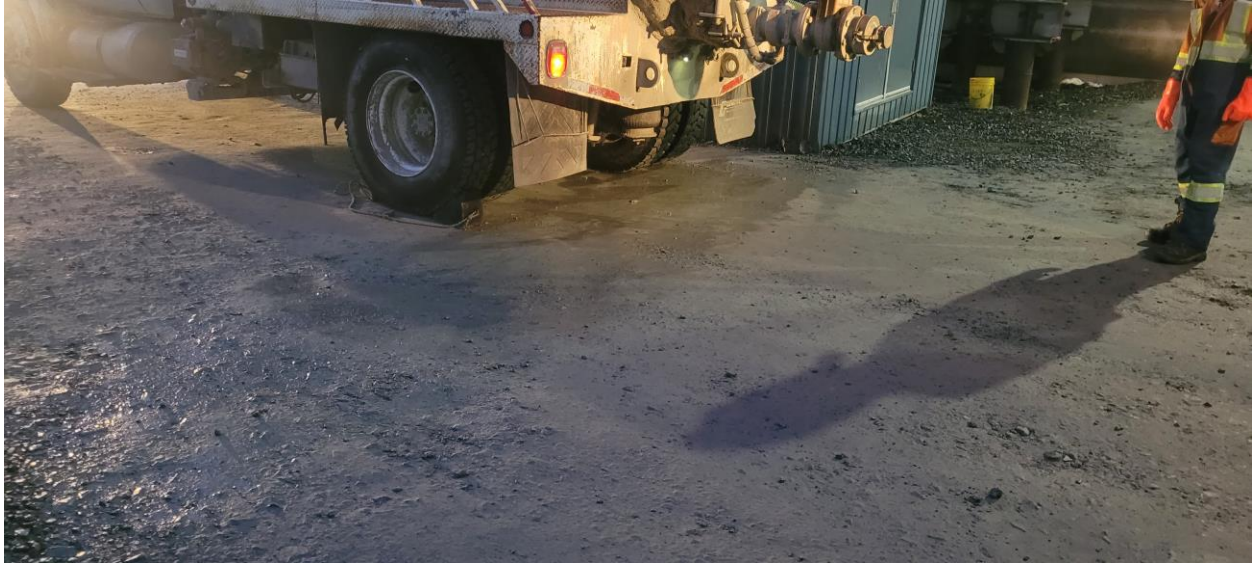
On September 30th, 2025, at approximately 6:30AM, a Surface Operations employee was training another on how to use the vacuum truck to perform a sewage transfer at the MSB lift station. The employee observed sewage leaking from a valve, releasing approximately 10 L of sewage onto the ground.

- After discharging the sewage during the transfer process, the employee unhooked the hose from the port before switching the transfer valve from the discharge position to the pump position.

Photo 1: Spill location.

The employee contacted their supervisor, who in turn contacted the Environment department by radio to notify them of the spill. The vacuum truck removed the contaminated water, and the contaminated material was excavated and brought to Landfarm A sorting area for remediation, as per the Spill Contingency Plan.

- A toolbox meeting was held by Surface Operations on October 21st to go over the incident and remind staff to keep focus on the task at hand to avoid preventable spills.

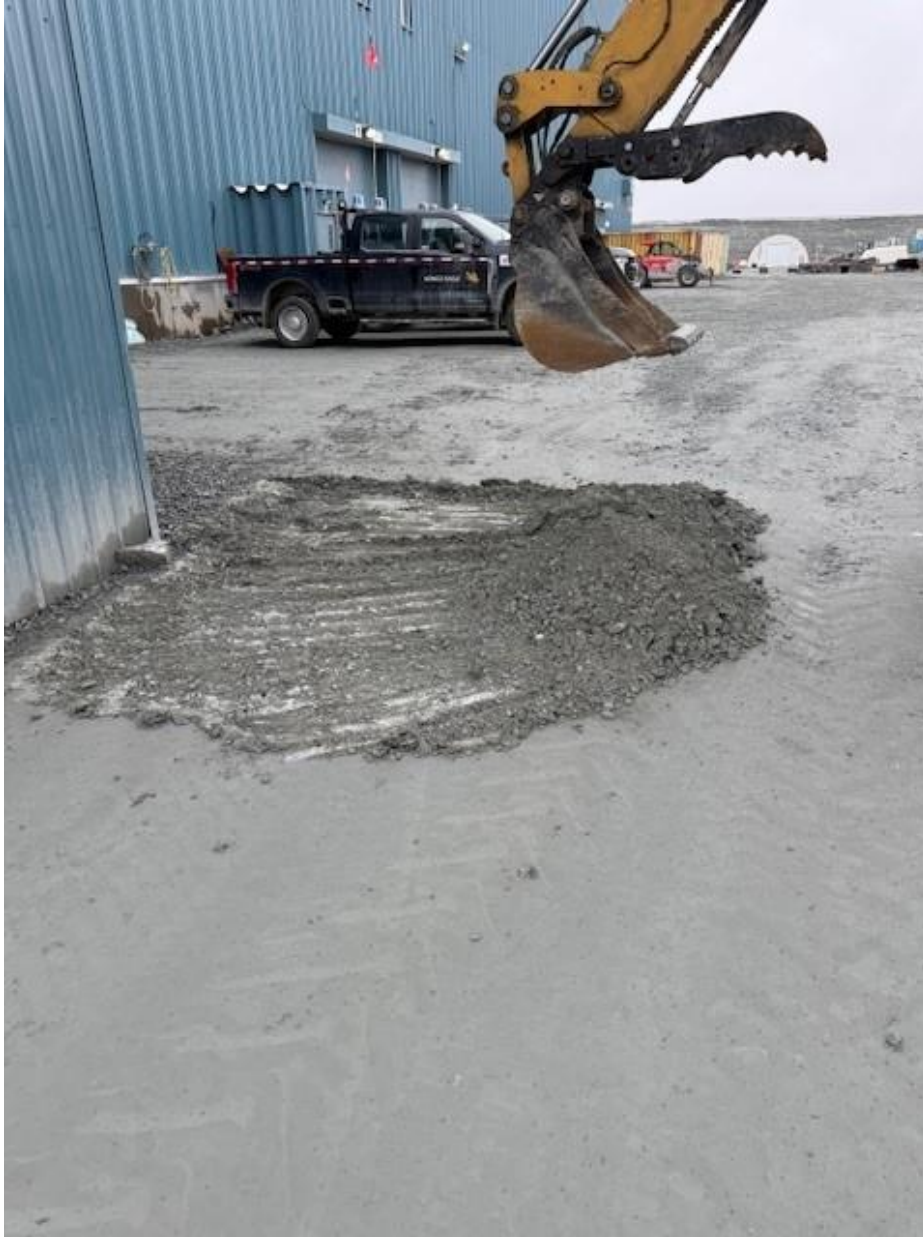
Photo 2: Spill location after remediation.
