November 2nd, 2025

Re: Follow-up Report Spill #2025-404 – Release of 140 L of hydraulic oil at the Meliadine Gold Project

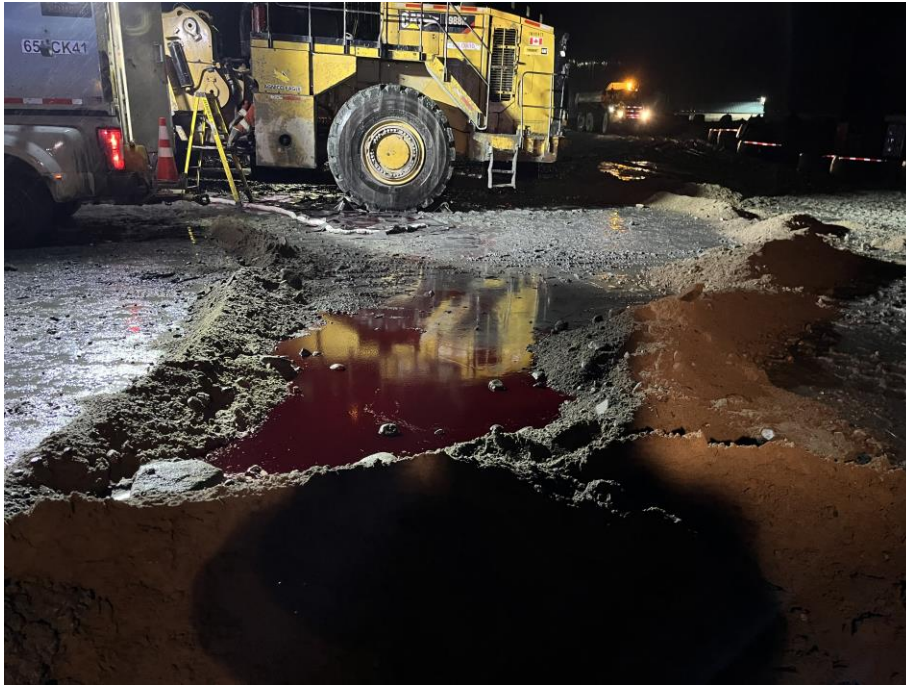
On October 4th, 2024, at approximately 9:00 PM, a worker in the Surface Operations department was operating a loader in the vicinity of the tailings dewatering building when a hydraulic line broke releasing approximately 140 L of hydraulic oil outside of the tailings dewatering building.

- The hydraulic hose broke due to wear.

Photo 1: Spill location.

The Surface Operations employee immediately stopped the equipment and contacted their supervisor. A spill kit was deployed to contain the spill. Sand was placed around the spill to prevent hydraulic oil from being washed away during rainfall. Contaminated spill pads were put in an oily solids Quatex bag and brought to a seacan at the hazardous materials laydown. Contaminated sand and excavated material were brought to Landfarm A for further remediation, as per the Spill Contingency Plan.

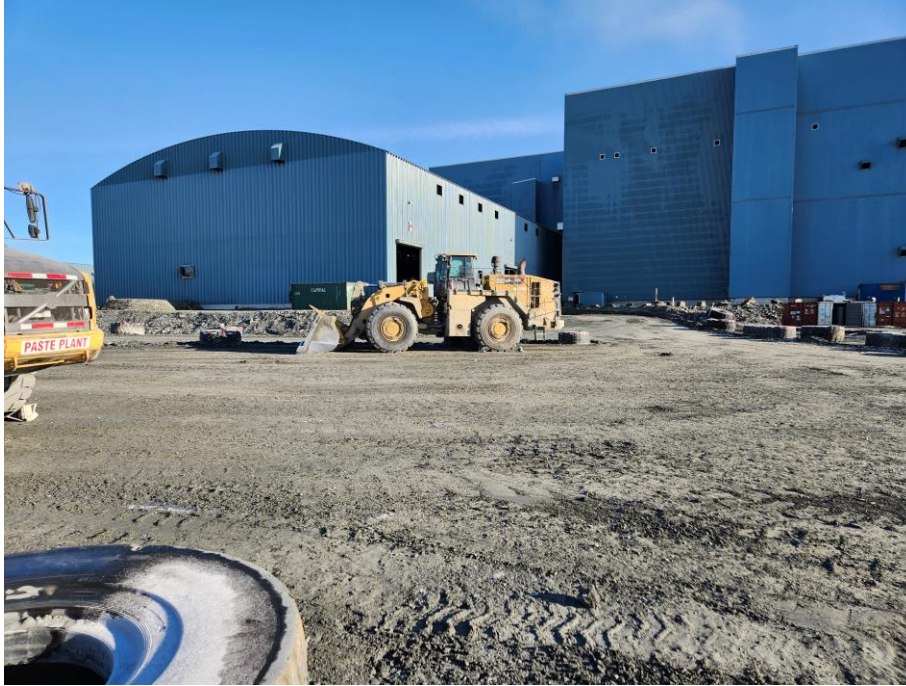
Photo 2: Spill location after remediation.
