Re: Follow-up Report Spill #2025-408 – Release of 100 L of Effluent Water Treatment Plant Sludge at the Meliadine Gold Project

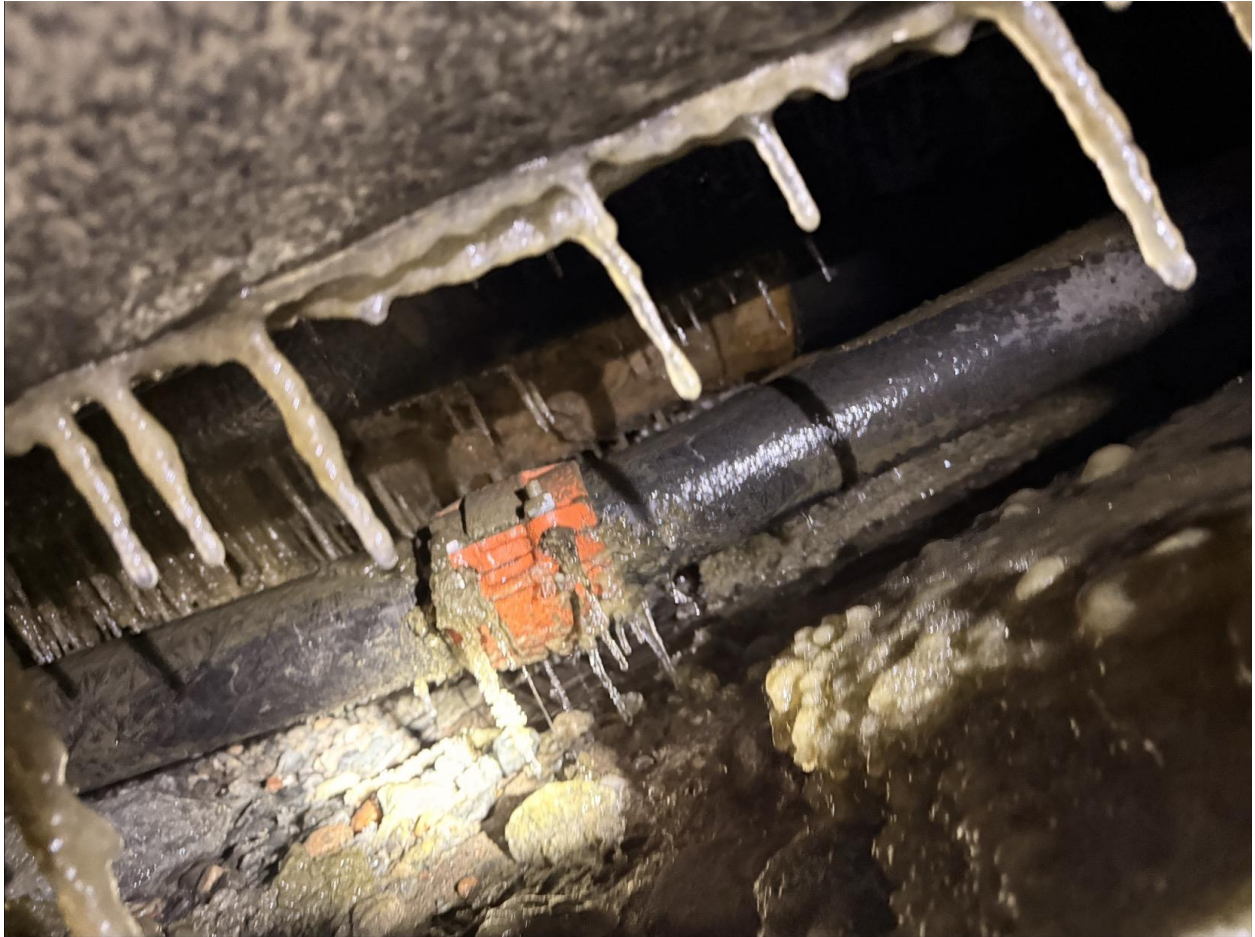
On October 8th, 2025, at approximately 1:30AM, it was noted during an inspection of the EWTP to TIRI02 sludge line that sludge was leaking from a hugger, releasing approximately 100 L of EWTP sludge onto the ground at the southern toe of CP1.

- The hugger loosened due to strain on the line and contraction of the HDPE in the winter, resulting in a slow leak.

Photo 1: Location of the spill.

- The line will be fused next open water season to limit the use of huggers.
