November 30th, 2025

Re: Follow-up Report Spill #2025-425 – Release of 30 L of sewage at the Meliadine Gold Project

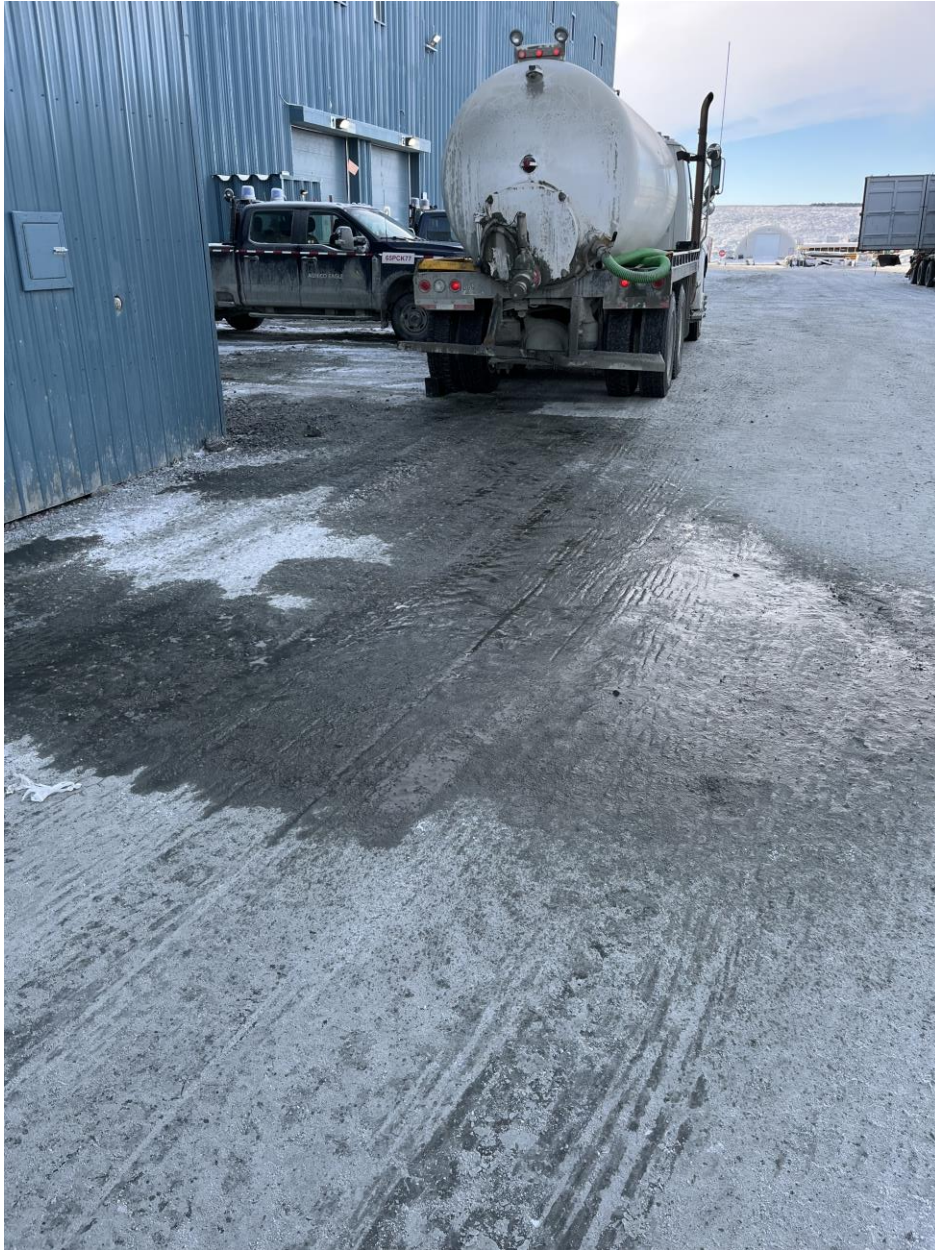
On October 31st, 2025, at approximately 12:30PM, a Surface Operations worker was performing a sewage transfer at the MSB lift station when they saw sewage leaking from around the tank level window at the back of the truck, resulting in a spill of approximately 30 L of sewage onto the industrial pad.

- A rental vacuum truck was used while the regular unit was under maintenance. The rental truck had a worn seal around the tank level window, which allowed the release.

Photo 1: Spill location.

Upon discovering the leak, the worker reversed the valve on the sewage truck to stop suction and prevent further leakage. They then called their supervisor and Environment personnel to declare the spill. Surface Operations workers then used the vacuum truck to clean the sewage spilled on the ground. The contaminated soil was excavated and brought to Landfarm A as per the Spill Contingency Plan.

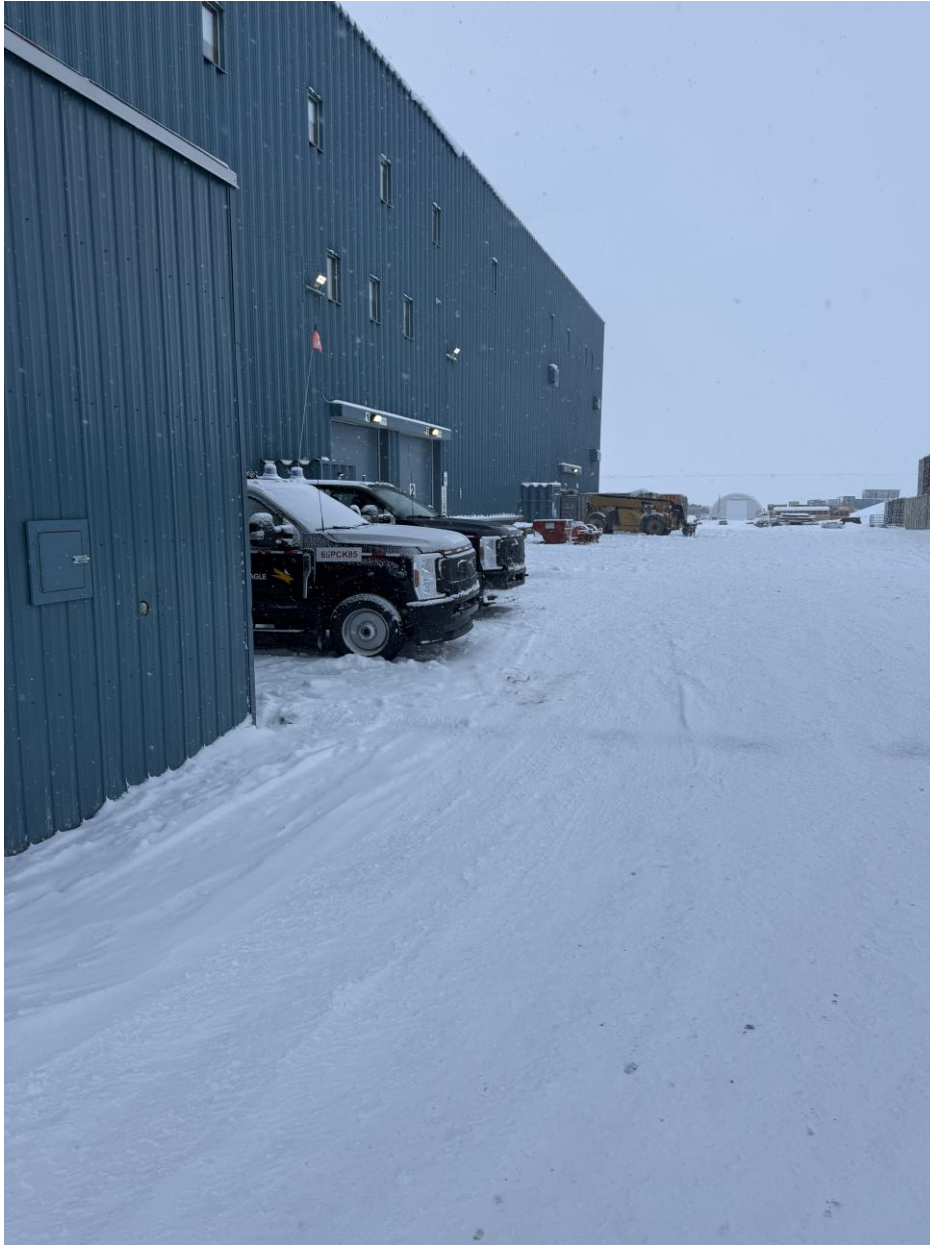
Photo 2: Spill location after remediation.
