December 16, 2025

**Re: Follow-up Report Spill #2025-444 – Release of 10 L of sewage at the Meliadine Gold Project**

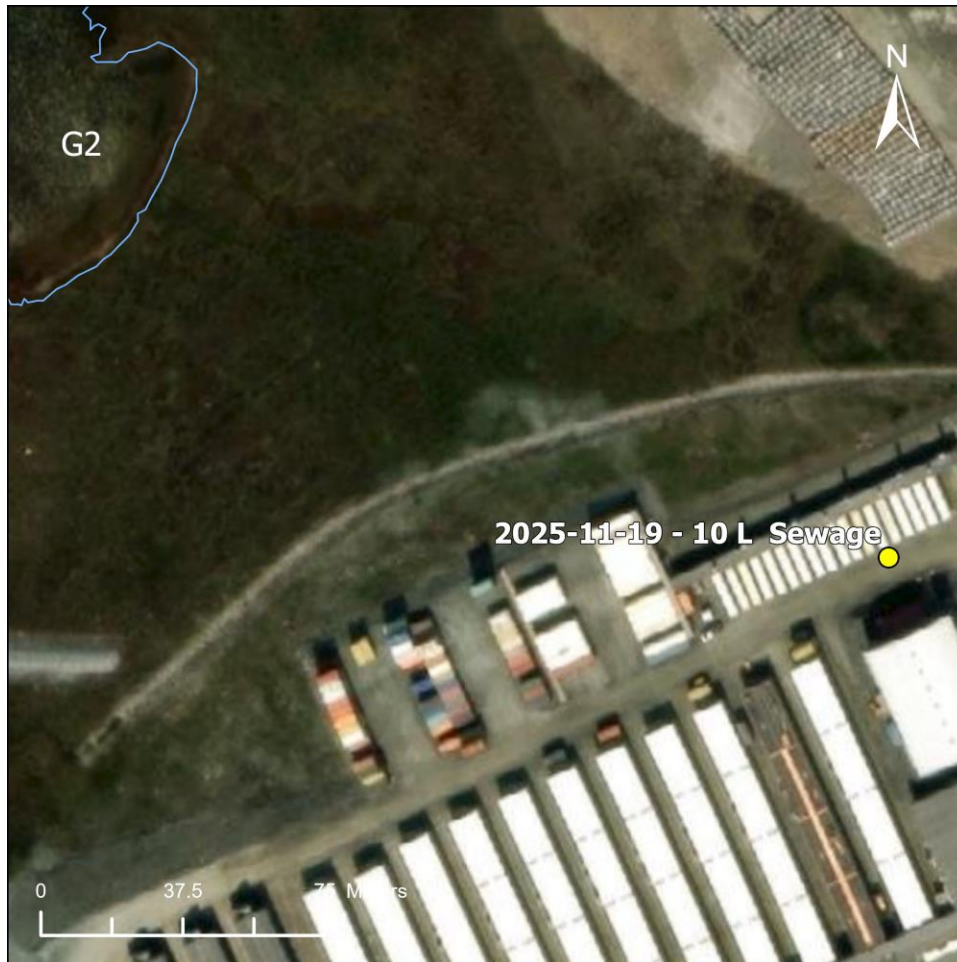
The spill occurred within the bounds of the site's runoff collection system; no water bodies were impacted or at risk of being impacted by the spill. The closest water body (Lake G2) is approximately 216 meters northwest (Figure 1).

**Figure 1:** Location of the spill and proximity to waterbodies.

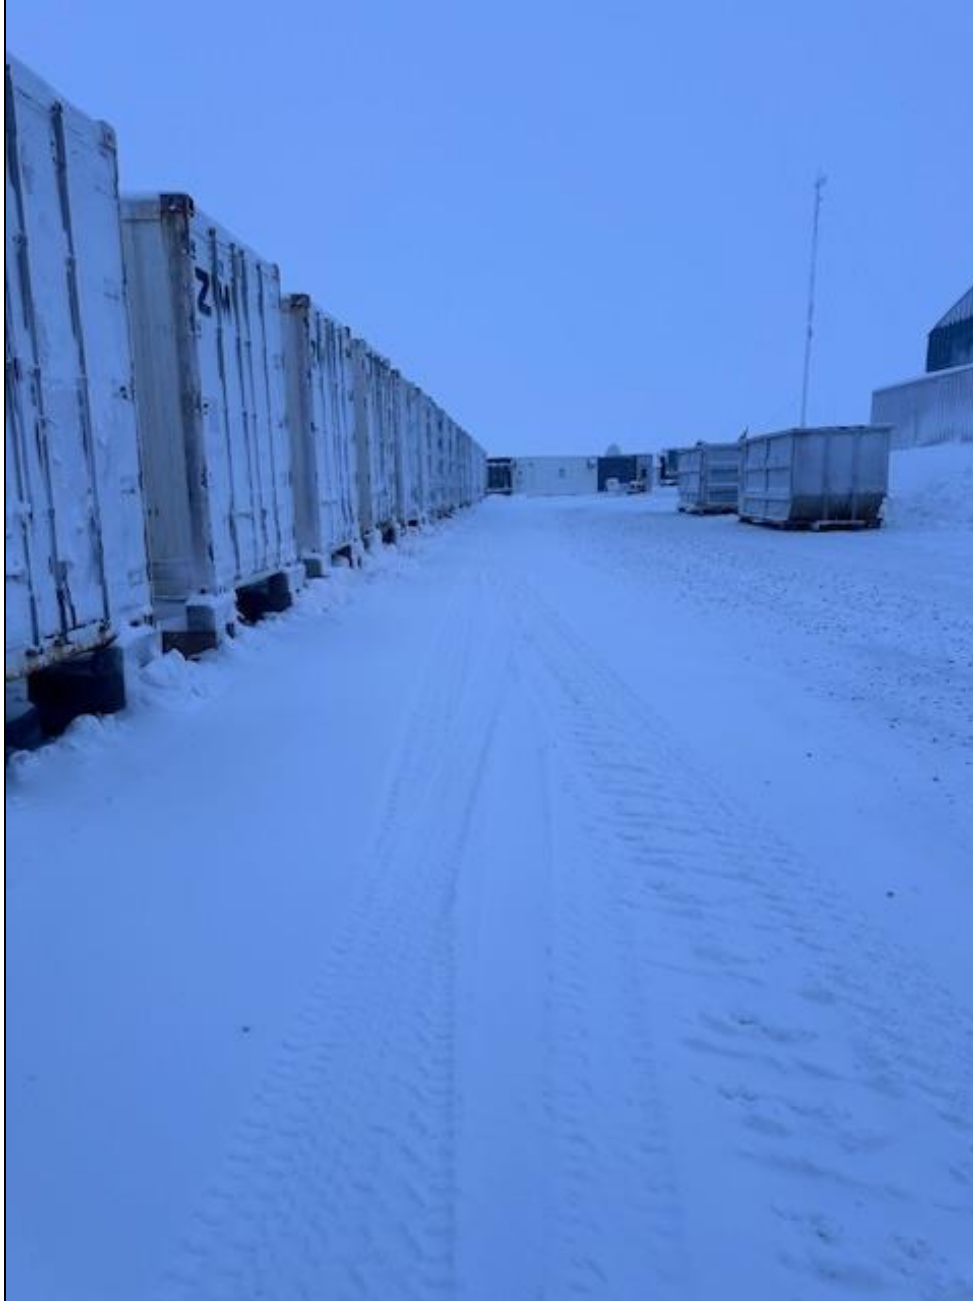
On November 19<sup>th</sup>, 2025, at approximately 8:30AM, while driving the vacuum truck on his sewage transfer route, a Surface Operations employee noticed that sewage was leaking from the discharge valve behind the truck. The employee stopped the truck and realized that approximately 10L of sewage spilled onto the ground behind the Gymnasium.

- The discharge valve on the truck was worn out, and with the vibration of the truck while driving, caused the valve to open and leak.
- No pre-inspection was completed prior to borrowing the Municipal vacuum truck in town.

**Photo 1:** Spill location after remediation.

The Surface Operations employee reached out to their supervisor for help in stopping the spill. They immediately started remediation using an excavator. Contaminated material was then brought to Landfarm A as per the Spill Contingency plan.

- Surface Operations personnel are no longer using the vacuum truck.
- In the event of emergency where AEM requests to borrow the municipal vacuum truck, a pre-op inspection will be conducted in Rankin Inlet prior to transporting the vacuum truck to site.
