Re: Follow-up Report Spill #2025-457 – Release of 40 L of sewage at the Meliadine Gold Project

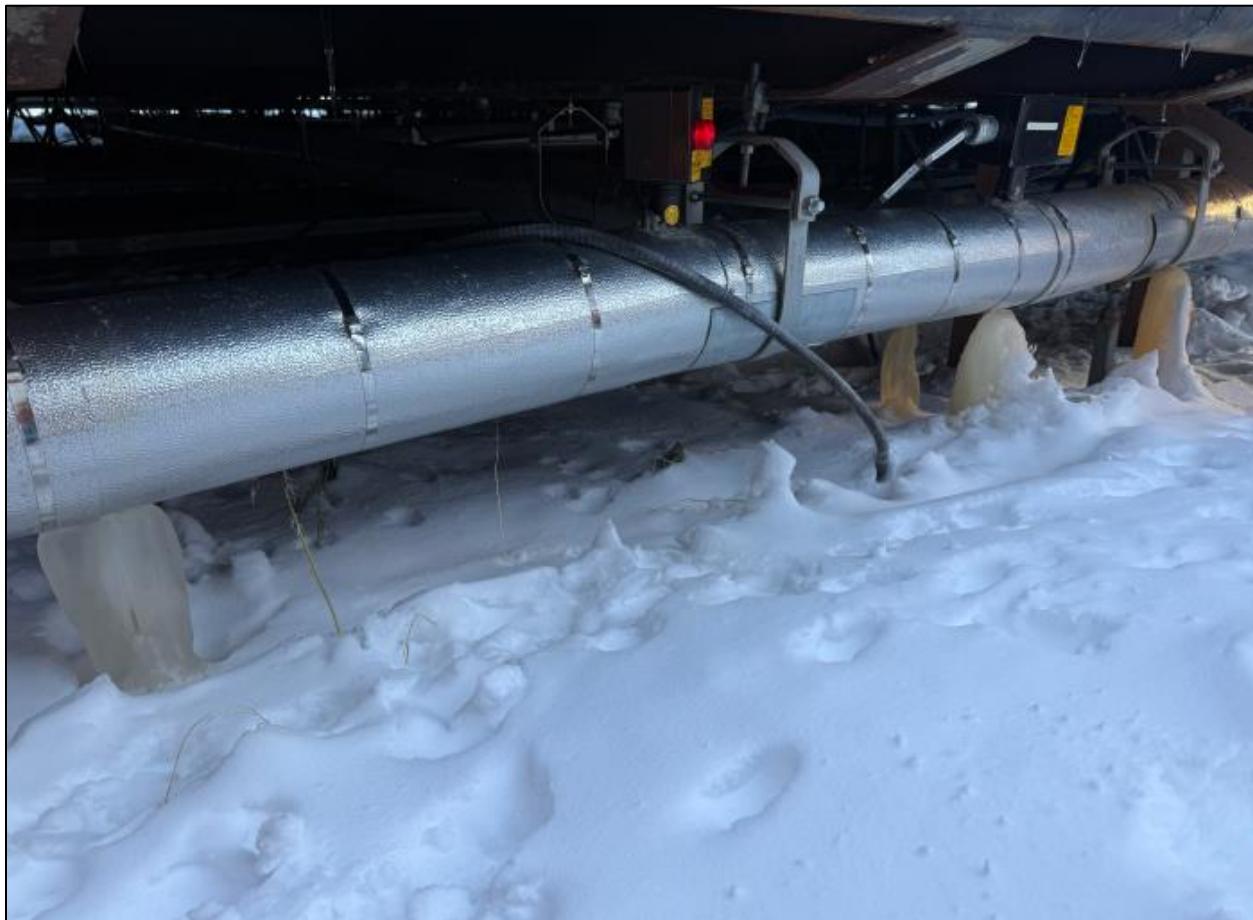
On December 4th, 2025, at approximately 5:00PM, an Energy and Infrastructure (E&I) maintenance employee noticed that multiple icicles had formed under the cafeteria's kitchen and bathroom drain line on the exterior of the building.

- Extreme cold temperatures caused a failure (crack or separation) in the kitchen drain line, allowing sewage to escape.
- The line later sealed when ice formed in and around the damaged area, stopping the active leak.

Photo 1: Spill location.

Contaminated material (ice and affected snow) was collected and transported to Landfarm A in accordance with the Spill Contingency plan.

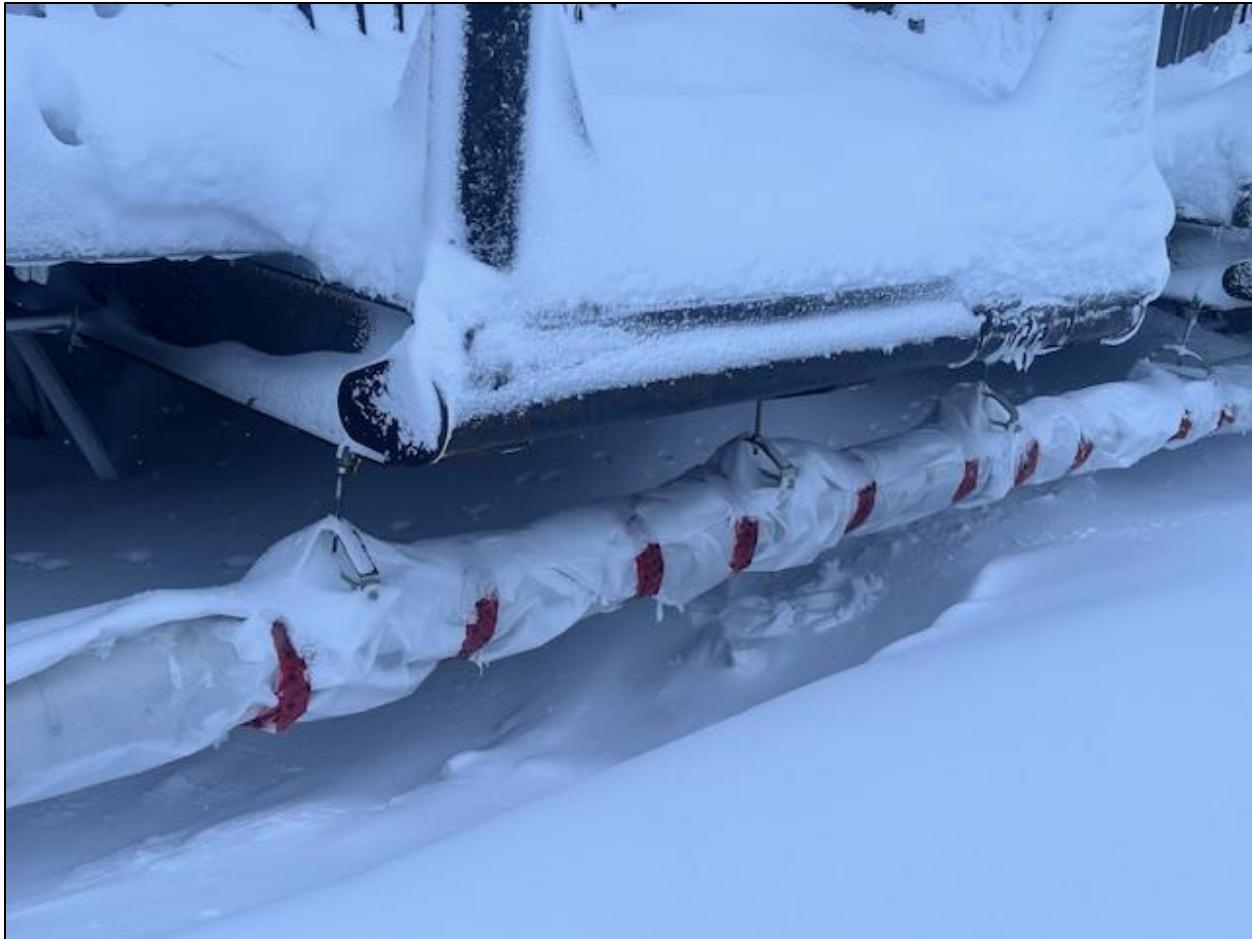
Photo 2: Spill location after remediation and tarp installation.

- A tarp was installed around the section of pipe that leaked near the kitchen to provide temporary protection and containment.
- The line will be inspected frequently (up to daily) throughout the remainder of the winter to check for signs of renewed leakage.
- A full inspection and any required repairs will be completed during the summer, when the heat trace system can be safely deactivated and the line exposed without increasing the risk of another spill.
