January 13, 2026

**Re: Follow-up Report Spill #2025-473 – Release of 3300 L of diesel at the Meliadine Gold Project**

**Description of Incident**

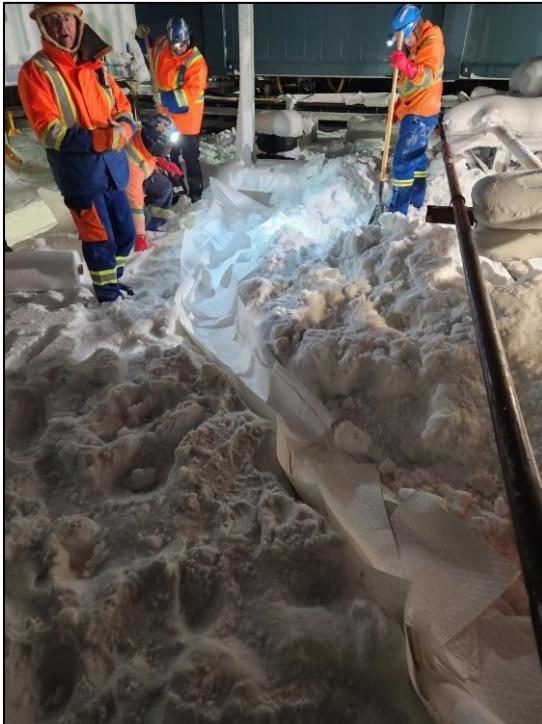
The spill occurred on a concrete pad within the bounds of the site's runoff collection system; no water bodies were impacted. The closest water body (Lake 1775) is approximately 352 meters north (Figure 1).

**Photos 1:** Spill location

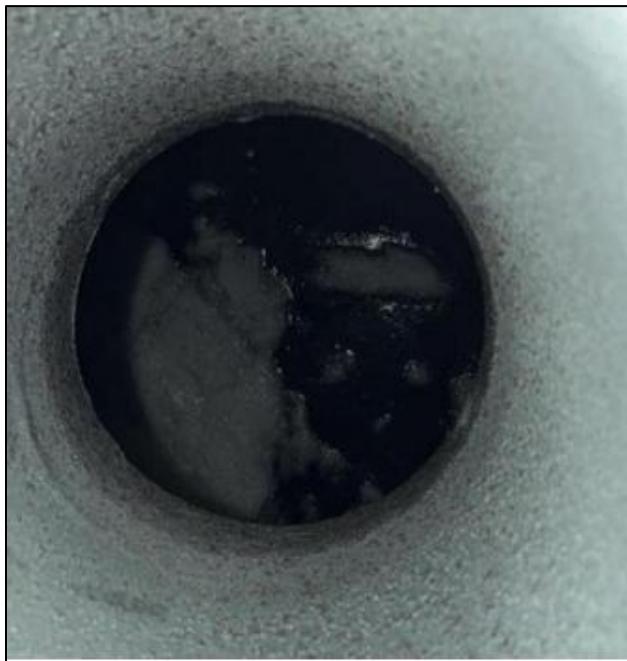
The immediate cause of the incident was summer-grade fuel freezing within the tank, forming paraffin chunks that likely obstructed the tank's analog level sensor, resulting in faulty readings (see Figure 4). Although winter-grade fuel was in the system at the time of the spill, these paraffin chunks remained. This obstruction caused the sensor to display artificially low fuel levels, which triggered automatic filling. The filling activated the high-high level alarm, which would typically interlock the fuel transfer sequence and terminate the transaction. However, because the analog sensor continued to report low fuel levels, it overrode the high-high level alarm, cleared the alarm, and initiated a new fuel transfer sequence. This cycle persisted for approximately 24 minutes, causing repeated fuel injections that ultimately overflowed the tank. However, the persistence of the low-level alarm eventually prompted human intervention.

**Photo 2:** Paraffin in diesel tank from summer fuel being left in tank too late into winter.

- A visual inspection to remove paraffin clumps from this tank has been completed and any tank that contained summer fuel has been scheduled to be inspected January 14<sup>th</sup>.

- The analog level sensor was proactively replaced on December 26 and reconfigured to transmit an upper-range value when inaccurate data is detected.
- A preventive maintenance task has been established to schedule the switch to winter fuel earlier in the year (end of August), starting in 2026.

- A checklist has been created to ensure that summer fuel is emptied in the daily tanks prior to winter.

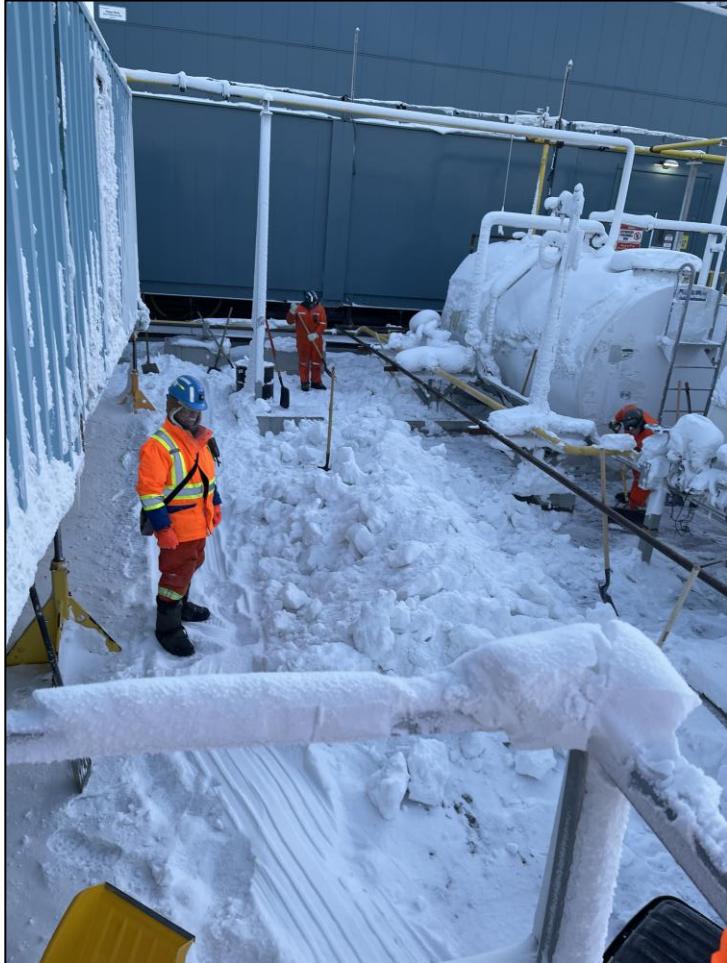
After absorption, the contaminated pads were collected, filling two Quatrex bags (approximately  $1.5 \text{ m}^3$ ), and transported to the hazmat laydown area for shipment south for proper disposal. The contaminated snow was excavated by hand and machine and moved to the Snow Cell in accordance with the Spill Contingency Plan; approximately  $6 \text{ m}^3$  of snow was removed. Since the spill occurred on a concrete pad and the ground was frozen solid, no diesel entered the environment. Snow and ice were scraped until the concrete surface was exposed.

**Photo 3:** Spill location during remediation

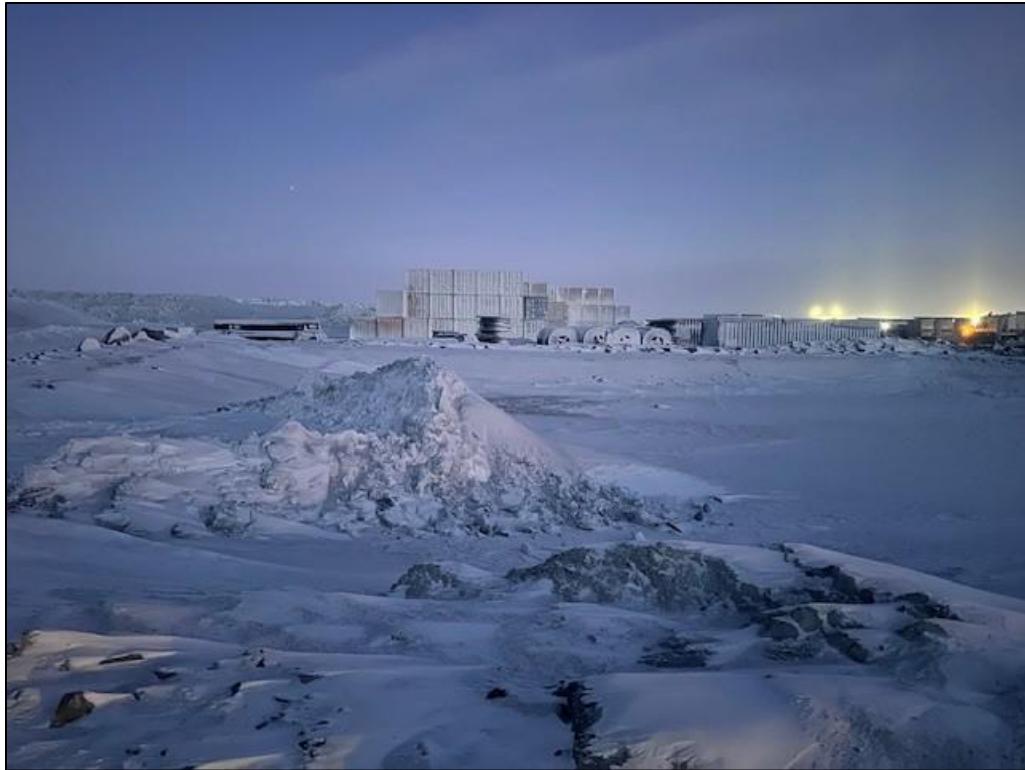
**Photo 4:** Material collected and placed at the contaminated Snow Cell
