January 13, 2026

Re: Follow-up Report Spill #2025-472 – Release of 6 m³ of sewage at the Meliadine Gold Project

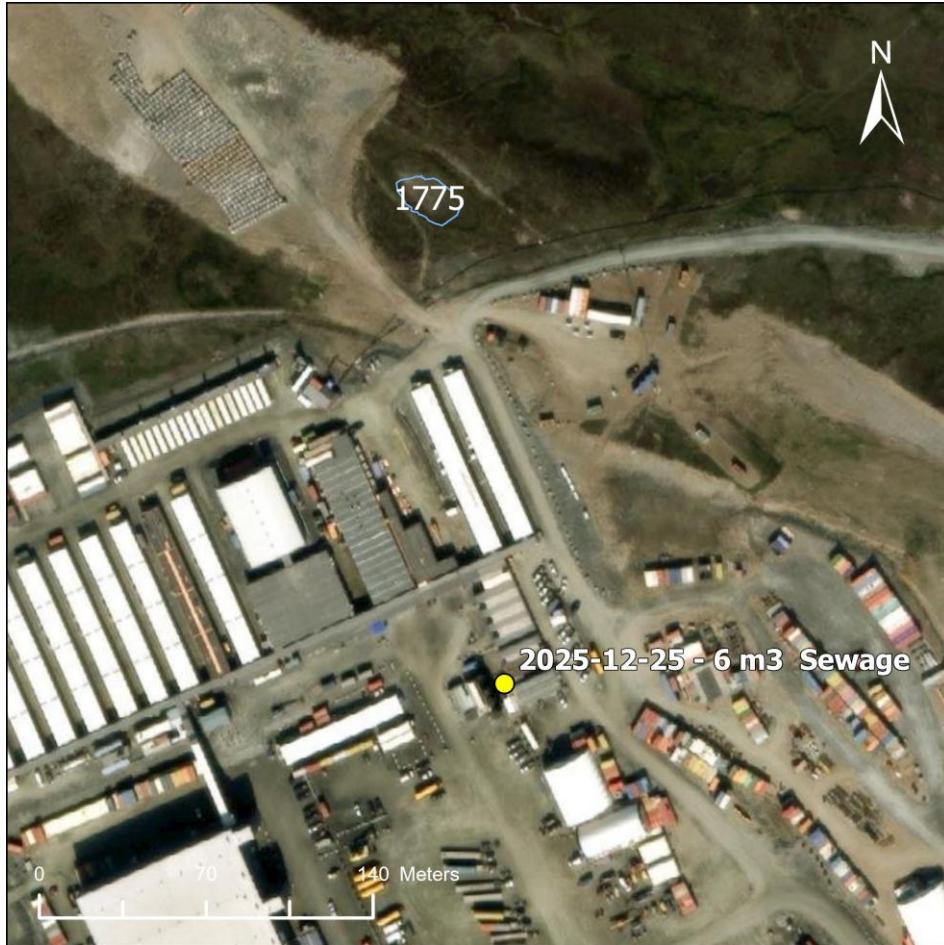
The spill occurred within the bounds of the site's runoff collection system; no water bodies were impacted. The closest water body (1775) is approximately 187 meters north (Figure 1).

Figure 1: Location of the spill and proximity to waterbodies.

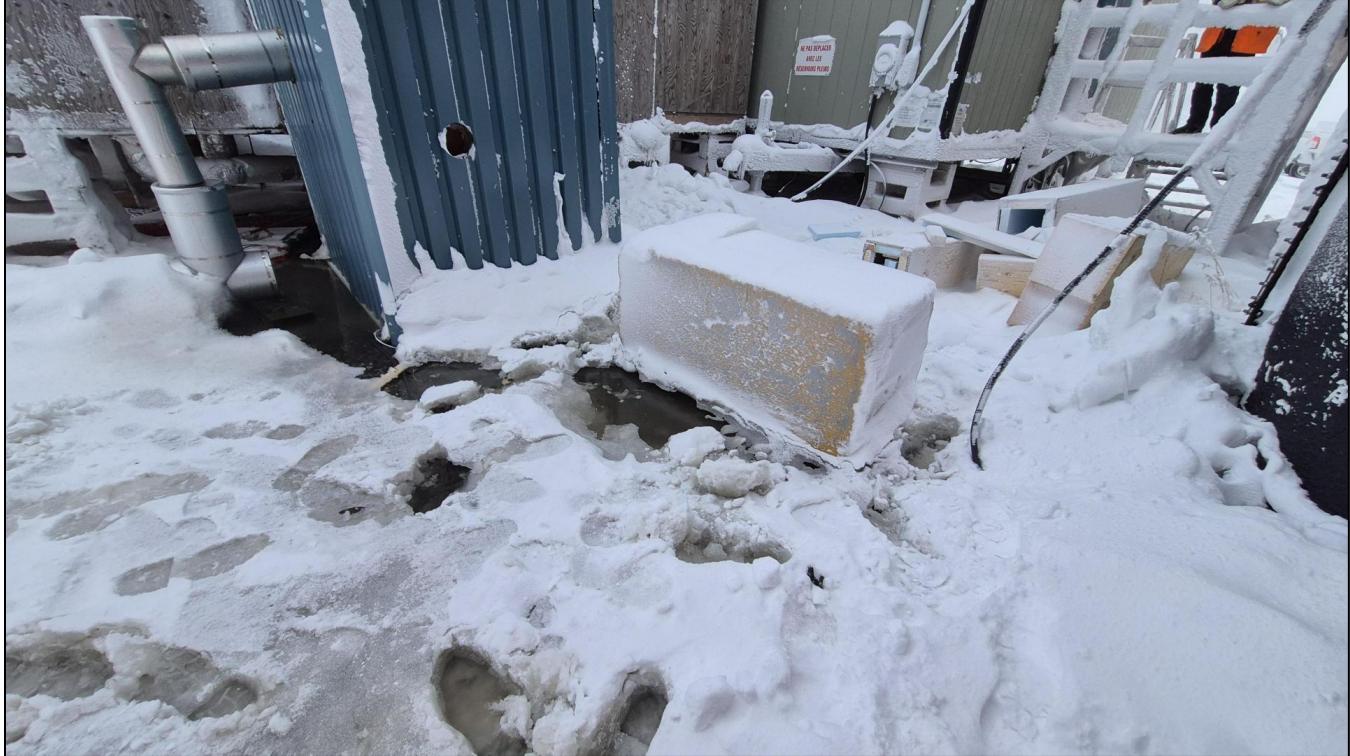
On December 25th, 2025, at approximately 1:00PM, an Energy and Infrastructure (E&I) Maintenance employee was working at the Sewage Treatment Plant (STP) when he noticed sewage was spilling from an external pipe connected to the C-wing lift station building, an emergency wing that is only opened when space at camp is limited. Approximately 6 m³ of sewage over an area of 125 m² spilled onto the ground between the C-wing and the STP.

- Wear and tear were observed on the seal of the external piping at the C-wing lift station where the failure occurred. This section of the line is located outdoors and was installed without insulation, increasing the risk of freezing and subsequent failure.

Photo 1: Spill Location

- A plan has been made by E&I Maintenance and Environment for the containment and cleanup of the contaminated water upon freshet in the spring of 2026.
- A work order has been created to improve the external C-wing sewage line and lift station in the spring of 2026
 - Redo of the entire line and seals, adding insulation and a check valve.
 - Adjust the lift station float to a lower-level setting, so that the pump starts more often to prevent freezing up the line.

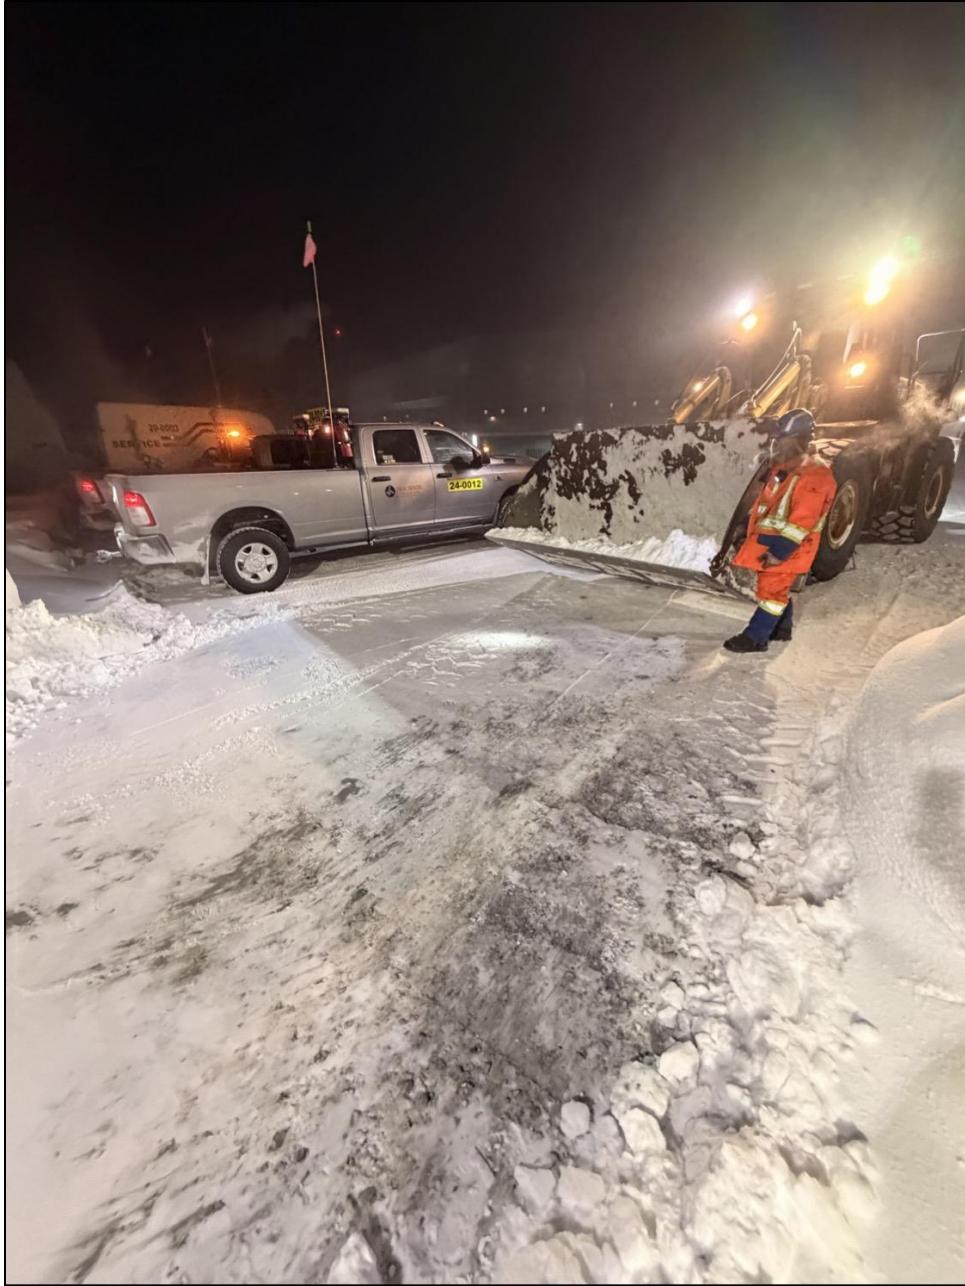
Photo 2: Spill location after remediation

The E&I Maintenance team promptly closed the valve to prevent further spillage and notified their supervisor and the Environment Department. The area where the spill occurred is tightly confined by infrastructure which affected the recovery of spilled material. Freezing conditions also affected recovery. Additional clean-up will be conducted as is feasible during summer 2026. All contaminated material will be managed and disposed of in compliance with the Spill Contingency Plan.
