Re: Follow-up Report Spill #2026-004 – Release of 80 L of Sewage at the Meliadine Gold Project

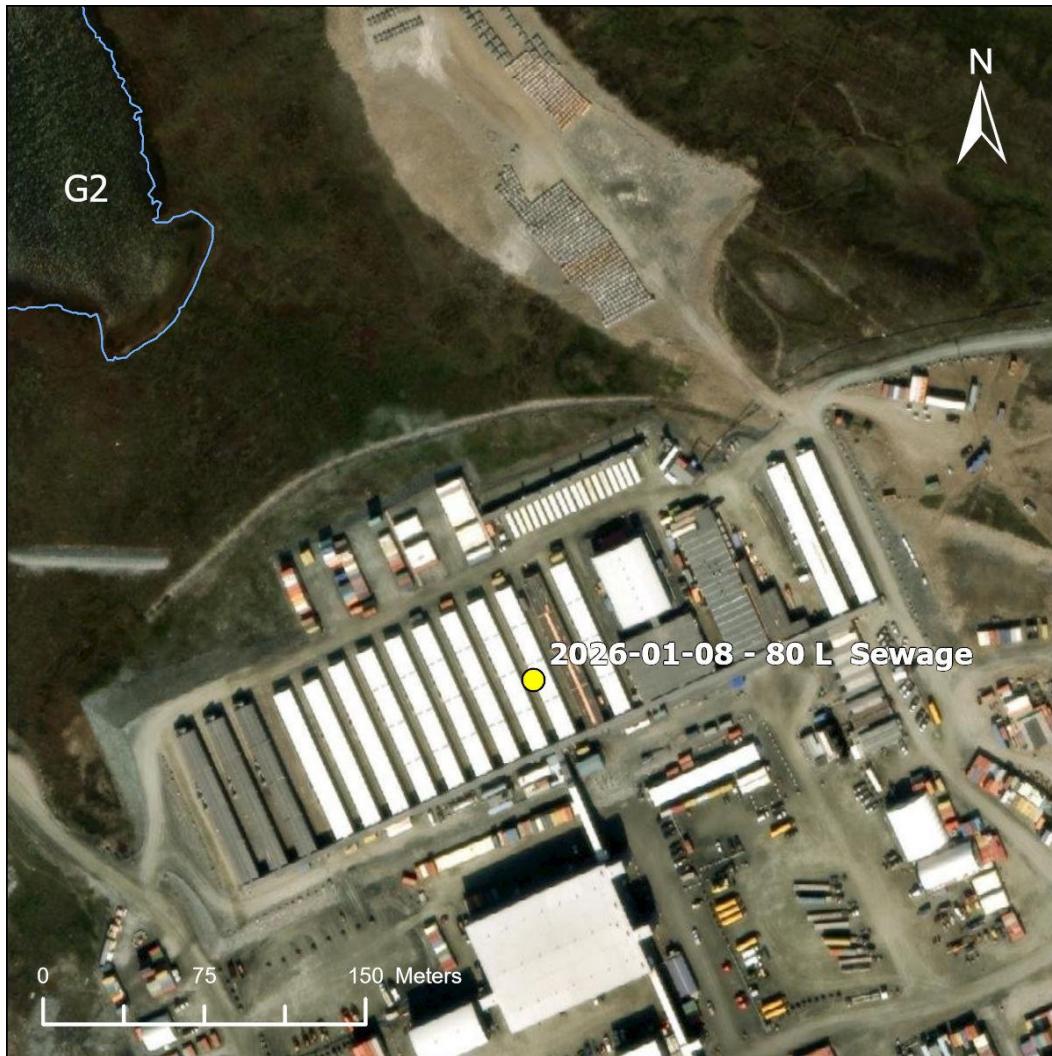
The spill occurred within the site's water management infrastructure, and as such, no waterbodies were impacted by the spill. The closest water body (Lake G2) is approximately 235 meters northwest, as seen in Figure 1.

Figure 1: Location of the spill and proximity to waterbodies.

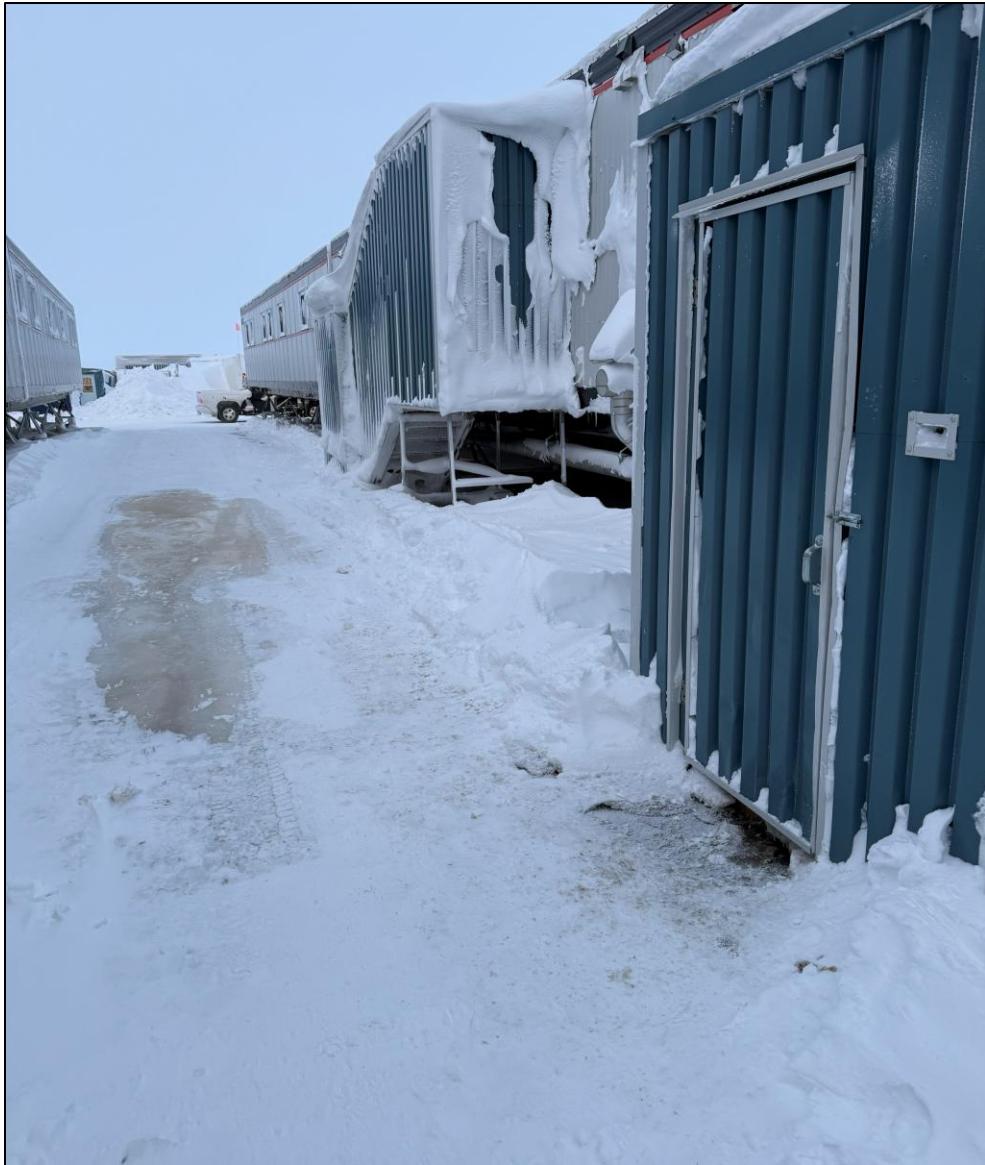
On January 8th, 2026, at 09:00, approximately 80 L of sewage spilled onto the industrial pad outside the Wing 2 lift station. Upon inspection, it was discovered the lift station pump impeller was obstructed by non-compliant material, which led to the pump's failure and caused the lift station to overflow.

- Non-compliant material was flushed down a toilet in Wing 2. This resulted in the pump's impeller being obstructed and clogged, which led to the pump's failure and the lift station overflow.

Photo 1: Spill location

Upon discovering the spill, a vacuum truck and a plumber were dispatched to respond to the spill. The vacuum truck was utilized to empty the contents within the secondary containment. The contaminated material was recovered and transported to Landfarm A in accordance with the Spill Contingency Plan.

- A verification was done to ensure that the instructional signs for non-compliant material were posted in every bathroom in wing 2.
- A Meliadine Minute regarding what cannot be flushed down the toilet was distributed to the entire site.

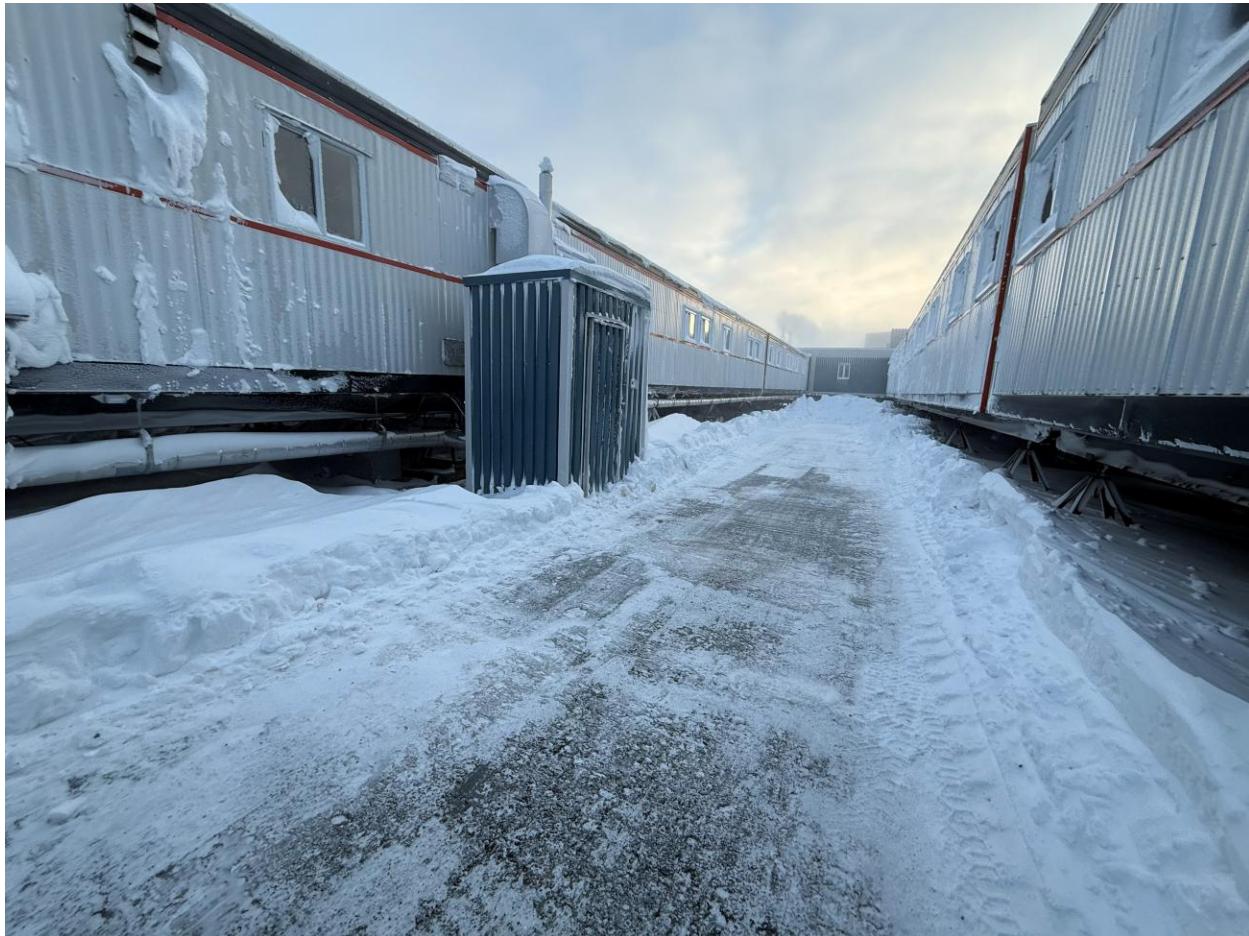
Photo 2: Spill location post remediation
