February 16th, 2026

Re: Follow-up Report Spill #2026-104 – Release of 850 L of emulsion at the Meliadine Gold Project

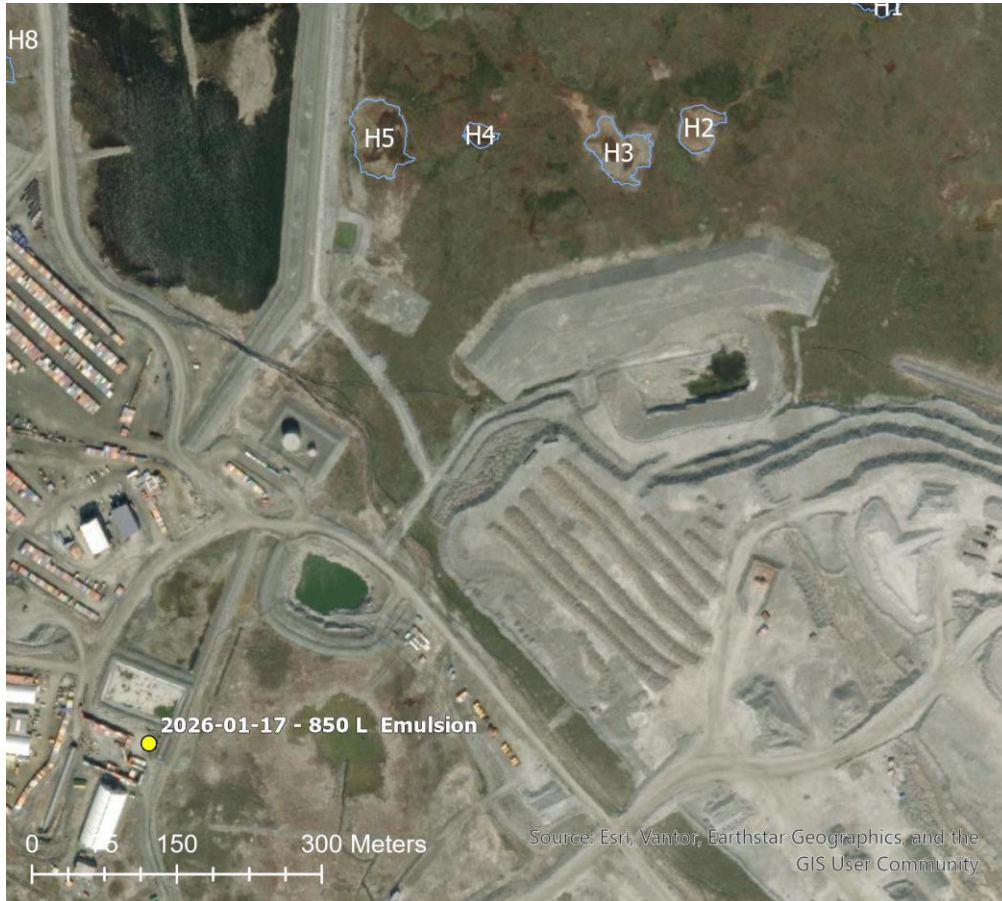
The spill occurred within the site's water management infrastructure, and as such, no waterbodies were impacted by the spill. The closest water body (H5) is approximately 655 meters northeast, as seen in Figure 1.

Figure 1: Location of the spill and proximity to waterbodies.

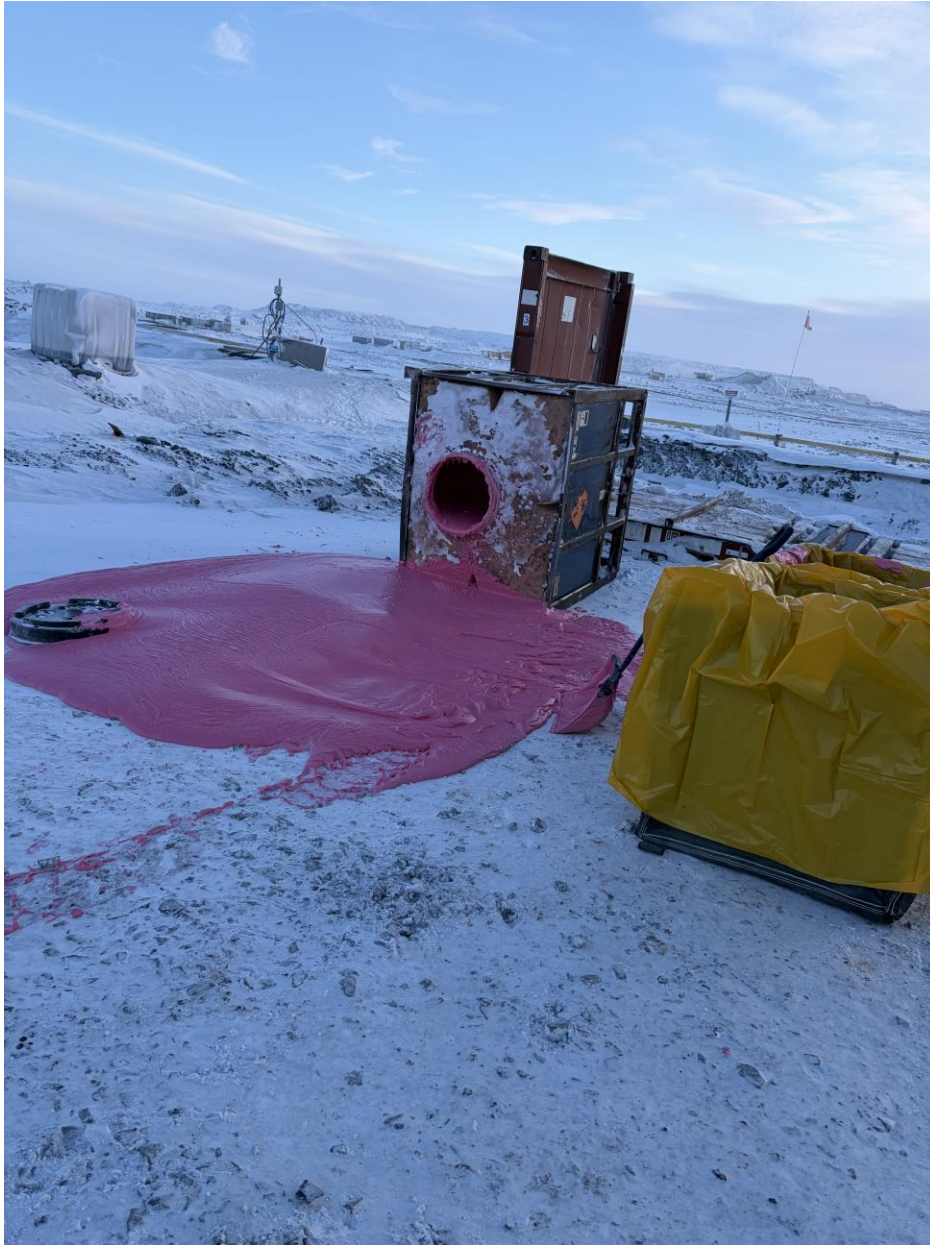
On January 17th, 2026, at approximately 9:30AM, 850 L of emulsion was spilled at the Portal 1 emulsion pad. While attempting to move a bin of emulsion off a flatbed truck with a telehandler, the bin on the forks got caught on the bin next to it, causing the bin to slide off the forks and flip on its side, spilling most of its contents.

- Ineffective communication between the operator and the spotter. While a spotter was assigned, they did not adequately communicate the risk associated with the falling bin. This represents a failure in both spotter and operator performance, as well as a gap in training.

Photo 1: Emulsion spill location, Portal 1 laydown.

The operator immediately notified their supervisor and the acting Environment coordinator to report the spill. Given the freezing temperatures and natural viscosity of the emulsion, the spill was easily contained to an approximate area of 3 m². Underground personnel hand shoveled the emulsion into Quatrex bags, to be later recirculated in the emulsion plant. A loader was then used to scrape up any remaining traces; the contaminated material was collected and disposed of in a bore hole for an upcoming blast.

- All underground crews were required to review the spotter procedure. In addition, morning safety meetings reinforced the importance of the spotter maintaining continuous visual contact with the load and ensuring clear communication is made with the operator if needed. The procedure review and discussions also emphasized the need to inspect the load prior to any movement to help prevent potential entanglements or similar incidents in the future.

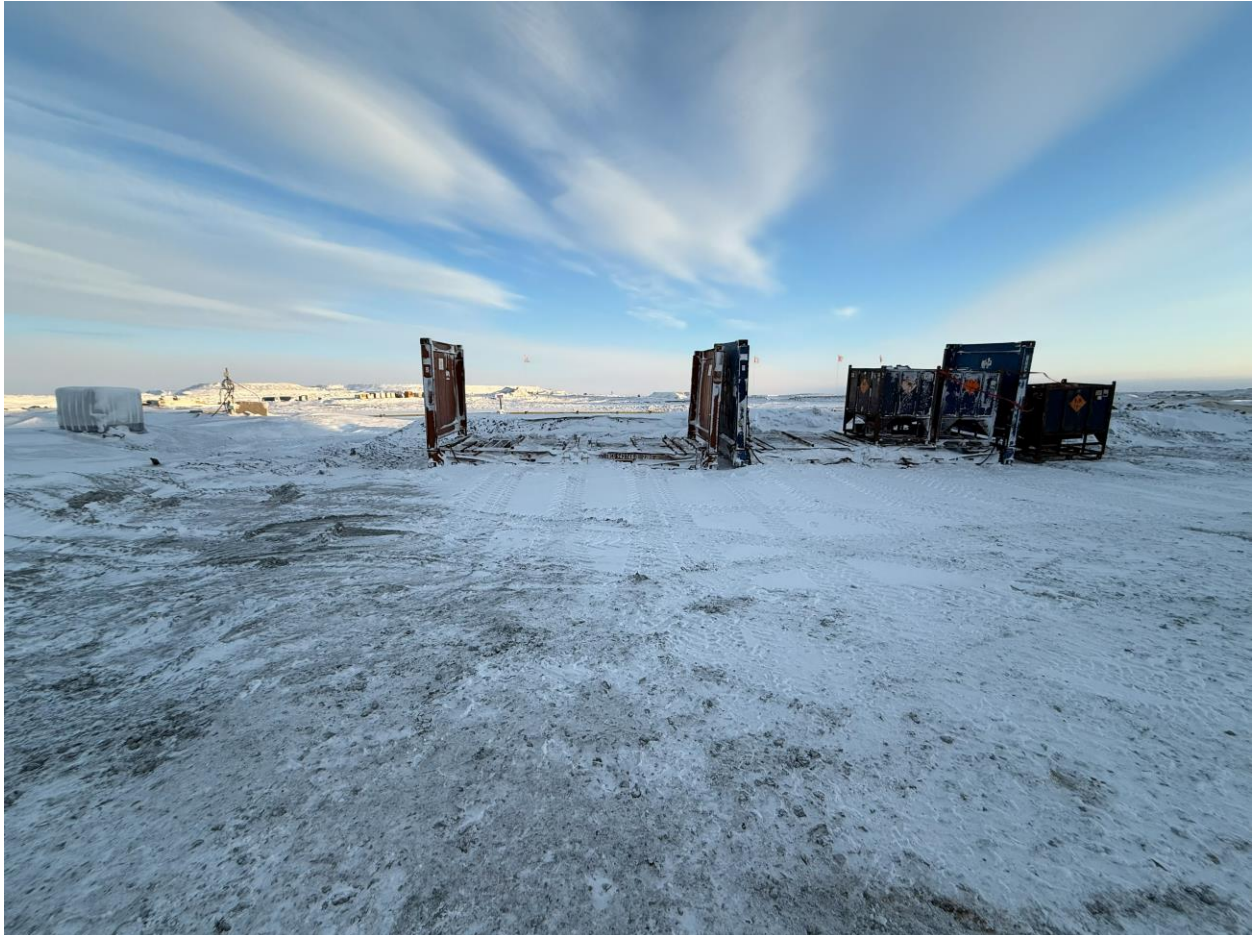
Photo 2: Emulsion spill location, remediated.
