March 28, 2026

Re: Follow-up Report Spill #2026-052 – Release of 250 L of Glycol at the Meliadine Gold Project

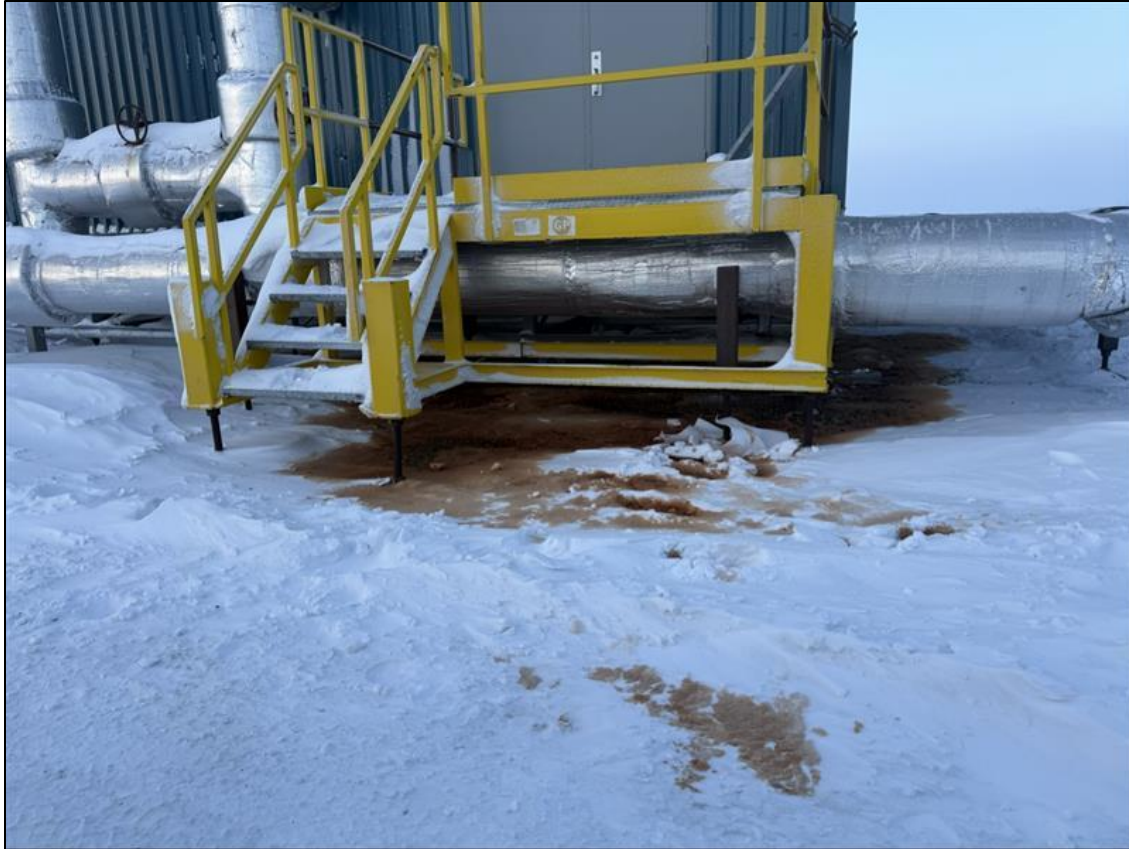
On February 27th, 2026, at approximately 10:30PM, 250 L of glycol was found on the ground at the east vent raise. The pump is in the pump house at the east vent raise. While most of the glycol was contained within the building, some escaped through the entryway.

- A mechanical seal failed on a glycol pump, causing the spill. This pump had been inactive for over a year. Upon startup, the pump seal failed due to having dried out during the extended period of inactivity.

Photo 1: Spill location.

- A work order has been created to modify the building by installing a secondary containment berm around the pump platform, in order to reduce the risk of material escaping the building in the future.

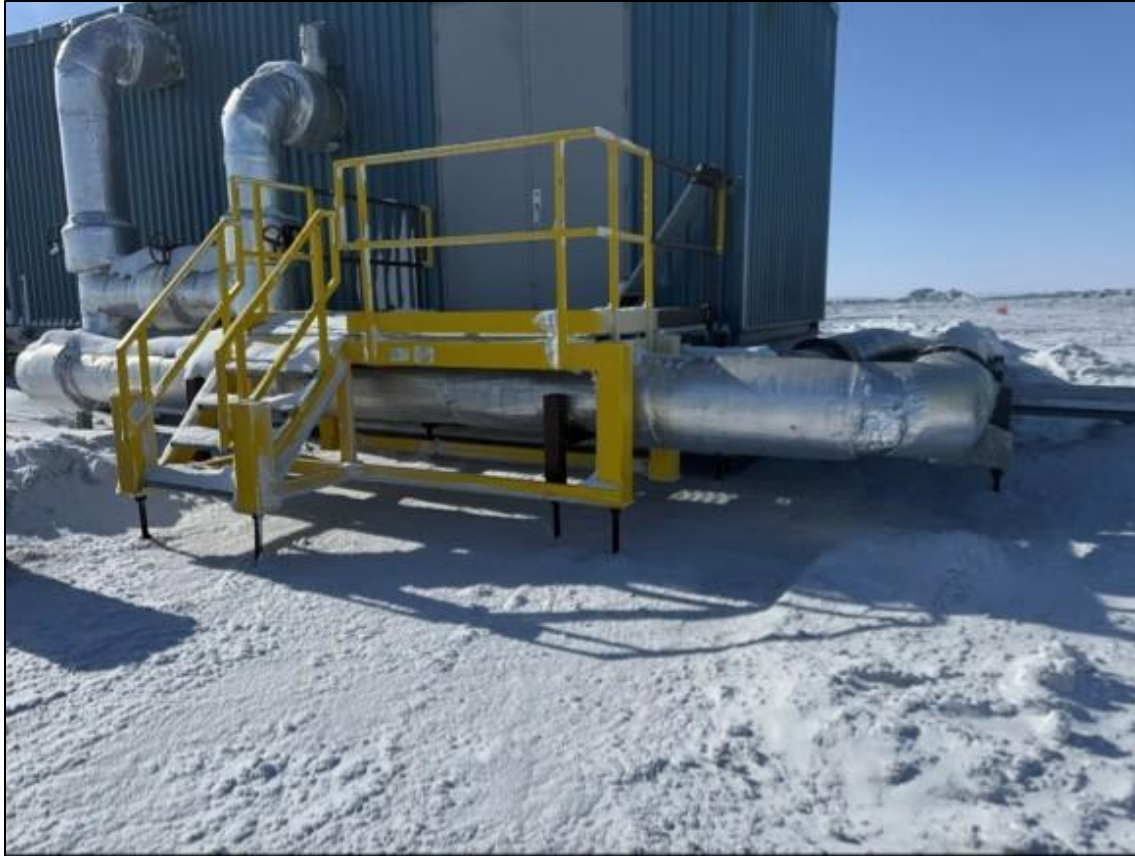
Photo 2: Spill location after remediation.

An employee observed the spill while passing through the area and immediately notified the E&I Maintenance Supervisor. The E&I supervisor requested the employee to activate the emergency stop on the pump to halt the leak and prevent further release. The majority of the spilled material accumulated beneath the infrastructure. A spill kit was deployed, and all accessible products were recovered using a sucker truck and by hand-shoveling the remaining material into drums. Contaminated soil and used spill response materials were placed into two quatex bags and transferred to a hazmat laydown area for shipment south in accordance with the Spill Contingency Plan.
