April 03, 2026

Re: Follow-up Report Spill #2026-063 – Release of 200 L of diesel at the Meliadine Gold Project

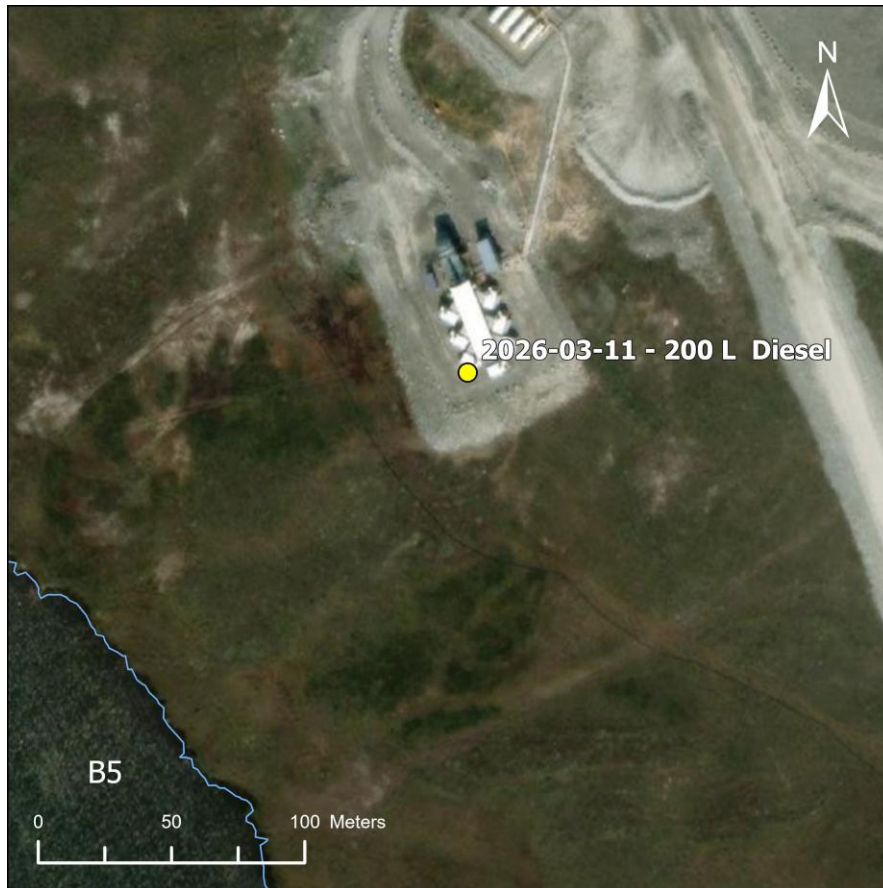
The spill did not occur within the bounds of the site's runoff collection system, although the spill was contained in the close vicinity of the West Vent Raise building. No water bodies were impacted or at risk of being impacted by the spill. The closest water body (Lake B5) is approximately 230 meters West (Figure 1).

Figure 1: Location of the spill and proximity to waterbodies.

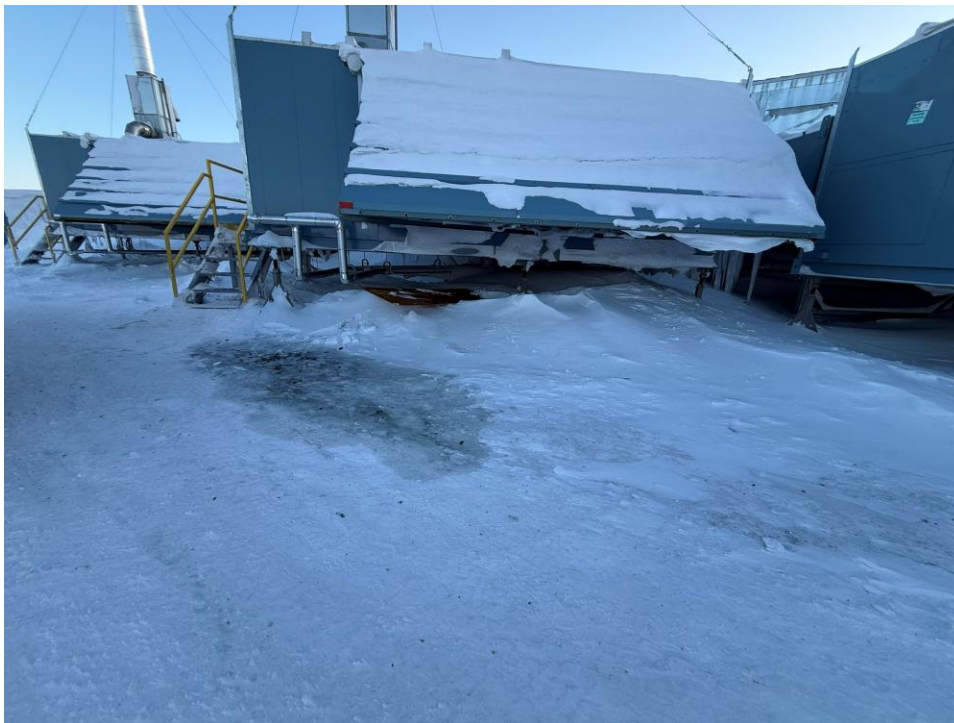
On March 11th, 2026, at approximately 7:00am, an Energy and Infrastructure (E&I) employee was performing their daily check at the West Vent Raise, when they noticed that diesel was spilling outside of the burner #2 room. They quickly went inside to isolate a pressure-reducing valve that had failed on the diesel supply line of the burner. The burner module was fully isolated from the diesel supply and has been locked out since the incident. Most of the diesel was captured inside the building, but approximately 200L of diesel seeped through the cracks under the building and onto the ground at the West Vent Raise.

- The pressure reducing valve diaphragms failed sometime during the night, resulting in diesel bypassing the diaphragm and leaking from the vent port into the burner module. Diesel made its way outside through cracks and joints of the building, creating the spill.

Photo 1: Spill location.

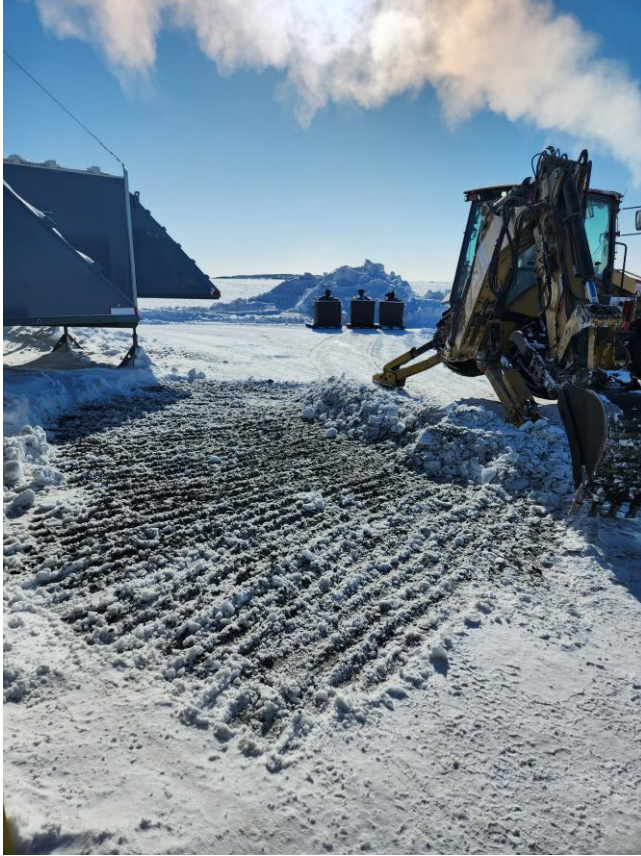
Photo 2: Spill location after remediation.

The E&I employee immediately notified their supervisor and the Environment Department about the spill. E&I personnel began the cleanup process right away. Three Quatrex bags of contaminated material were recovered. The rest of the accessible contaminated material was excavated (2 loader buckets) and transported to the snow cell. Because of the very cold temperatures at the time of the cleanup, only the superficial layer of soil could be removed.

Before freshet, a berm will be constructed around the building to contain any contaminated water resulting from snowmelt. This pooled water will then be vacuumed by truck and transported to the snow cell to prevent further contamination. Remediation beneath the building will be completed during Closure.
