April 15, 2026

Re: Follow-up Report Spill #2026-067 – Release of 350 L of hydraulic oil at the Meliadine Gold Project

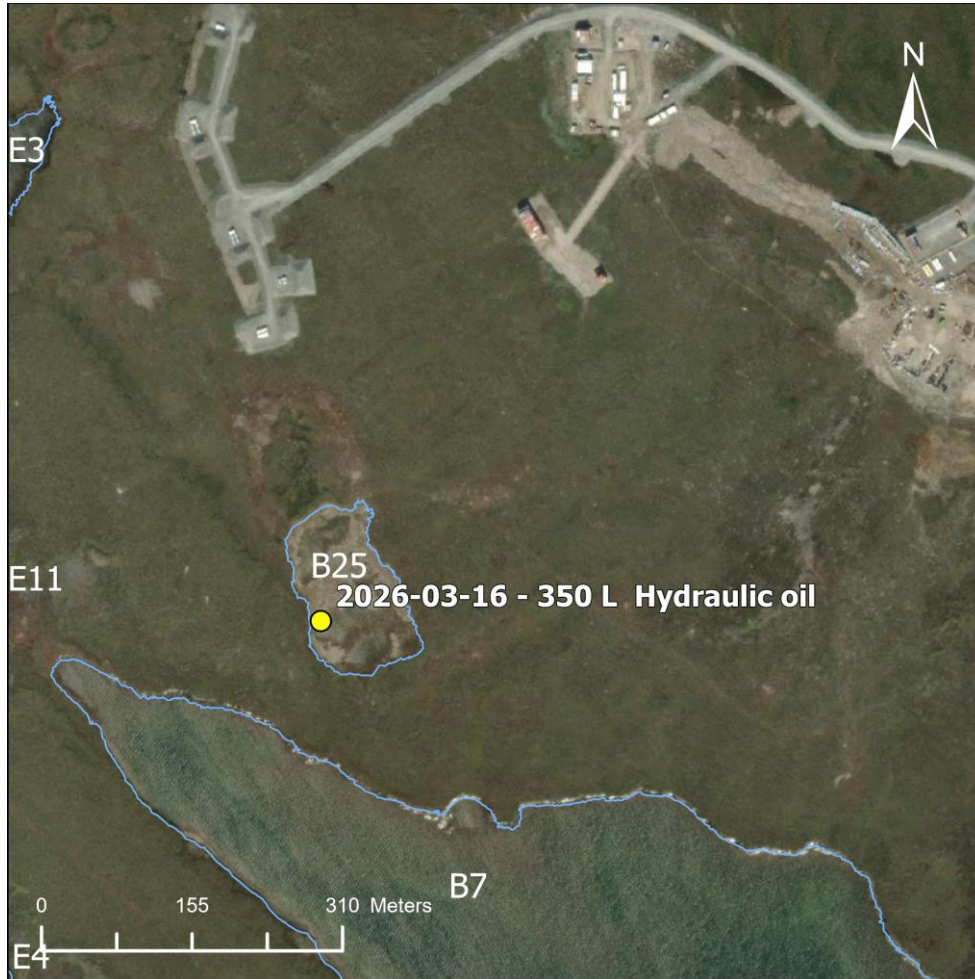
The spill occurred within the bounds of the site's runoff collection system; no water bodies were impacted by the spill. The closest water body (Lake B7) is approximately 91 meters southwest (Figure 1).

Figure 1: Location of the spill and proximity to waterbodies.

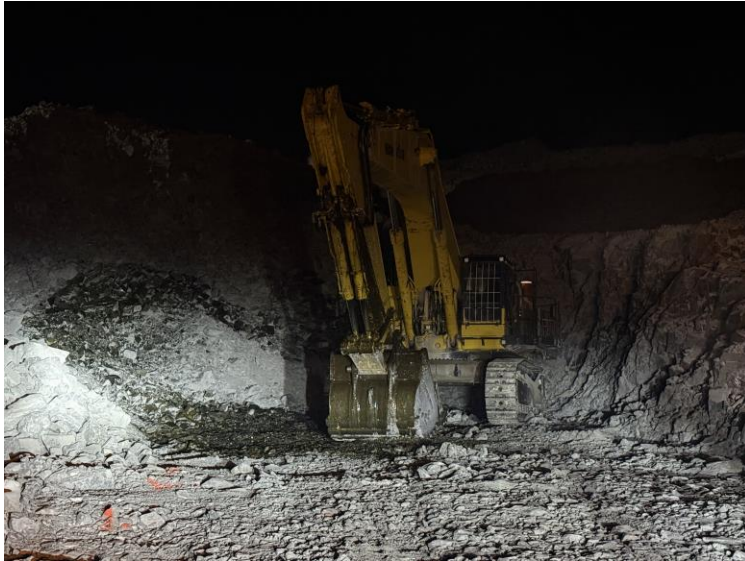
On March 16, 2026, at approximately 1:00AM, a Kivalliq Contractor Group (KCG) excavator operator was working when a cylinder hydraulic hose broke, resulting in a spill of approximately 350 L of hydraulic oil contained within an active area of excavation and the future location of CP8.

- While repositioning the PC-1250 excavator close to a pit wall, the excavator's stick made contact with the pit wall, resulting in damage to the bucket cylinders and causing the spill.
- The operator rotated the equipment 180 degrees after realizing that the bucket cylinders were damaged and leaking oil, allowing more product to spill and enlarging the spill area.
- Insufficient risk analysis of the work area: The operator also failed to document the tight work environment on his work card.

Photo 1: Spill location.

- The operator was met by their supervisors for a constructive feedback session.
- The operator had to review Section 7 of the KCG internal procedure *Excavator training Caterpillar 349/352*, which pertains to the safe and efficient operation of this type of heavy equipment.
- KCG will share this event and corrective actions to both rotations during their next weekly safety meetings, highlighting the immediate need to freeze the scene when a spill occurs as per the *Spill Contingency Plan*.

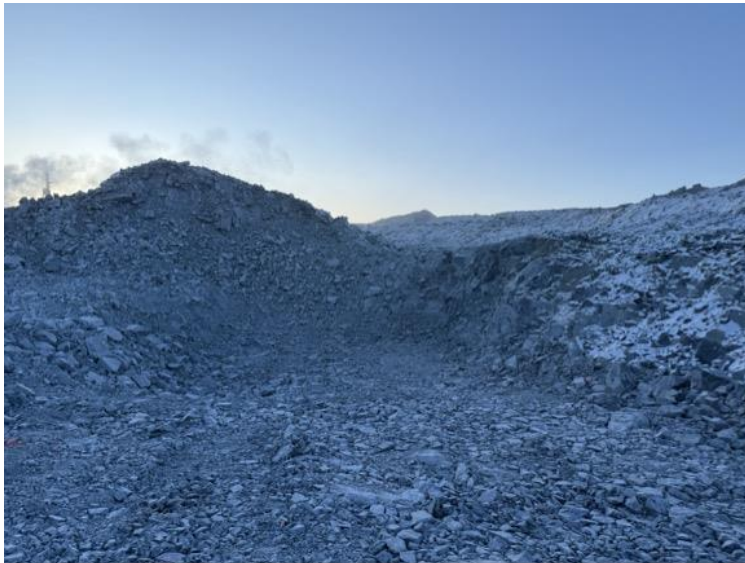
Photo 2: Spill location after remediation.

The KCG operator immediately notified their supervisor about the spill. At 6:00 AM the same day, they contacted the Environment Department to report the incident, and remediation work began. Due to the large volume of contaminated material requiring disposal (15 bins from a 40-ton truck), as much fine material as possible was screened and transported to Landfarm A for remediation. The coarser material was taken to Waste Rock Storage Facility 3 (WRSF3) to be encapsulated in overburden and covered with rock.
