MELIADINE DIVISION

Monitoring Program Summary Report

May 2017

SPILL REMEDIATION AND RECLAMATION REPORT
Meliadine Exploration Fuel Farm
Tank 18, 30 m³ Diesel Spill

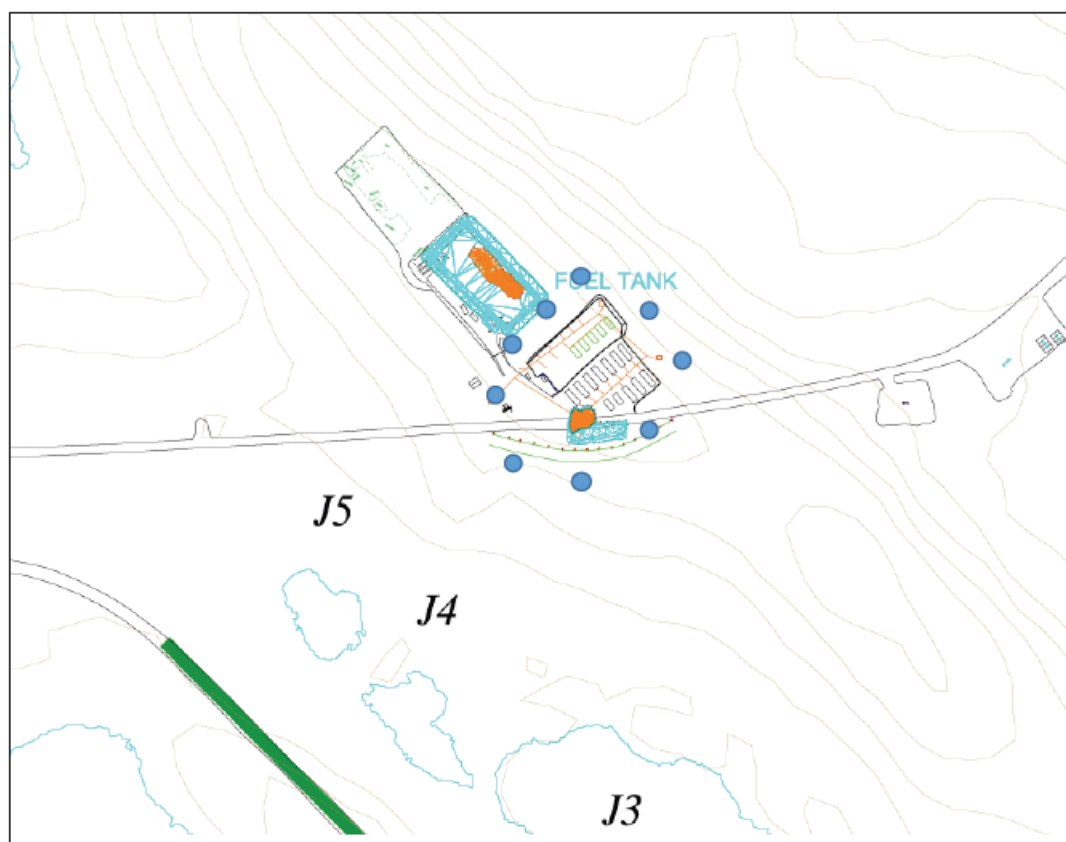
Figure 1: Proposed borehole locations around the spill site perimeter

1. Surface runoff that is collecting in low points from the spill site (License B fuel farm);
2. Soil samples collected from borehole locations around the perimeter of the spill site (9 location proposed, see Figure 1)
3. Shallow groundwater, if observed, can be collected from the boreholes (PVC pipe and a screen will be installed in the boreholes) ;
4. Water column samples from downstream lakes including J3, J4 and J5.

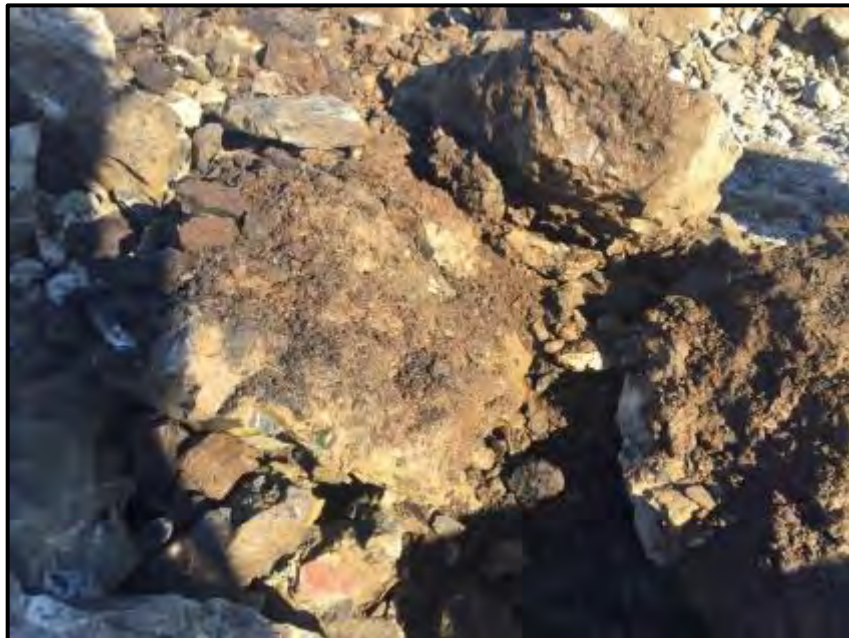
April 15: Free product accumulation at the interface between natural soil and permafrost near field screen location 1.

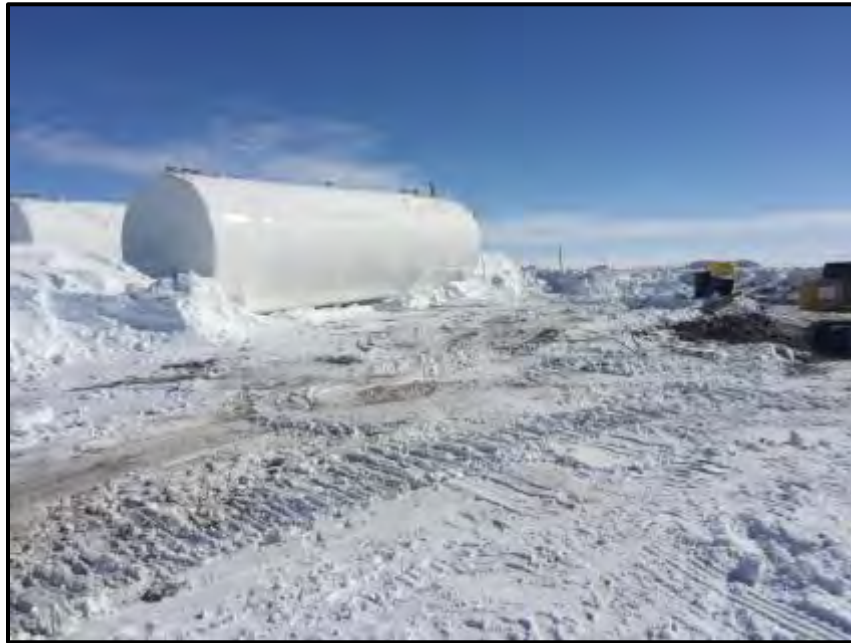
April 15: Area under Tank 18 after removal.

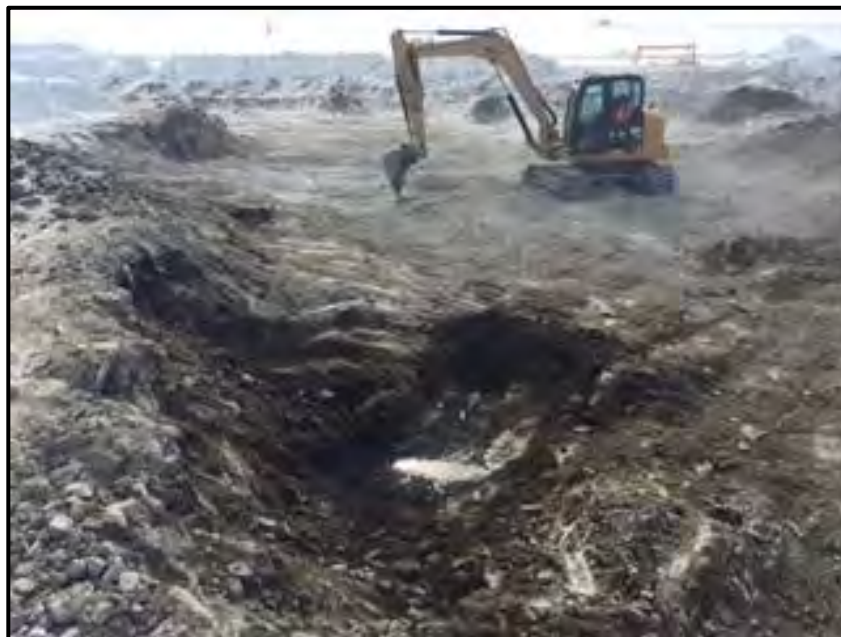
April 16: Free product accumulating in a small bellhole on the north side of the south excavation in the former tank 18 area.

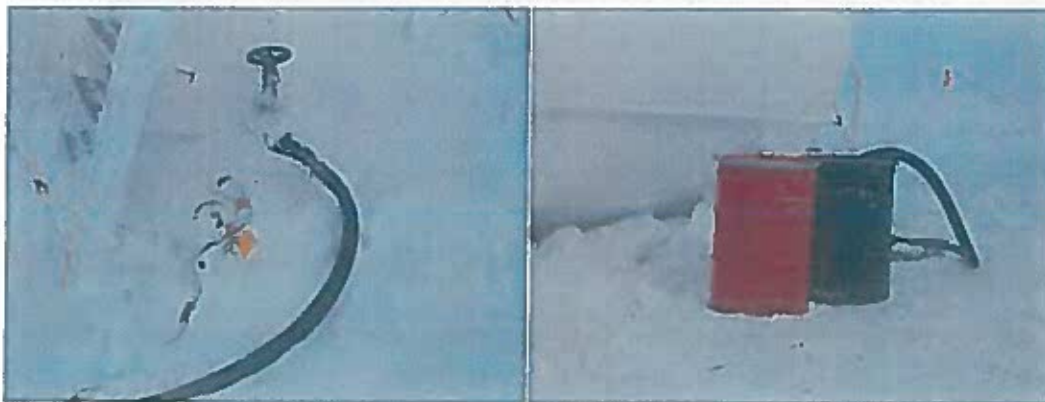
Picture 2: The secondary containment berm underneath the valve is full of contaminated snow – a drum for “fuel contaminated water” has been placed beside the tank for the placement of this contaminated snow

Done

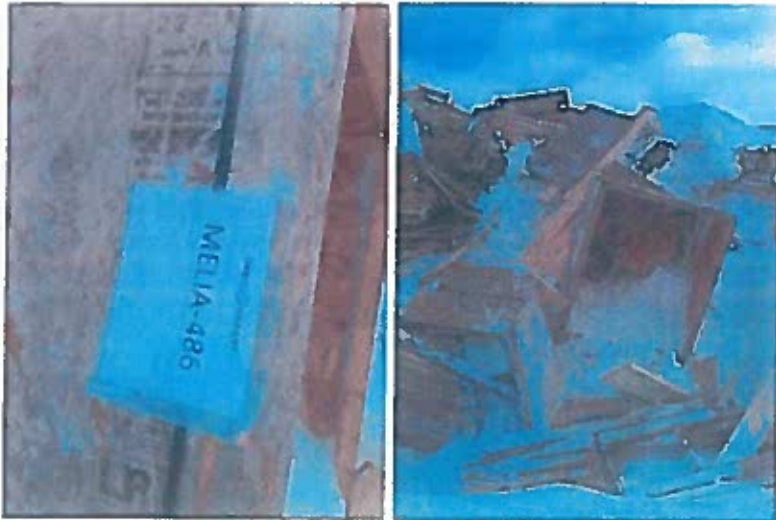
Picture 1: Pressed/plywood will need to be removed prior to ignition. Orbit stickers on the crates. Been removed by Orbit the day after construction put lots and removed the same day

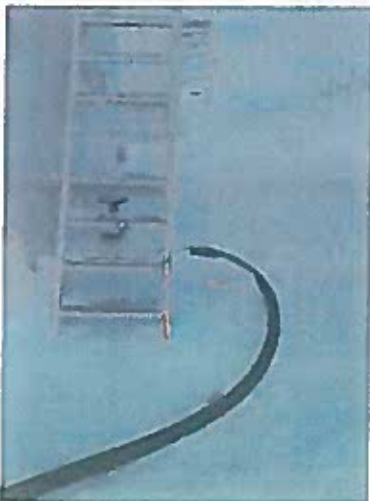
Picture 2: Fuel farm, hose connected to the tank's secondary containment need to be contained. Done, barrel been replaced with a hole on the side to prevent snow or water to get in
