APPENDIX K

Regulator Inspections and Baffinland's Responses

2023 and 2024 CIRNAC Inspections and Baffinland's Responses

**WATER LICENCE INSPECTION FORM**☒ Original
☐ Follow-Up Report

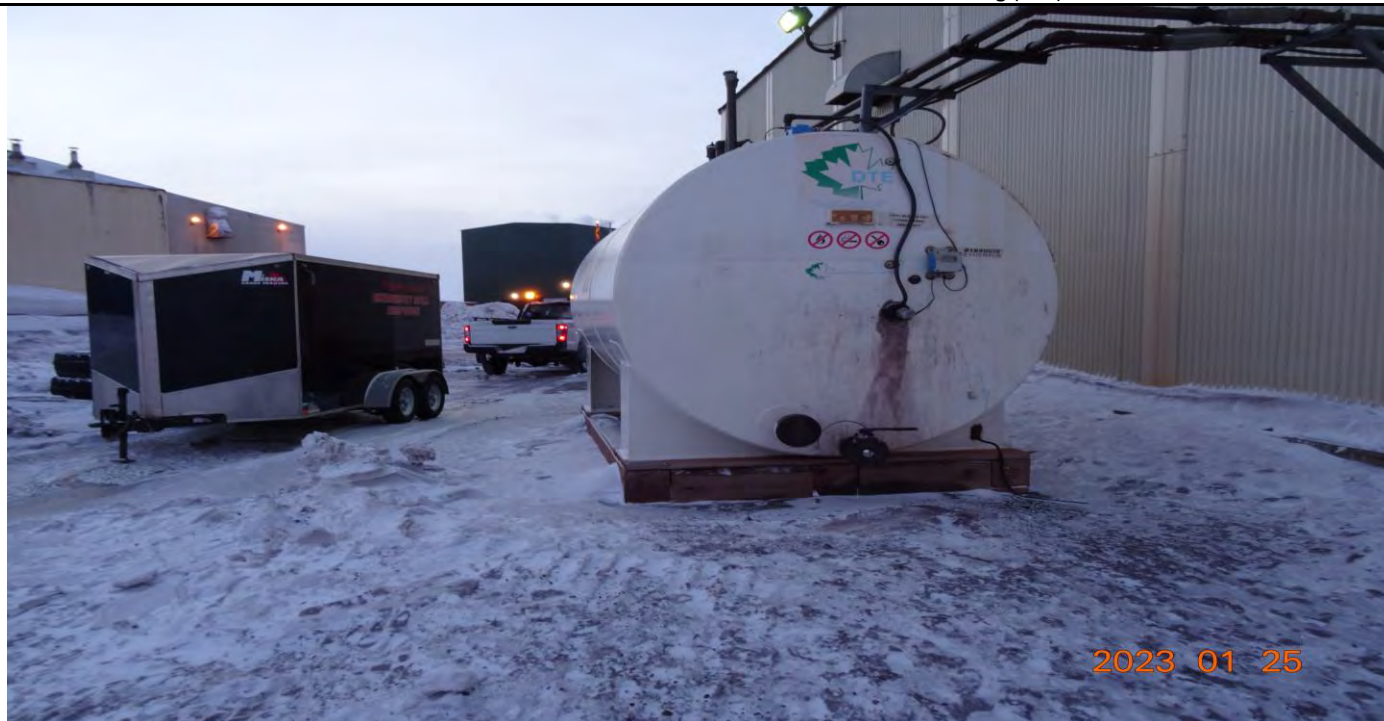
Photo #3

3. Inspector BOLT had found a fuel leak outside the Mine Rescue Building (Emergency Response Team building). The leak came from the large heating fuel tank (10,000L) outside the building. The tank at the time of inspection held 6540.64Litres. The amount of spill is unknown. A drip pan was placed under to stop leak from spilling onto the ground. (See photo #3)

Description: General site photo of Fuel tank and surrounding buildings.

3	Mine Rescue Building	Ensure clean-up of identified fuel spill, licensee must submit a follow up report to the inspector 30 days after the submission of a spill report. Ensure all spills are reported and cleaned up as per the approved Spill Contingency Plan.	On investigation of the potential fuel spill at the fuel tank outside the Mine Rescue Building, it was found that the area around the drain valve was wet. The drain valve was tightened and the handle removed, to ensure a re-occurrence would not happen and, as a precaution, a spill tray was temporarily placed beneath the drain valve. Photo 2 in Attachment 2 shows the fuel tank after the seal around the drain valve was fixed, with the temporary spill tray in place. Fuel storage tanks across the Project will continue to be inspected on a regular basis as per Baffinland's policies. The area will be monitored during warming

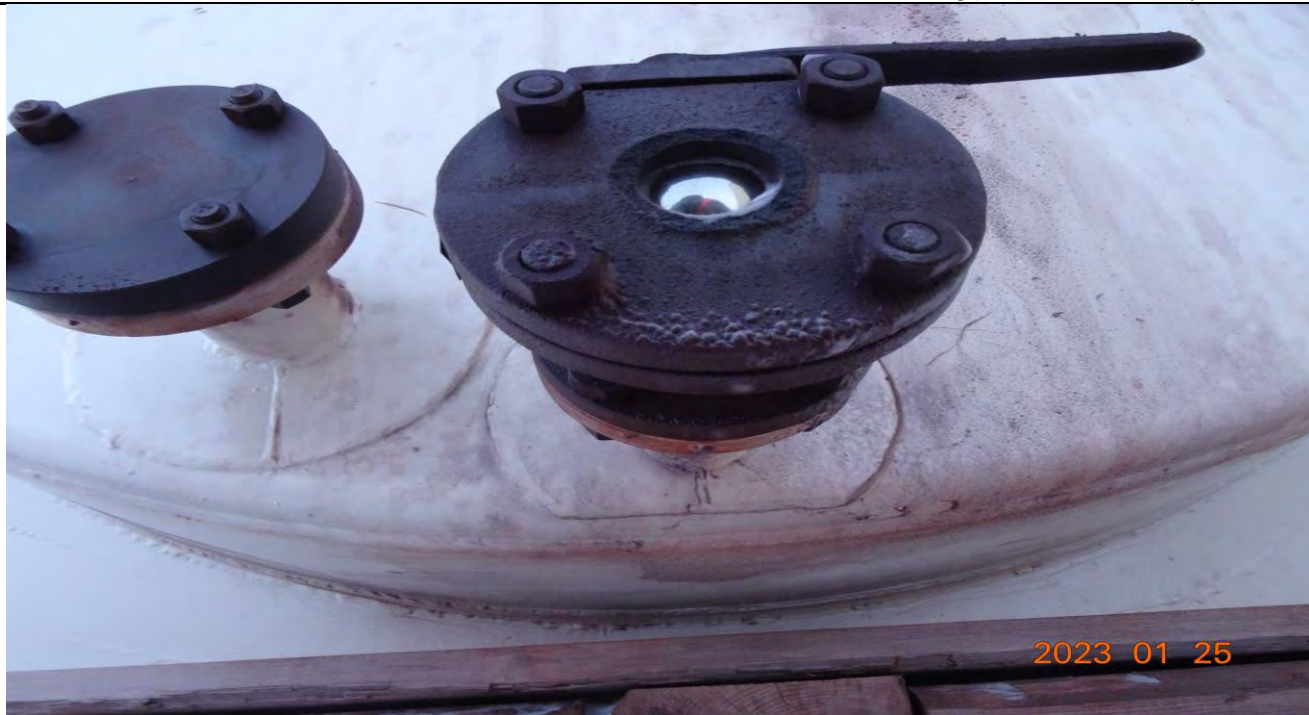
Photo #3

Description: Diesel Drips were observed on this valve. Snow directly under was saturated in Diesel.

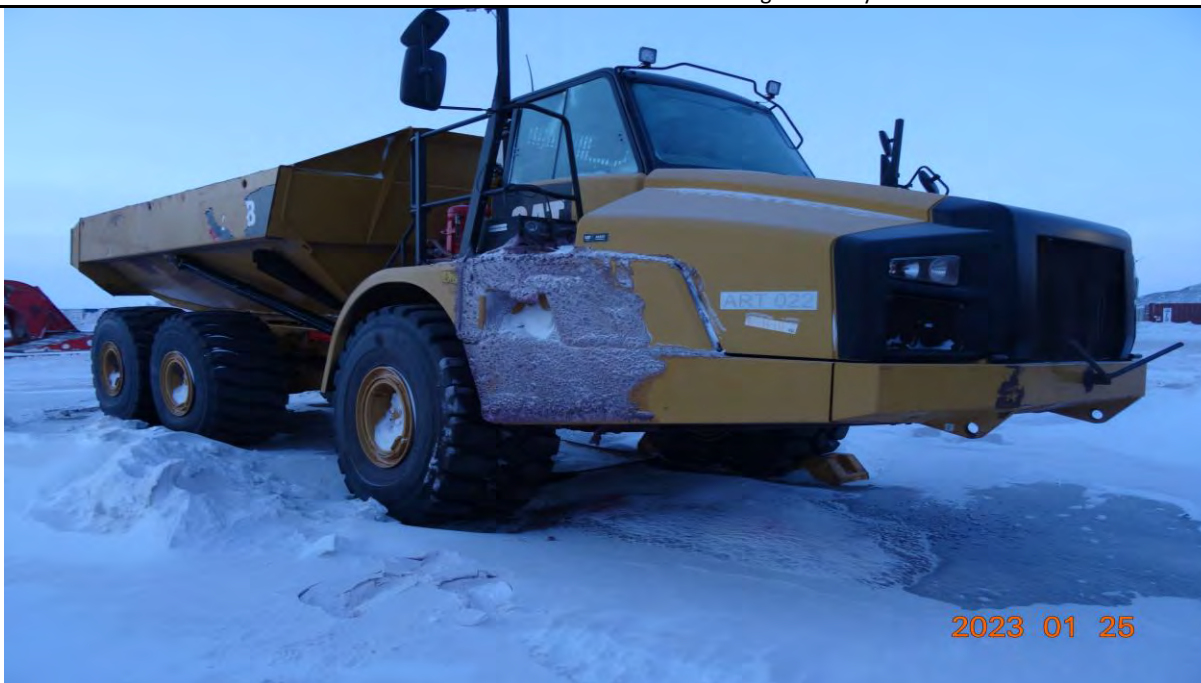
Photo #4

4. At the Waste Management building laydown, an articulating rock truck (ART-022) was found leaking hydraulic oil onto the snow, with no visible containment. (No drip pan) (See photo #4)

Description: Hydraulic Leak coming from above the front right wheel well

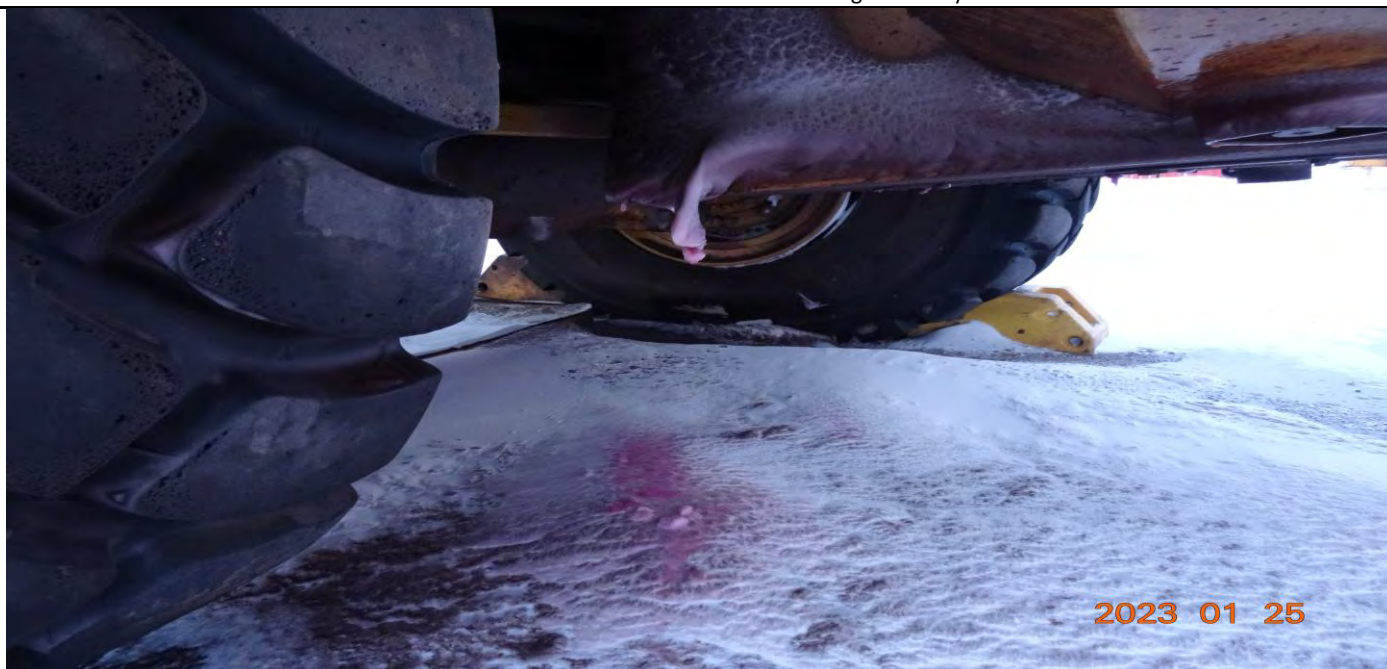
Photo #4

Description: Photo of hydraulic leak onto snow, Drip pan is sitting too far back and won't catch any leaking fluid.

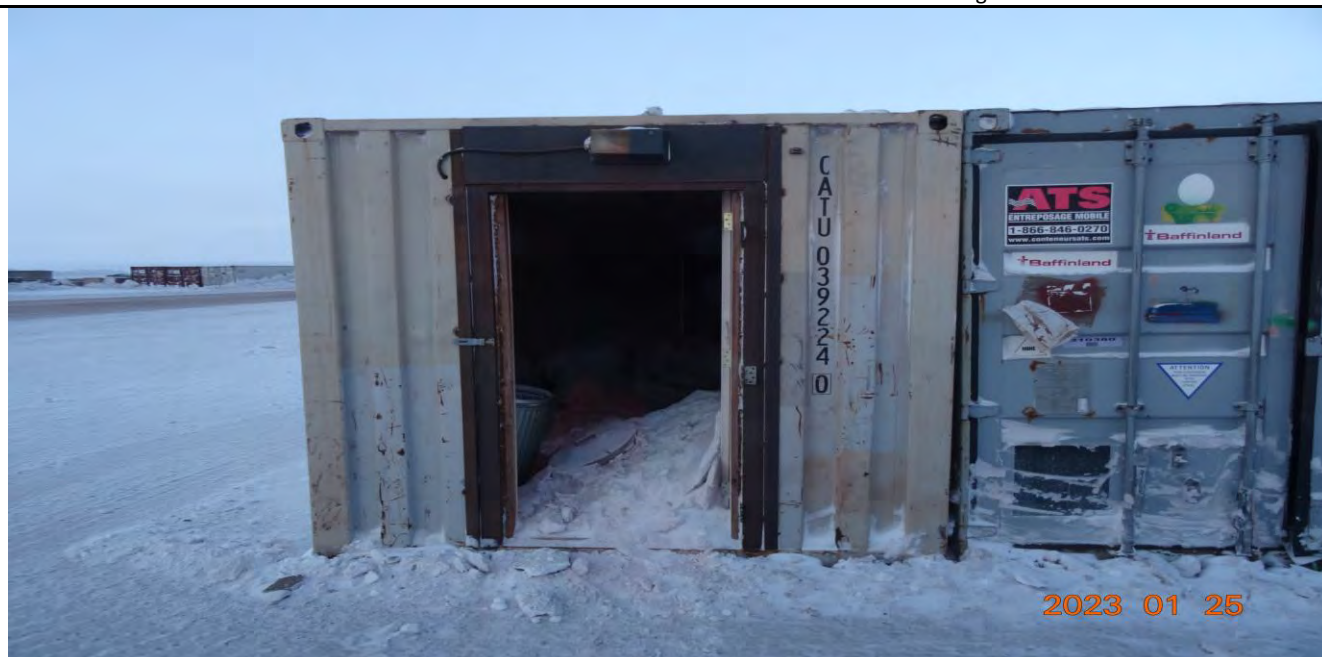
Photo #5

5. Outside of the Incinerator building, a storage shipping container was missing its front door, allowing wildlife to access the storage shipping container. Upon entry of the shipping container BOLT noted a garbage bin open to the environment and it appeared to be allowing access to wildlife. (See photo #5)

Description: Door is unable to close, and a metal trash bin is present inside with animal attractants.

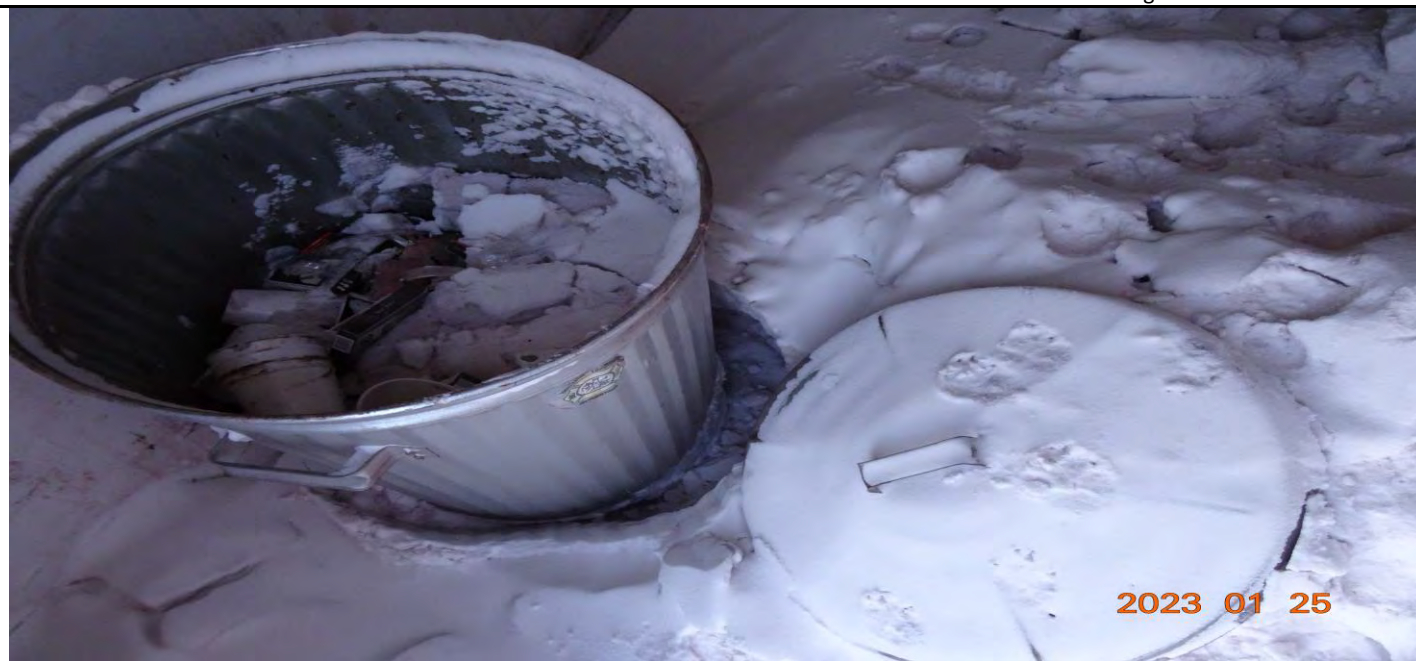
Photo #5

Description: Image shows Fox tracks inside sea can, and Animal Attractants inside trash bin.

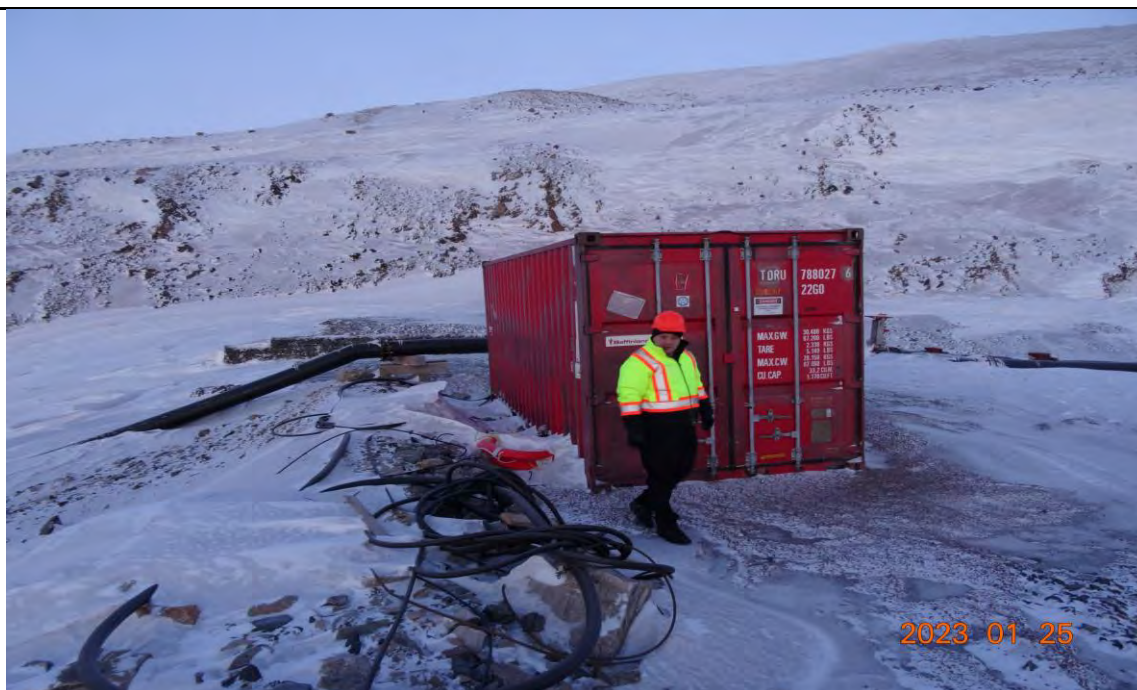
Photo #6

6. At the 105 dam, inspector BOLT noted concerns with tangled wire and wooden debris outside of the facility. (See photo #6)
7. At the OHT Laydown (ore haul truck laydown), inspector Bolt had noted 4 – 1000 litre totes each sitting in snow that was covering their respective secondary containment. The secondary containment "drip pans" were unacceptable for use as they were all filled with snow, reducing the available space for leaks. The snow also caused the walls of the secondary containment to fall outward, which would allow substances to flow out into the receiving environment. (See photo #7)

Description: Loose wood and tangled wires. Loose pallet was located behind the sea can. (Unsightly Debris)

6. Ensure loose debris is collected and disposed of accordingly.
7. Ensure all 1000L Totes outside of storage berms have proper secondary containment. "The Licensee shall implement preventive and mitigation measures to prevent any Wastes associated with the undertaking from entering any Water bodies." – "Part D, #8 of the water licence 2AM-MRY1325"

Cm t. #	Project Location	Description of Concern or Finding	Baffinland's Response
6	105 Dam	Ensure loose debris is collected and disposed of accordingly.	Wires identified near the seacan at the KM105 Dam do not pose a risk associated with entry of wastes to any Water bodies and therefore do not require preventative and mitigation measures in accordance with Part D, Item 8 of the water licence. Minor loose wood material observed was removed from the area. At that time, as good housekeeping practice, the wire was also untangled. Photo 5 in Attachment 2 shows the KM105 Dam area with the wooden debris removed and the wire untangled.
7	OHT Laydown	Ensure all 1000L Totes outside of storage berms have proper secondary containment. "The Licensee shall implement preventive and mitigation measures to prevent any Wastes associated with the undertaking from entering any Water bodies." – "Part D, #8 of the water license 2AM-MRY1325"	Accumulated snow around the totes at the OHT Laydown was excavated from the area to ensure effective secondary containment of the spill trays was restored. Photo 6 in Attachment 2 shows the area with the accumulated snow removed. Baffinland is committed to ensuring that containers are placed within appropriate secondary containment. Following the successful trial of secondary containment spill pallets for the hazardous waste totes at the Mine Site Crusher Maintenance Facility in late 2021, Baffinland is proceeding with the procurement of additional secondary containment spill pallets for use across site.

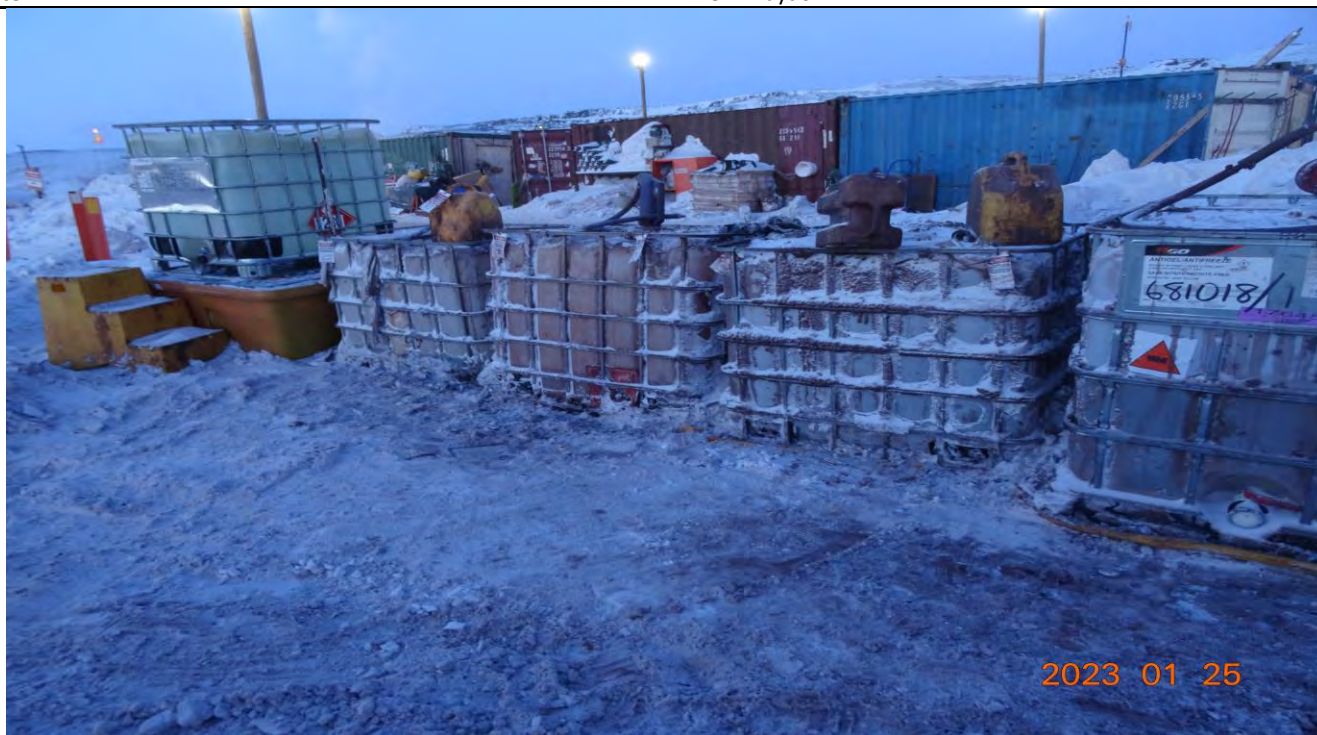
Photo #7

Description: 4 1000Litre totes each with their secondary containment buried in snow. All 4 secondary containment ineffective.

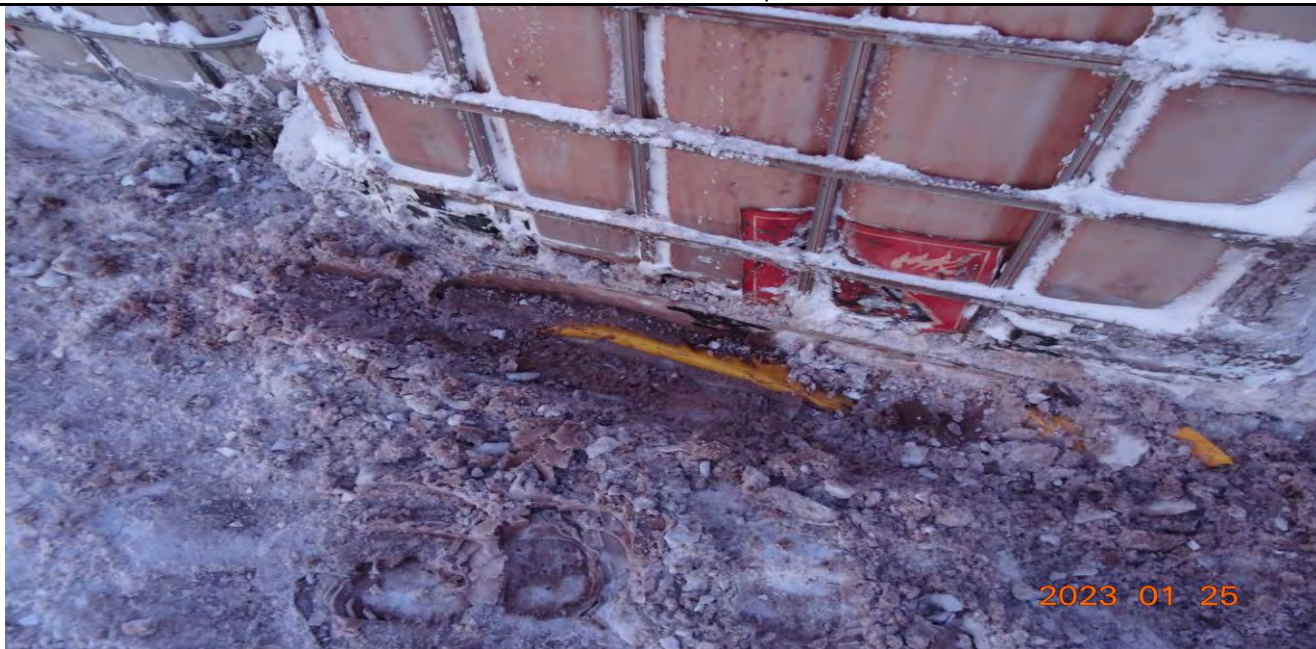
Photo #7

Description: Up-close photo of the buried secondary containment.

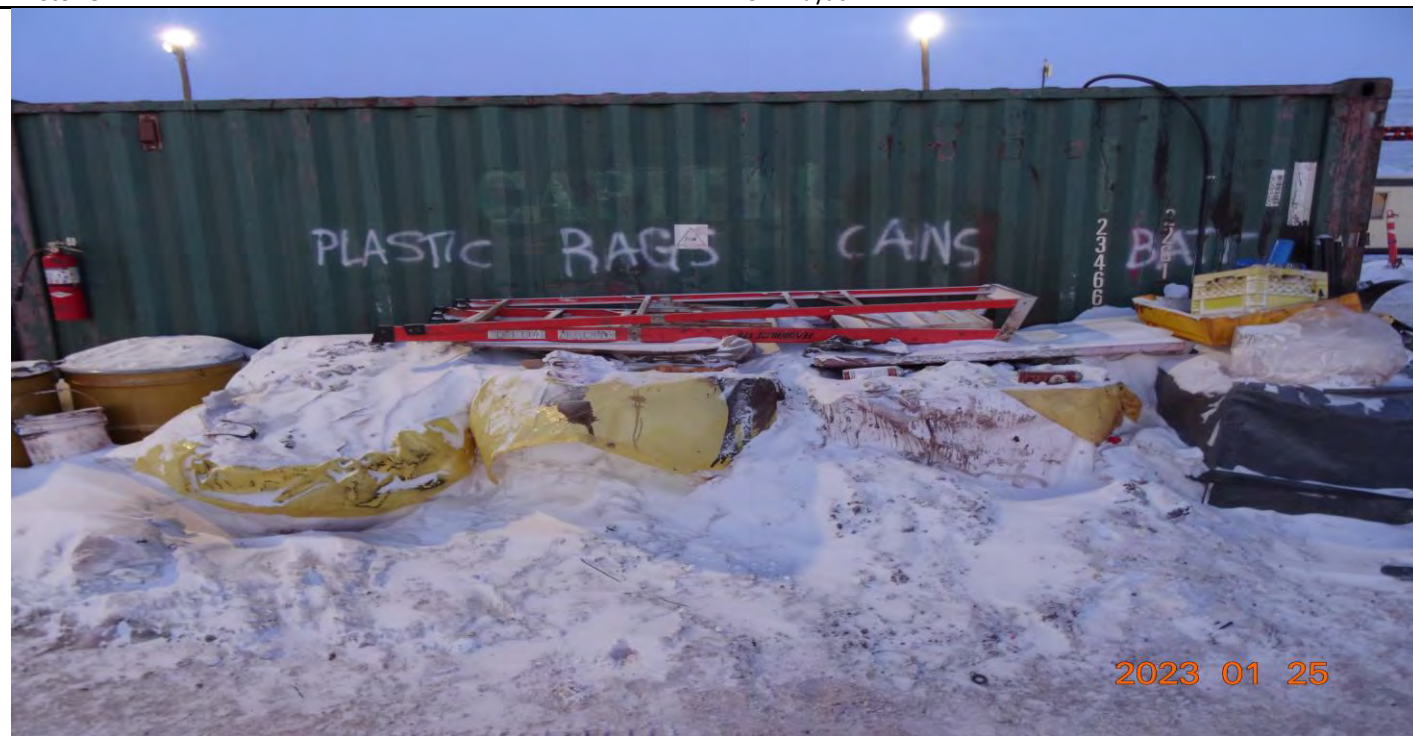
Photo #8

8. OHT laydown, there were 4 identified Quatrex bags overflowing with used 1lb propane bottles, batteries, garbage, aerosols bottles, oily rags and contaminated snow. The Quatrex bags were filled with snow as well. Inspector BOLT also noted that used 20lbs propane bottles were placed on the ground rather than in their storage container. The propane storage container was filled with snow, making it unable to close. (See photo #8)

Description: Overflowing waste in Quatrex bags at OHT Laydown. Waste has become filled with snow and looks to be mixed with other types of Waste.

8. Properly sort, safely store and dispose of any waste at OHT Laydown. Ensure contaminated snow and dirt is stored in the land farm and dealt with accordingly. "Baffinland will ensure that all hazardous waste generated at the Project is effectively managed and disposed. Hazardous waste will be properly stored, transported, treated and disposed. All site personnel (including contractors) will be responsible for managing the waste they generate and will be required to comply with the procedures provided in this Plan, the Hazardous Materials and Hazardous Waste Management Plan (BAF-PH1-830-P16-0011) and will be subject to monitoring and enforcement." - section 3.8 of the Waste Management Plan

8	OHT Laydown	Properly sort, safely store and dispose of any waste at OHT Laydown. Ensure contaminated snow and dirt is stored in the land farm and dealt with accordingly. "Baffinland will ensure that all hazardous waste generated at the Project is effectively managed and disposed. Hazardous waste will be properly stored, transported, treated and disposed. All site personnel (including contractors) will be responsible for managing the waste they generate and will be required to comply with the	Baffinland continues to focus on housekeeping and debris management. Operational areas are inspected for the presence of debris during routine compliance inspections and any issues are generally addressed as they are identified. Materials and wastes stored at the OHT Laydown were assessed and subsequently cleaned up, properly sorted and disposed of as appropriate, and the area was organized. Photo 7 in Attachment 2 shows the current status of the area at the OHT Laydown following the clean-up and reorganization. Baffinland will ensure this area is inspected during routine compliance inspections to ensure ongoing compliance with waste sorting and disposal practices as per the Waste Management Plan, and the

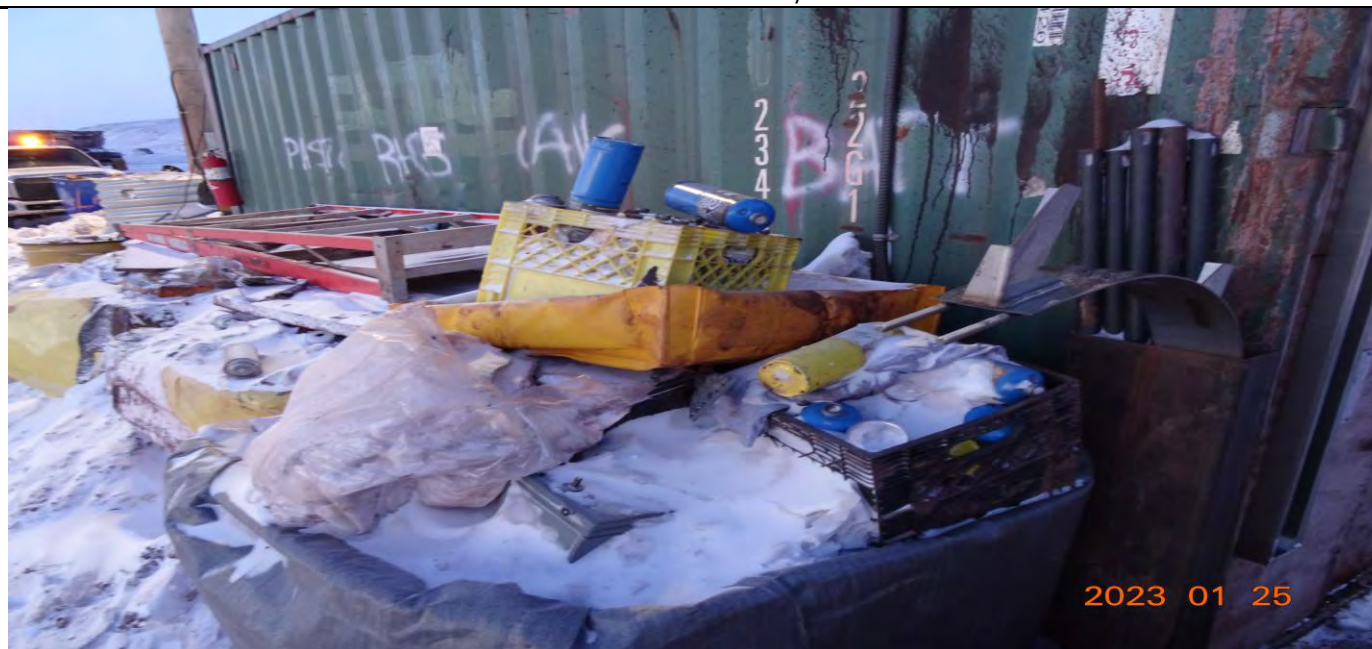
Photo #8

Description: Photo of Batteries, Propane Bottles, secondary containment "drip pan" all stacked together.

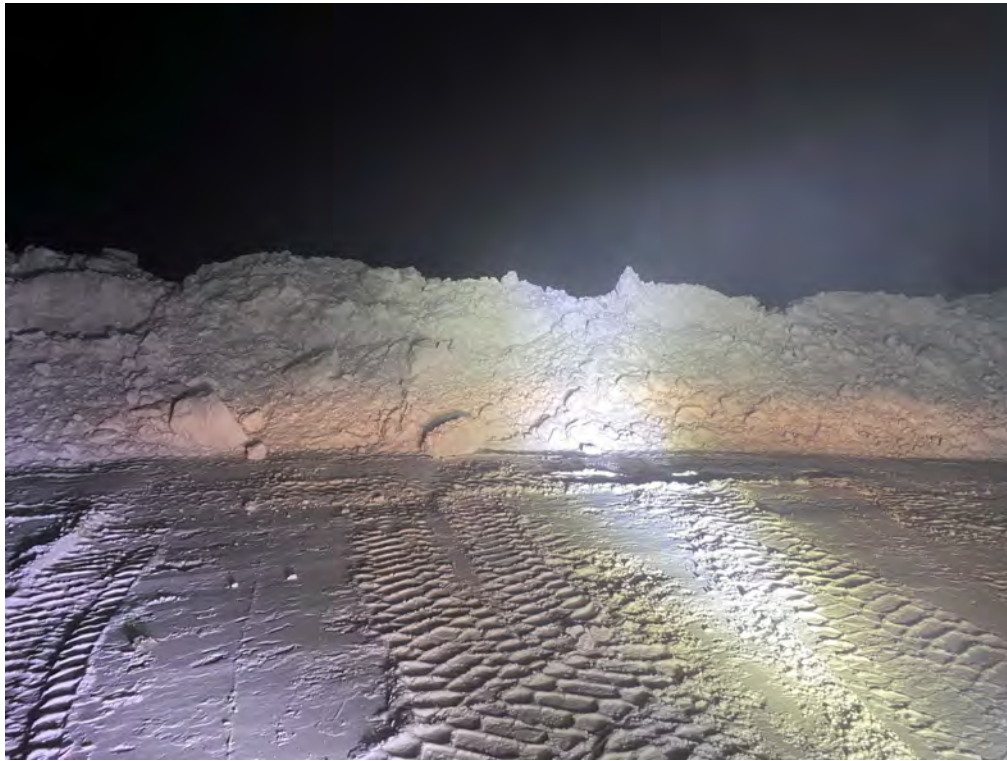
Photo 1. Open Burn Facility with Cardboard Debris Removed, Feb 13

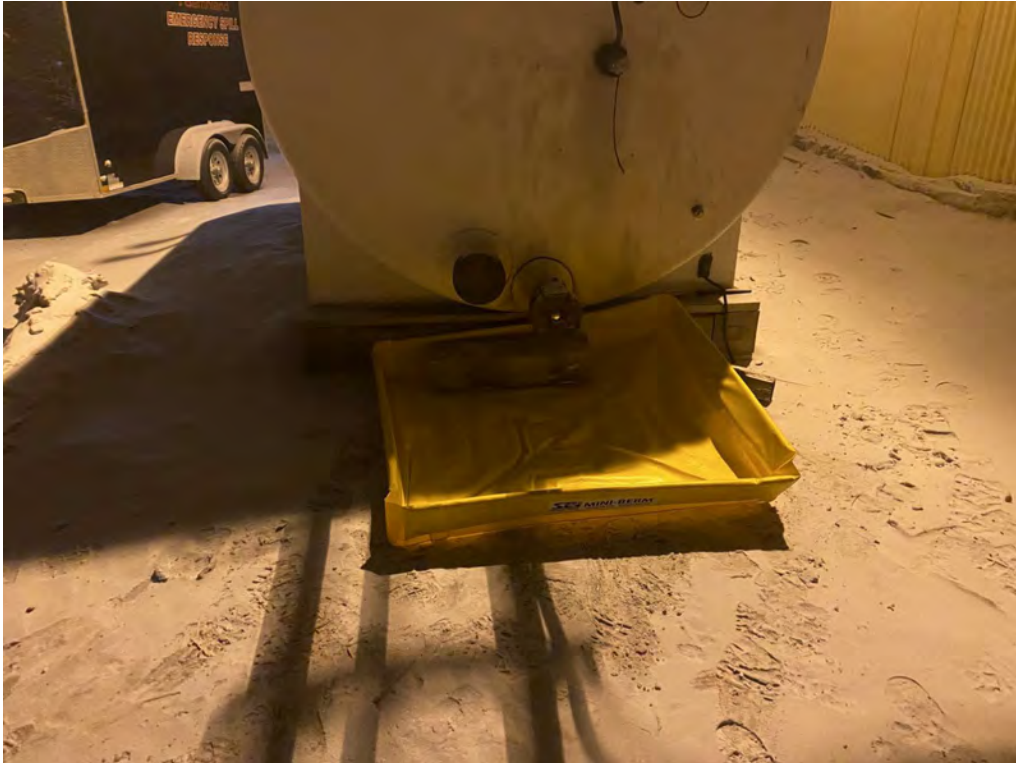
Photo 2. Fuel Tank at Mine Rescue Building after Valve Repair (with Temporary Spill Tray), Feb 13

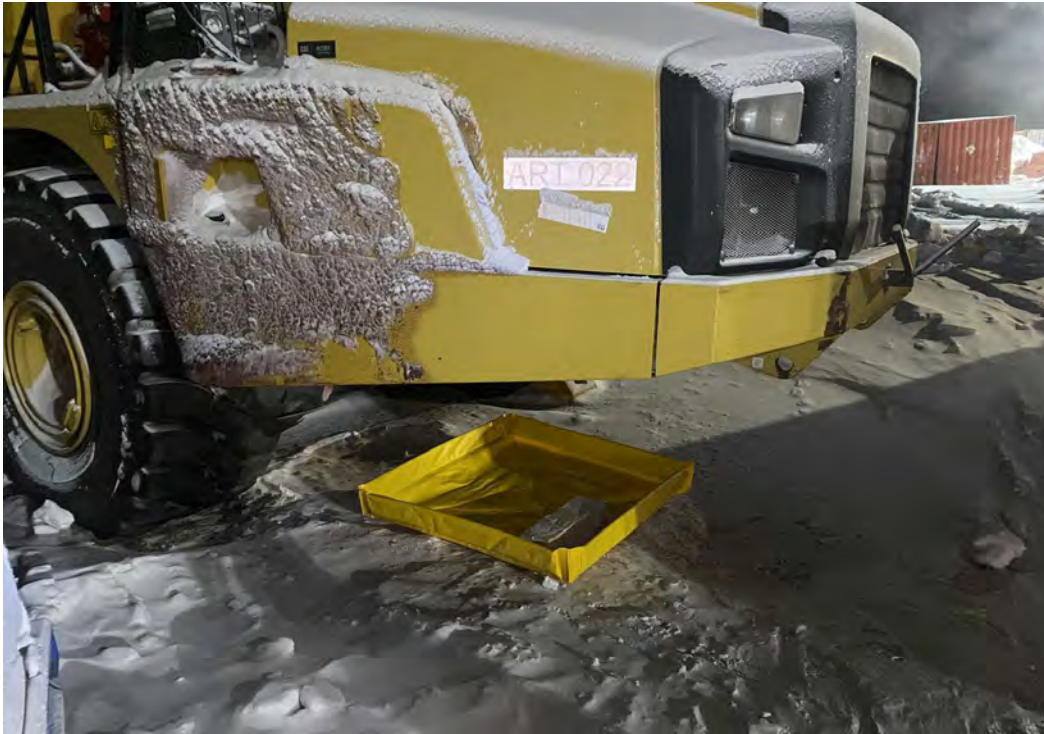
Photo 3. ART Following Removal of Minor Surficial Staining with Additional Spill Tray, Feb 13

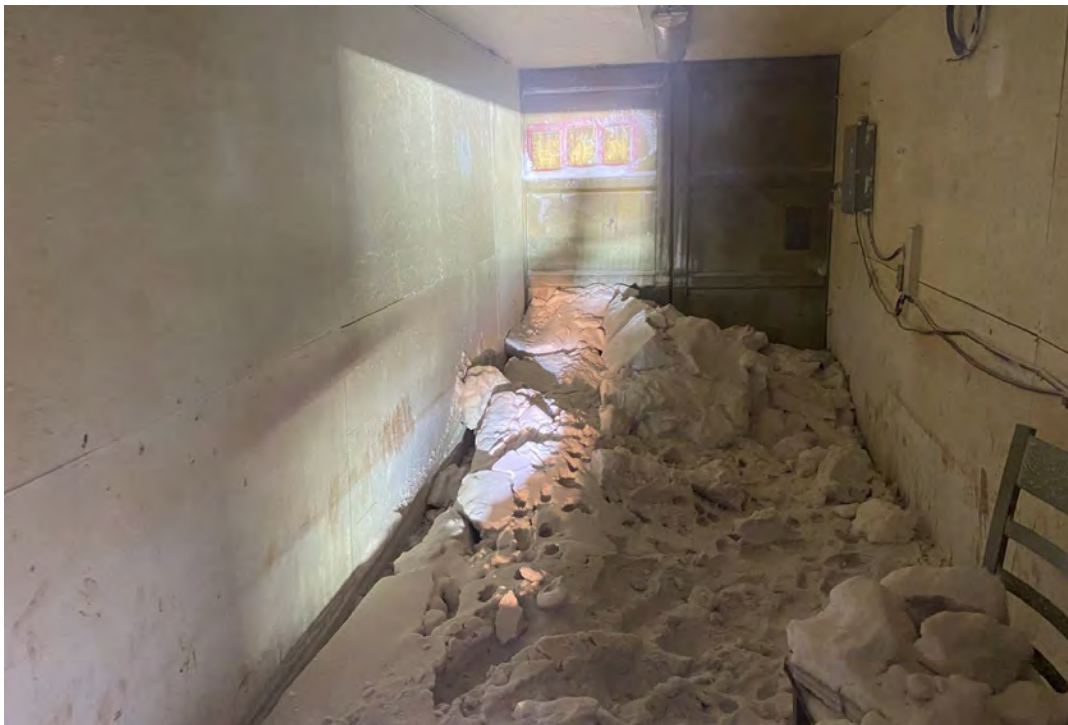
Photo 4. Seacan at Incinerator Facility with Trash Bin Removed and Door Properly Closed, Feb 13

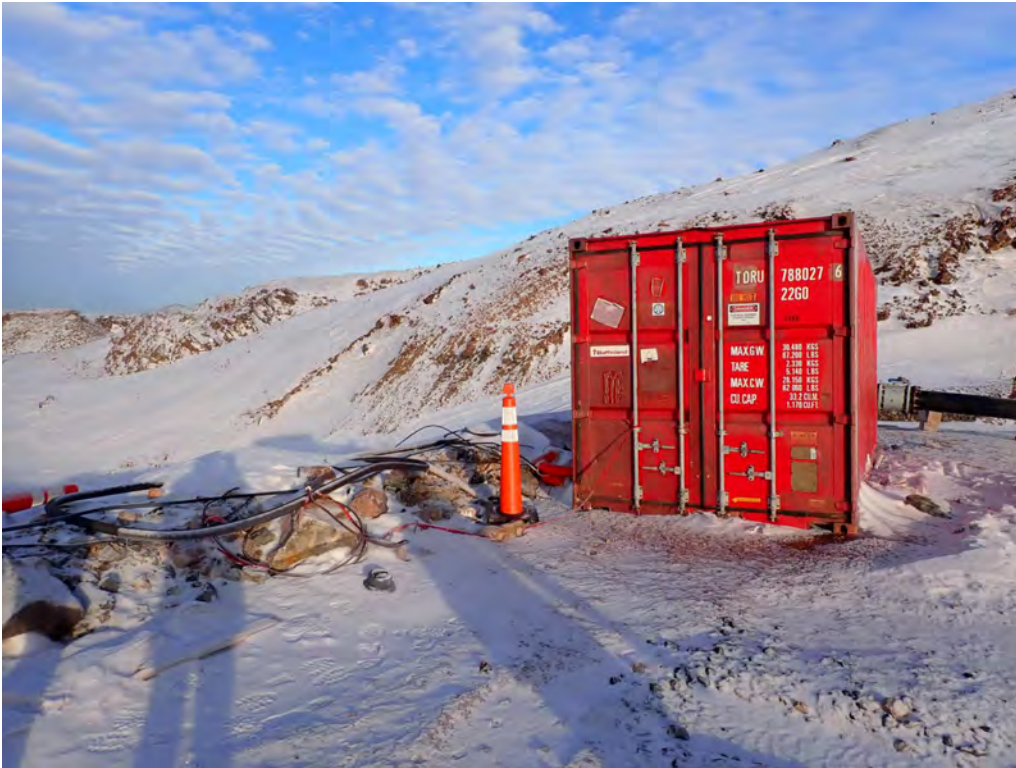
Photo 5. Photo KM105 Dam Area with Wood Debris Removed and Wire Untangled, Mar 9

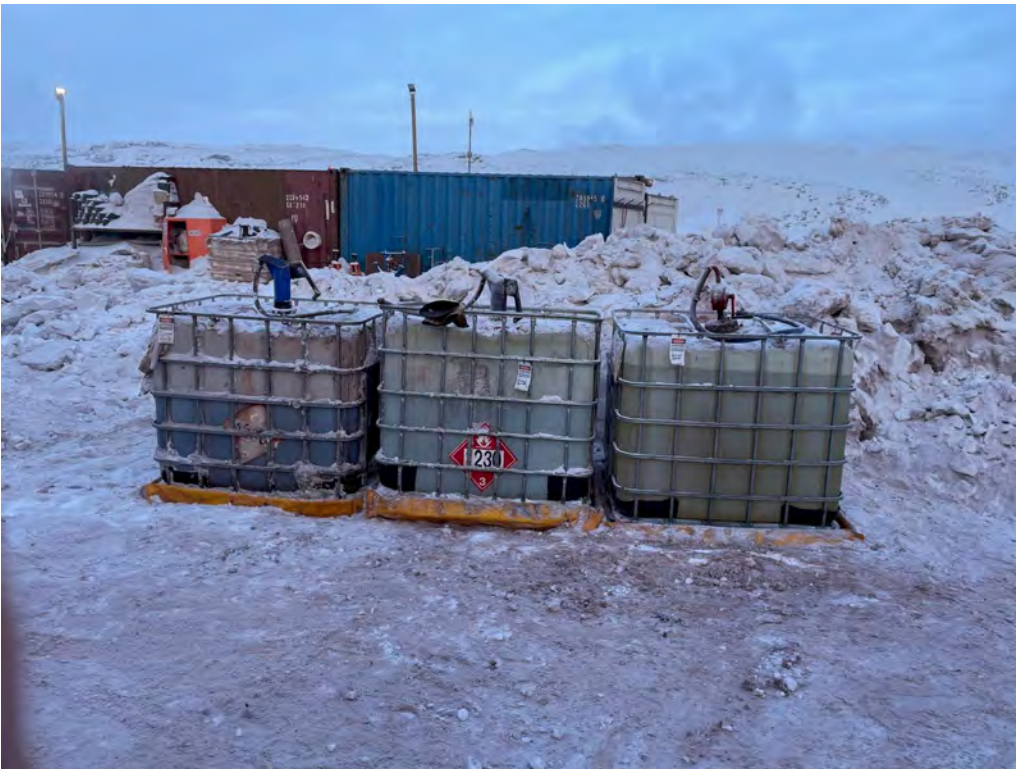
Photo 6. OHT Laydown with Accumulated Snow Removed from Around Secondary Containment, Feb 14

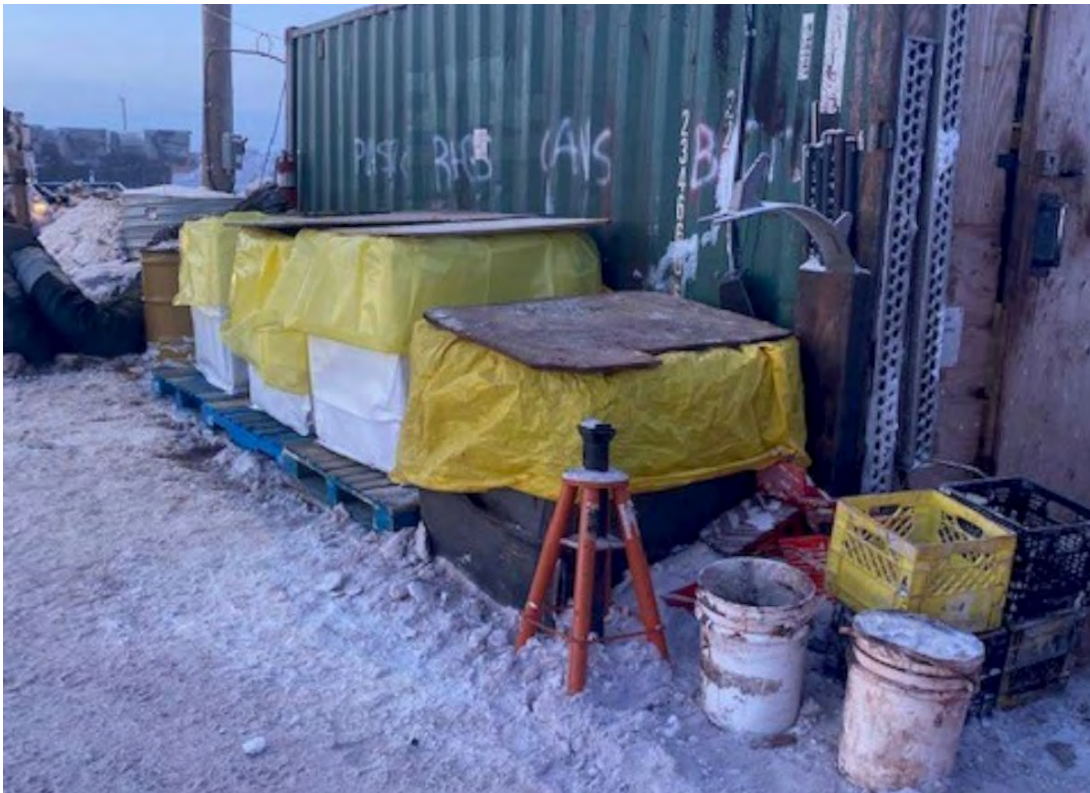
Photo 7. OHT Laydown Waste Storage Area Following Clean-up and Reorganization, Feb 14

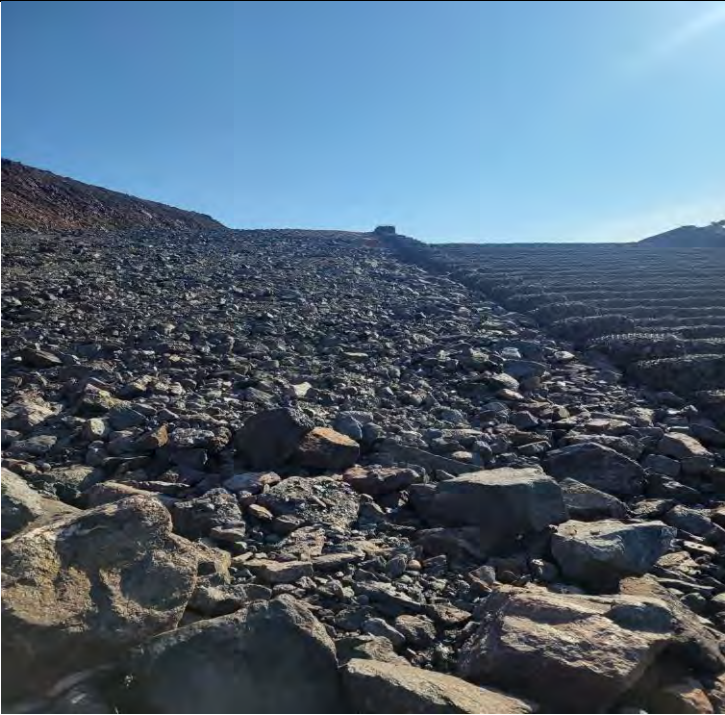
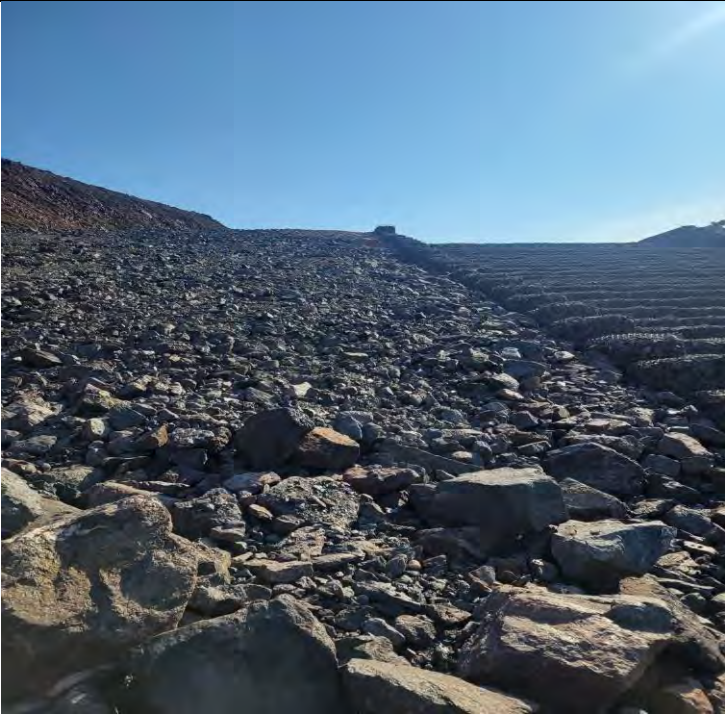
Photo Log	Location
Photo #3	KM105 Surface Water Management Pond Dam

Description: Photo of dam looking up from the bottom of the dam to show structure. It is still unclear exactly where the leak is coming from.

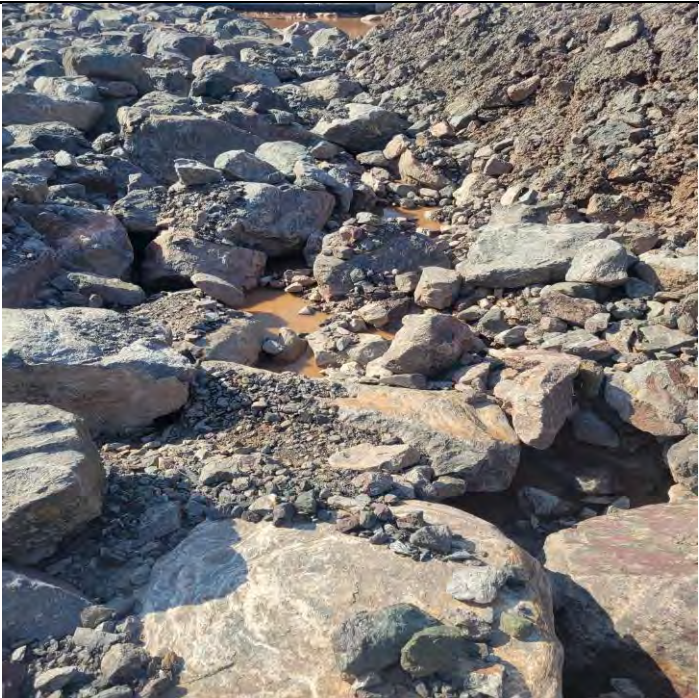
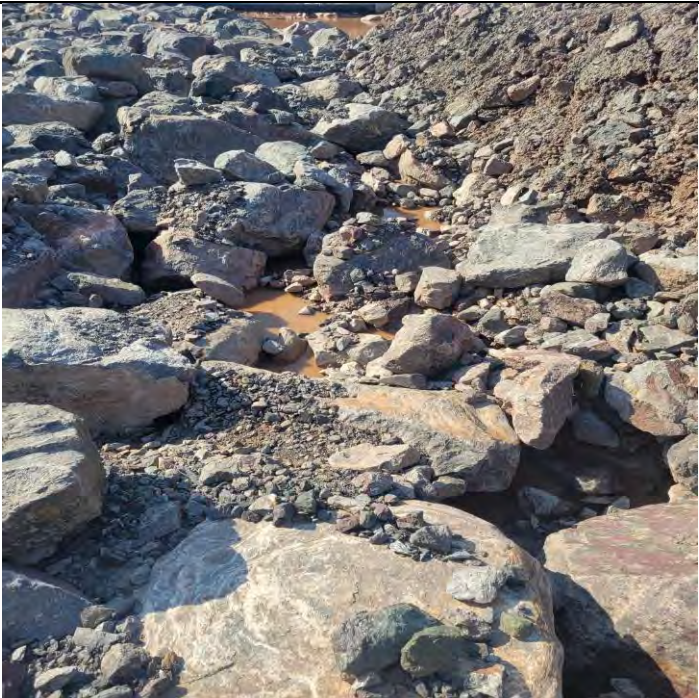
Photo Log	Location
Photo #4	Bottom of KM105 Dam

Description: Untreated water coming from a leak in the dam which follows the stream down to Camp Lake.

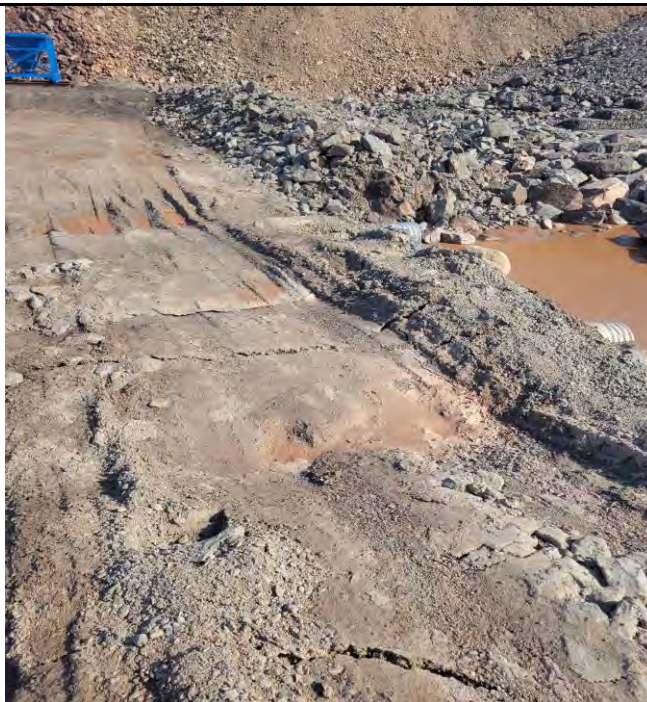
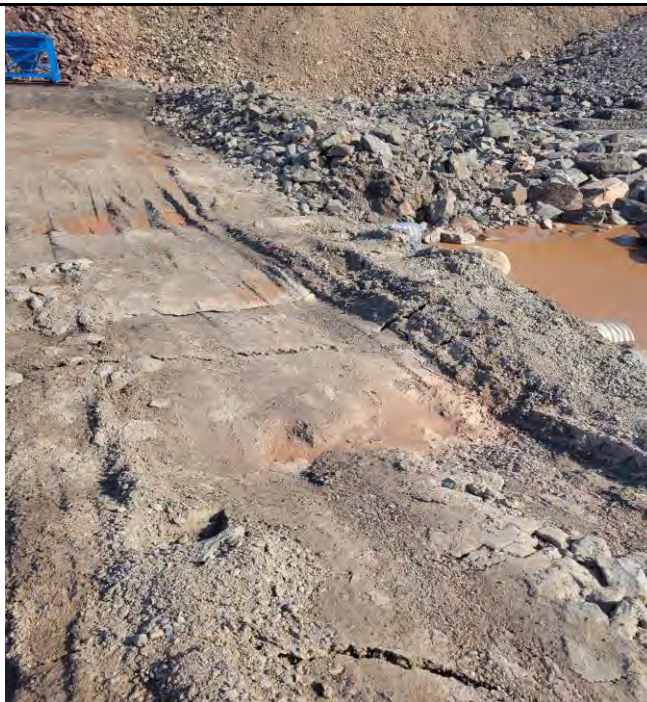
KM105 at the bottom of the dam.

Description: Evidence of erosion above the culverts. Access road has started to crack and has a possibility of washing away.

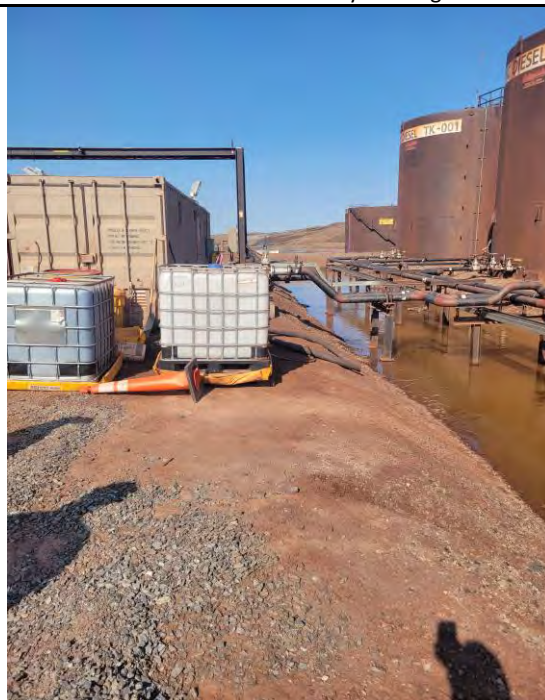
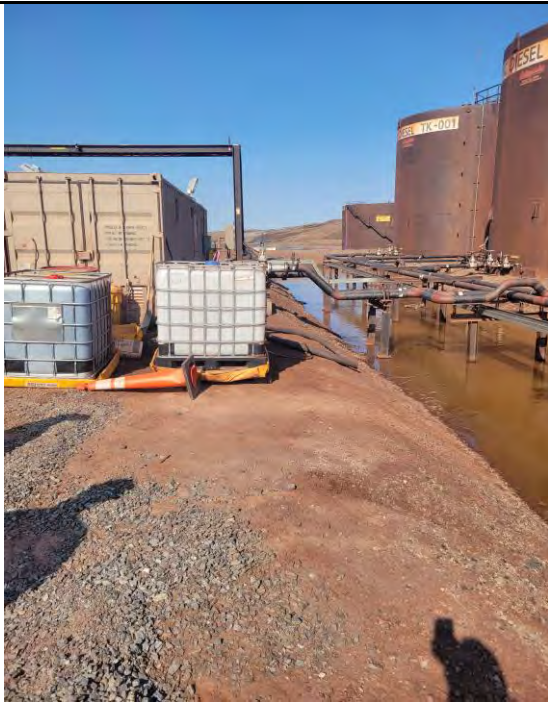
Mary River light vehicle refueling station

5. Stained soil was also observed at the light vehicle refuelling station. The ground staining suggested that Gasoline or Diesel had migrated down into the Tank Farm berm, which had some water present.

Description: Previous spills seem to be migrating into the tank farm berm. Smells of fuel-stained soil was present near the totes.

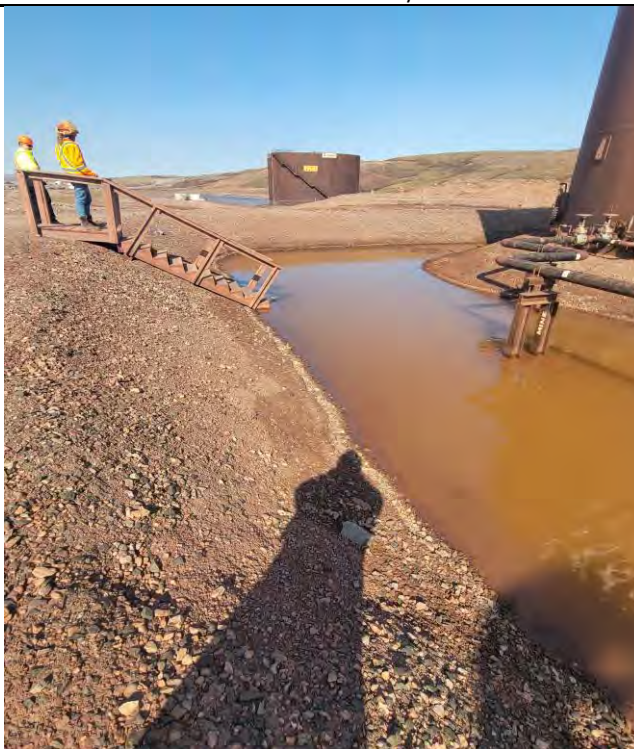
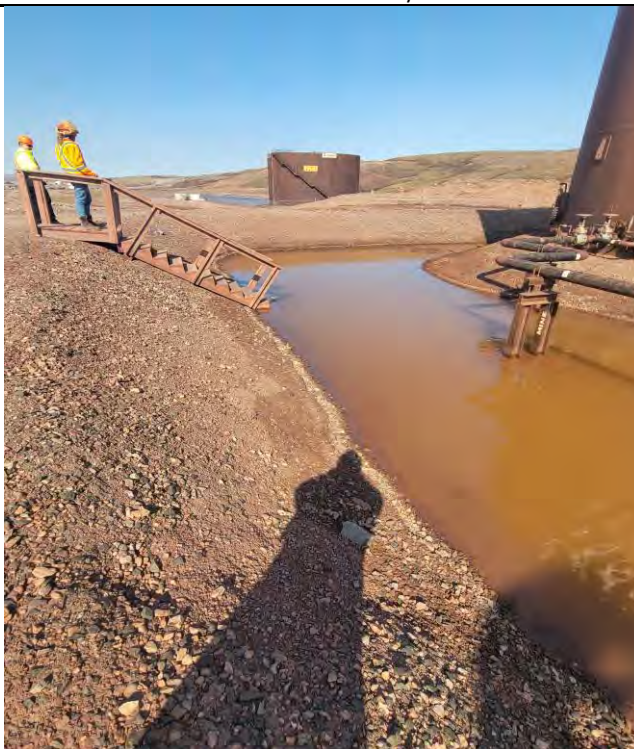
Mary River tank farm berm

6. Shortly after noticing the ground staining, a fuel sheen was discovered on the Northwest corner of the Tank Farm berm.
7. More small berms were not set up properly at the heavy equipment refuelling station. Any potential spills would have escaped from the berm and enter the environment. Ground staining was also present at the heavy equipment refuelling station.

Description: Some fuel sheen was seen on the edge of the water. Photo looking West.
