APPENDIX K

Regulator Inspections and Baffinland's Responses

2023 and 2024 CIRNAC Inspections and Baffinland's Responses

**WATER LICENCE INSPECTION FORM**☒ Original
☐ Follow-Up Report

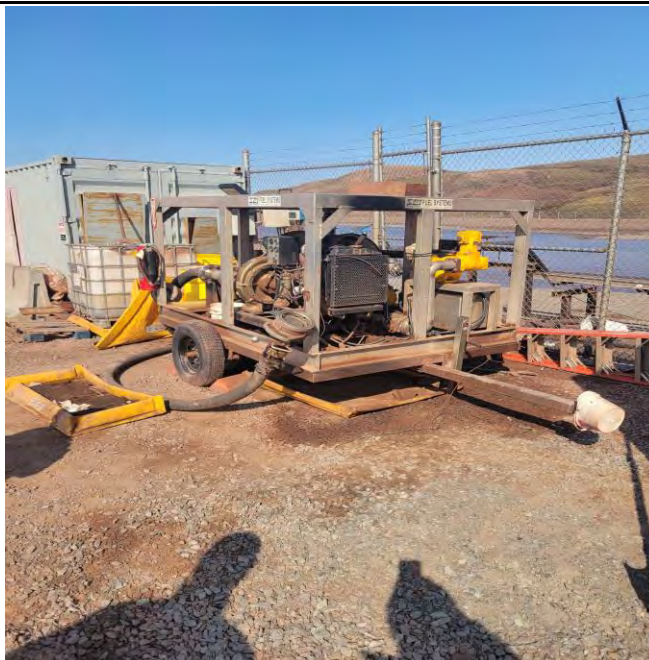
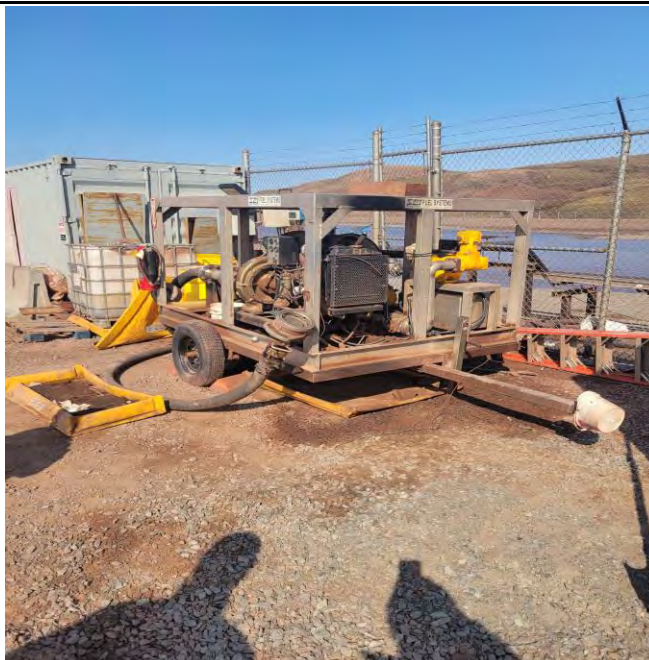
Mary River heavy vehicle refueling station

Description: More berms showing improper set-up. Any fuel spilled would not be contained and would cause a spill.

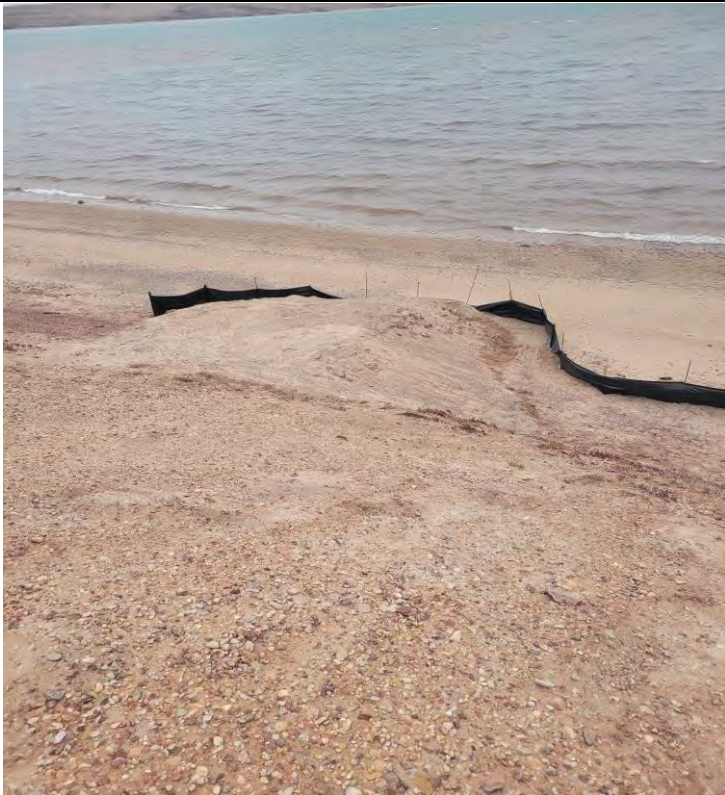
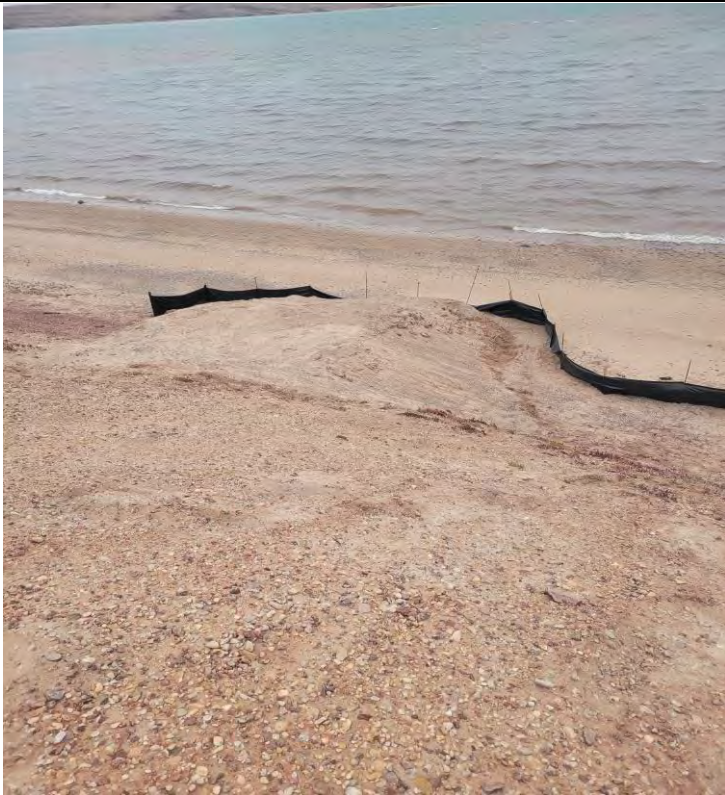
Photo Log	Location
Photo #13	Milne Inlet Shoreline

Description: A spring freshet caused water to erode some areas and transfer sediments towards the ocean. A silt fence was installed to minimize impacts.

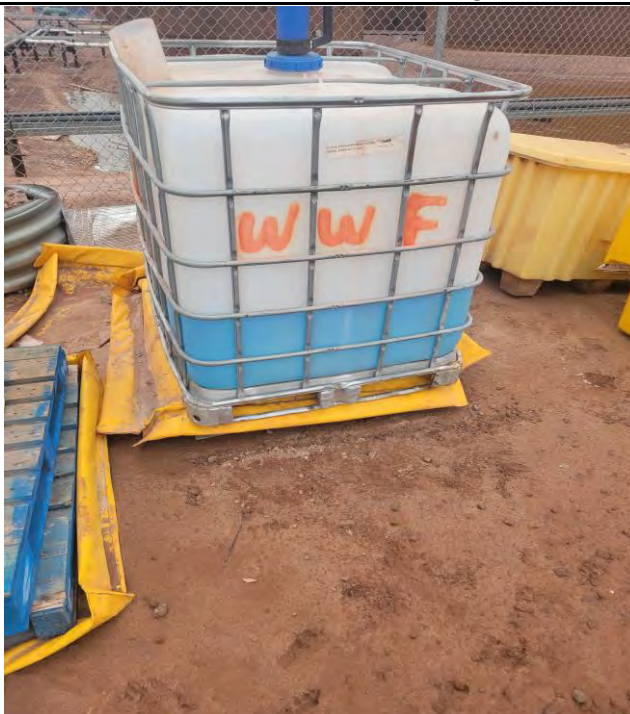
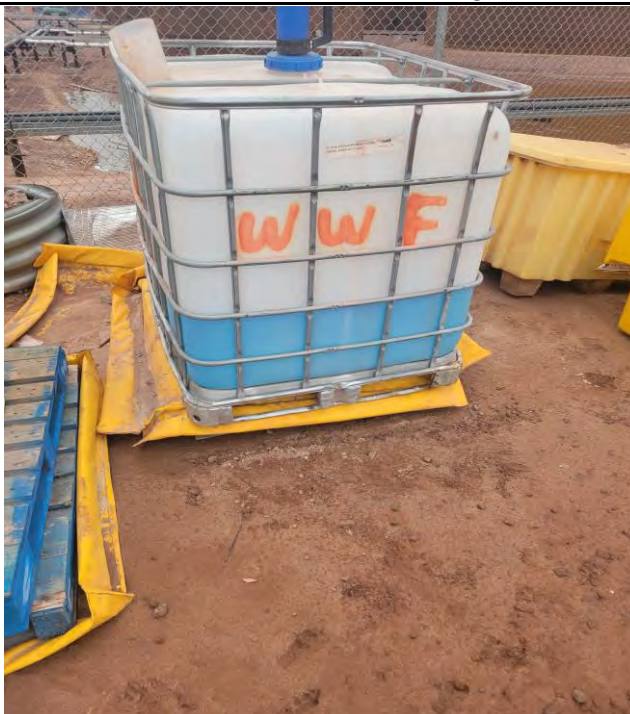
Milne Inlet light vehicle refueling station

Description: More berms improperly set up.

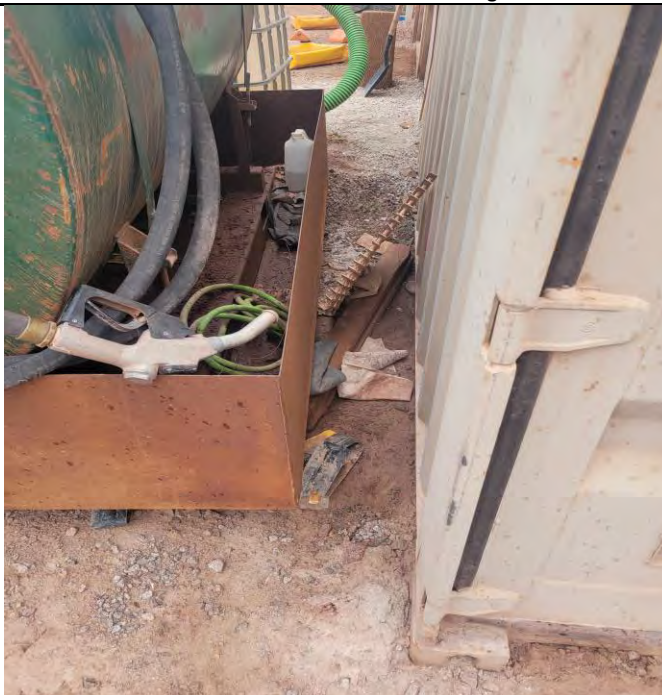
Milne Inlet light vehicle refueling station

10. More berms were seen at the light vehicle refuelling station in Milne and were not set up properly. Ground staining and fuel odour were also present at this location. Inspector Pasalic requested that this spill be reported to the NT-NU spill line.

Description: Inspector Pasalic discovered a spill that was not reported to the NT-NU spill line. Pasalic stated that this spill should be reported and remediated.

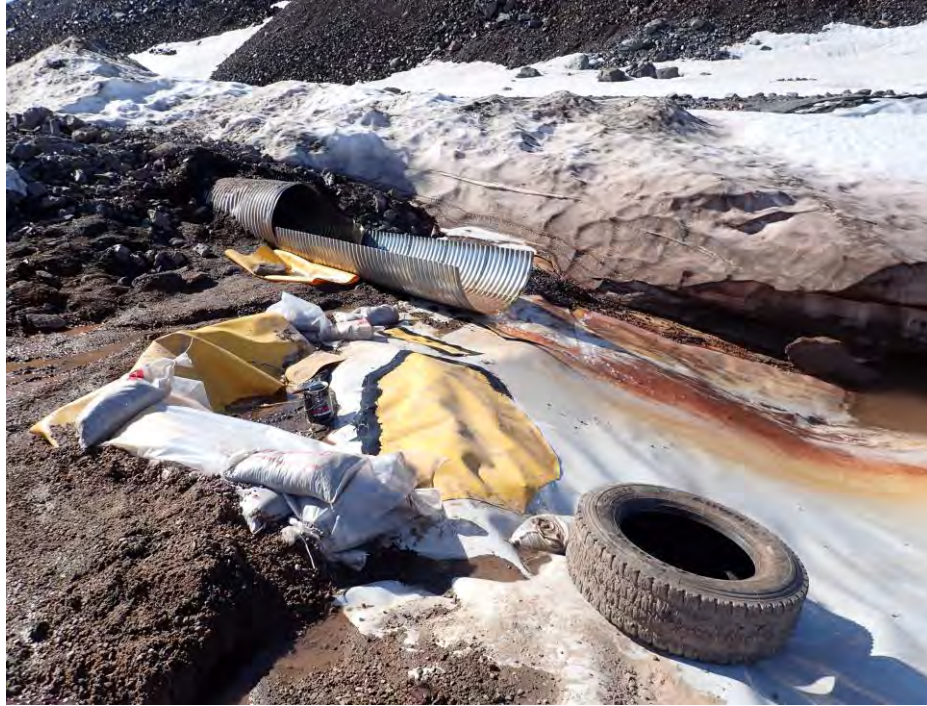
Photo 1 – Liner repair at the WRF pond ditch inflow. July 16, 2023

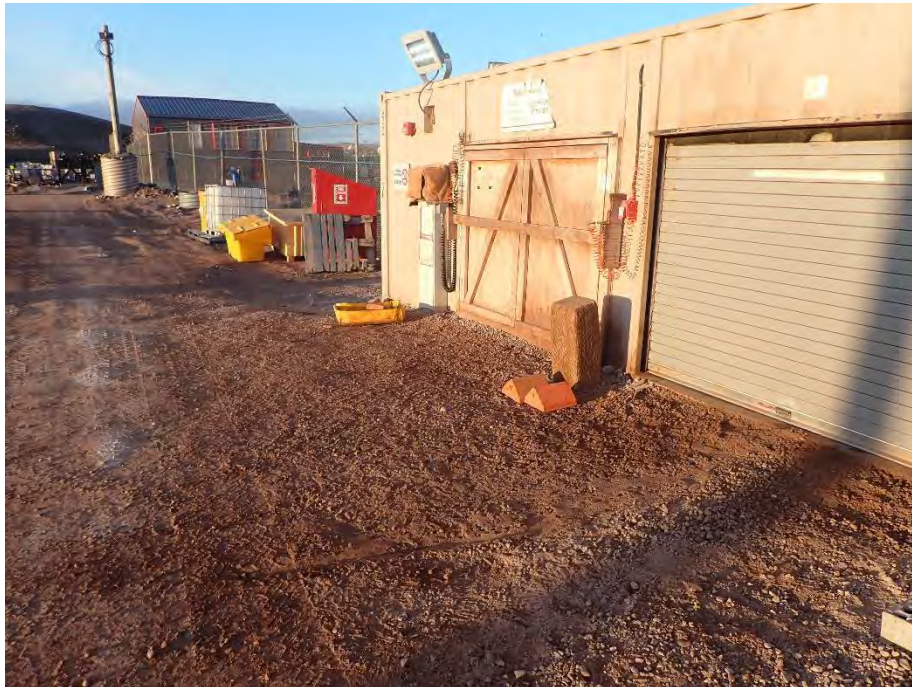
Photo 2 – Spill trays at Milne Port light vehicle refueling area replaced, August 2023

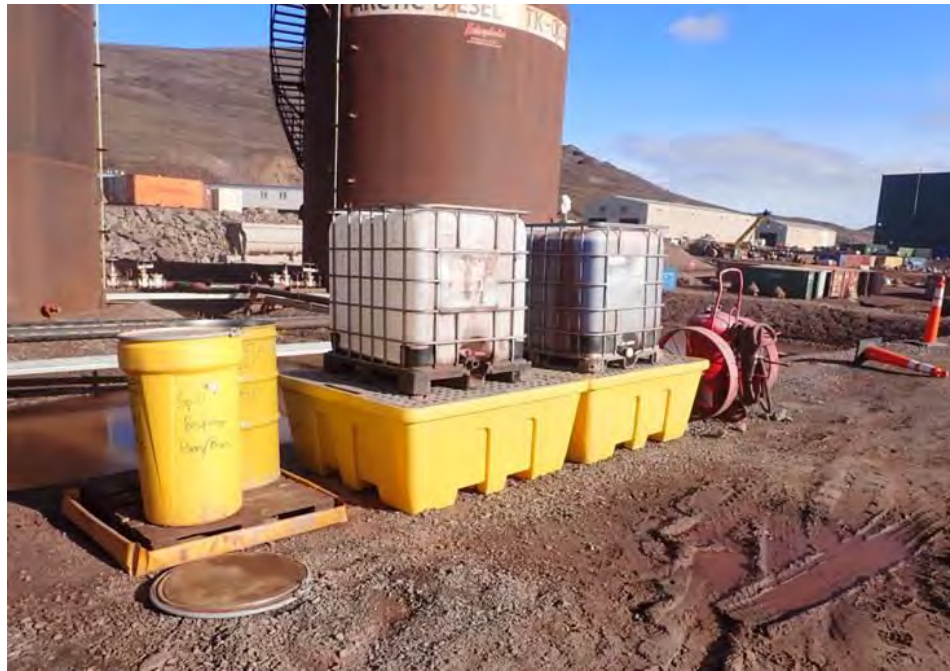
Photo 3 – Spill trays at Mary River light vehicle refueling area replaced, August 2023

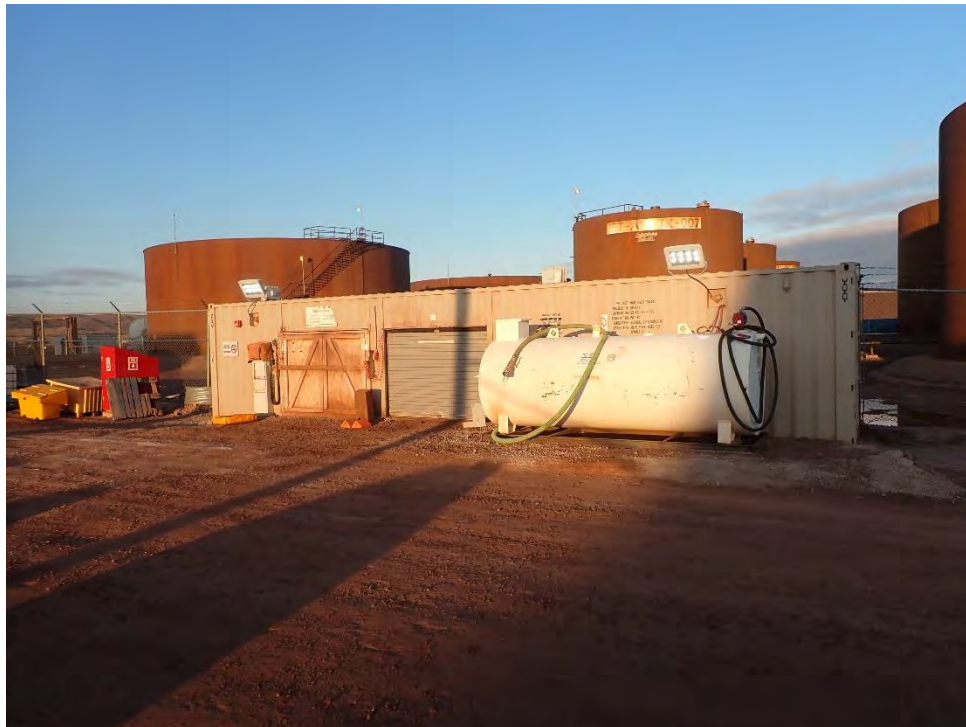
Photo 4 – Contaminated soil removed, and old fuel tank replaced with new double walled tank.
September, 2023

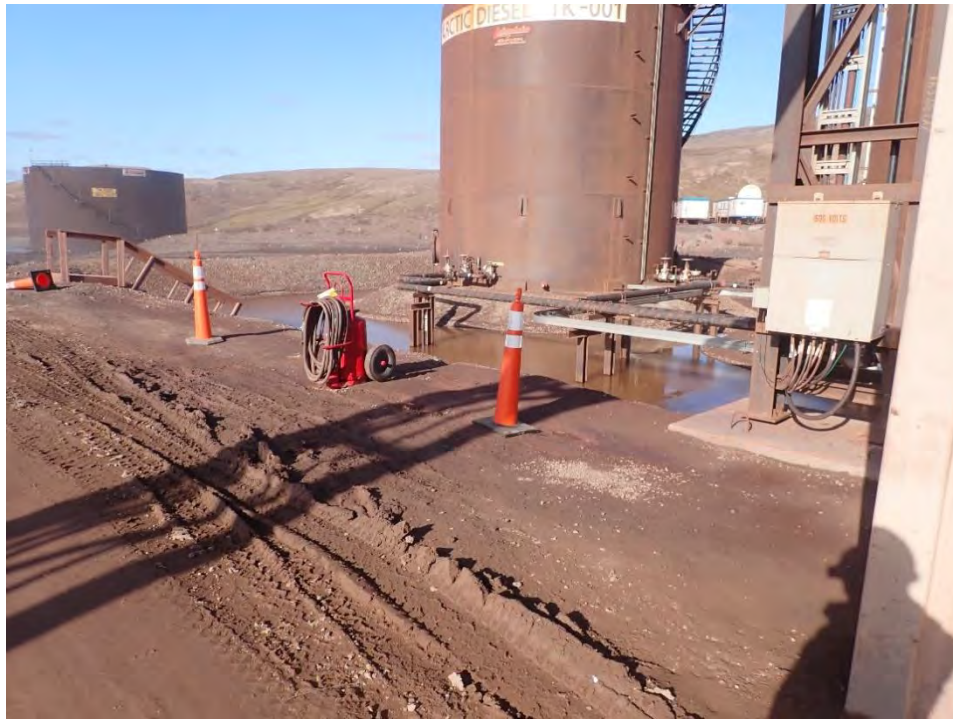
Photo 5 – Contaminated soil removed, and ponding water being removed for treatment. September, 2023

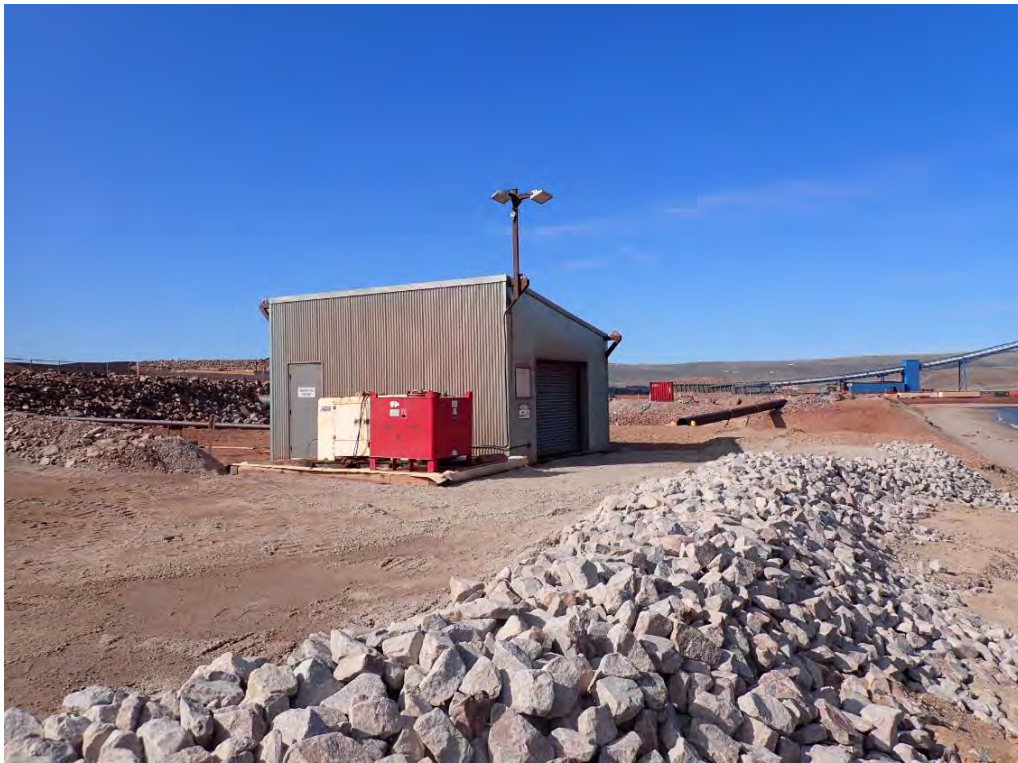
Photo 6 – Follow up to spill 23-294 showing re-enforced bank to prevent further erosion

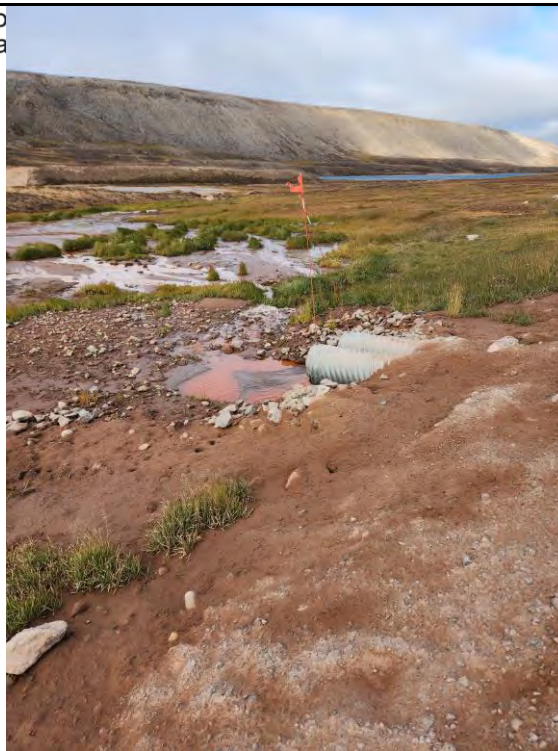
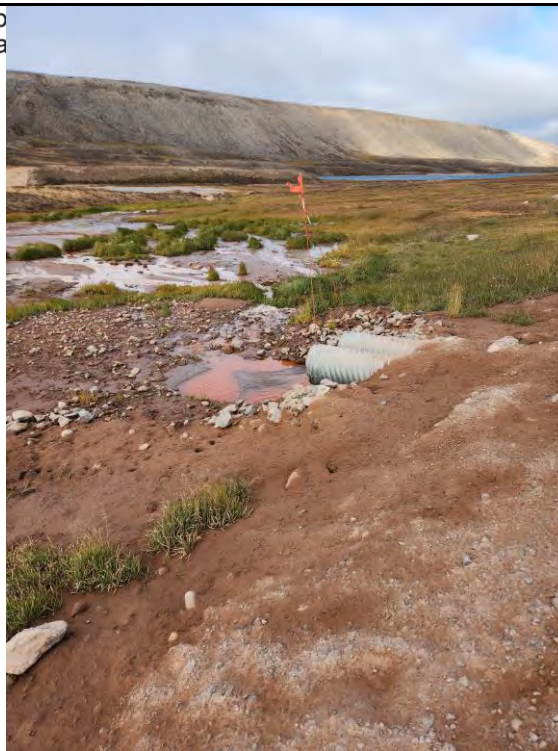
Description: Sediment-laden water was observed coming out of the culvert at KM 92.

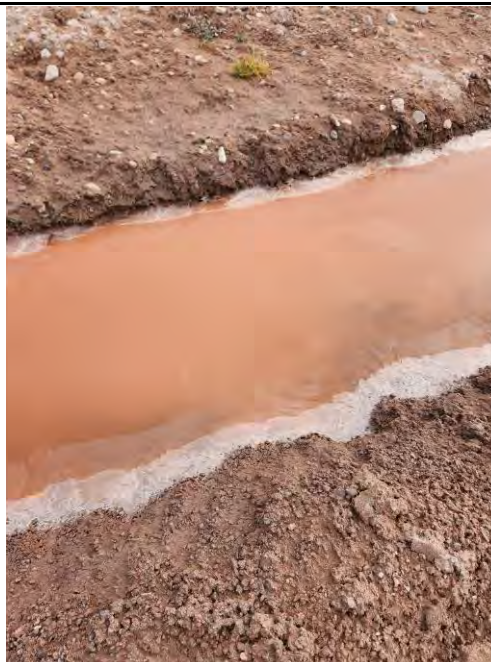
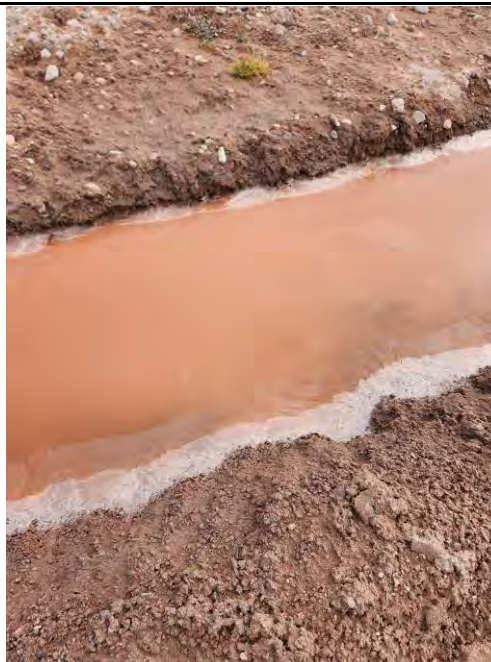
Description: Sediment-laden water flowing downstream into the culverts.

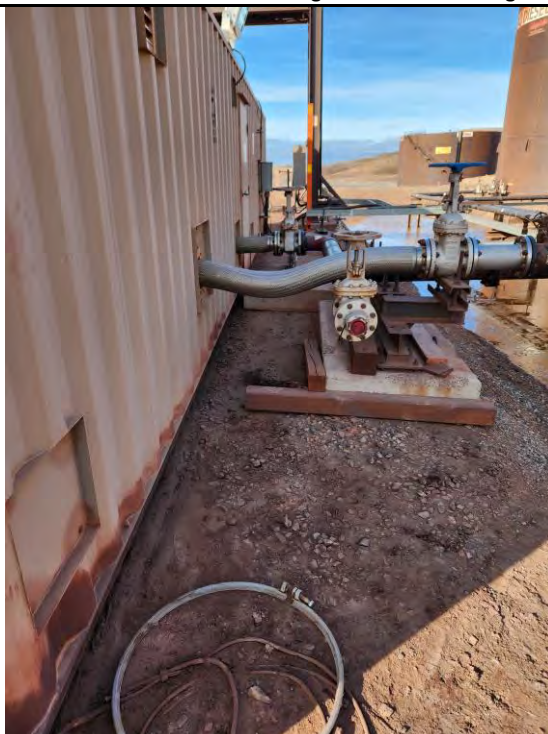
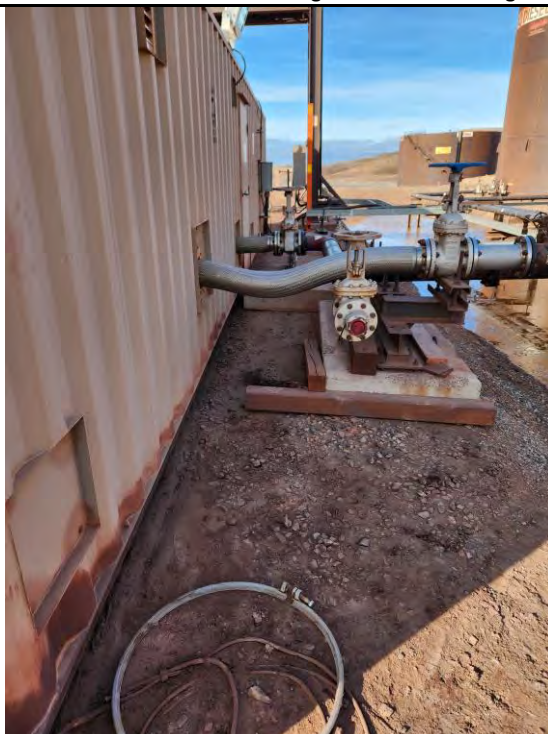
Light Vehicle Refueling Station

Description: Fuel staining and odours were present under the flex pipe.

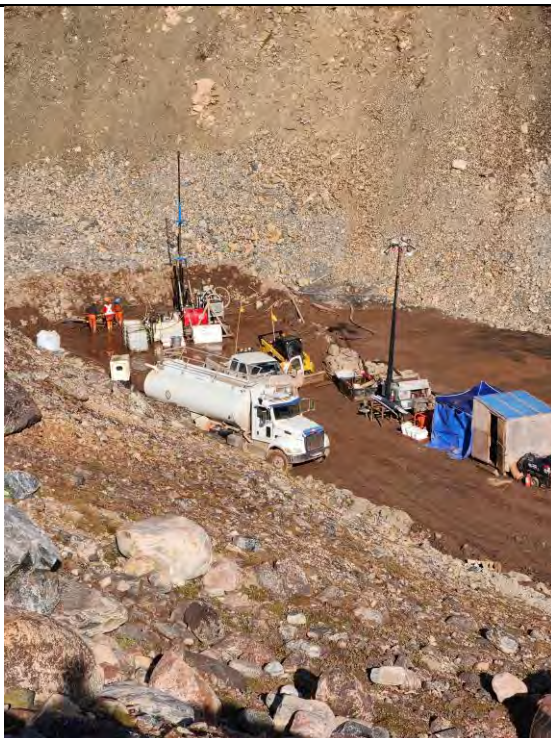
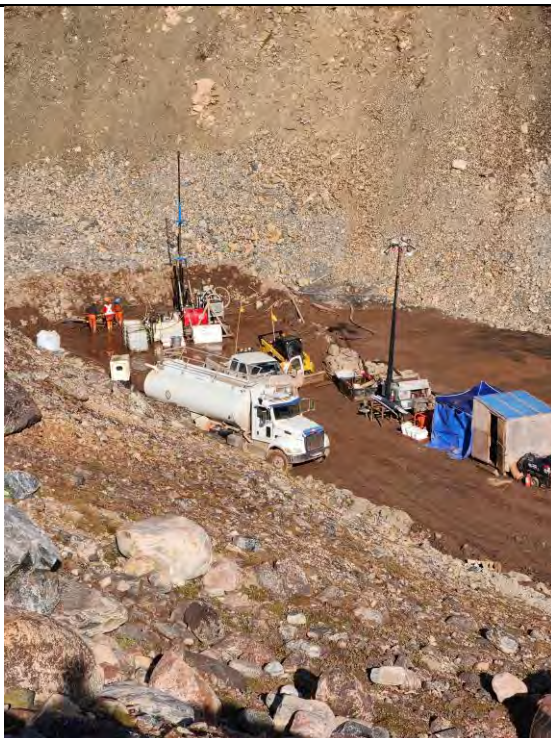
KM 105 – Bottom of dam

Description: Geotechnical drilling to identify a leak in the dam.

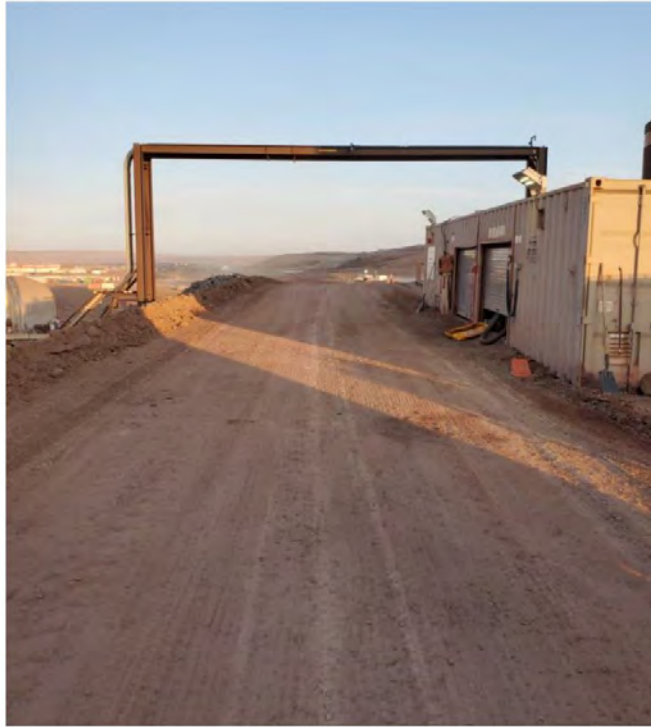
Photo 1. Mary River fuel station showing stained substrate removed and replaced with clean fill. Sept 16, 2023

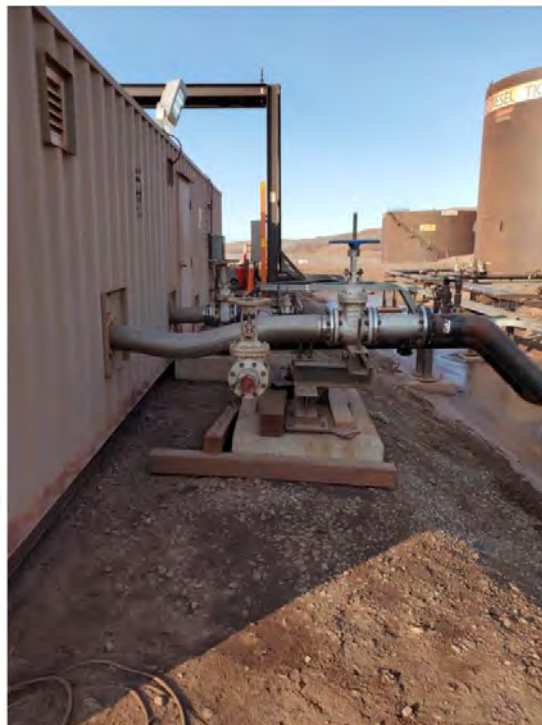
Photo 2. Mary River fuel filling station showing stained substrate removed under flex line. Sept 16, 2023

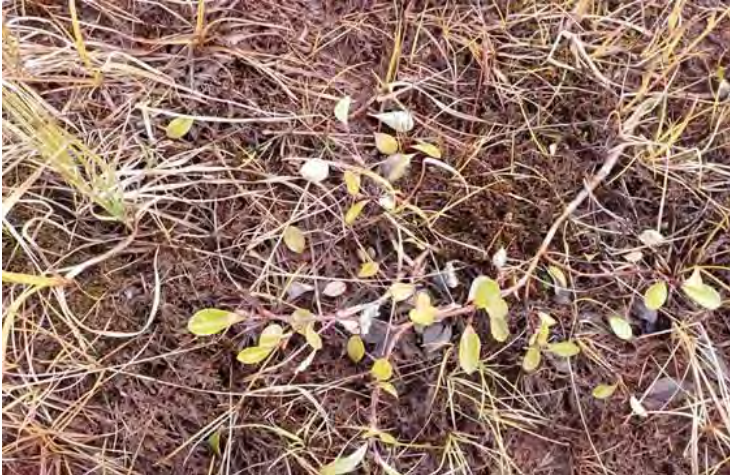
Photo 1 – vegetation in the area does not appear dusty, not suspected to be affected by road dust.

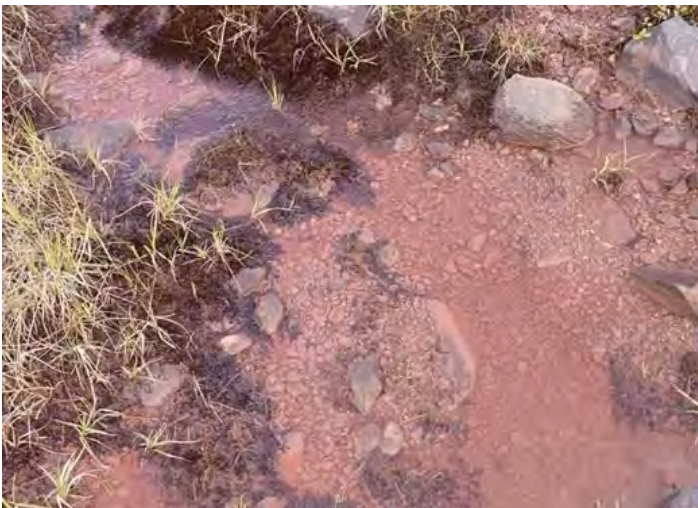
Photo 3 – Clear water on top of rusty coloured ground material

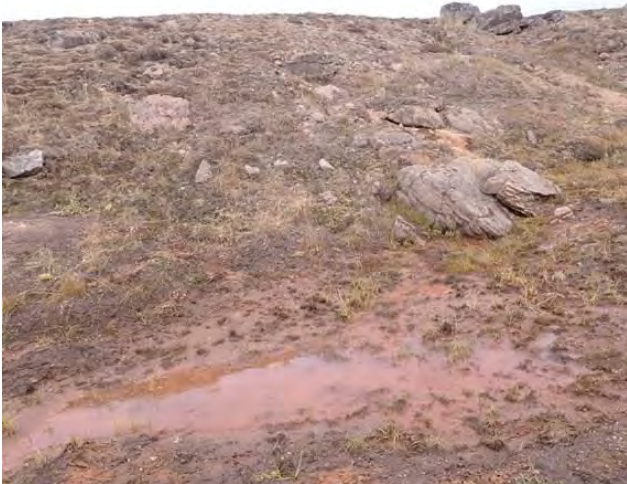
Photo 6 - Valley below the hill where water is first observed becoming red and turbid (Location 2)

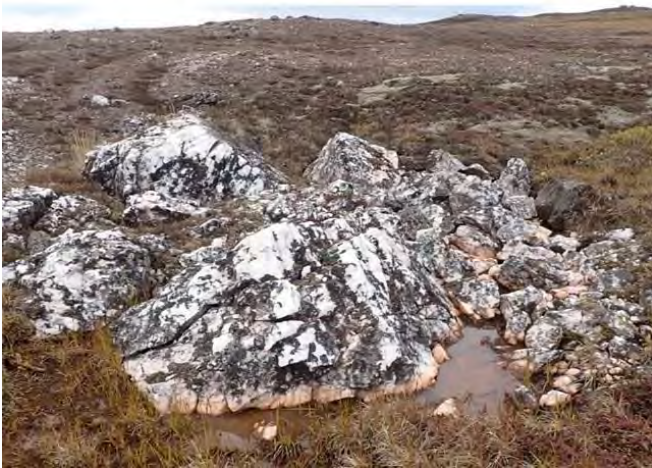
Photo 7 - Staining from red runoff water well away from any mine disturbance

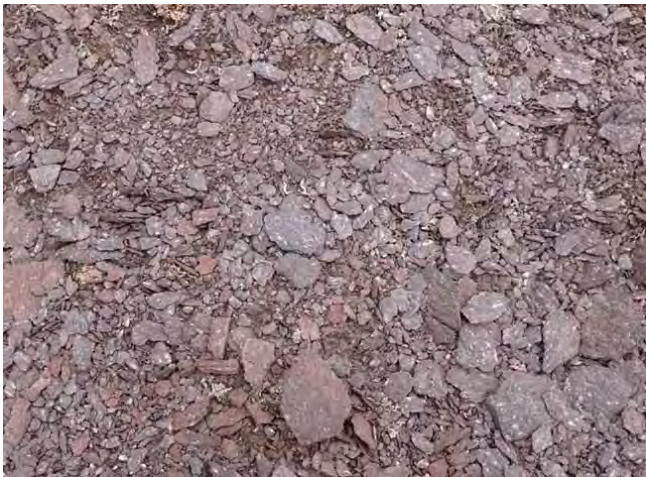
Photo 8 - On top of the hill with clear water adjacent to it exposed, weathered, naturally occurring iron rich rocks.

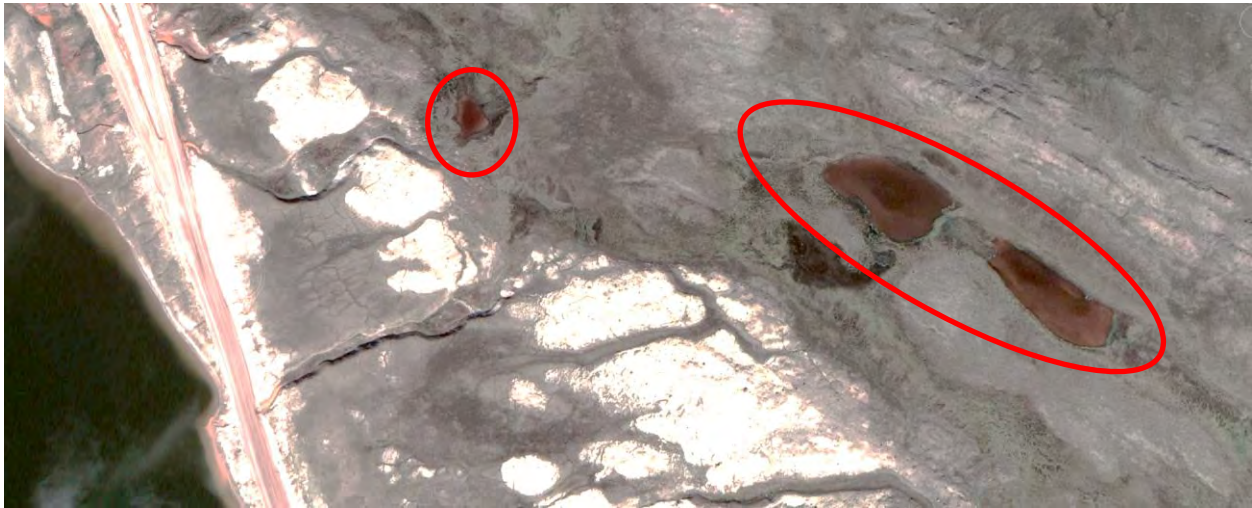
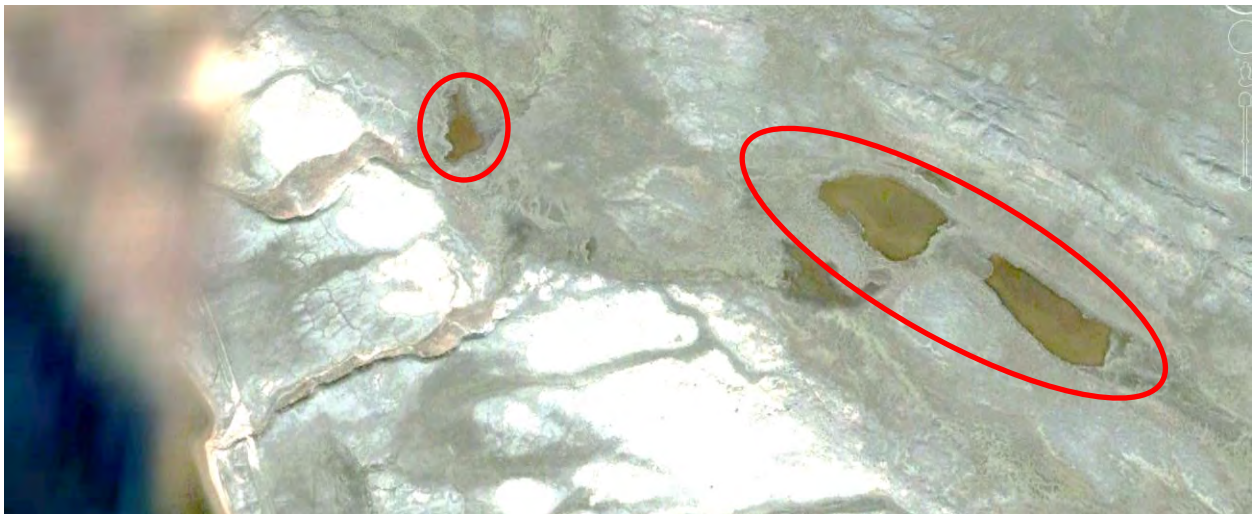
Figure 1 - 2020 (September) Imagery adjusted for brightness and contrast.

Although the overall colour tone of the 2005 photo is different, one can clearly see discoloured water in the circled ponds in both periods, indicating this has been happening prior to mine influence.

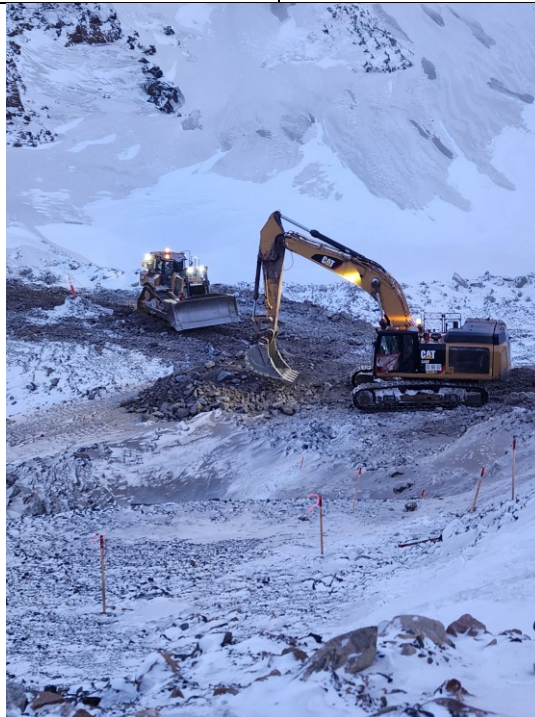
Photo No. 1	Lat/Long (DD.MM.SS.SS, NAD83)
Photo	71.18.709'N, 79.15.490'W

Description:
Drilling operations and preparing to inject grout into the KM105 Dam to repair the leak.

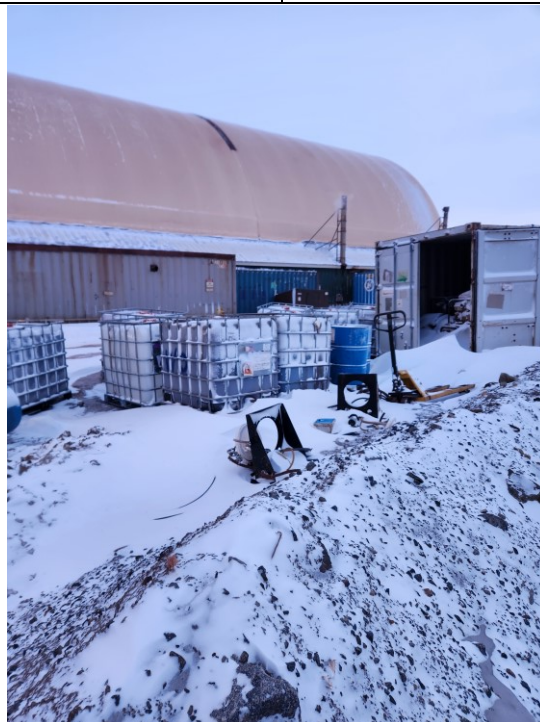
Photo No. 2	Lat/Long (DD.MM.SS.SS, NAD83)
Photo	71.18.779'N, 79.16.488'W

Description:
Totes of hazardous waste not situated within secondary containment. Photo taken behind the OHT Wash Bay.

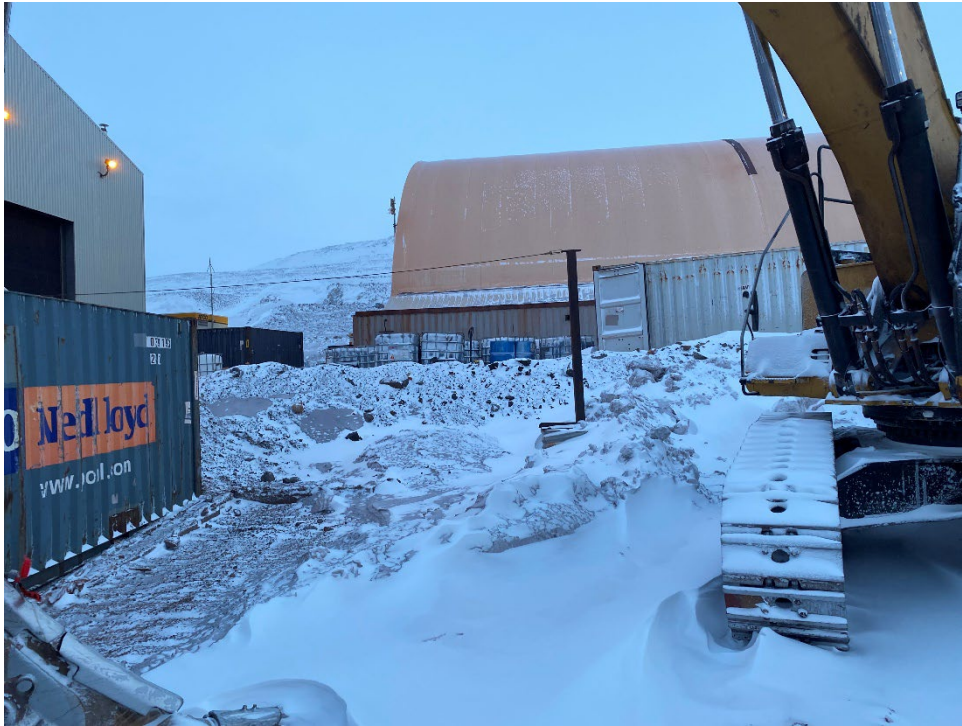
Photo 1. Totes with waste water and waste oil out of secondary containment behind the OHT Wash Bay.
February 14, 2024

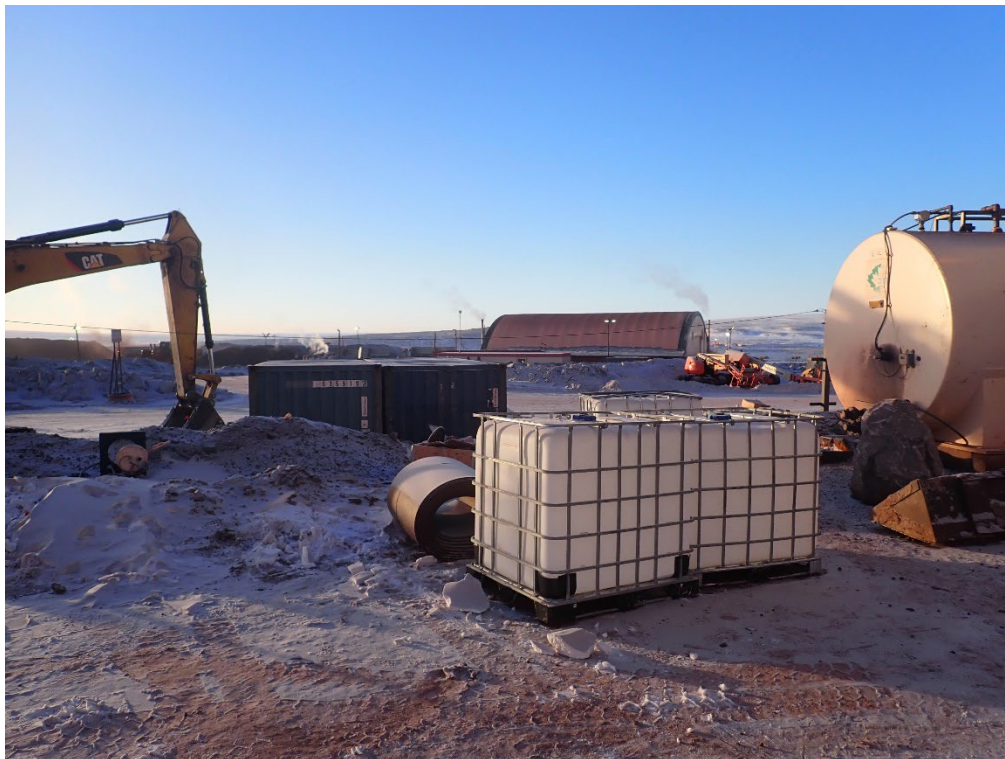
Photo 2. Totes with waste water and waste oil removed from OHT Wash Bay area. Totes pictured in photo are empty. February 18, 2024

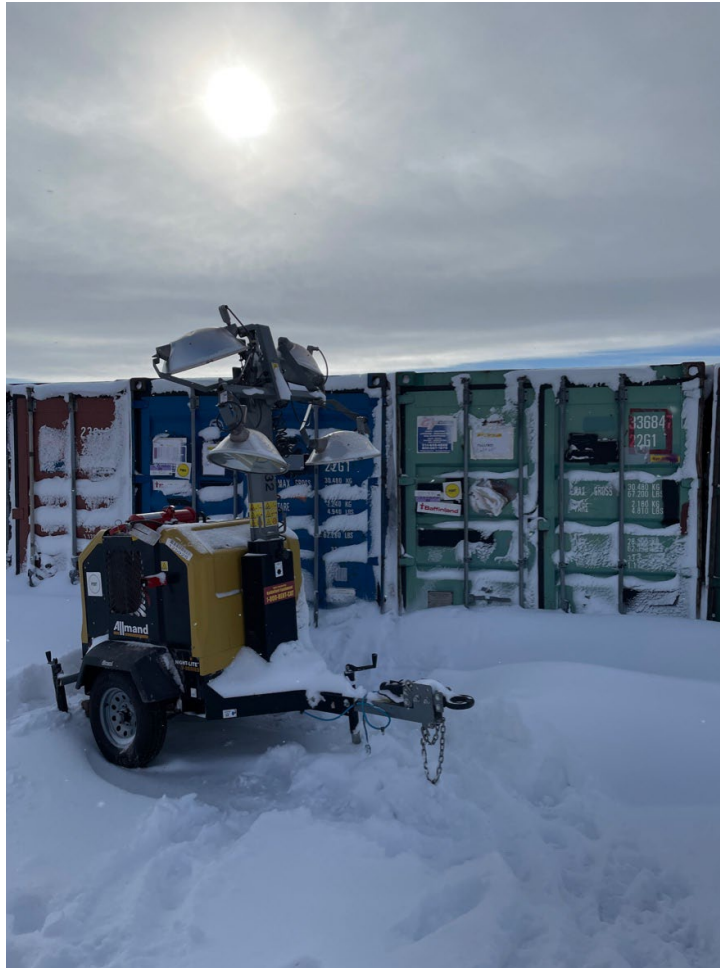
Photo 1: Photograph of generator/light plant near stacked seacans taken during the inspection (note make and model on the side)
