APPENDIX K2

2023 QIA Inspections and Baffinland's Responses

**Re: Baffinland Iron Mines Corporation's Mary River Project – Qikiqtani Inuit Association
June 2023 General Site Inspection Findings and Recommendations**

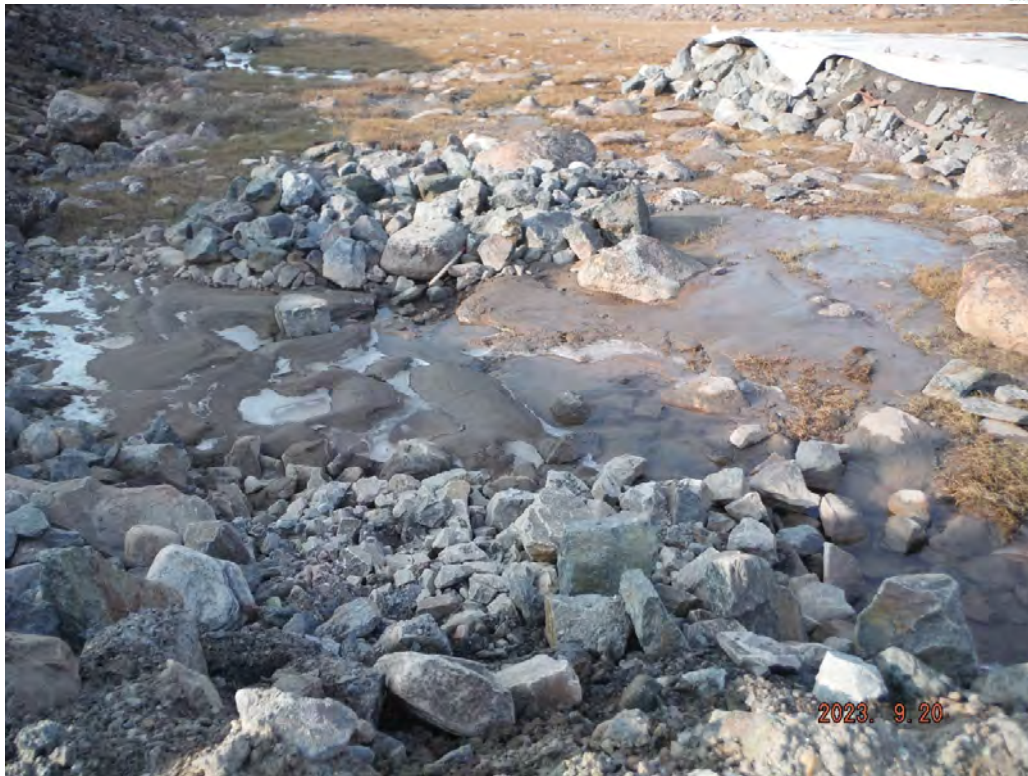
Photo 1 – Fine sediments accumulating downstream of dam at km105 (Sep 2023).

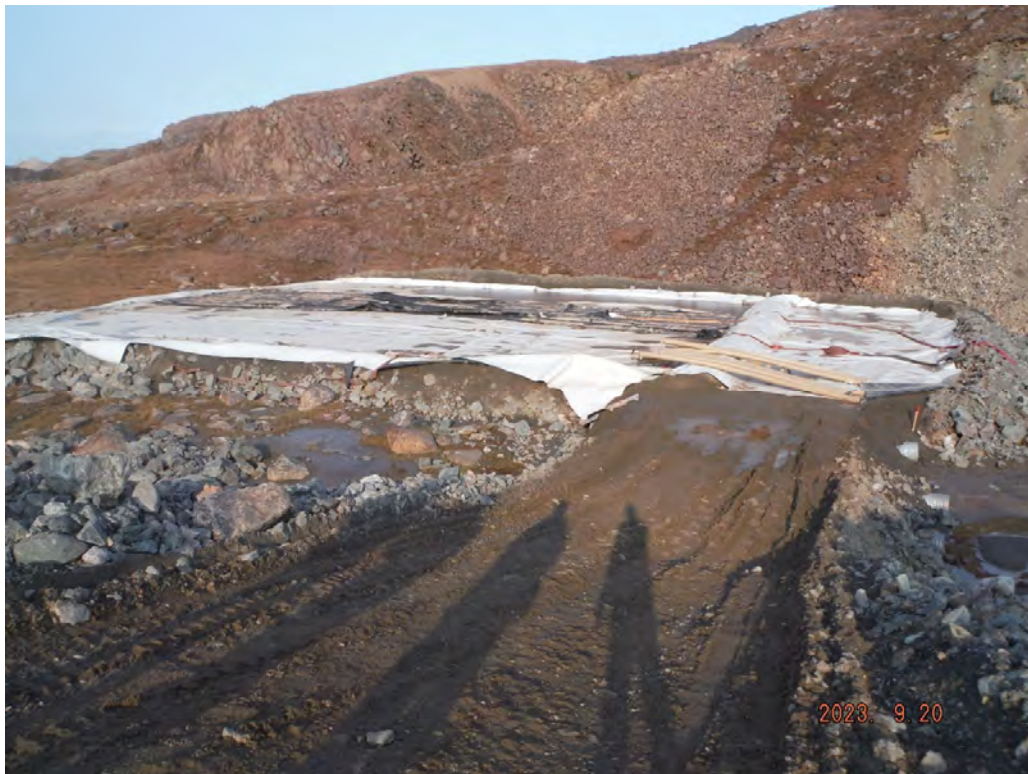
Photo 2 – Geobag downstream of dam/pond at km105 (Sep 2023).

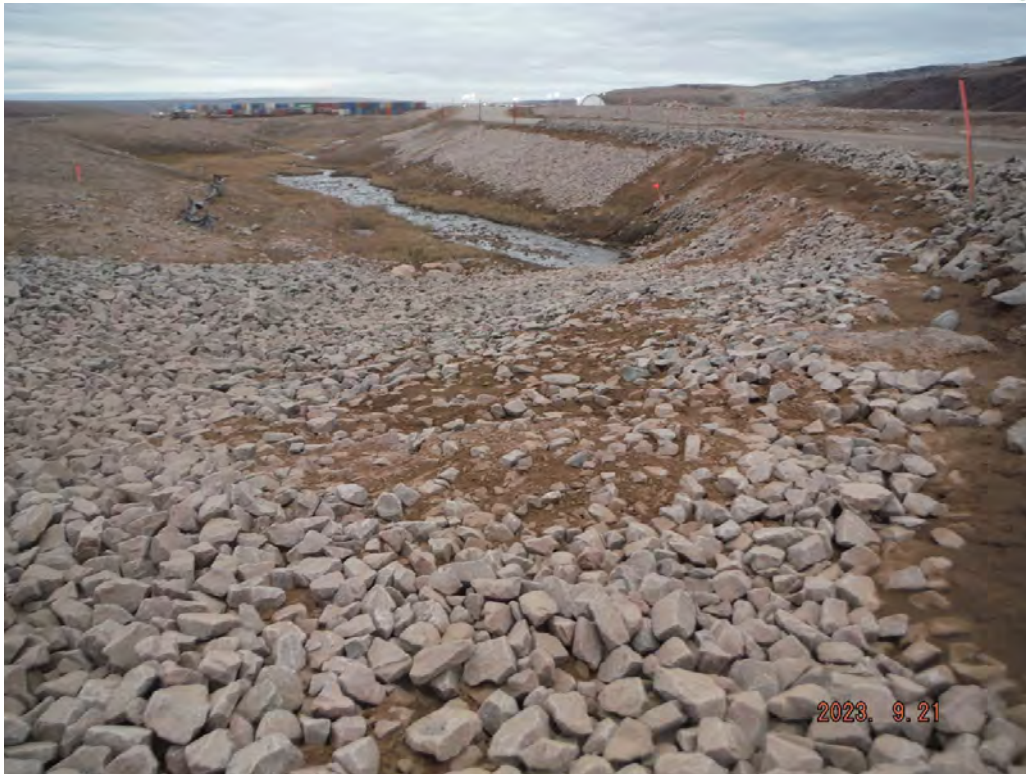
Photo 3 – Immediately south of the mine road adjacent to the Sheardown Lake Tributary (Sep 2023).

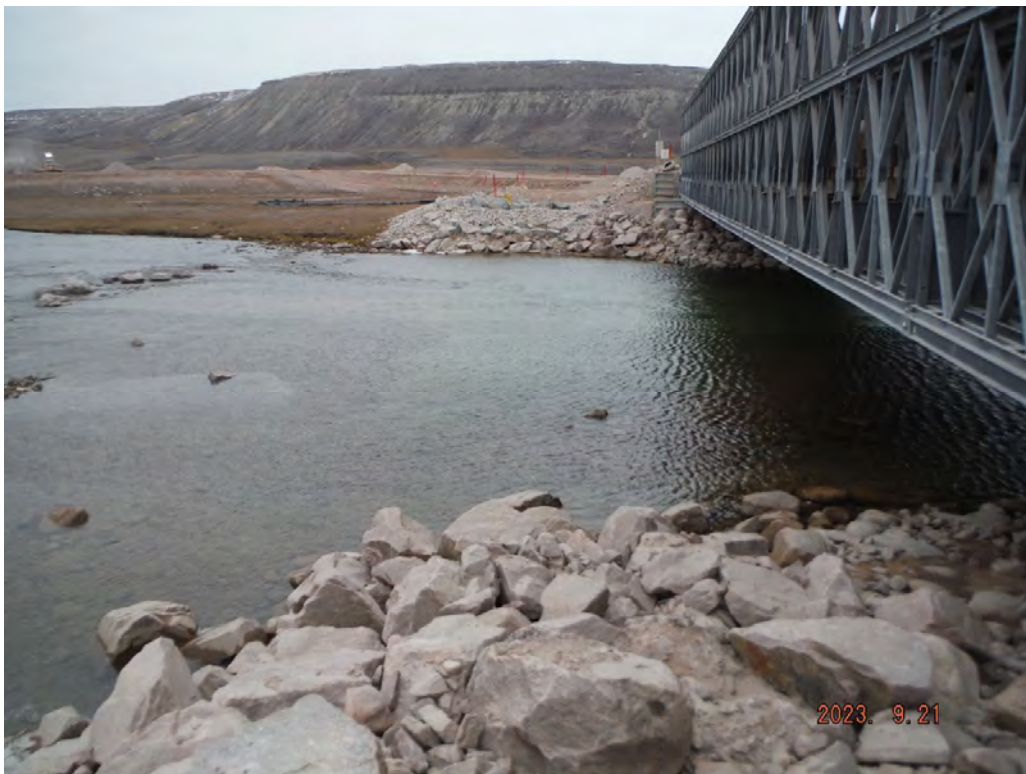
7	Phillips Creek crossing at KM17	The face of the sheet piles on the old bridge abutments are damaged. These are on the south side of the Tote Road on the east and west side of the stream. Fine sediments are exposed to erosion and have the potential to enter Phillips Creek (Appendix A Photos 10 and 11).	<ul style="list-style-type: none"> • Place ESCs at the base of the abutments to prevent any fine sediments from entering Phillips Creek. • Remove the old abutments and the fine materials from these two areas – old abutments are still in place. • Place coarse rock in disturbed areas to stabilize slopes and prevent fine sediments from entering Phillips Creek. 	No action observed

Photo 4 – Phillips Creek crossing at km17 (Sep 2023).

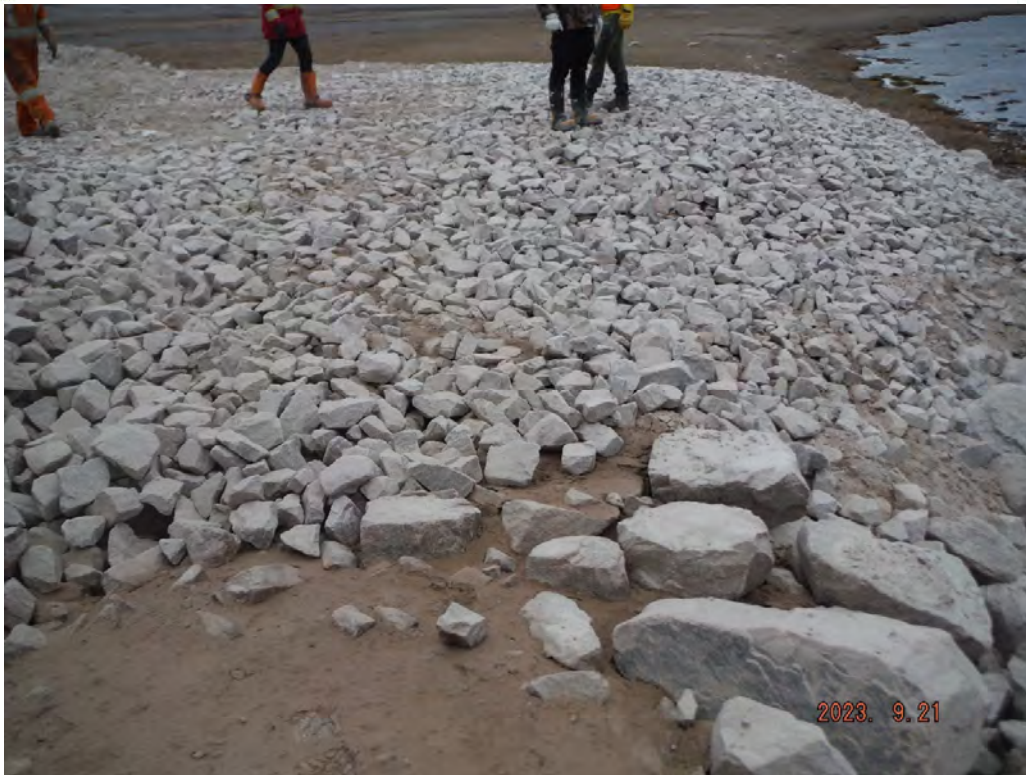
Photo 5 – Phillips Creek crossing at km17 (Sep 2023).

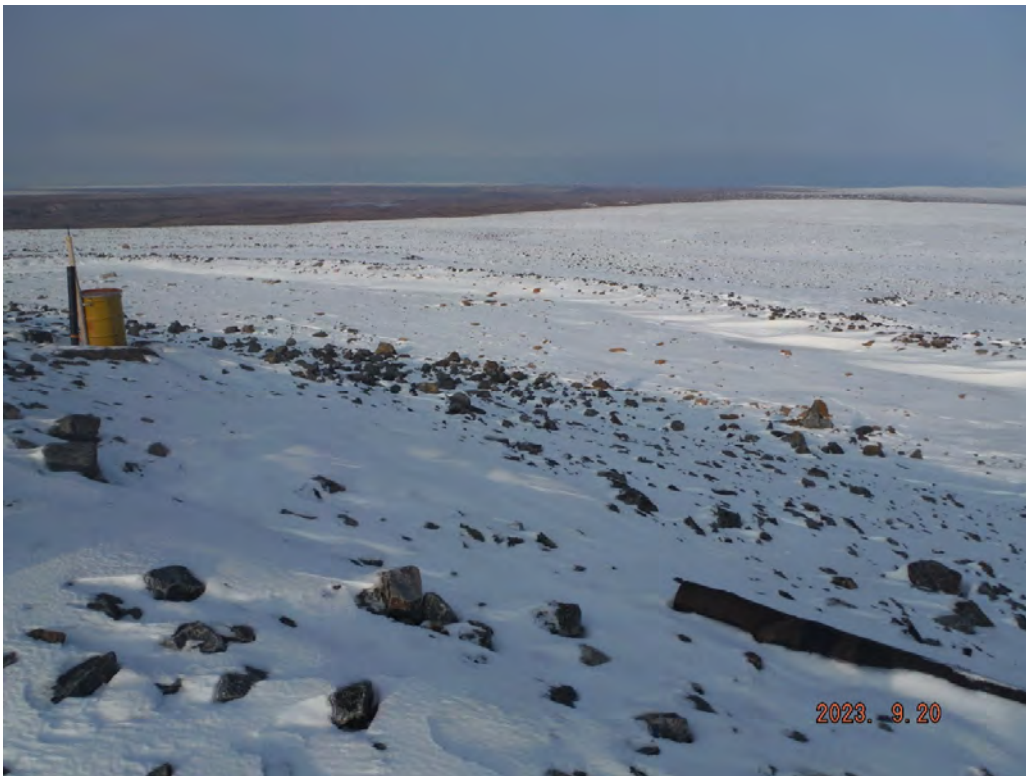
Photo 6 – Waste Rock Facility treatment pond berm where seepage had been reported (Sep 2023).

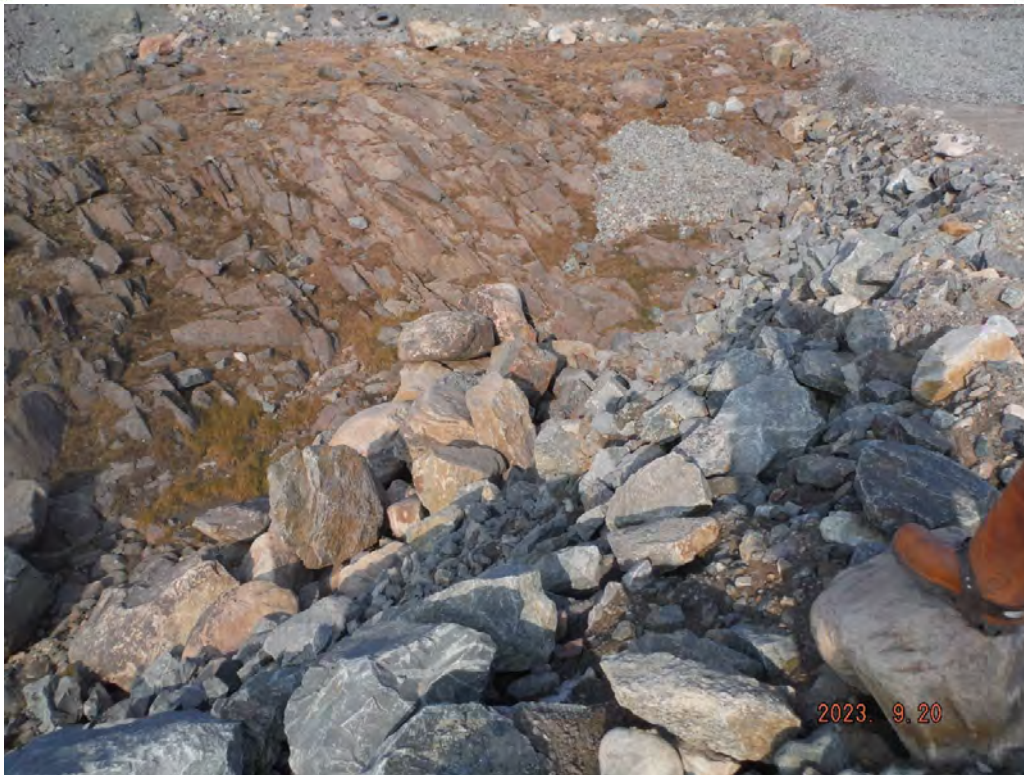
Photo 7 – Gully west of the km107 treatment pond where fines were observed (Sep 2023).

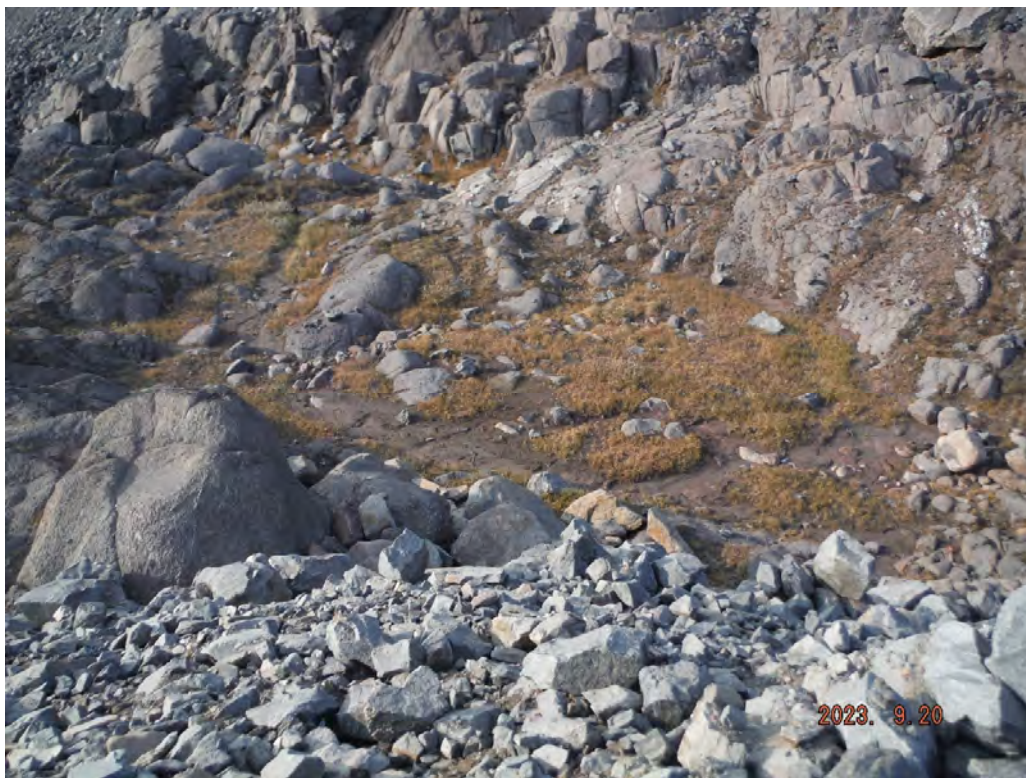
Photo 8 – Gully west of the km107 treatment pond where fines were observed (Sep 2023).

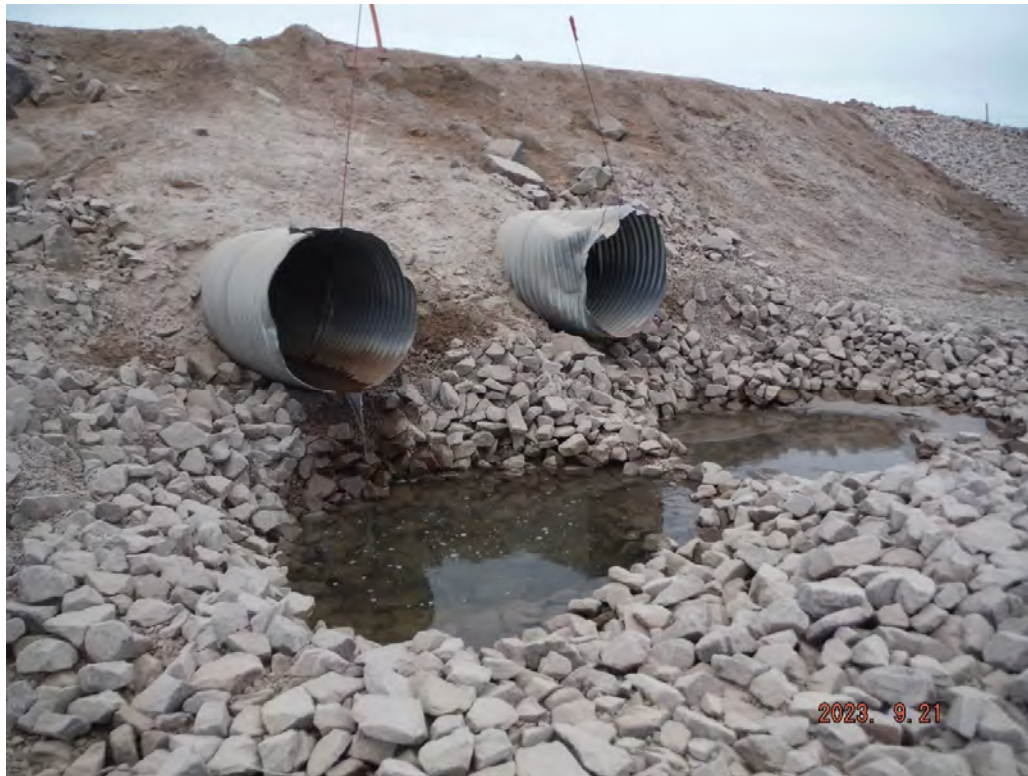
Photo 9 –SDCT-1 Tributary at km63 perched culverts (Sep 2023).

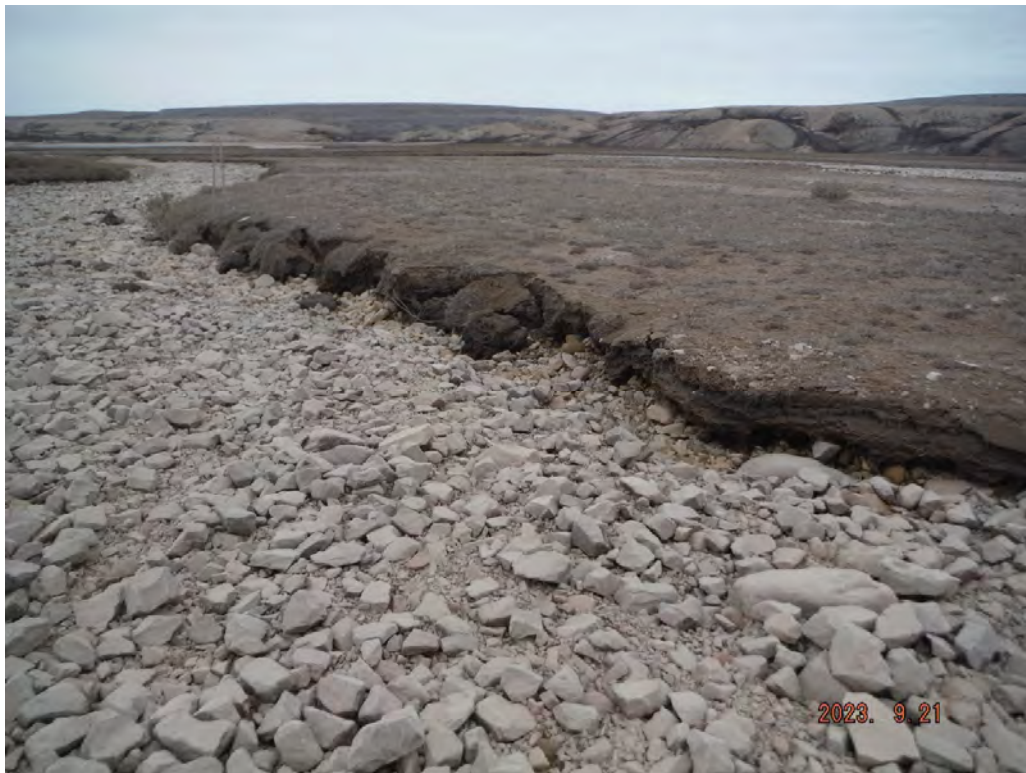
Photo 10 –SDCT-1 Tributary at km63 streambank erosion (Sep 2023).

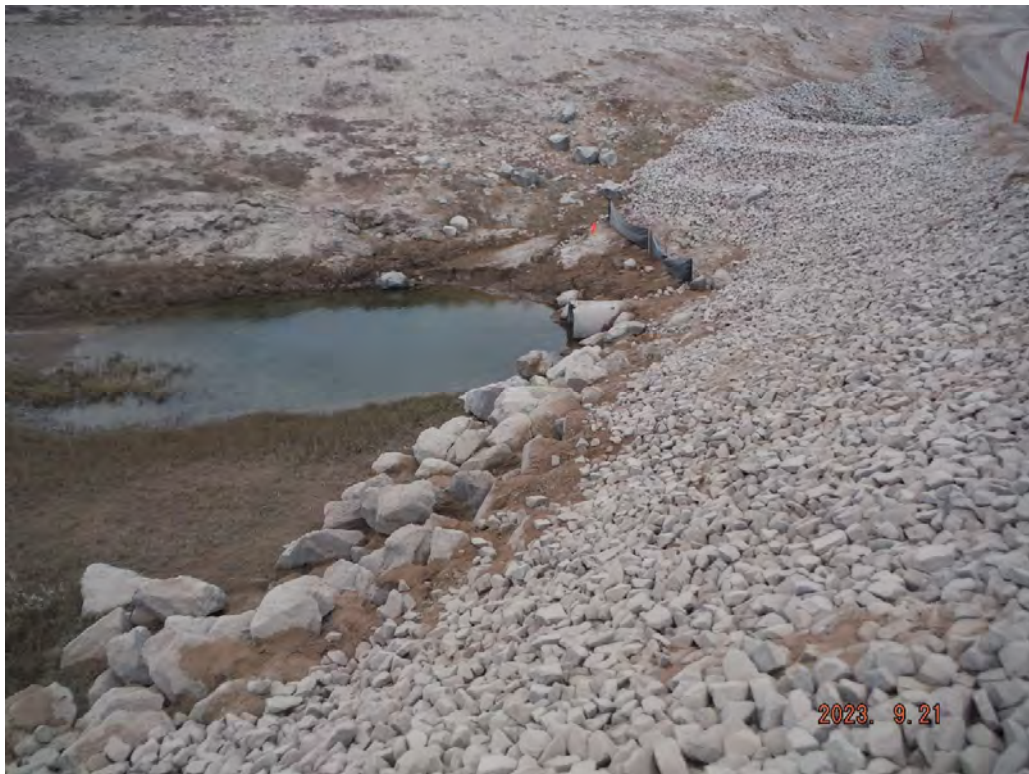
Photo 12 – Km85 watercourse crossing where erosion control with rock has taken place (Sep 2023).

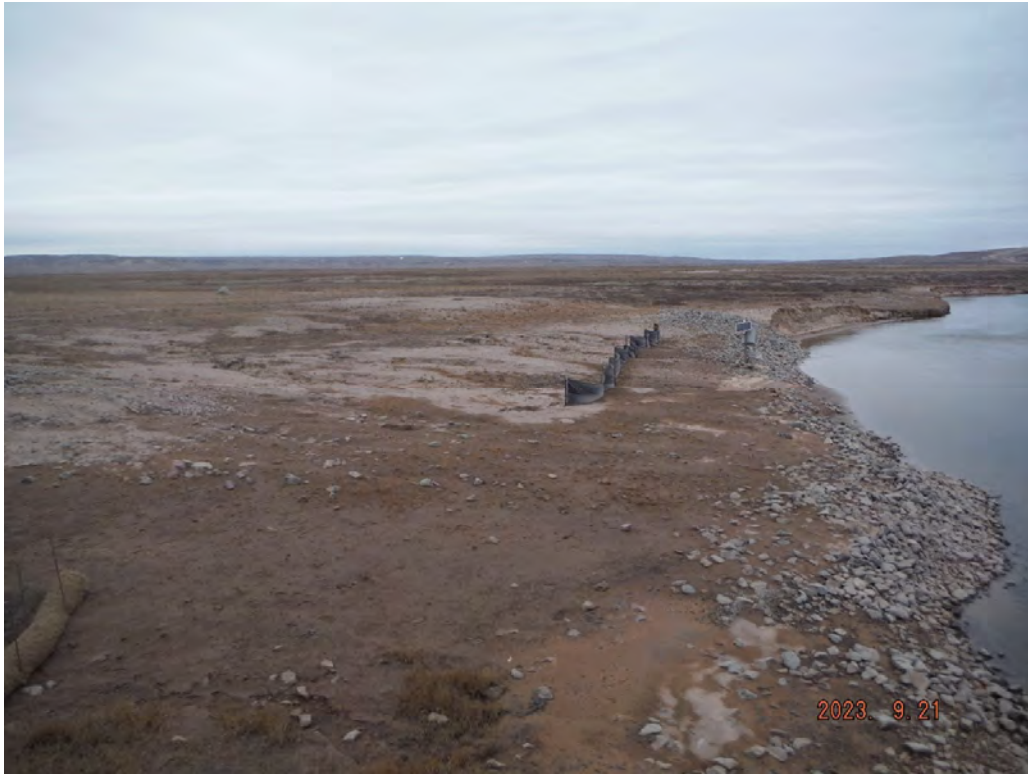
Photo 13 – km80 watercourse crossing where ESC measures have been implemented (Sep 2023).

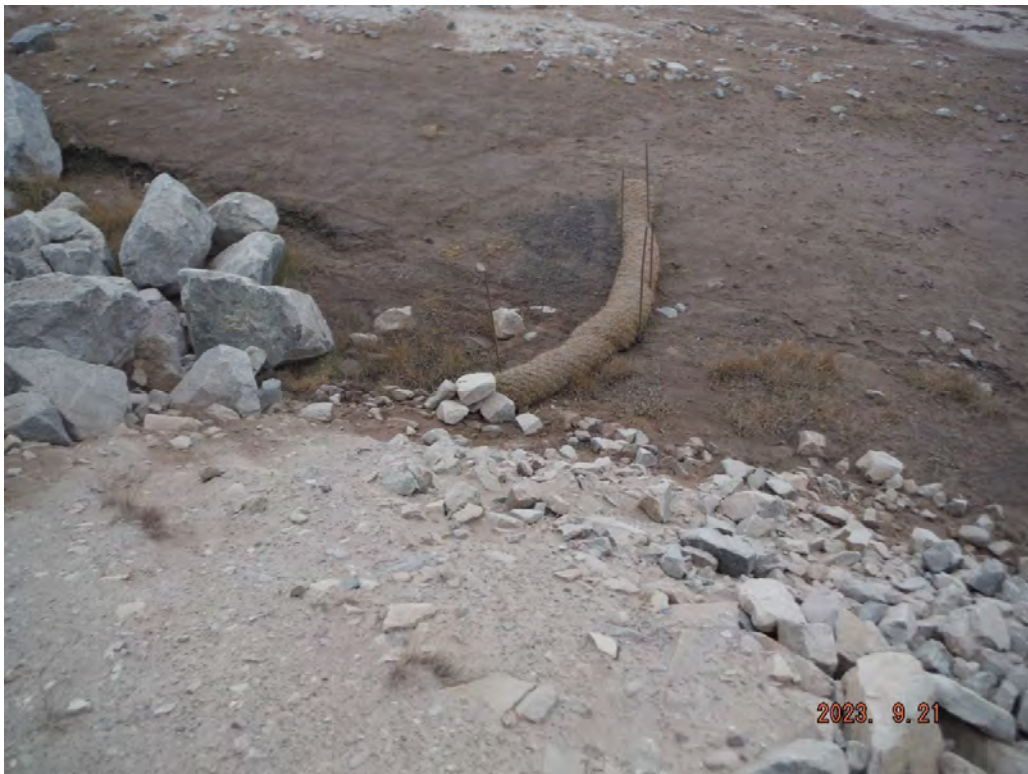
Photo 14 – km80 watercourse crossing where ESC measures have been implemented (Sep 2023).

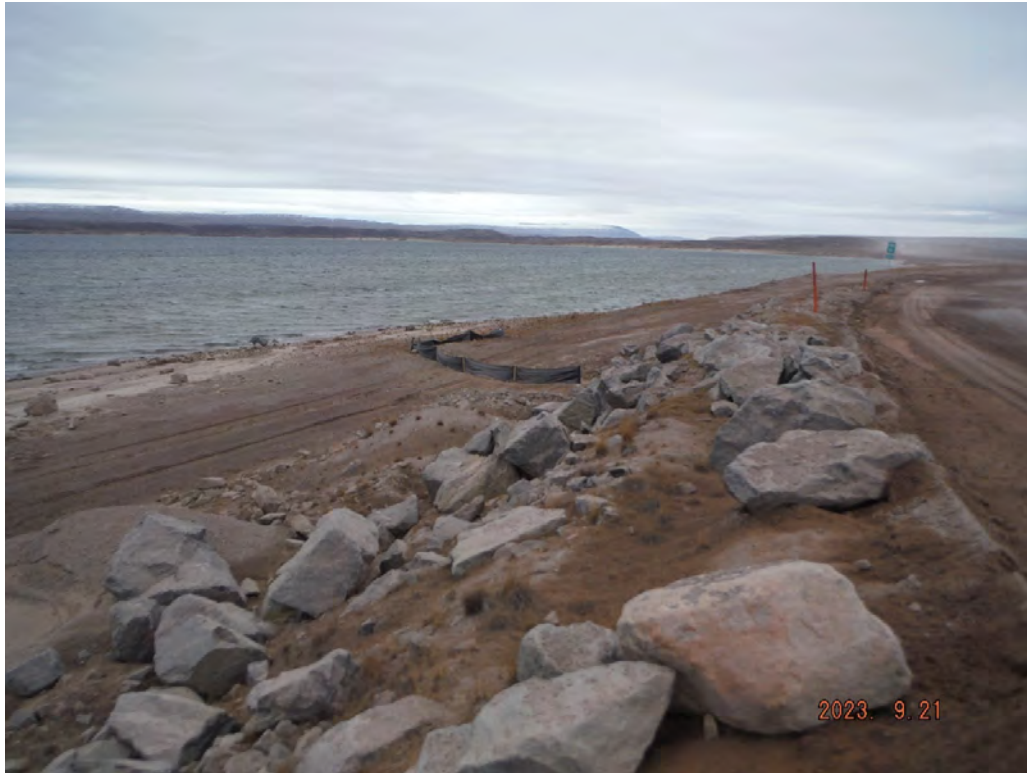
Photo 15 – km80 watercourse crossing where ESC measures have been implemented (Sep 2023).

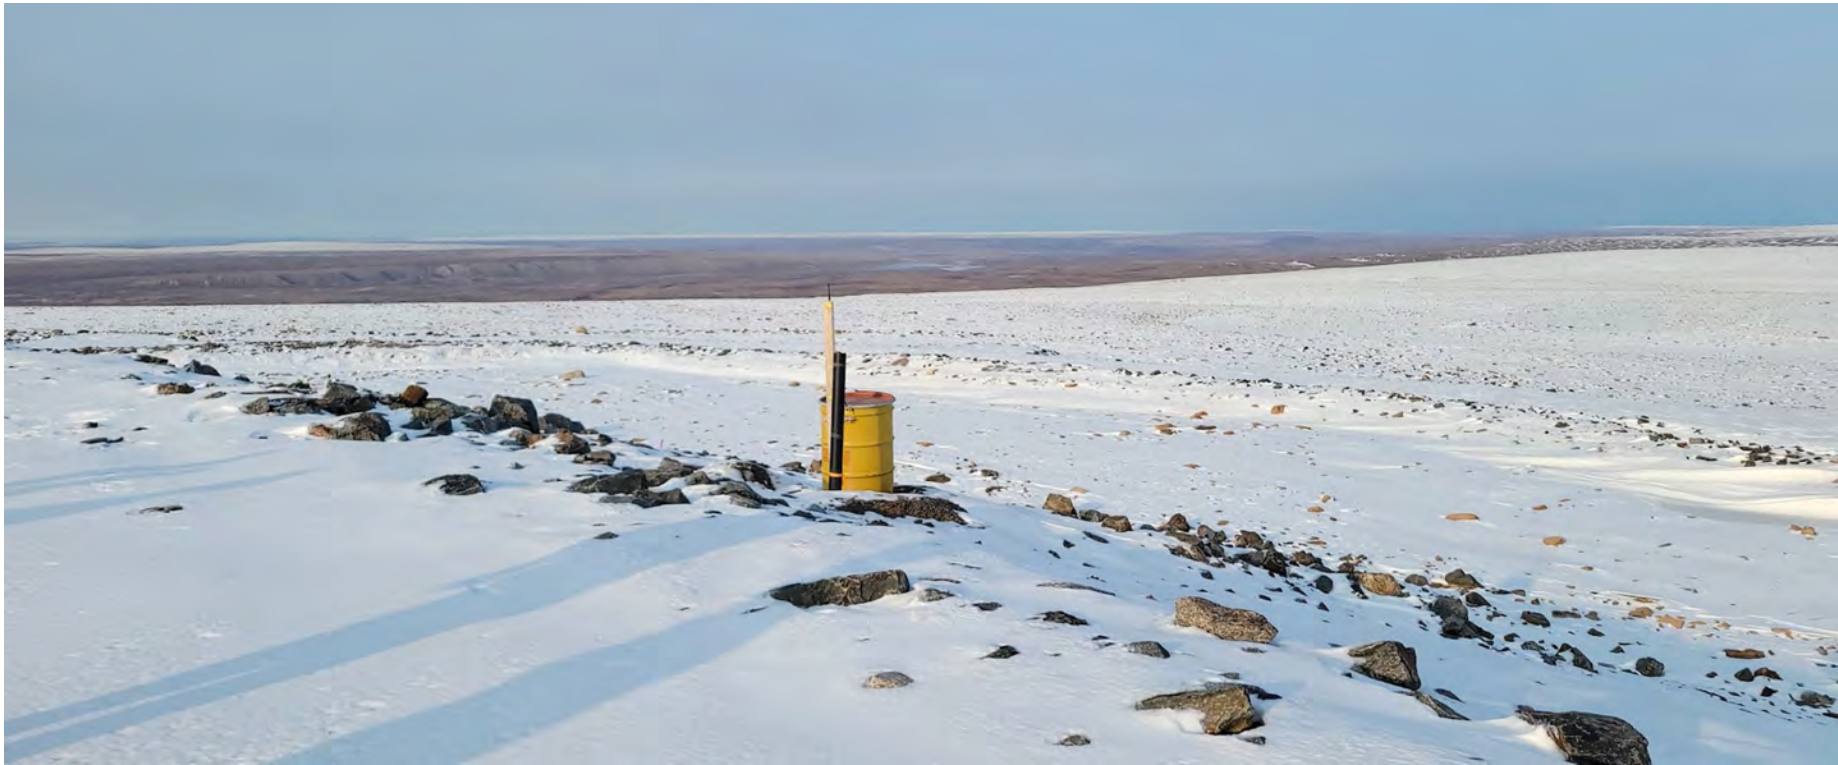
Photo 1: Secondary collection area downstream of Waste Rock Facility Surface Water Management Pond. It was unclear at the time of the Inspection whether this area is lined.

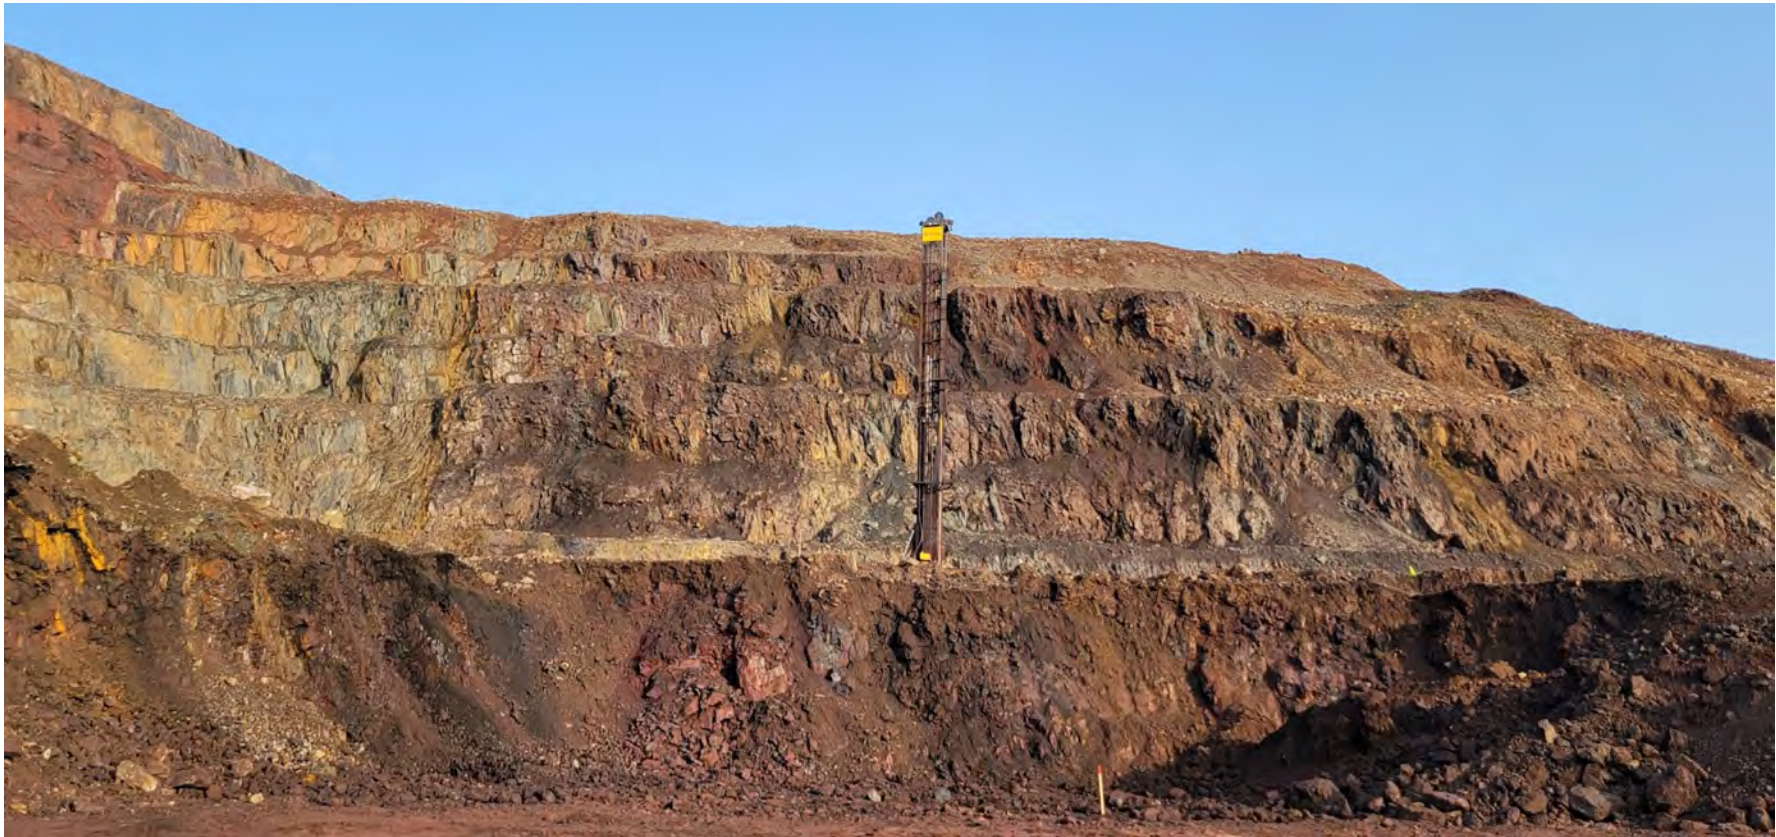
Photo 2: Close up of altered and weathered facies in pit wall.

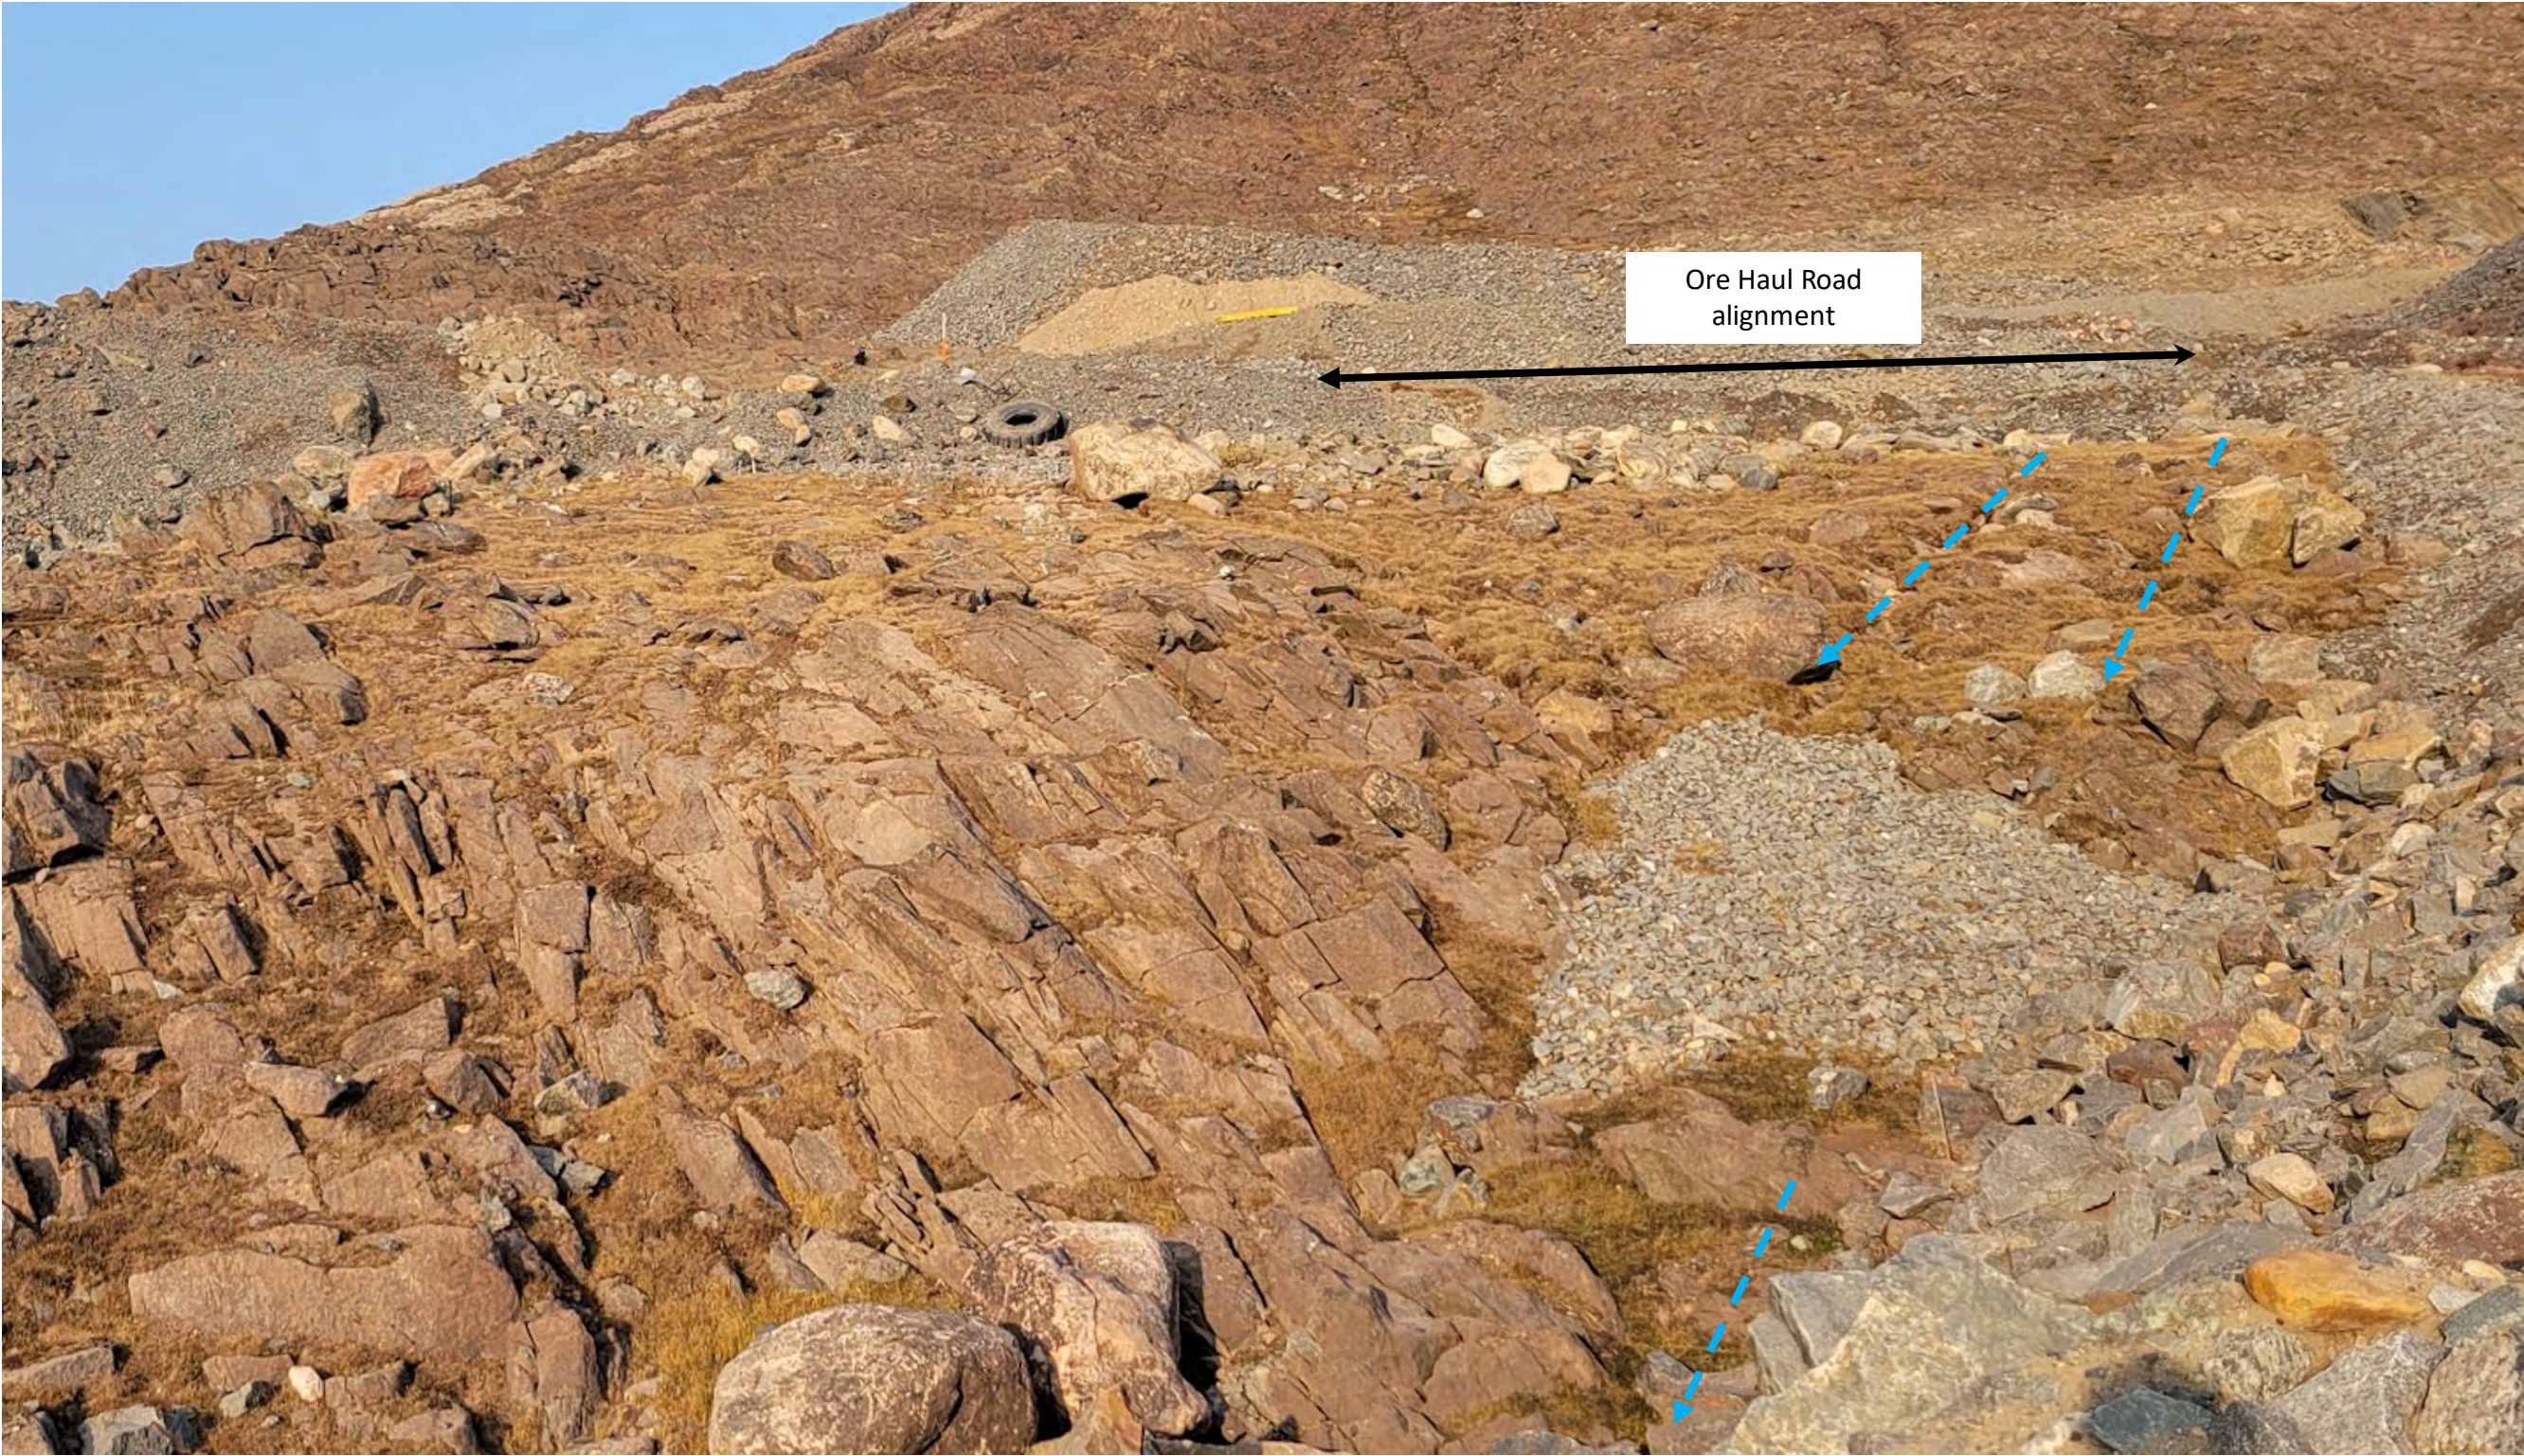
Photo 3: Area south and west of the southwest corner of the KM 106 Ore Stockpile with open geological structure that appears to allow water to flow through. Direction of water flow is shown.

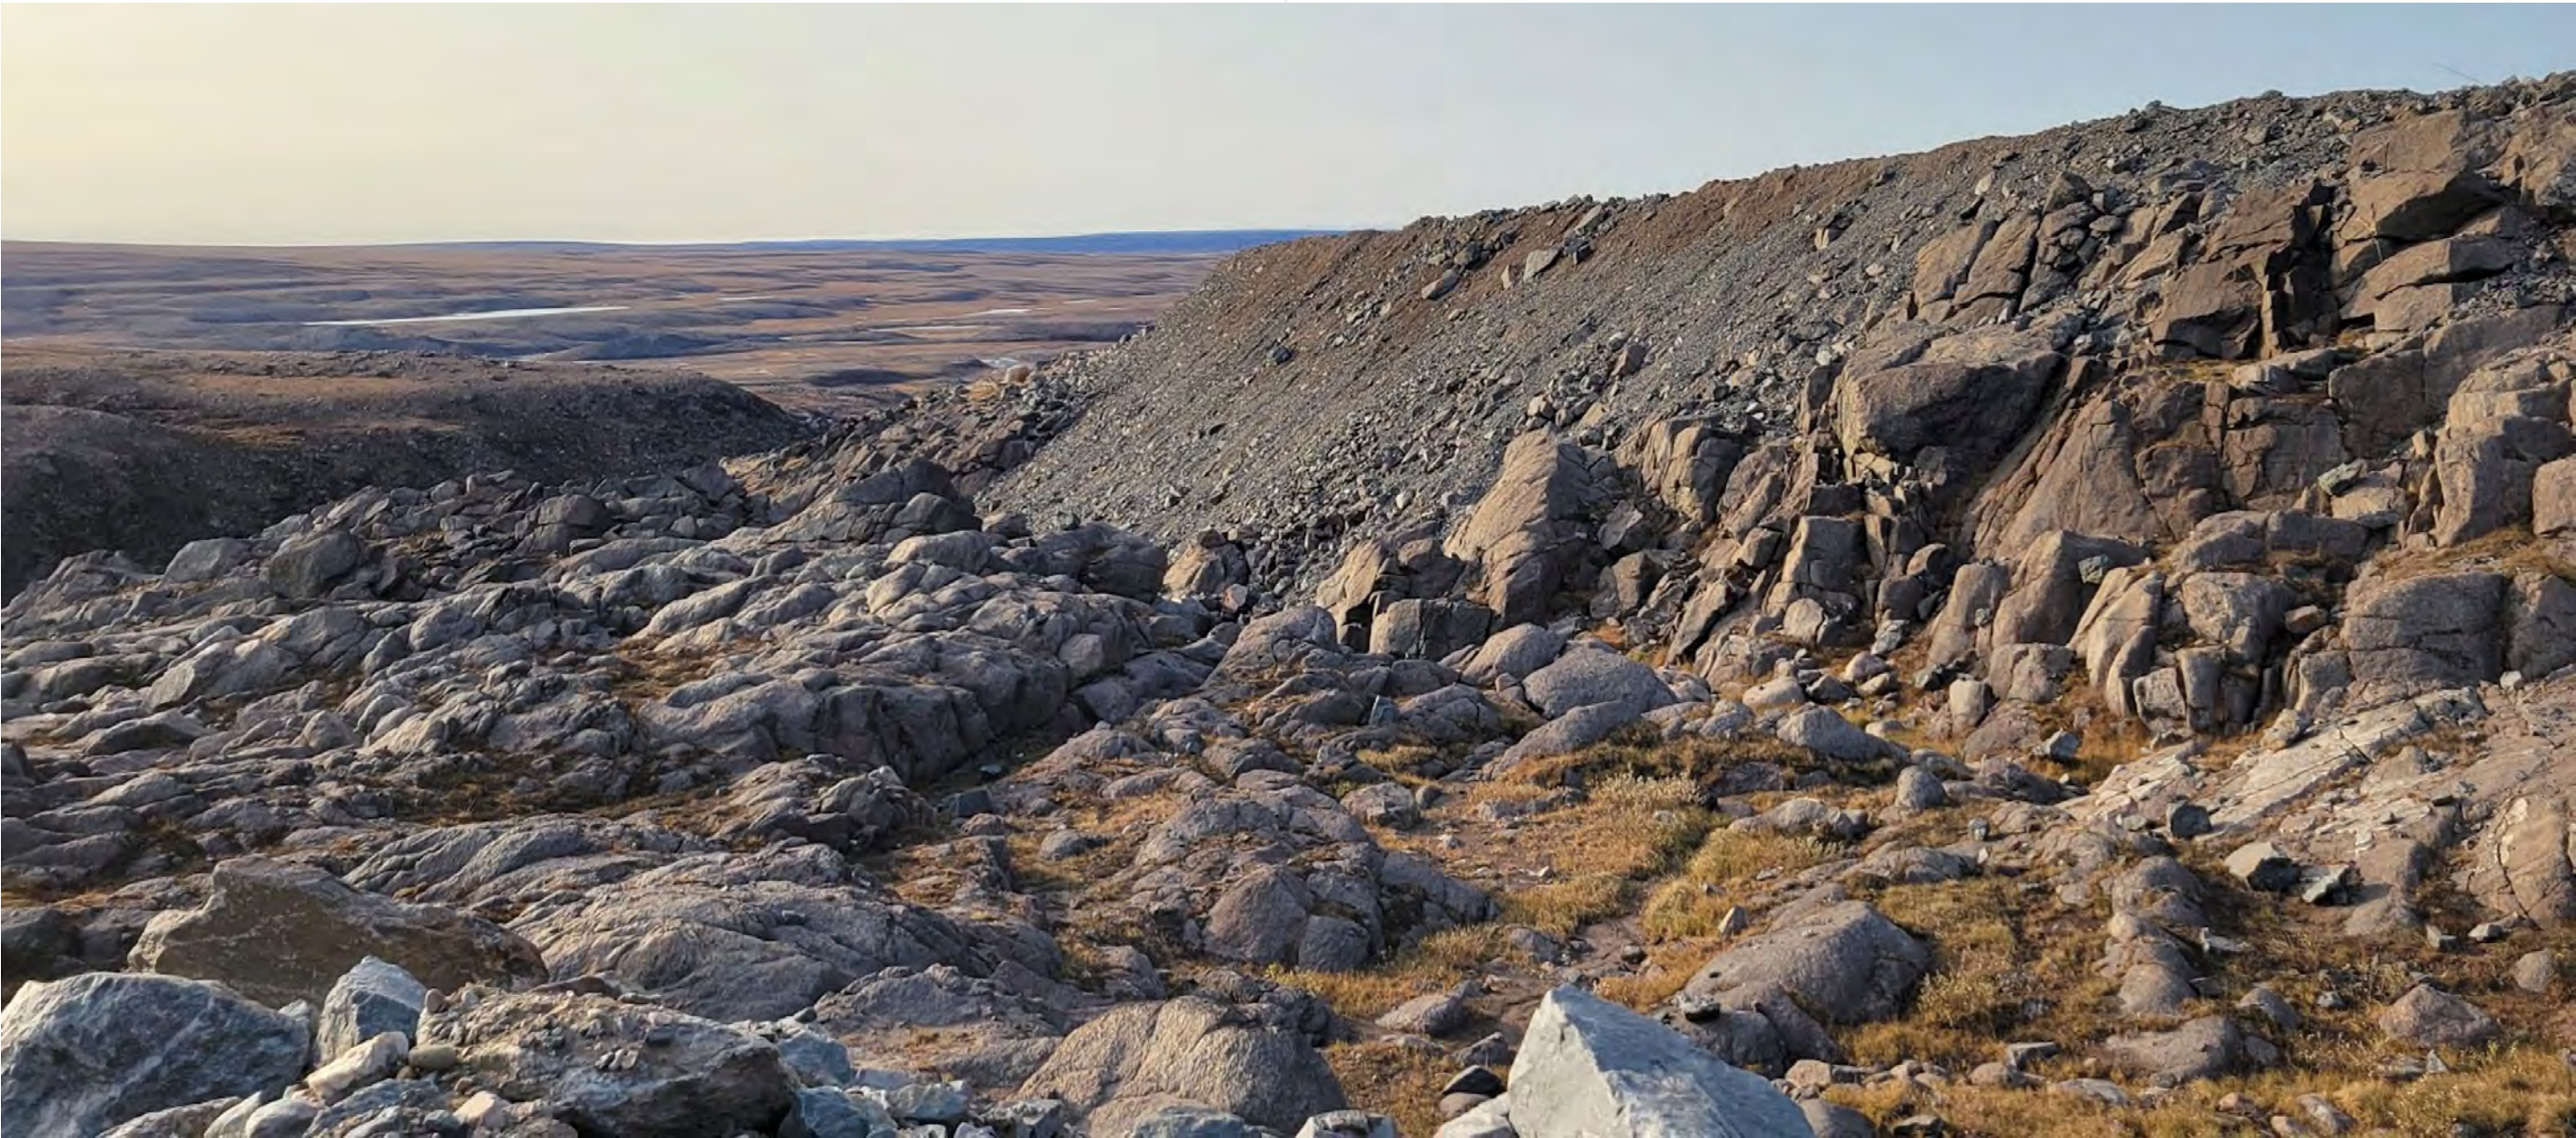
Photo 4: Downstream of area shown in Photo 3 showing evidence of previous water flow – area west and south of the KM 106 Surface Water Management Pond.
