APPENDIX K2

2023 QIA Inspections and Baffinland's Responses

**Re: Baffinland Iron Mines Corporation's Mary River Project – Qikiqtani Inuit Association
June 2023 General Site Inspection Findings and Recommendations**

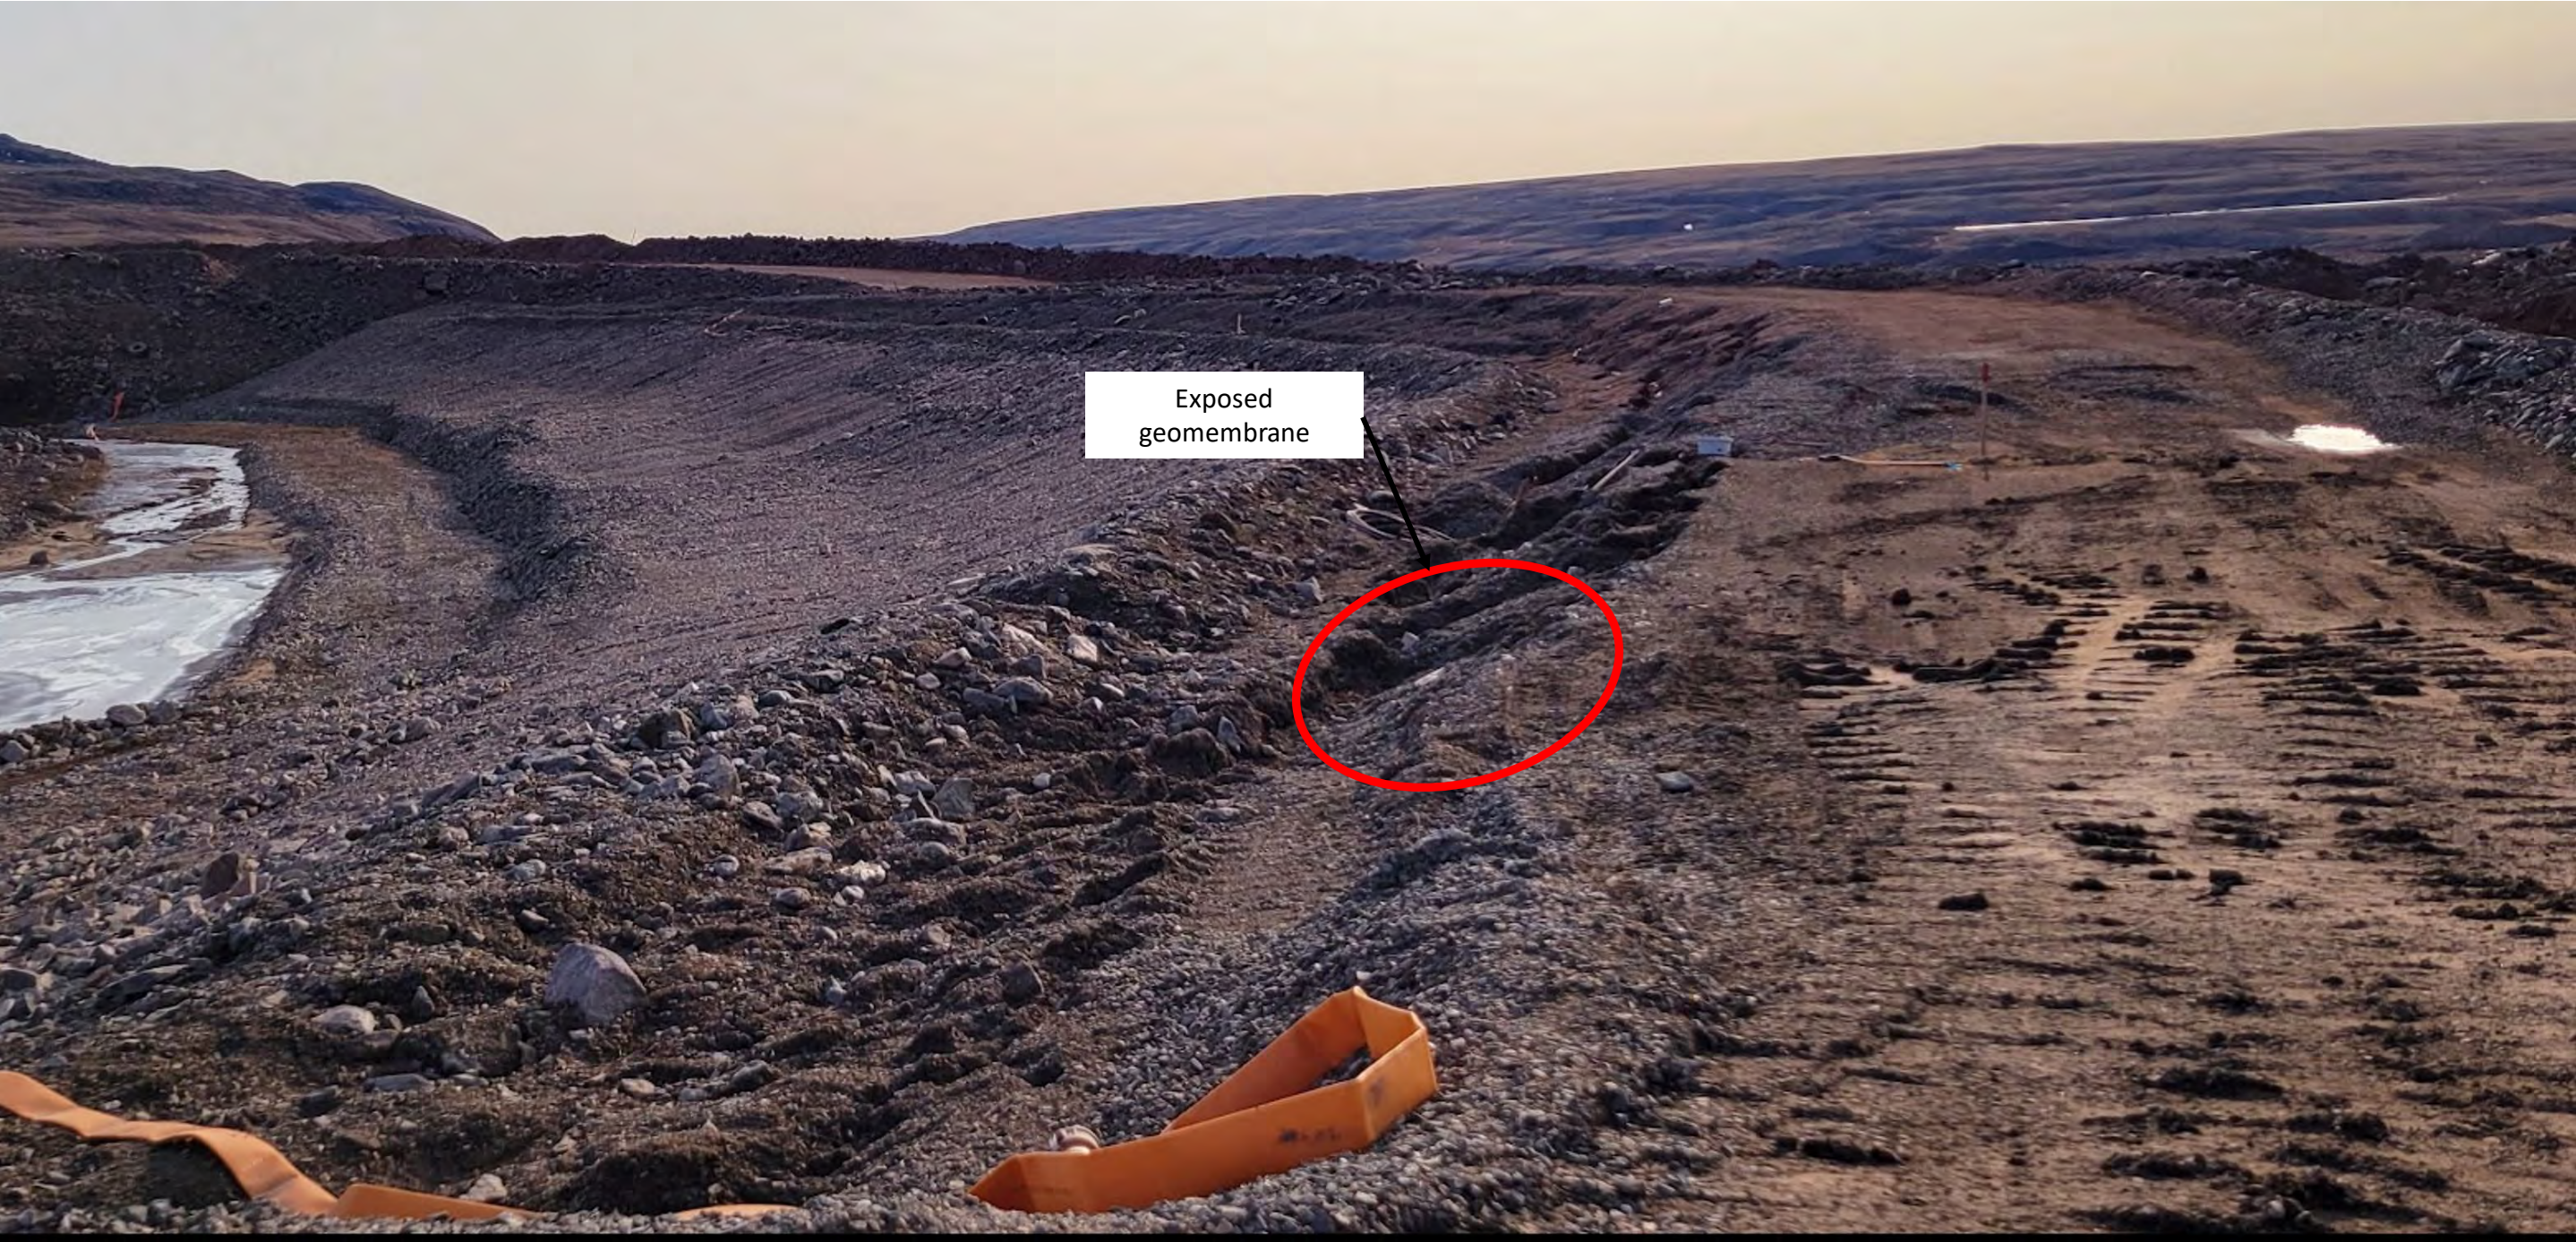
MISL Environmental Associates – Geotechnical and Geo-Environmental Review of the Mary River Project			
Item No.	Project Location	Description of Concern	QIA Requested Action
3	KM105 Sedimentation Pond - South	<p>2022: Extensive slumping of the upper third of the upstream slope (App B Photo 10, App C Figure 19)</p> <p>2023: While the area with exposed geomembrane observed during the 2022 Inspection was repaired, slumped material has not been tied into embankment crest materials. Initial formation of erosion gullies was observed (App B Photo 3).</p>	<p>Response provided to Baffinland's response to the 2022 Requested Action: While the distinction between structural fills and those placed to increase an embankment's thermal capacity is understood, it should also be noted that placement of any type of fill, especially on the upstream faces of embankments must be done in a way that does not allow those materials to be eroded (especially during annual rainy periods) and allowed to accumulate as sediment within the limits of the sedimentation pond the embankments were designed to contain. As such, it is requested that any loose fills that could be at risk of erosion during the 2023 rainy period be secured prior to the start of that period and the ability of those placed fills to withstand runoff associated with 2023 rainfall events be evaluated.</p> <p>2023: Given the unheeded warning provided about the potential for erosion of this area in 2022, providing proper tie in between the uppermost slumped materials of the upstream slope and the embankment crest is requested to be completed ASAP and before commencement of heavy snow accumulation in this area as freshet meltwater can exacerbate the nascent erosional features observed.</p> <p>An as-built report documenting the nature of remediation that was completed at this location is still requested.</p>

Photo 5: View of damaged crest and upper portion of the upstream slope of the KM 105 South Embankment. The damage to the uppermost surface the downstream slope continues to progress.

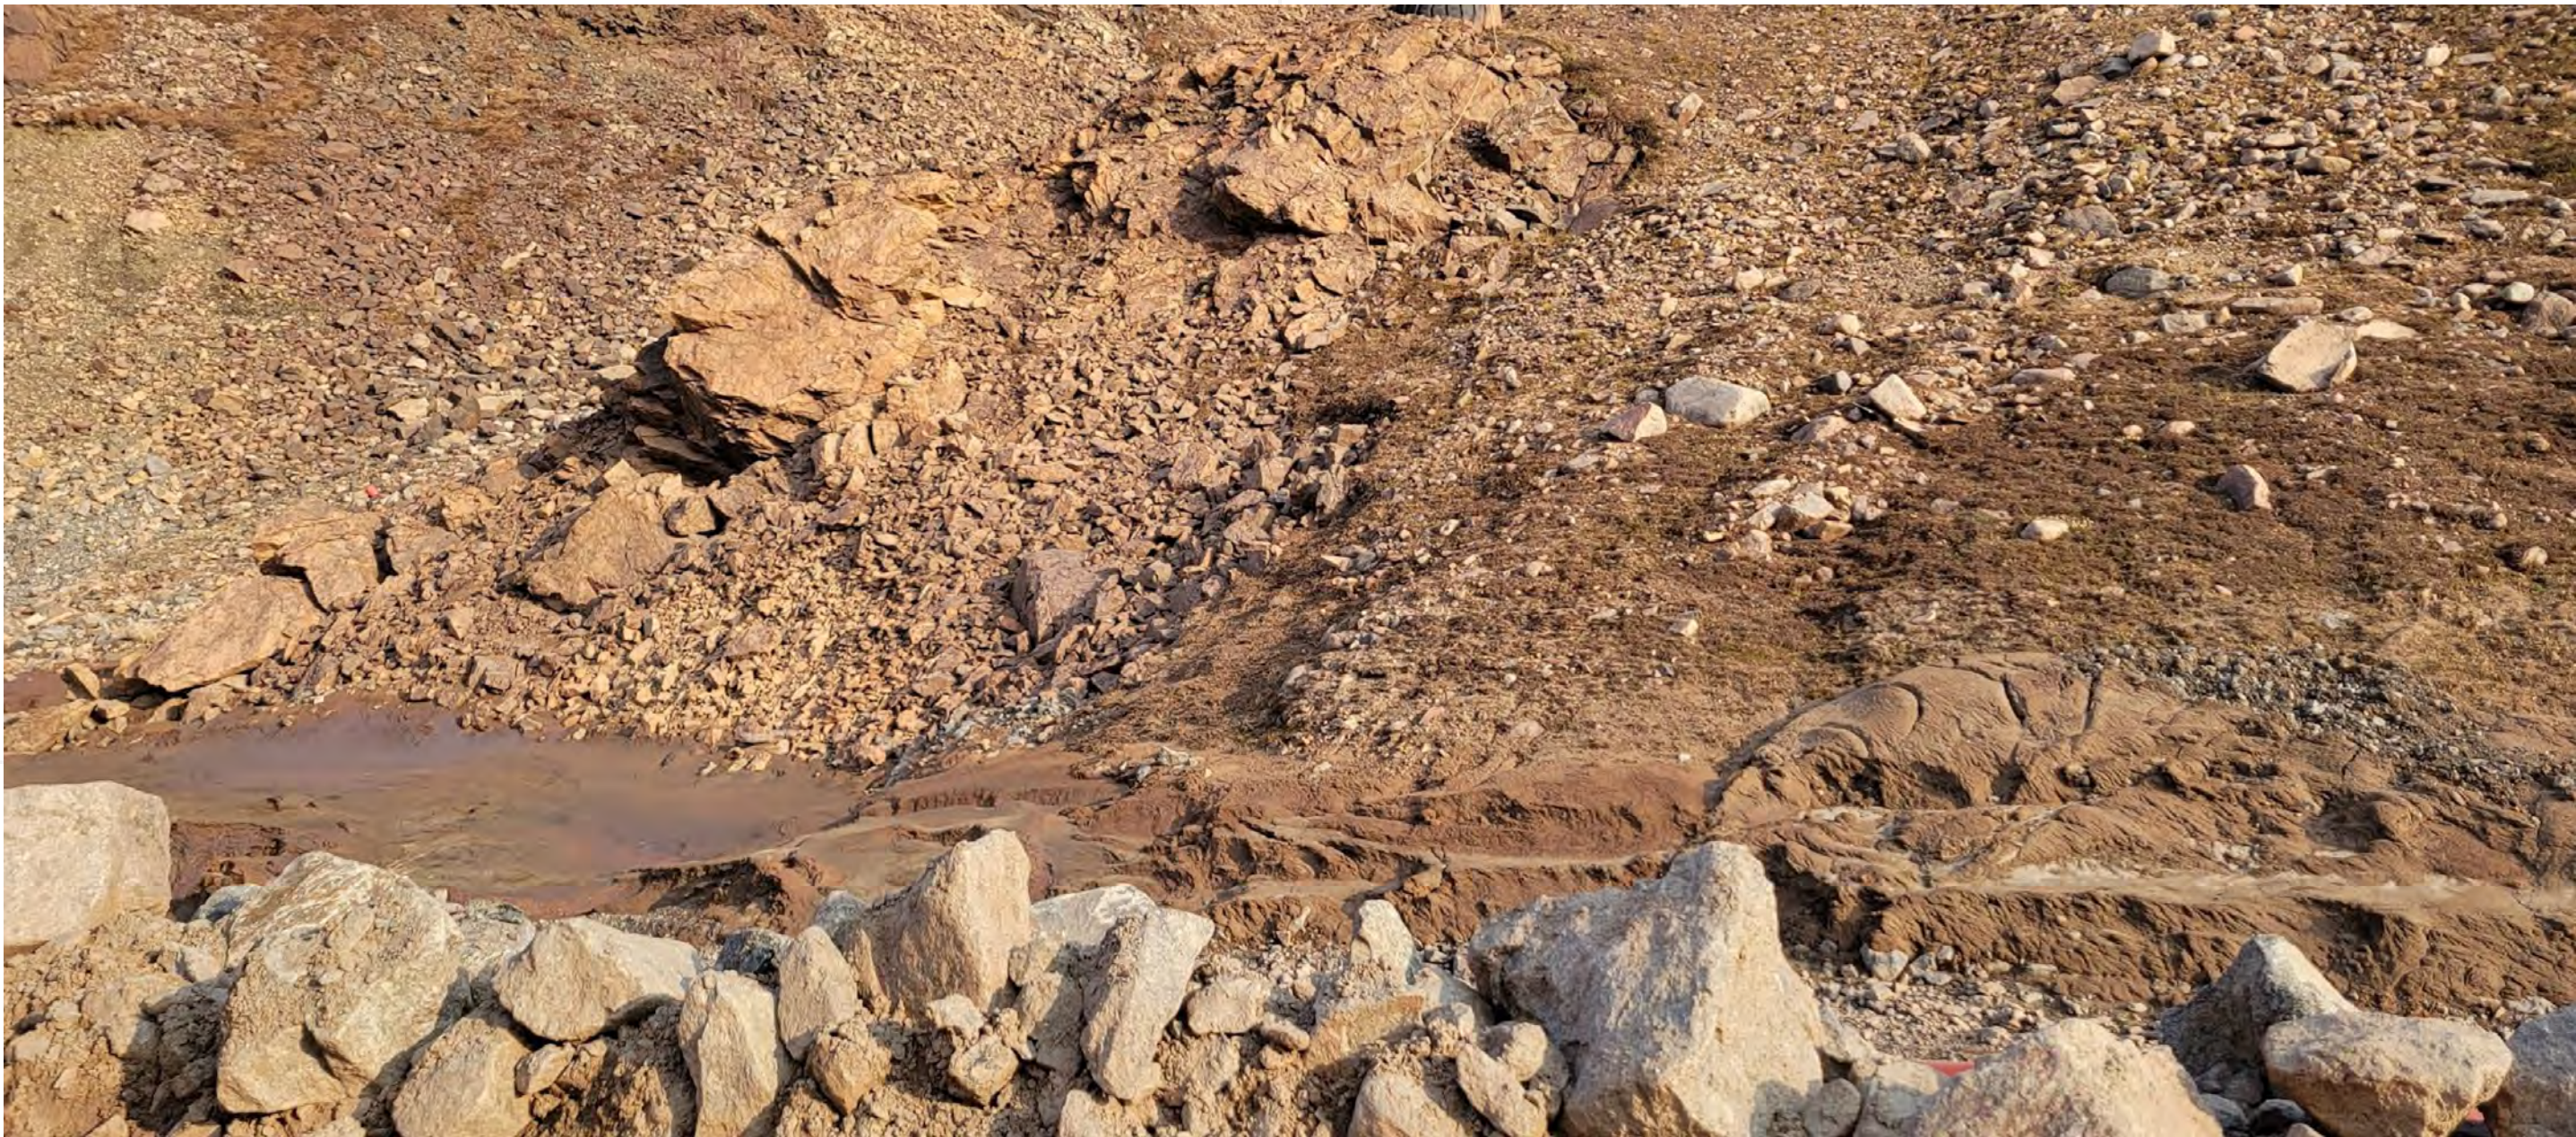
Photo 6: View of thick layers of deposited sediment in the base of the KM 105 pond.

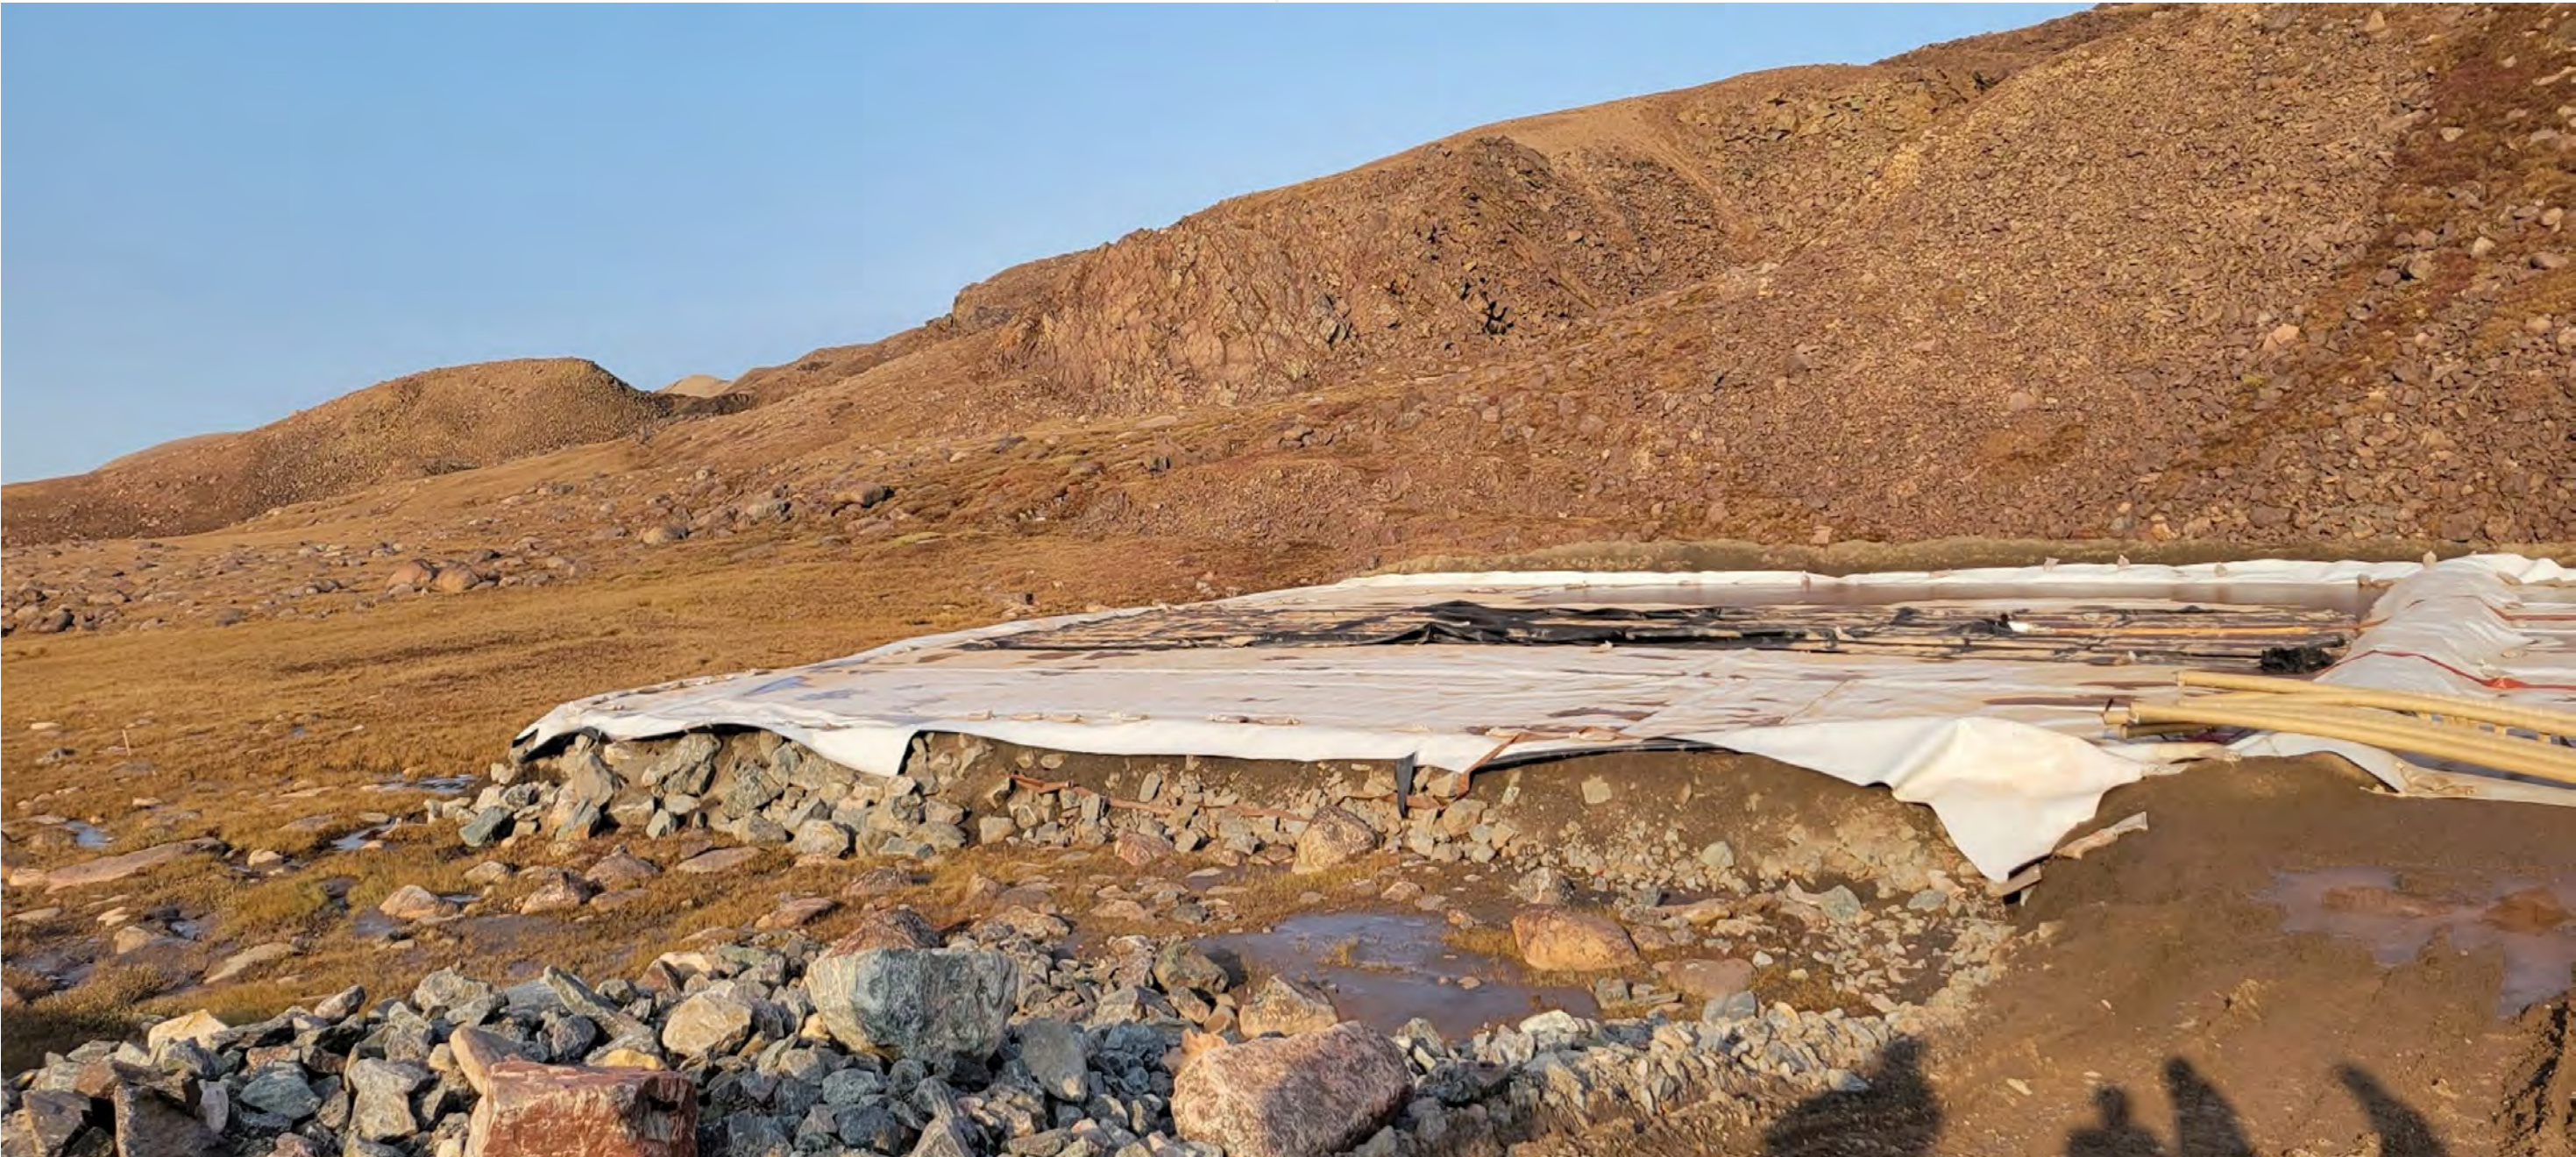
Photo 7: View of pad extended northwards and adjacent to the downstream toe of the KM 105 Northwest Embankment. The black geobag (pictured) lies on top of a white geomembrane. At the time of the September 2023 Inspection, the geobag was not in use. Site personnel indicated that the system was installed at some point after the June 2023 Inspection to capture sediment laden water seeping from the toe of the embankment. It is recommended that this system be configured to provide an auxiliary line of defense to mitigate undesirable sediment loading to waters that ultimate report to Shear Down Lake. It was also noted that the pad created was extended beyond the original limits expected by QIA. A technical memo should summarize and provide details about the installation.

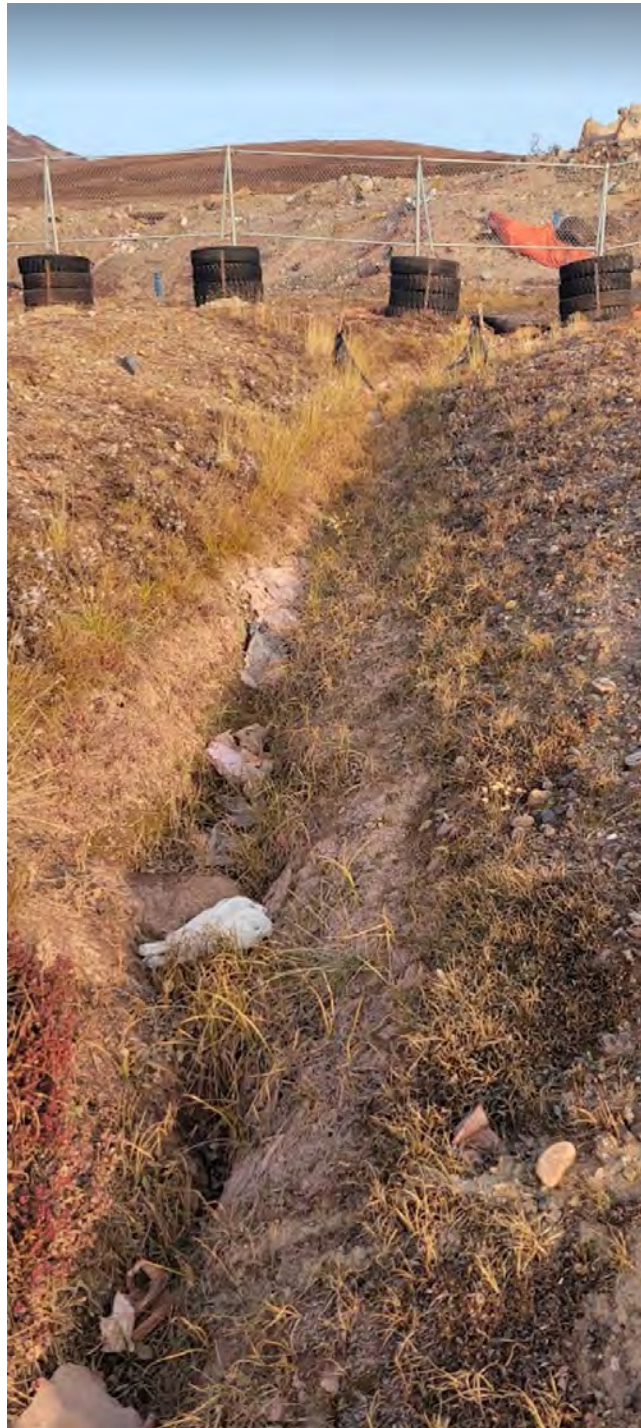
Photo 8A: Loose debris present outside of fence encircling the onsite landfill south of Sailivik Camp (Figure 10). The amount of metal present within the landfill was notable and raised a question about the longterm fate of metal stored in that facility.

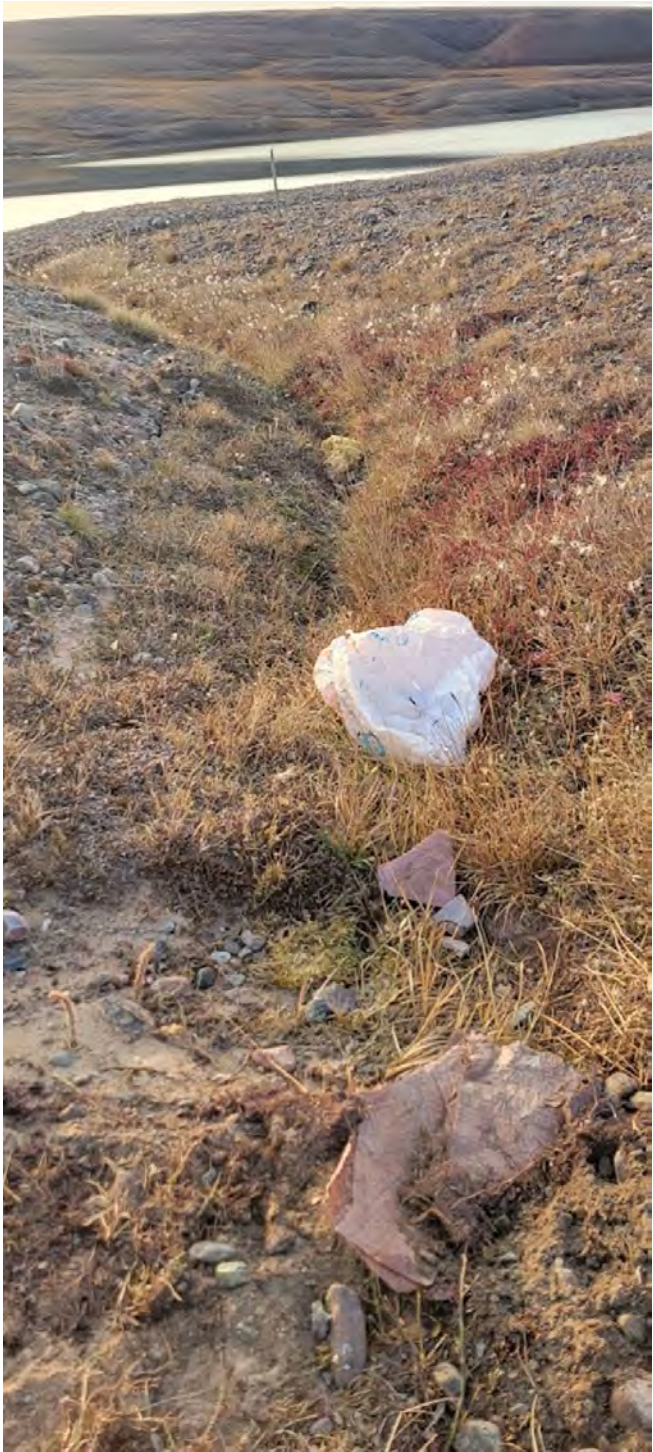
Photo 8B: Loose debris in water course that empties into Sheardown Lake that is downstream of the Landfill. The channel is also the continuation of the channel seen in Photo 8.

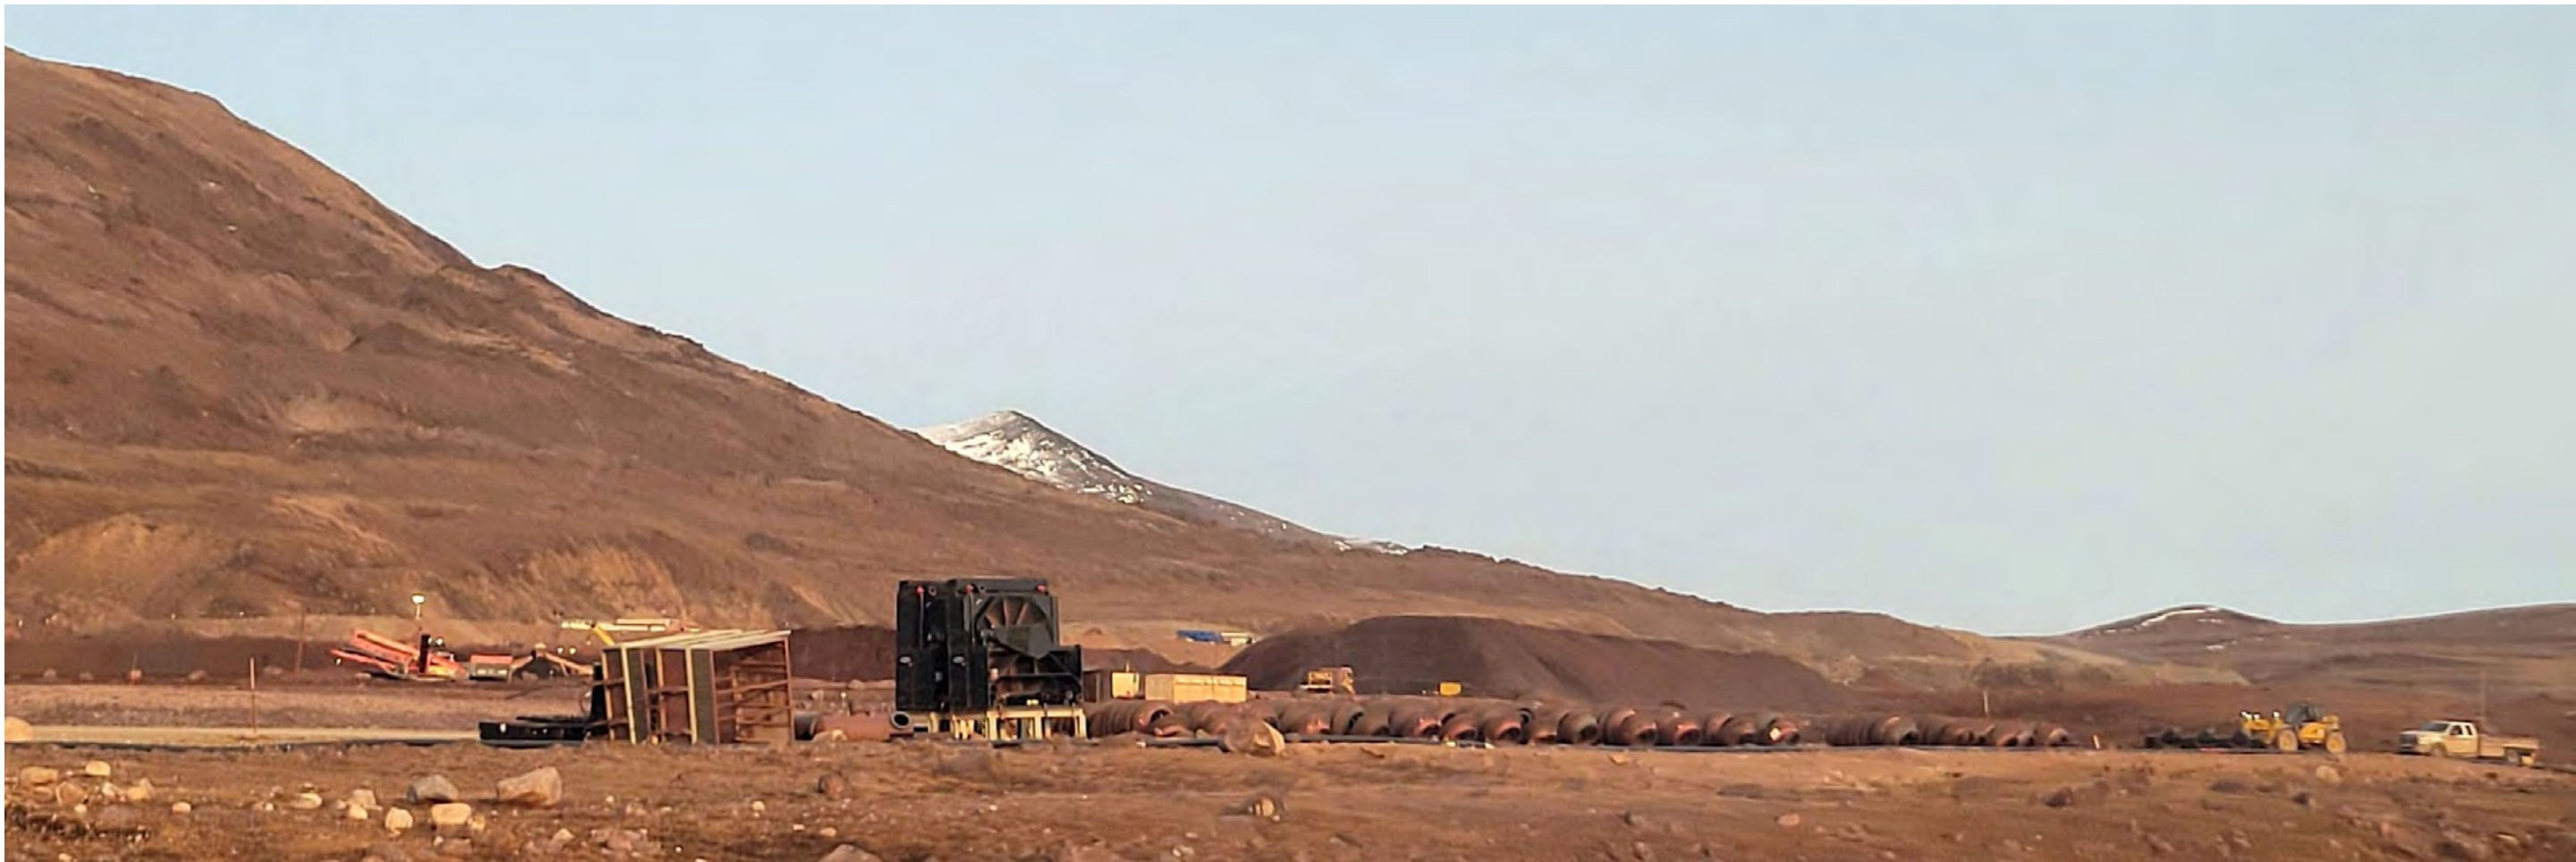
Photo 9: Significant volume of scrap steel and metal staged in area slightly north of the landfill.

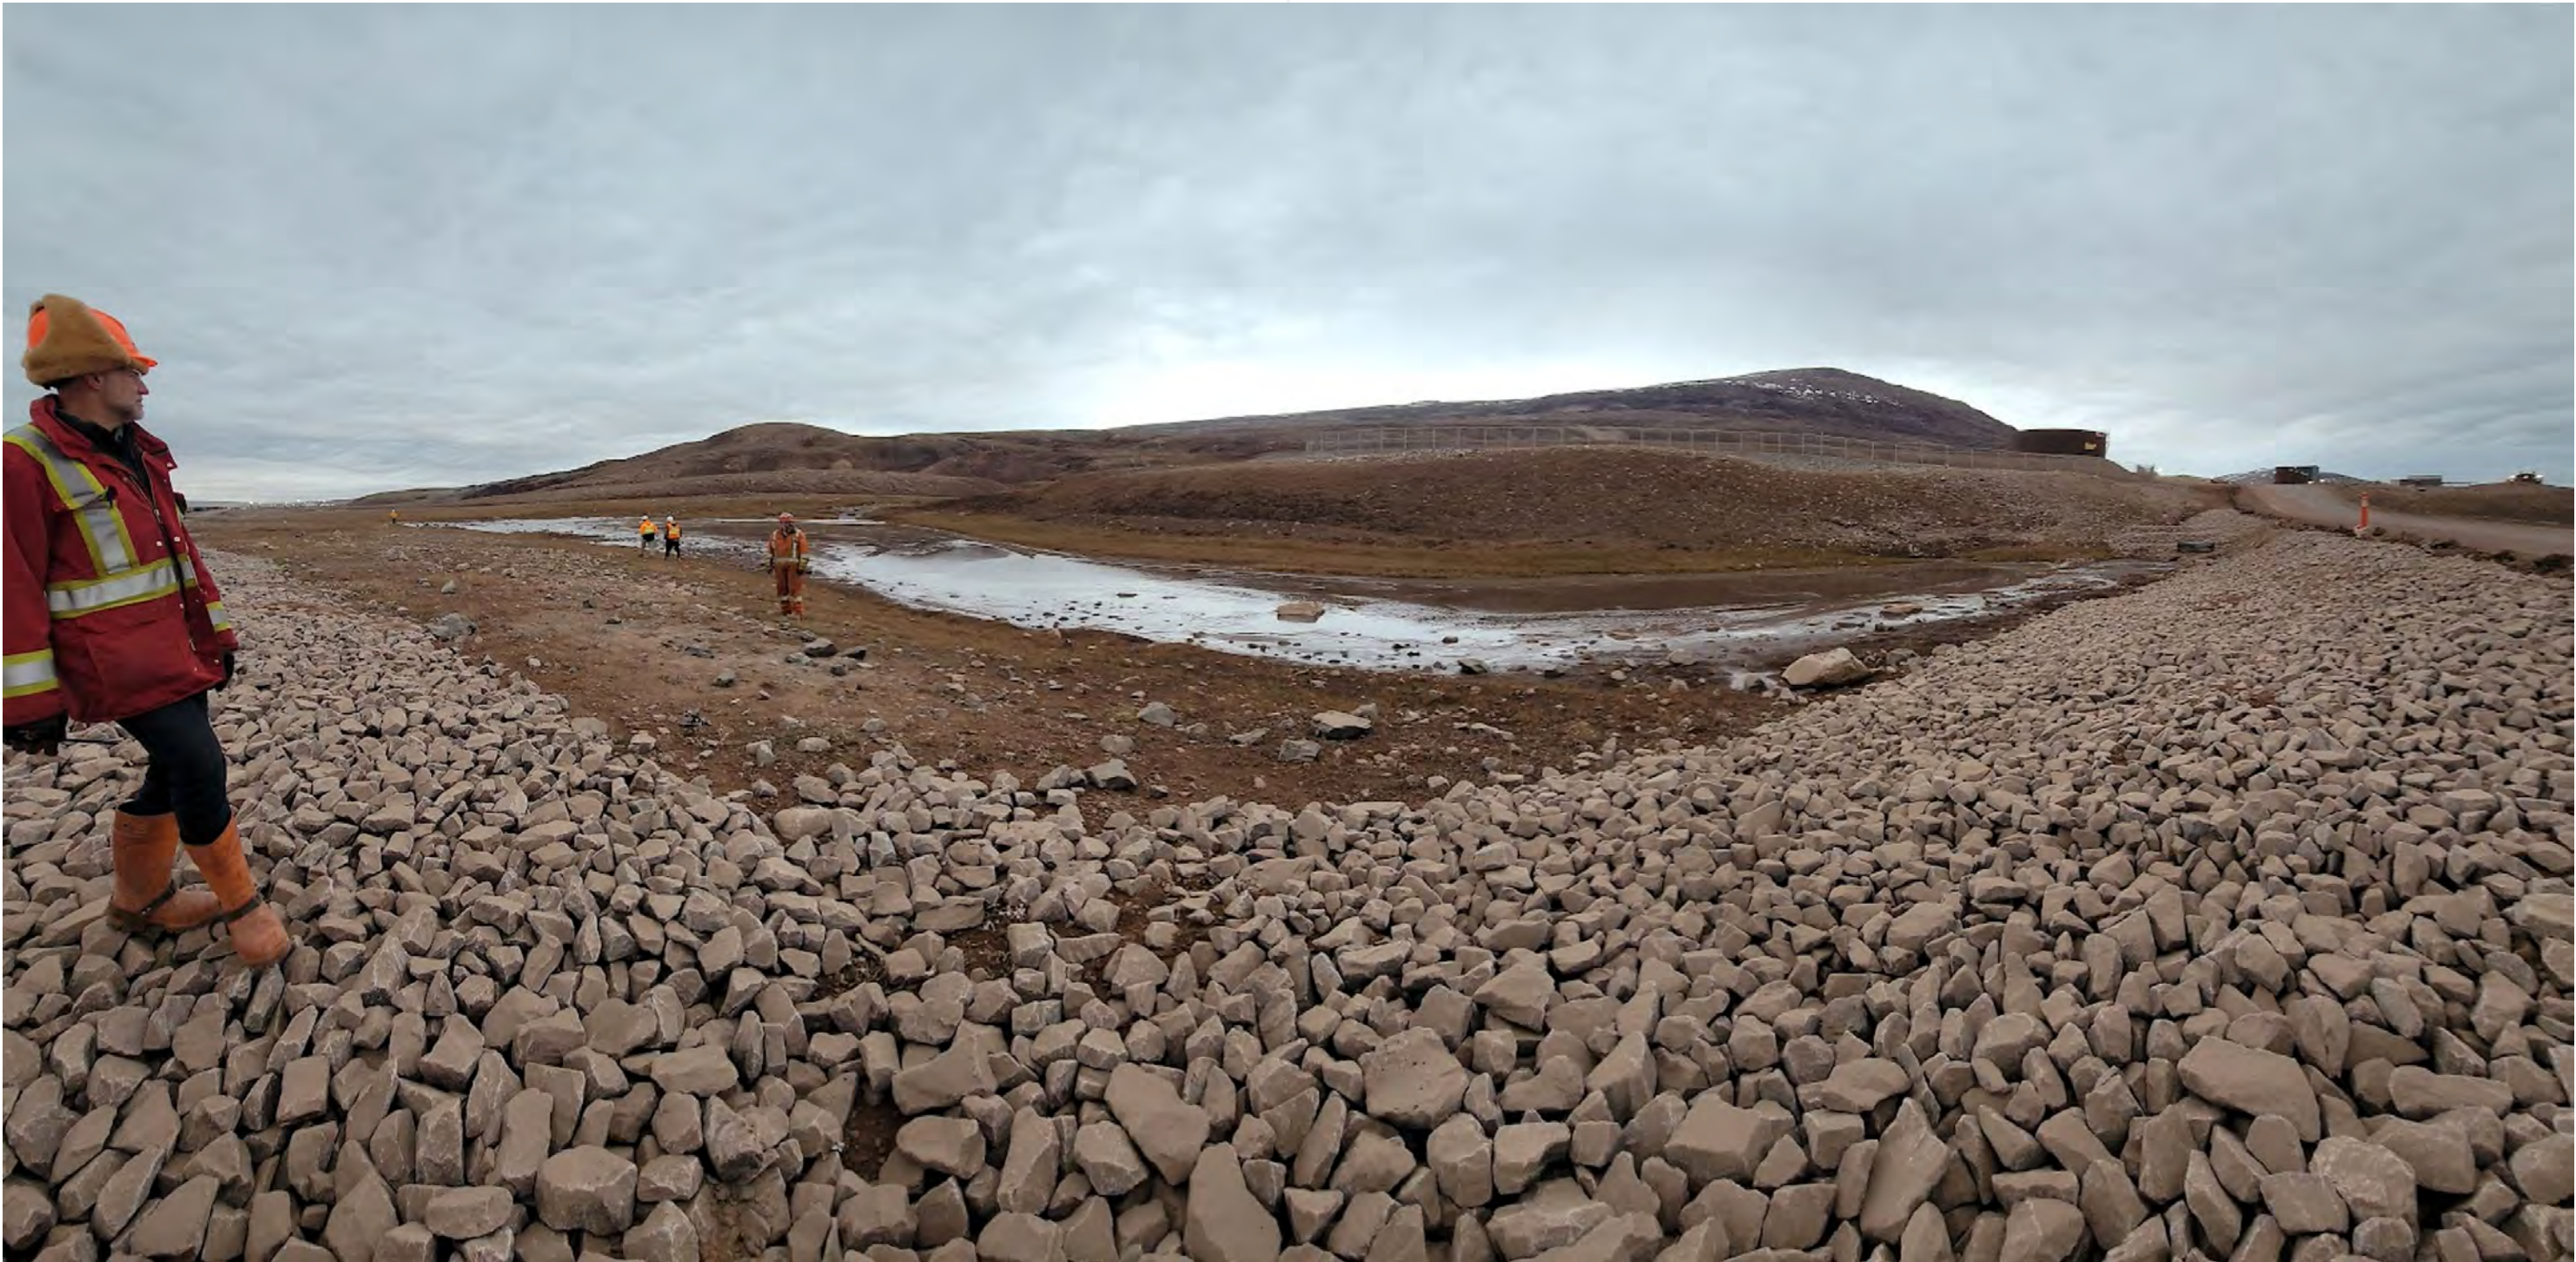
Photo 10B: View of north side of Tote Road just east of Sailivik Camp where armoring and sediment control civil works were completed in the period between the two independent environmental Inspections completed in 2023.

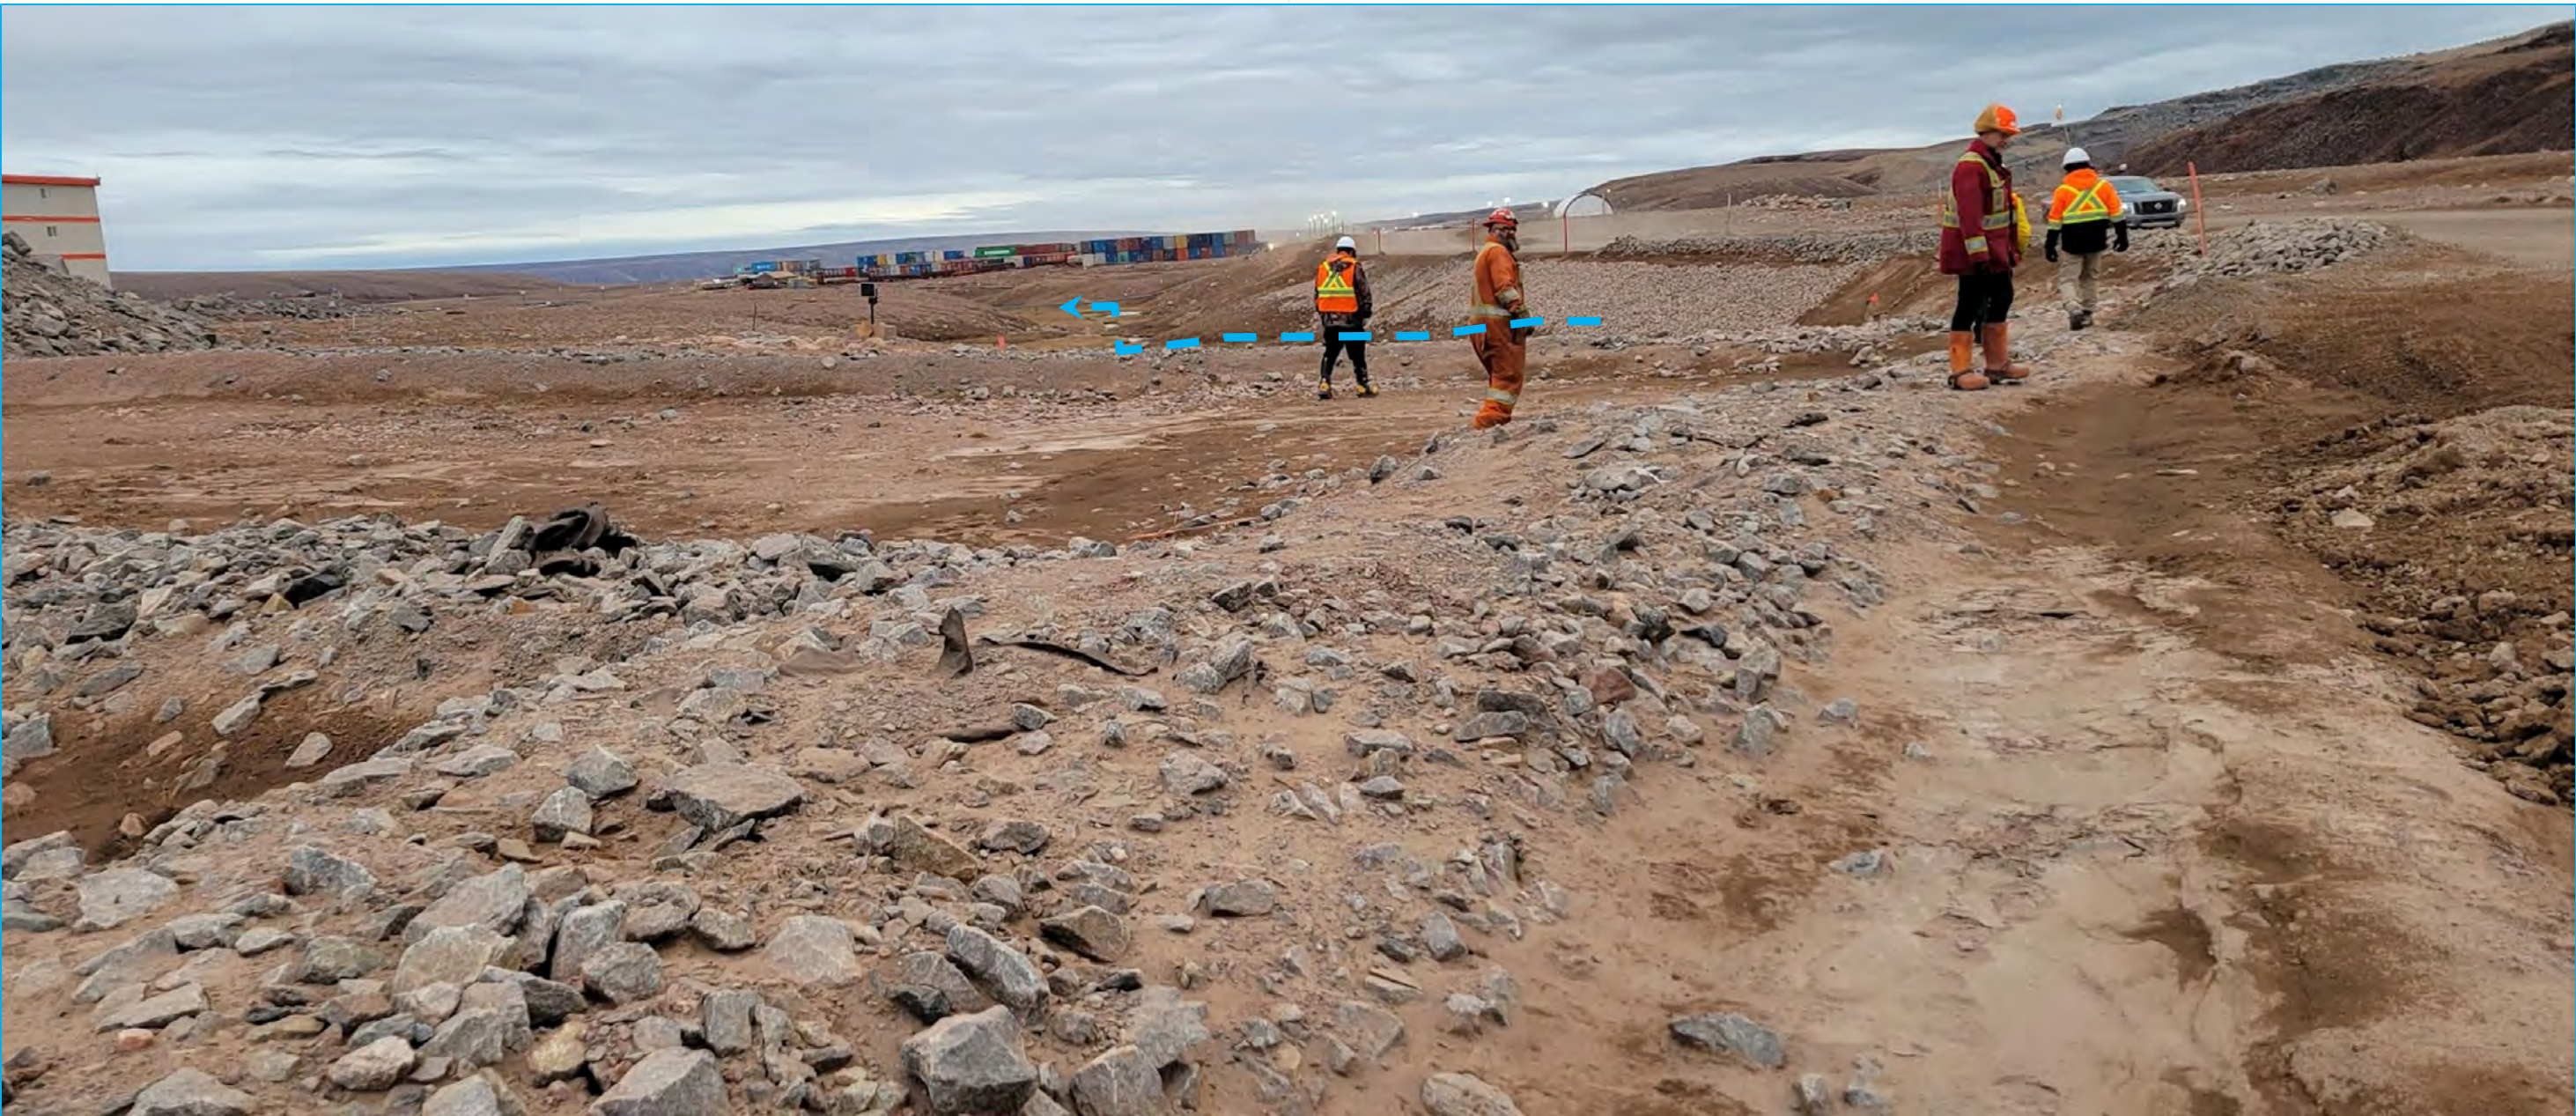
Photo 11A: View of riprap covered in sediment upstream of the channel that convey water to Sheardown Lake. Annual maintenance should include removal of accumulated sediment to allow sediment control structures to work effectively during the annual freshet. The broken blue arrow shows the direction and flow path of the water course that heads towards Sheardown Lake. This area is located north of Sallivik Camp but on the south side of the Tote Road. View looking northwest towards the laydown area.
