APPENDIX K2

2023 QIA Inspections and Baffinland's Responses

**Re: Baffinland Iron Mines Corporation's Mary River Project – Qikiqtani Inuit Association
June 2023 General Site Inspection Findings and Recommendations**

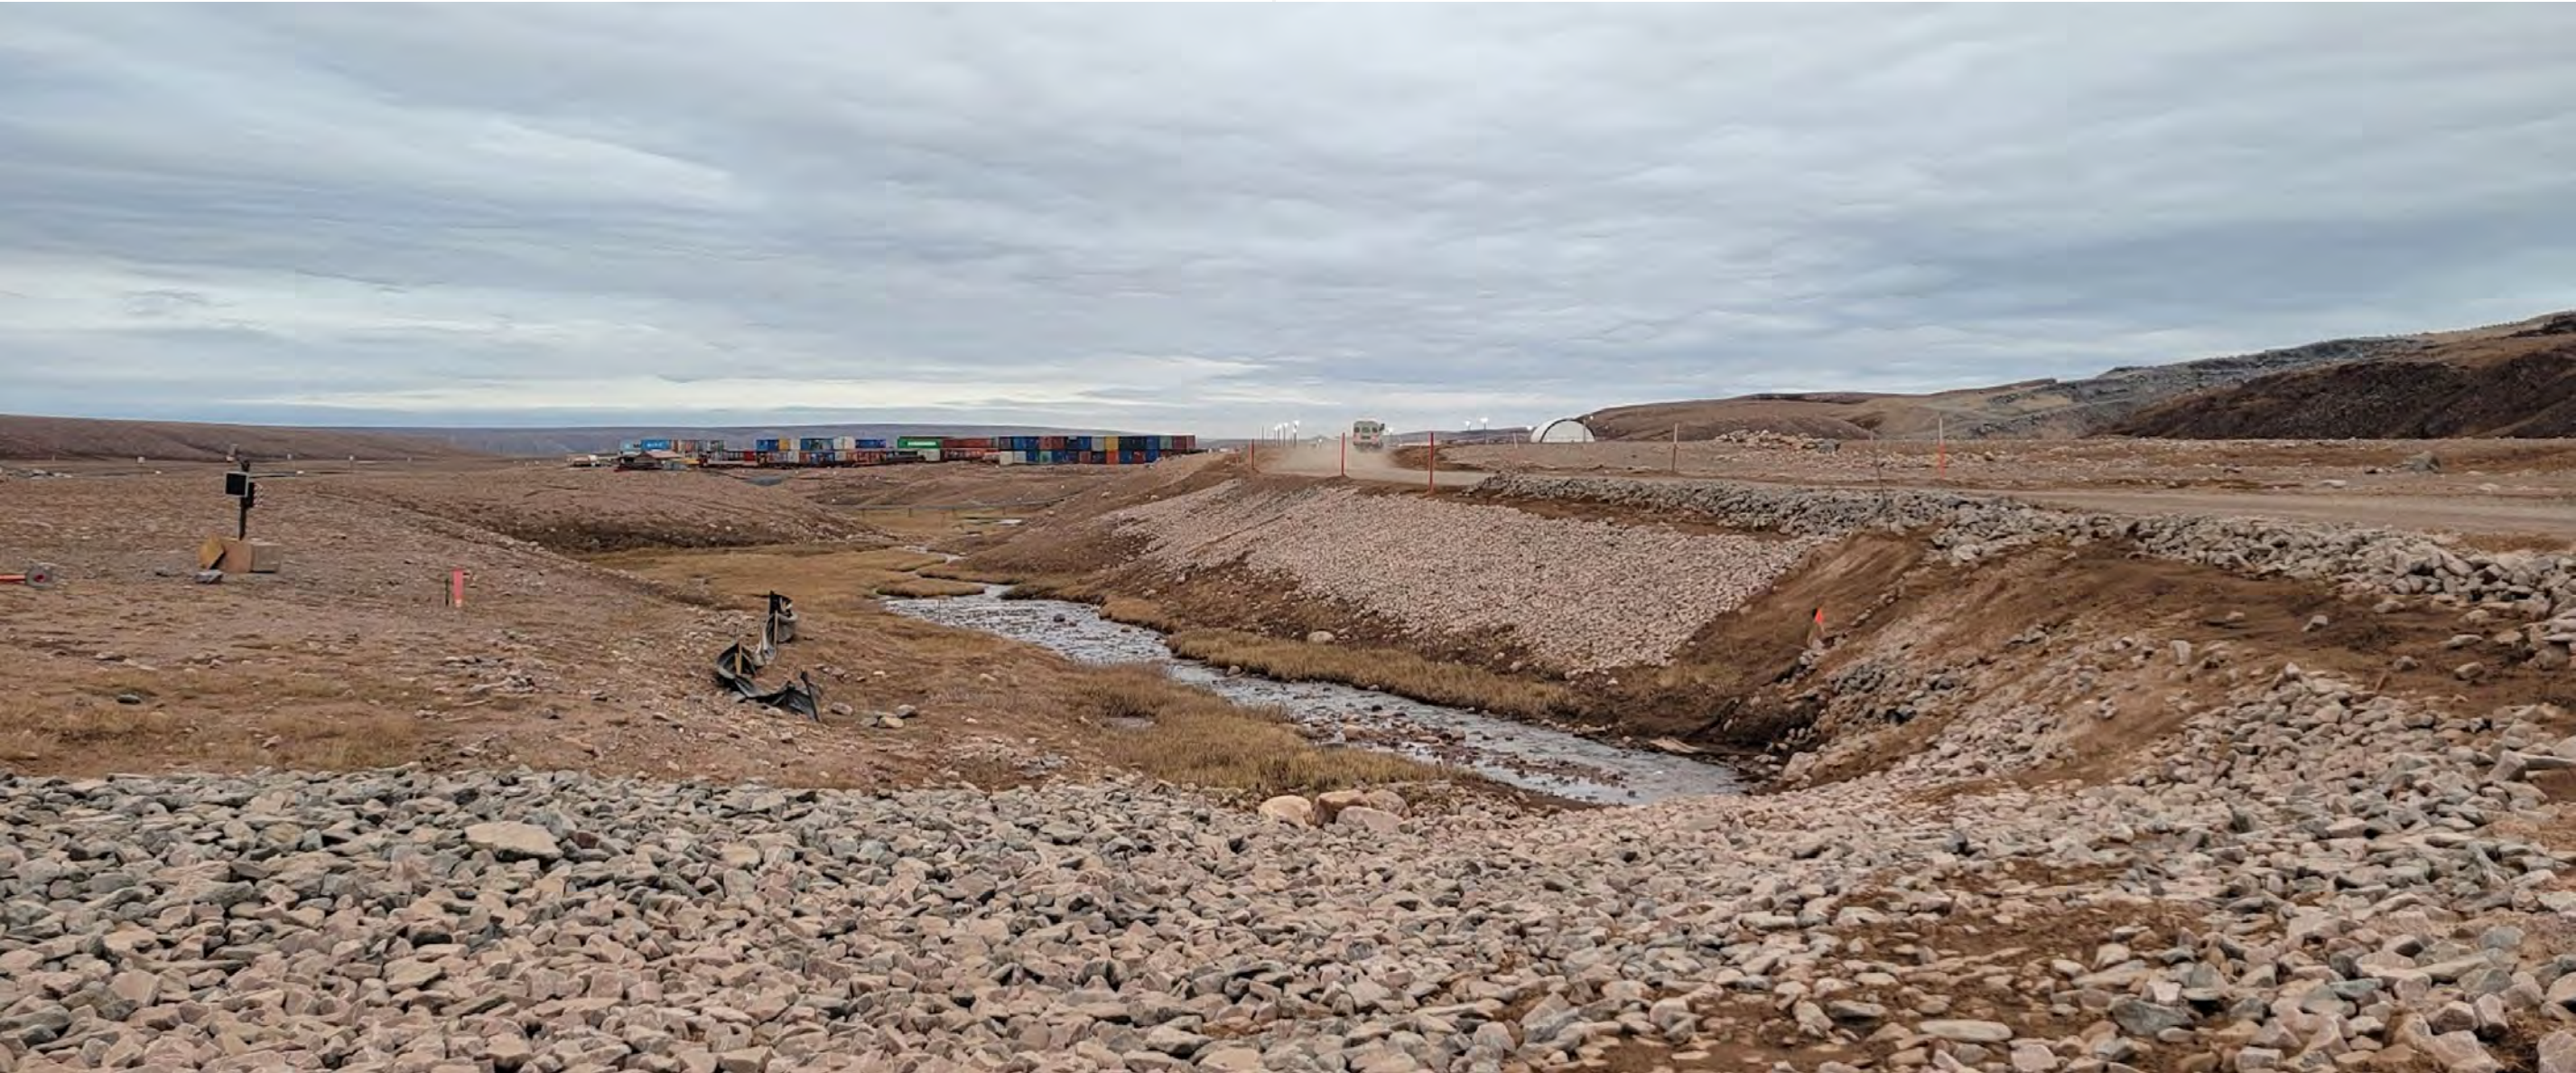
Photo 11B: Closer view of side slope armoring upstream of channel conveying water to Sheardown Lake pictured in Photo 11A. Areas of accumulated sediment on the surface of rock armoring are evident and in need of cleaning prior to the onset of the 2023 freshet. A commonly observed condition of silt fences at the site where they have been installed is also seen left of the center of the photo. It is recommended that silt fences be replaced by coir logs which have improved filter and sediment capture capability with the added benefit of greater durability, especially in this application context.

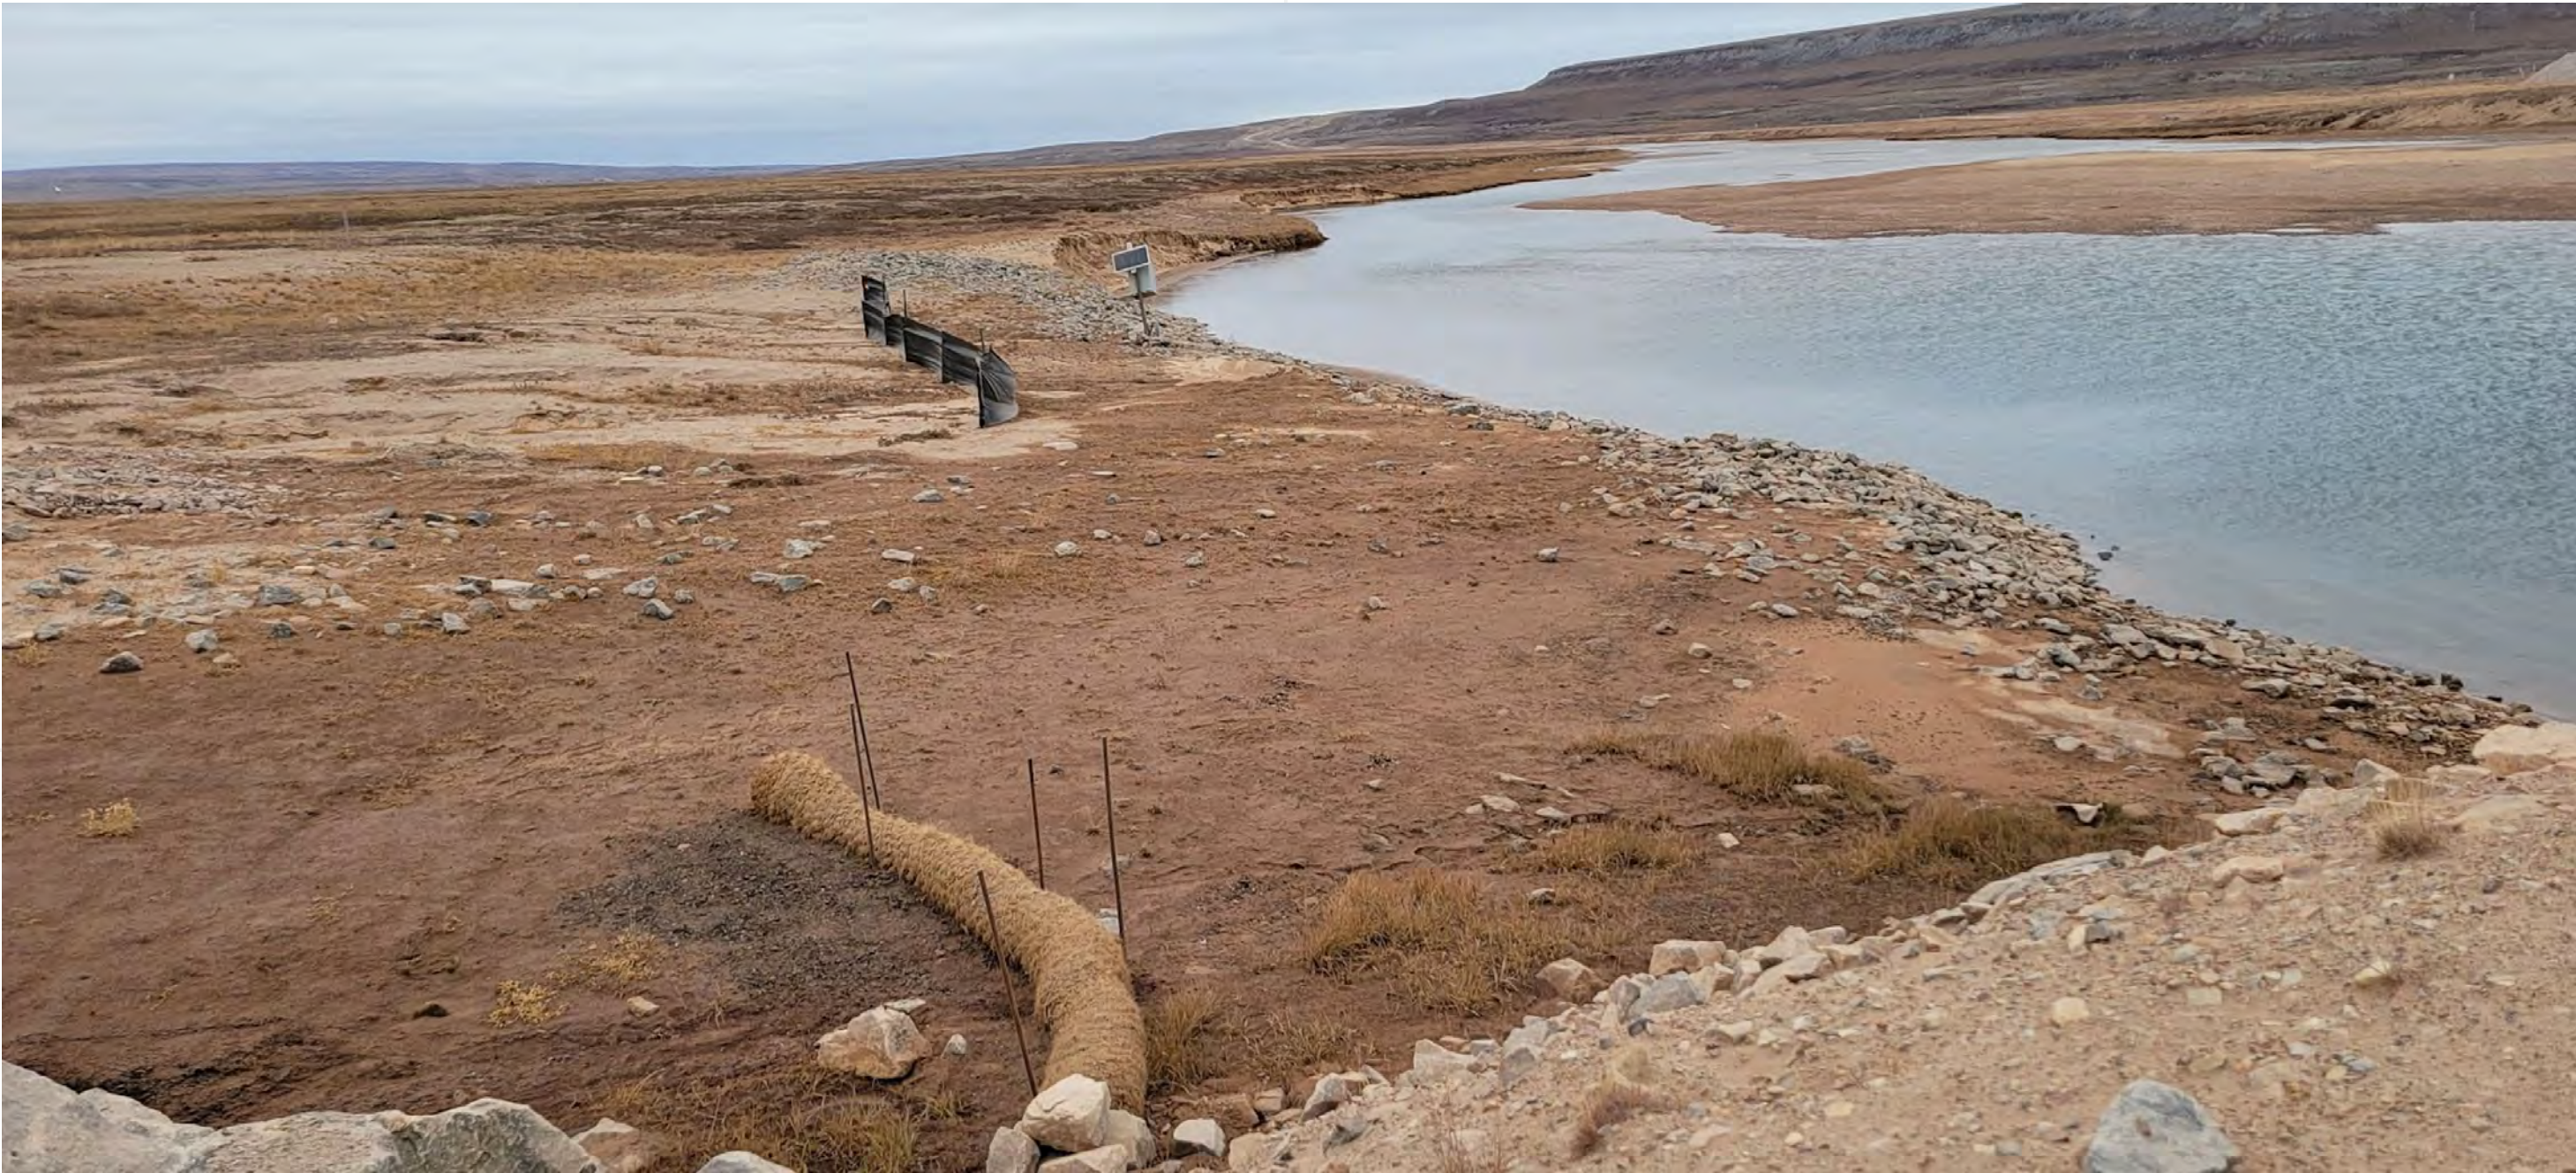
Photo 12: View of areas on south bank of river at KM 80 crossing showing use of both a silt fence and a coconut coir log. This area should be monitored to ensure that sediment control measures work as desired and adequately mitigate sediment runoff into the adjacent water body.
