MINING IMPACT SPECIALISTS LTD. <small>ENABLING CHANGE TO SERVE FUTURE GENERATIONS.</small>	  <small>EST. 1971 LIMITED environmental research associates</small>	2023 Mary River Project Site Visit #2		
		Key Photos from September 2023 Inspection		
Mining Impact Specialists Ltd.	LGL Limited	Date: 05 Dec 2023	Approved: LEB	Page: 17

KM105 SEDIMENTATION POND ---- GROUT CURTAIN PROJECT

955-221 Mary River Mine 2023 Environmental Audit

955-221-R-001

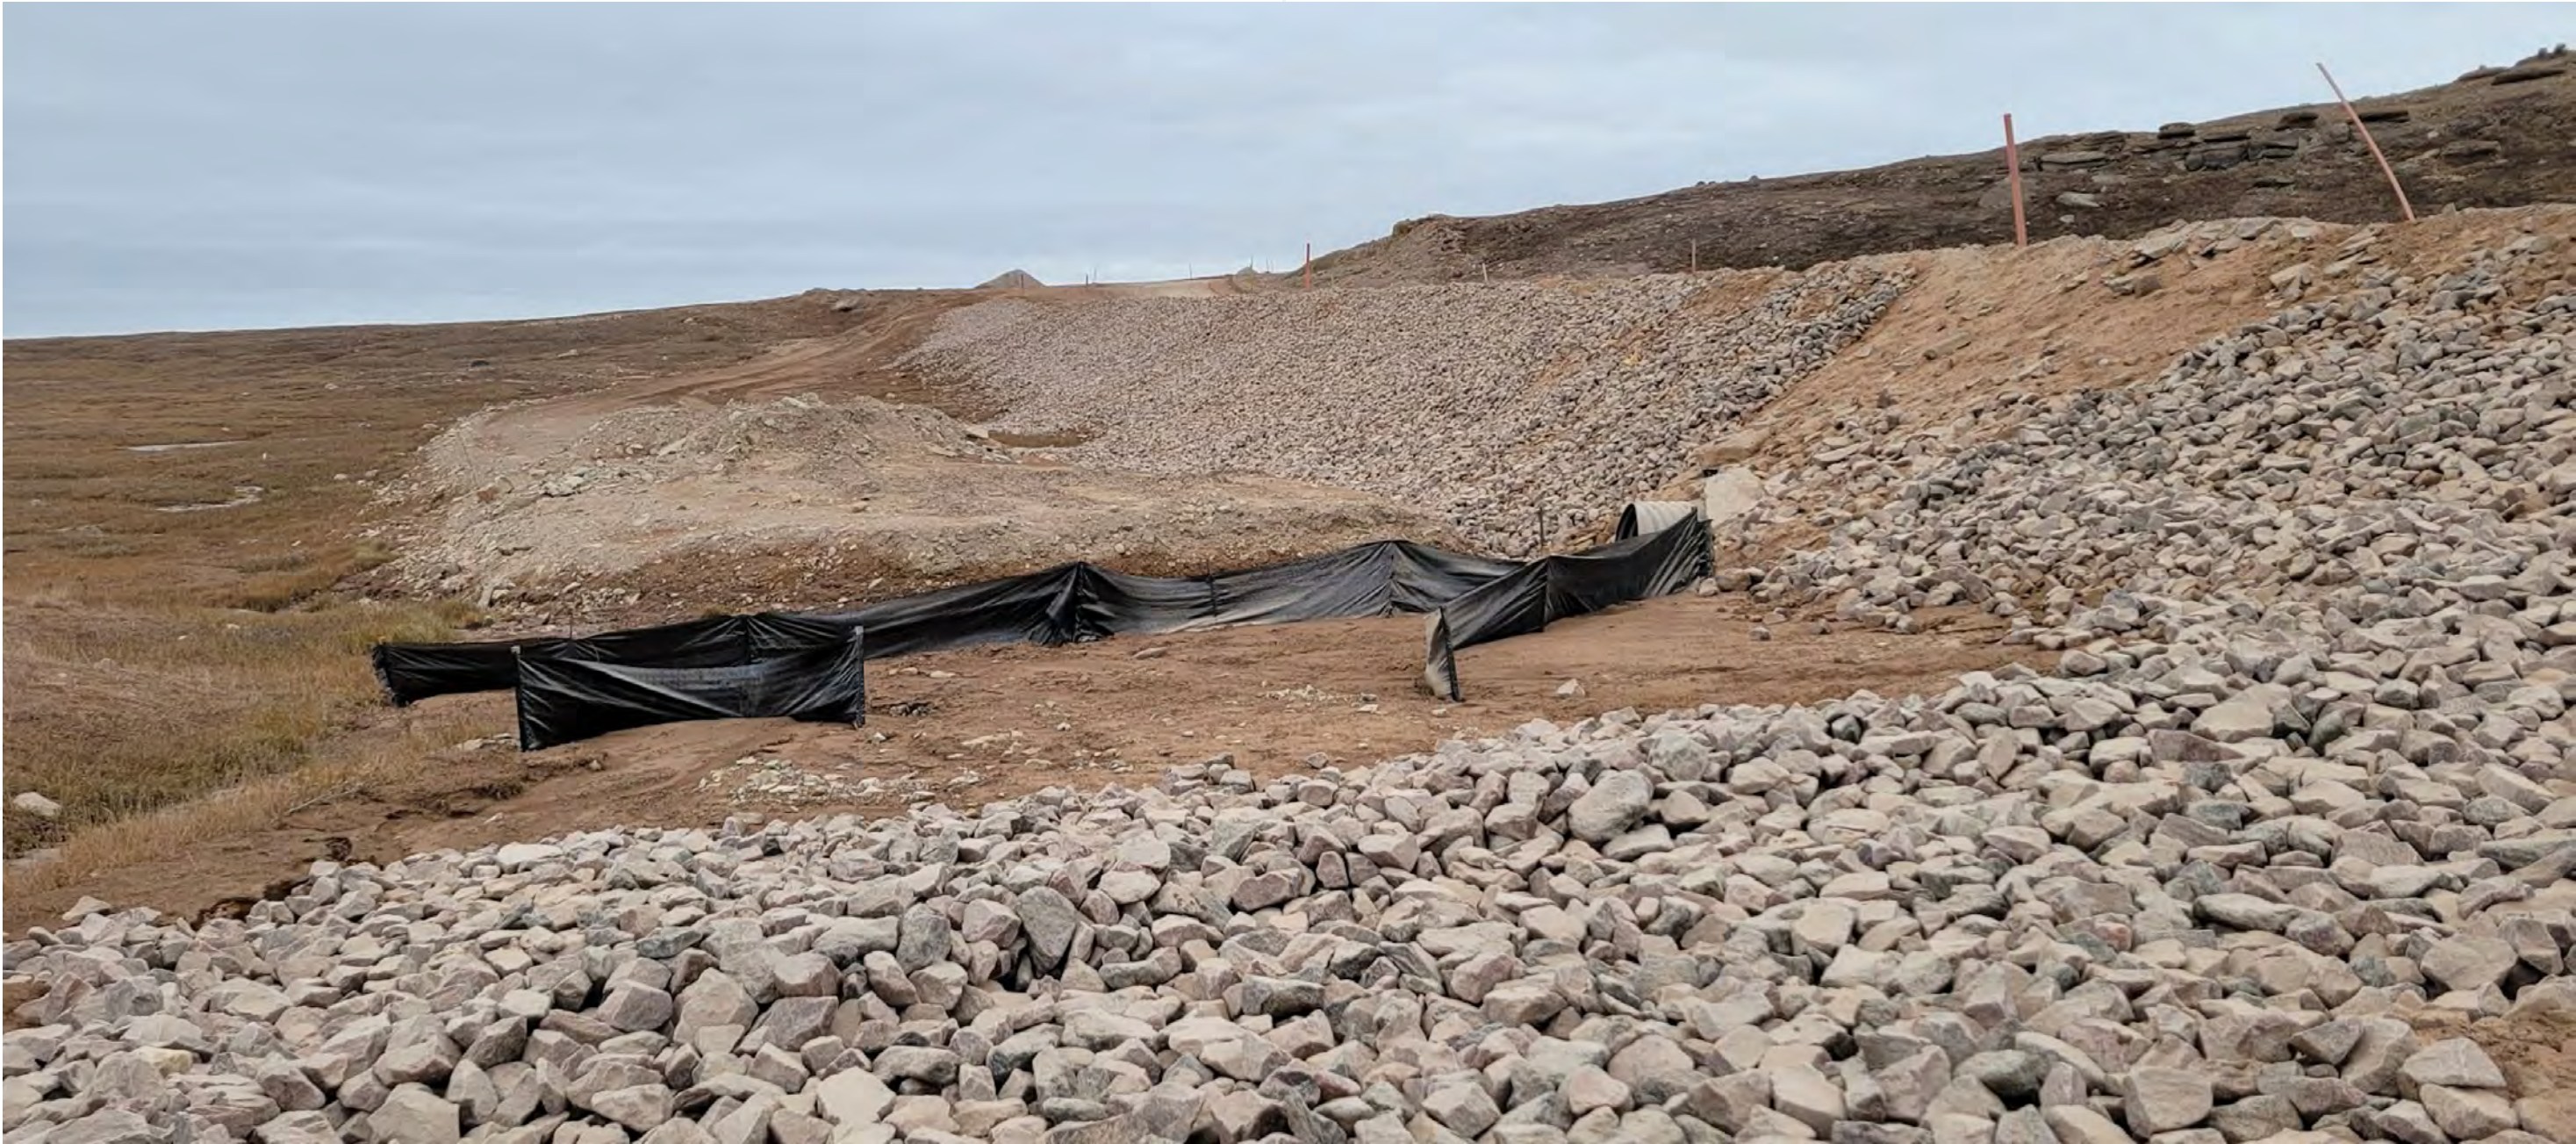
Photo 13A: Example of enhance armoring at KM74. Note accumulation of sediment on the surface or riprap above the culvert. Annual maintenance should ensure that all armoring is left in a condition that allows effective sediment management during the annual freshet,

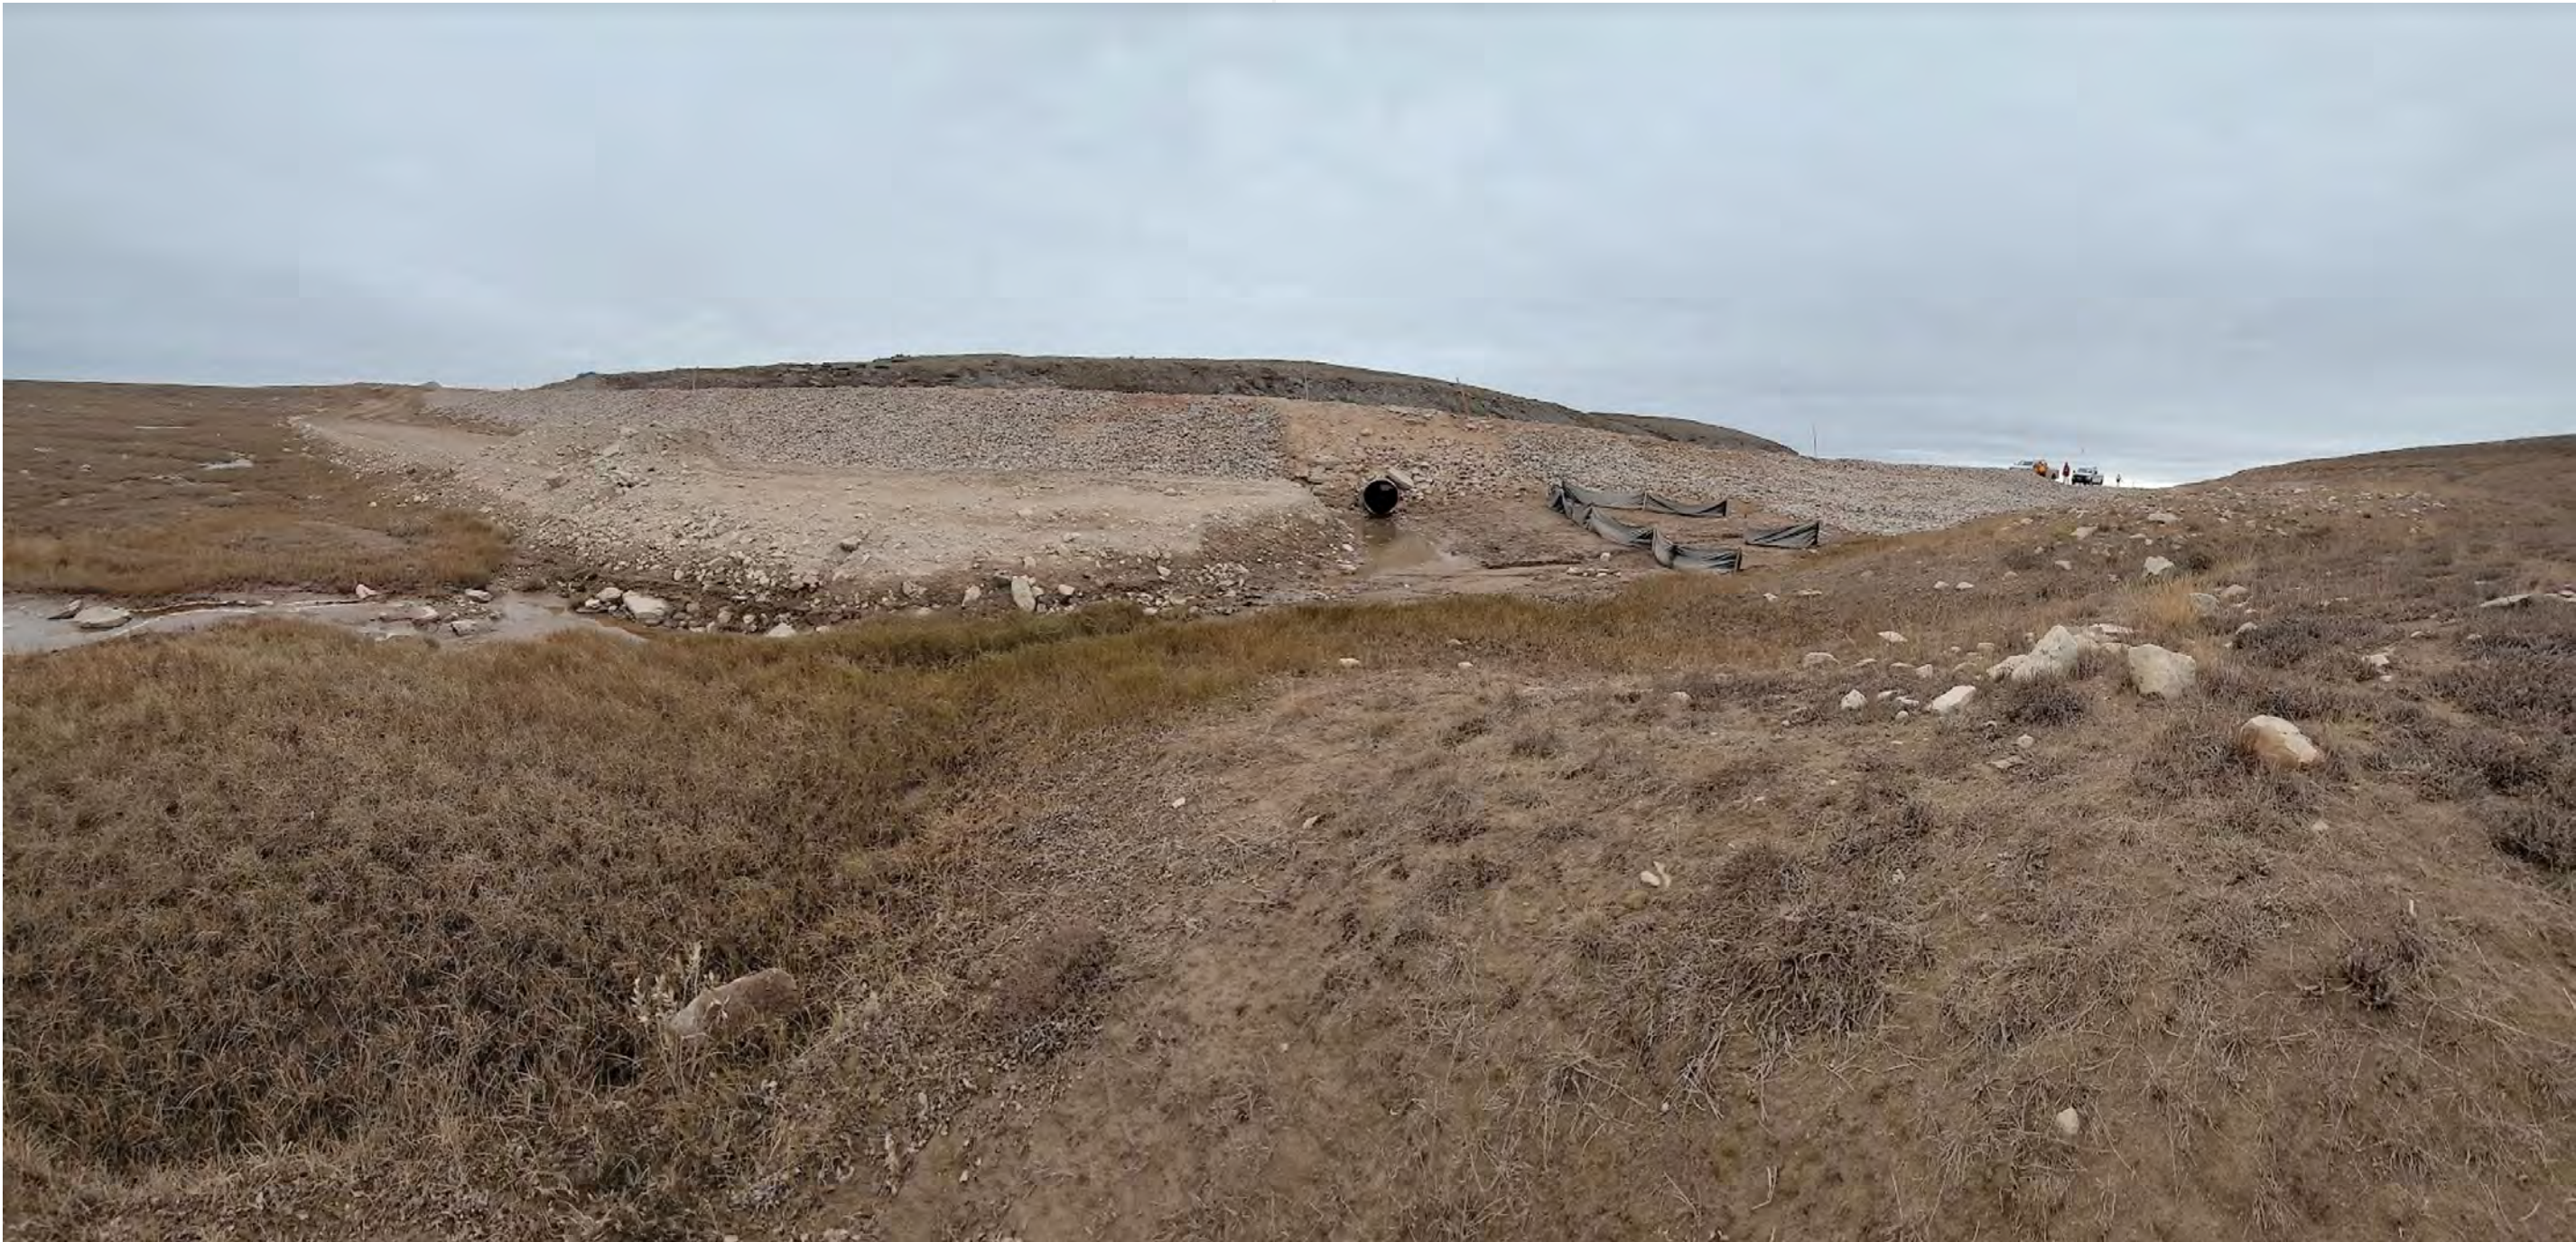
Photo 13B: View looking upstream towards culvert pictured in Photo 13A. Note that armoring appears to be incomplete with areas of exposed bare soil downstream of the silt fencing on the right side of the photo.

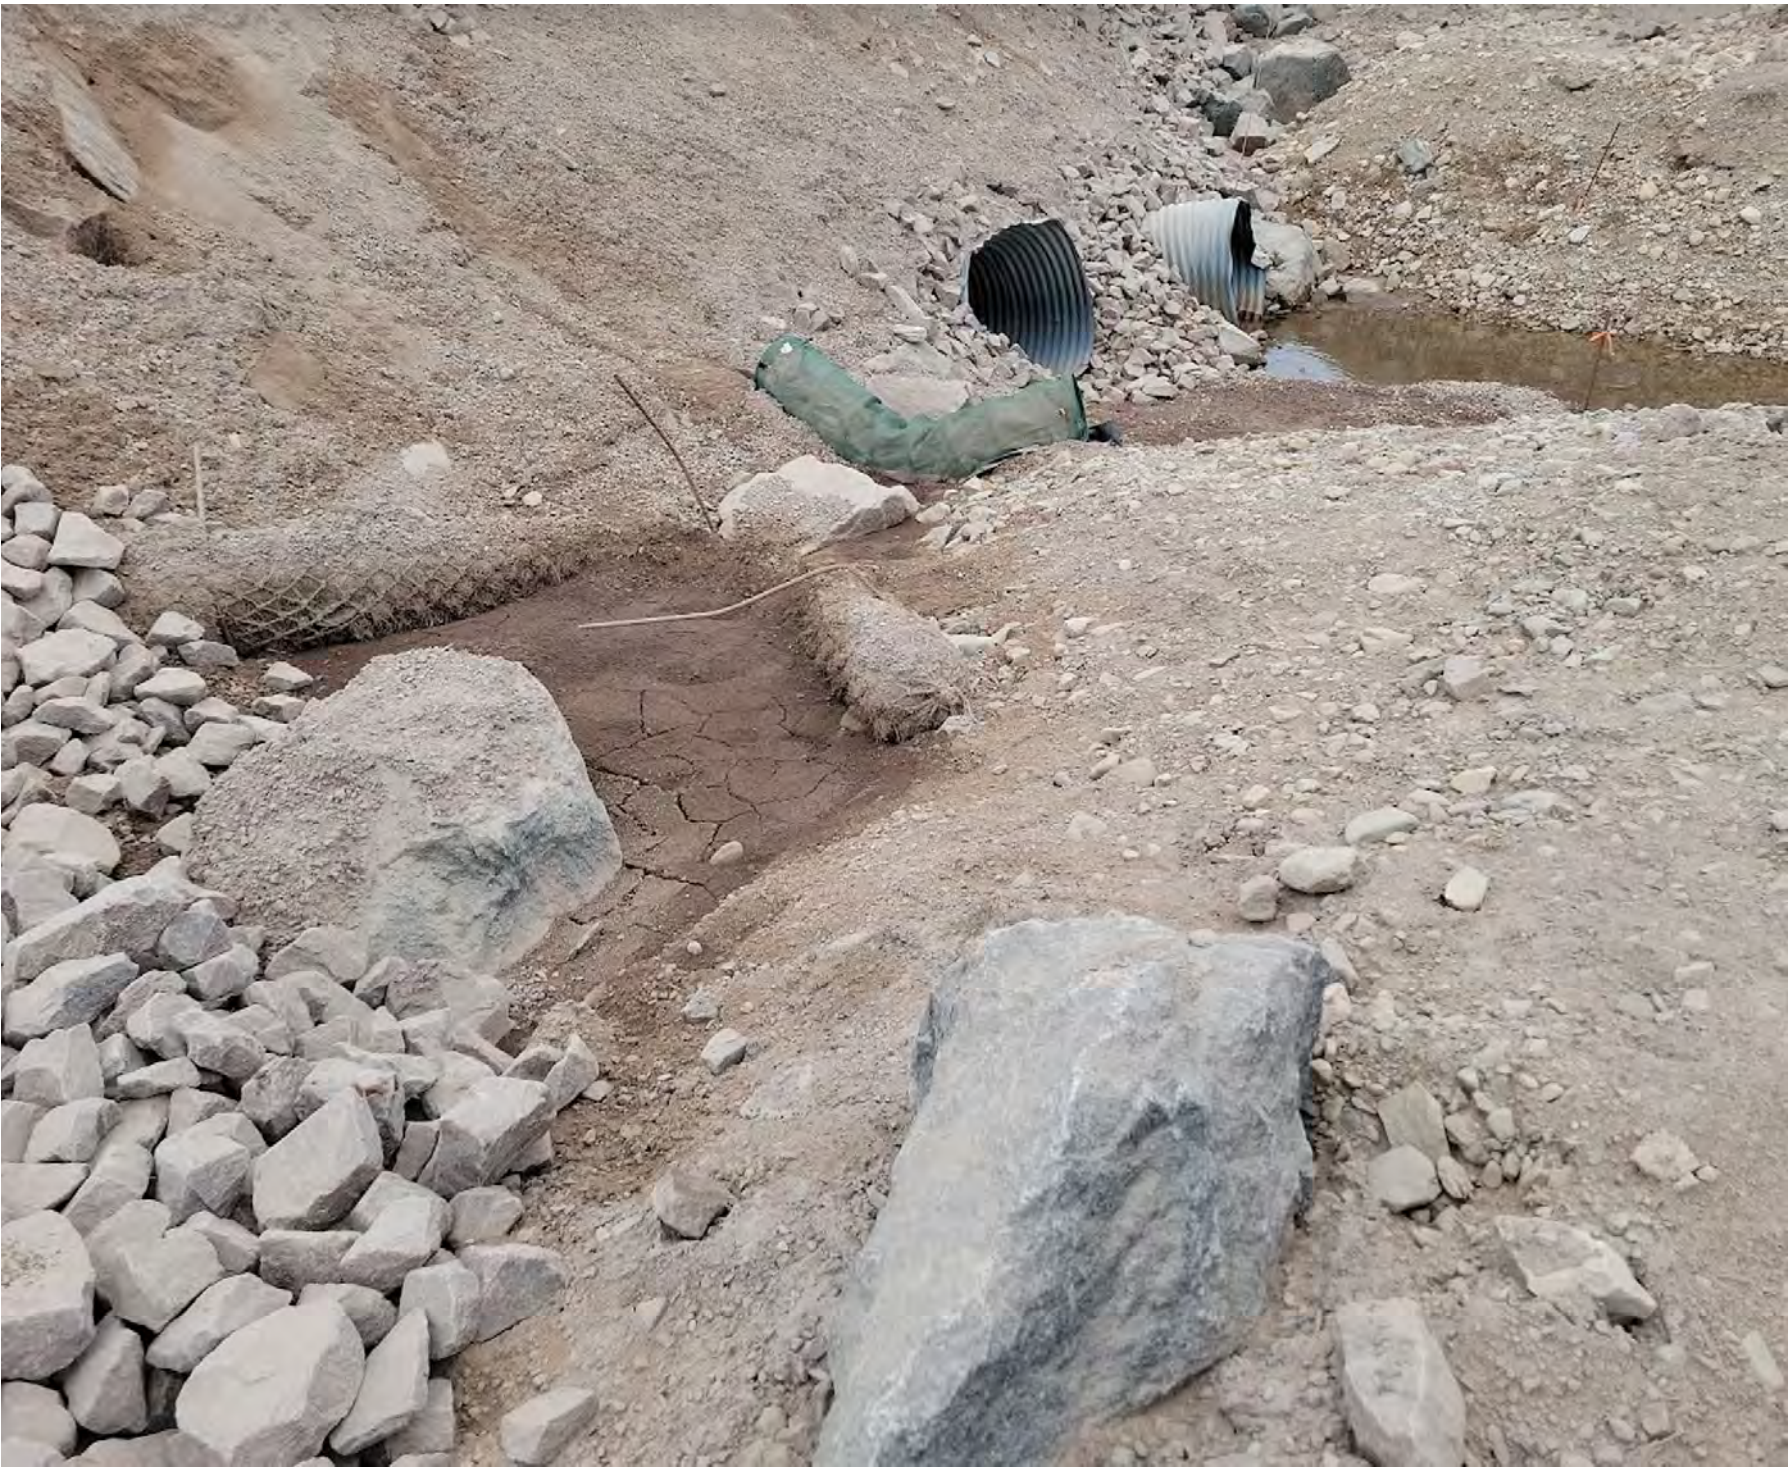
Photo 14: View of installed coconut coir log that needs the sediment accumulated upstream of it removed so that it can continue to function. As seen in the picture, it is evident that the sediment accumulation has resulted in the creation of a ramp that would make it easy for sediment laden waters to overtop the log during future sediment transport events.

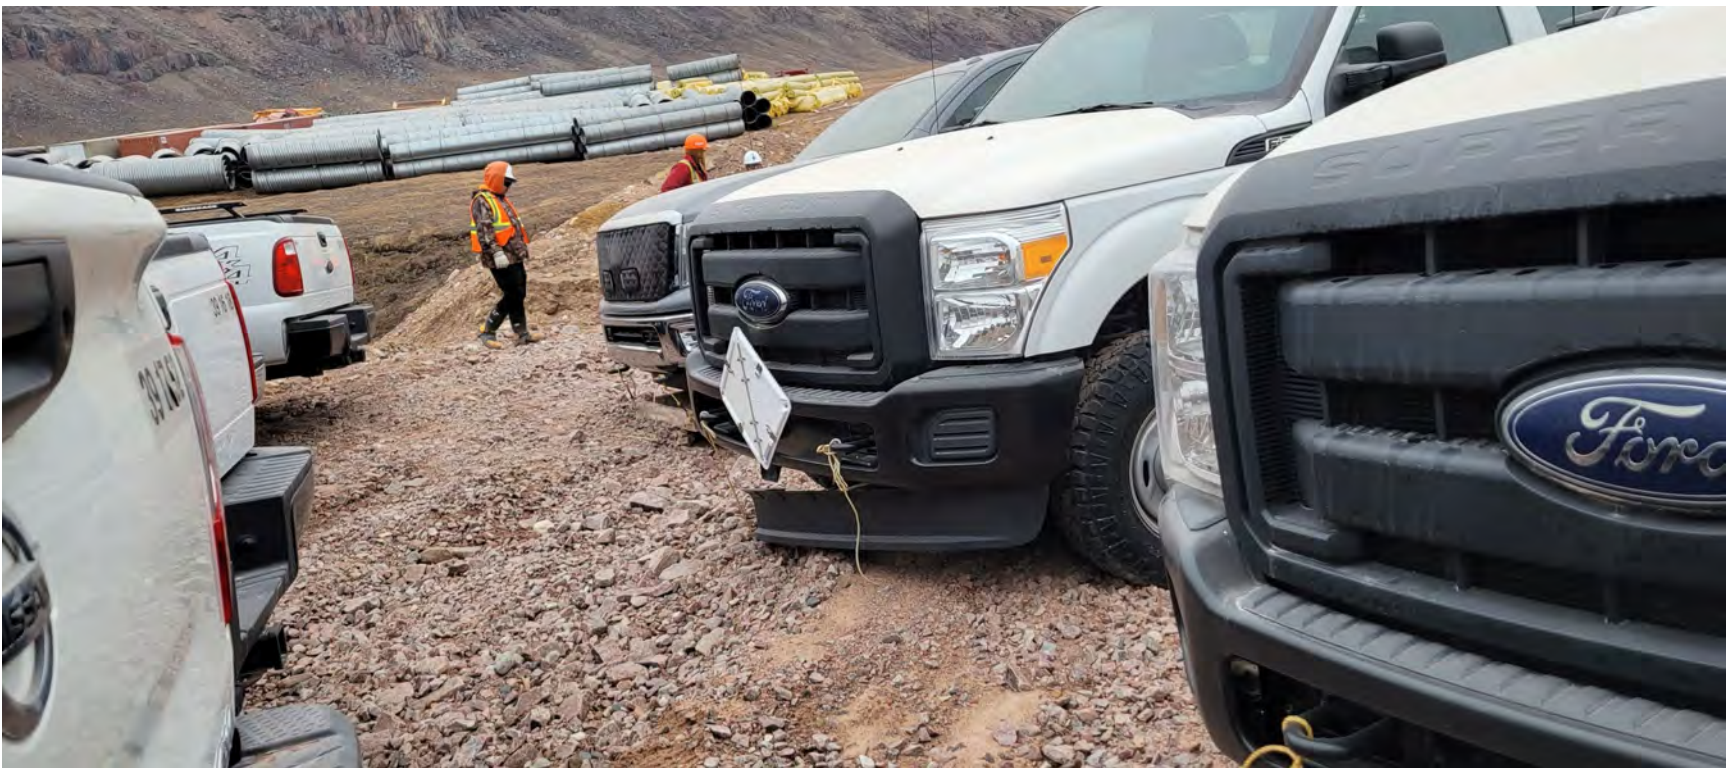
Photo 15A: View of damage starting to happen to parked vehicles at staging area near KM 7 as erosion gully develops beneath them.

21	Tote Road (KM7)	Sept 2023 – extensive erosion of surface materials leading to undermining ground stability at staging area where light trucks and other vehicles are stored. Ground beneath has been completely washed away creating unsafe conditions and potential loss of vehicle into downstream ravine that appears to be deepening.	Relocate vehicles from within the limits of the developing erosion gulley. Design and install properly armoured storm management channel to mitigate further development of existing gulley.	Baffinland will investigate options to mitigate erosion of the storm management channel and ensure safe conditions in the area.
22	Tote Road (entire alignment)	Sept 2023 – quarried rock from Q1 quarry could be a source of ultrafines contributing to dust generated on Tote Road. Only one truck reported to be operational	Sept 2023 – provide mineralogical data to QIA for ore and aggregates used to build the Tote Road. It will be used to assess and identify sources of ultra-fines and	Additional information on the mineralogy of the materials in the Q1 quarry was provided to QIA in correspondence dated October 31, 2023 (Swenson to Goddard).

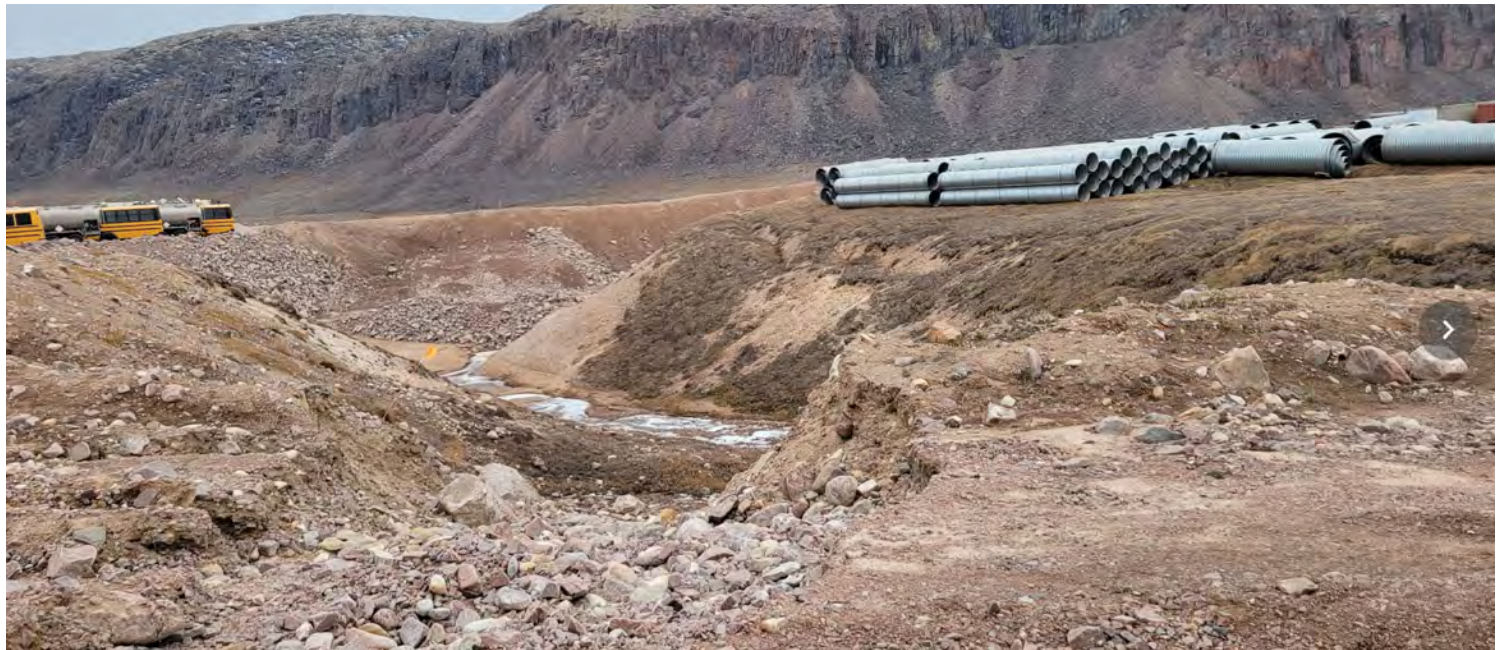
Photo 15B: View of channel that conveys flow west of equipment staging area.

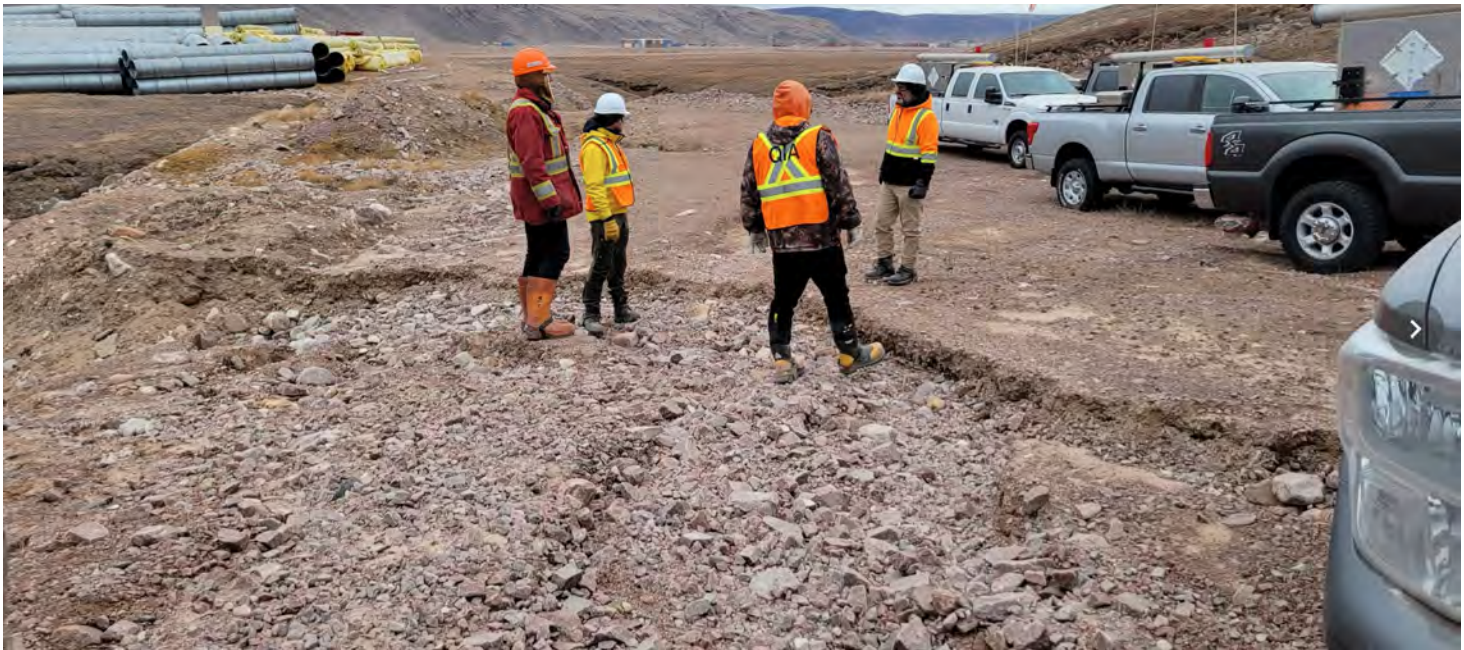
Photo 15C: View of erosion channel that has developed beneath parked vehicles at KM 7 staging area.

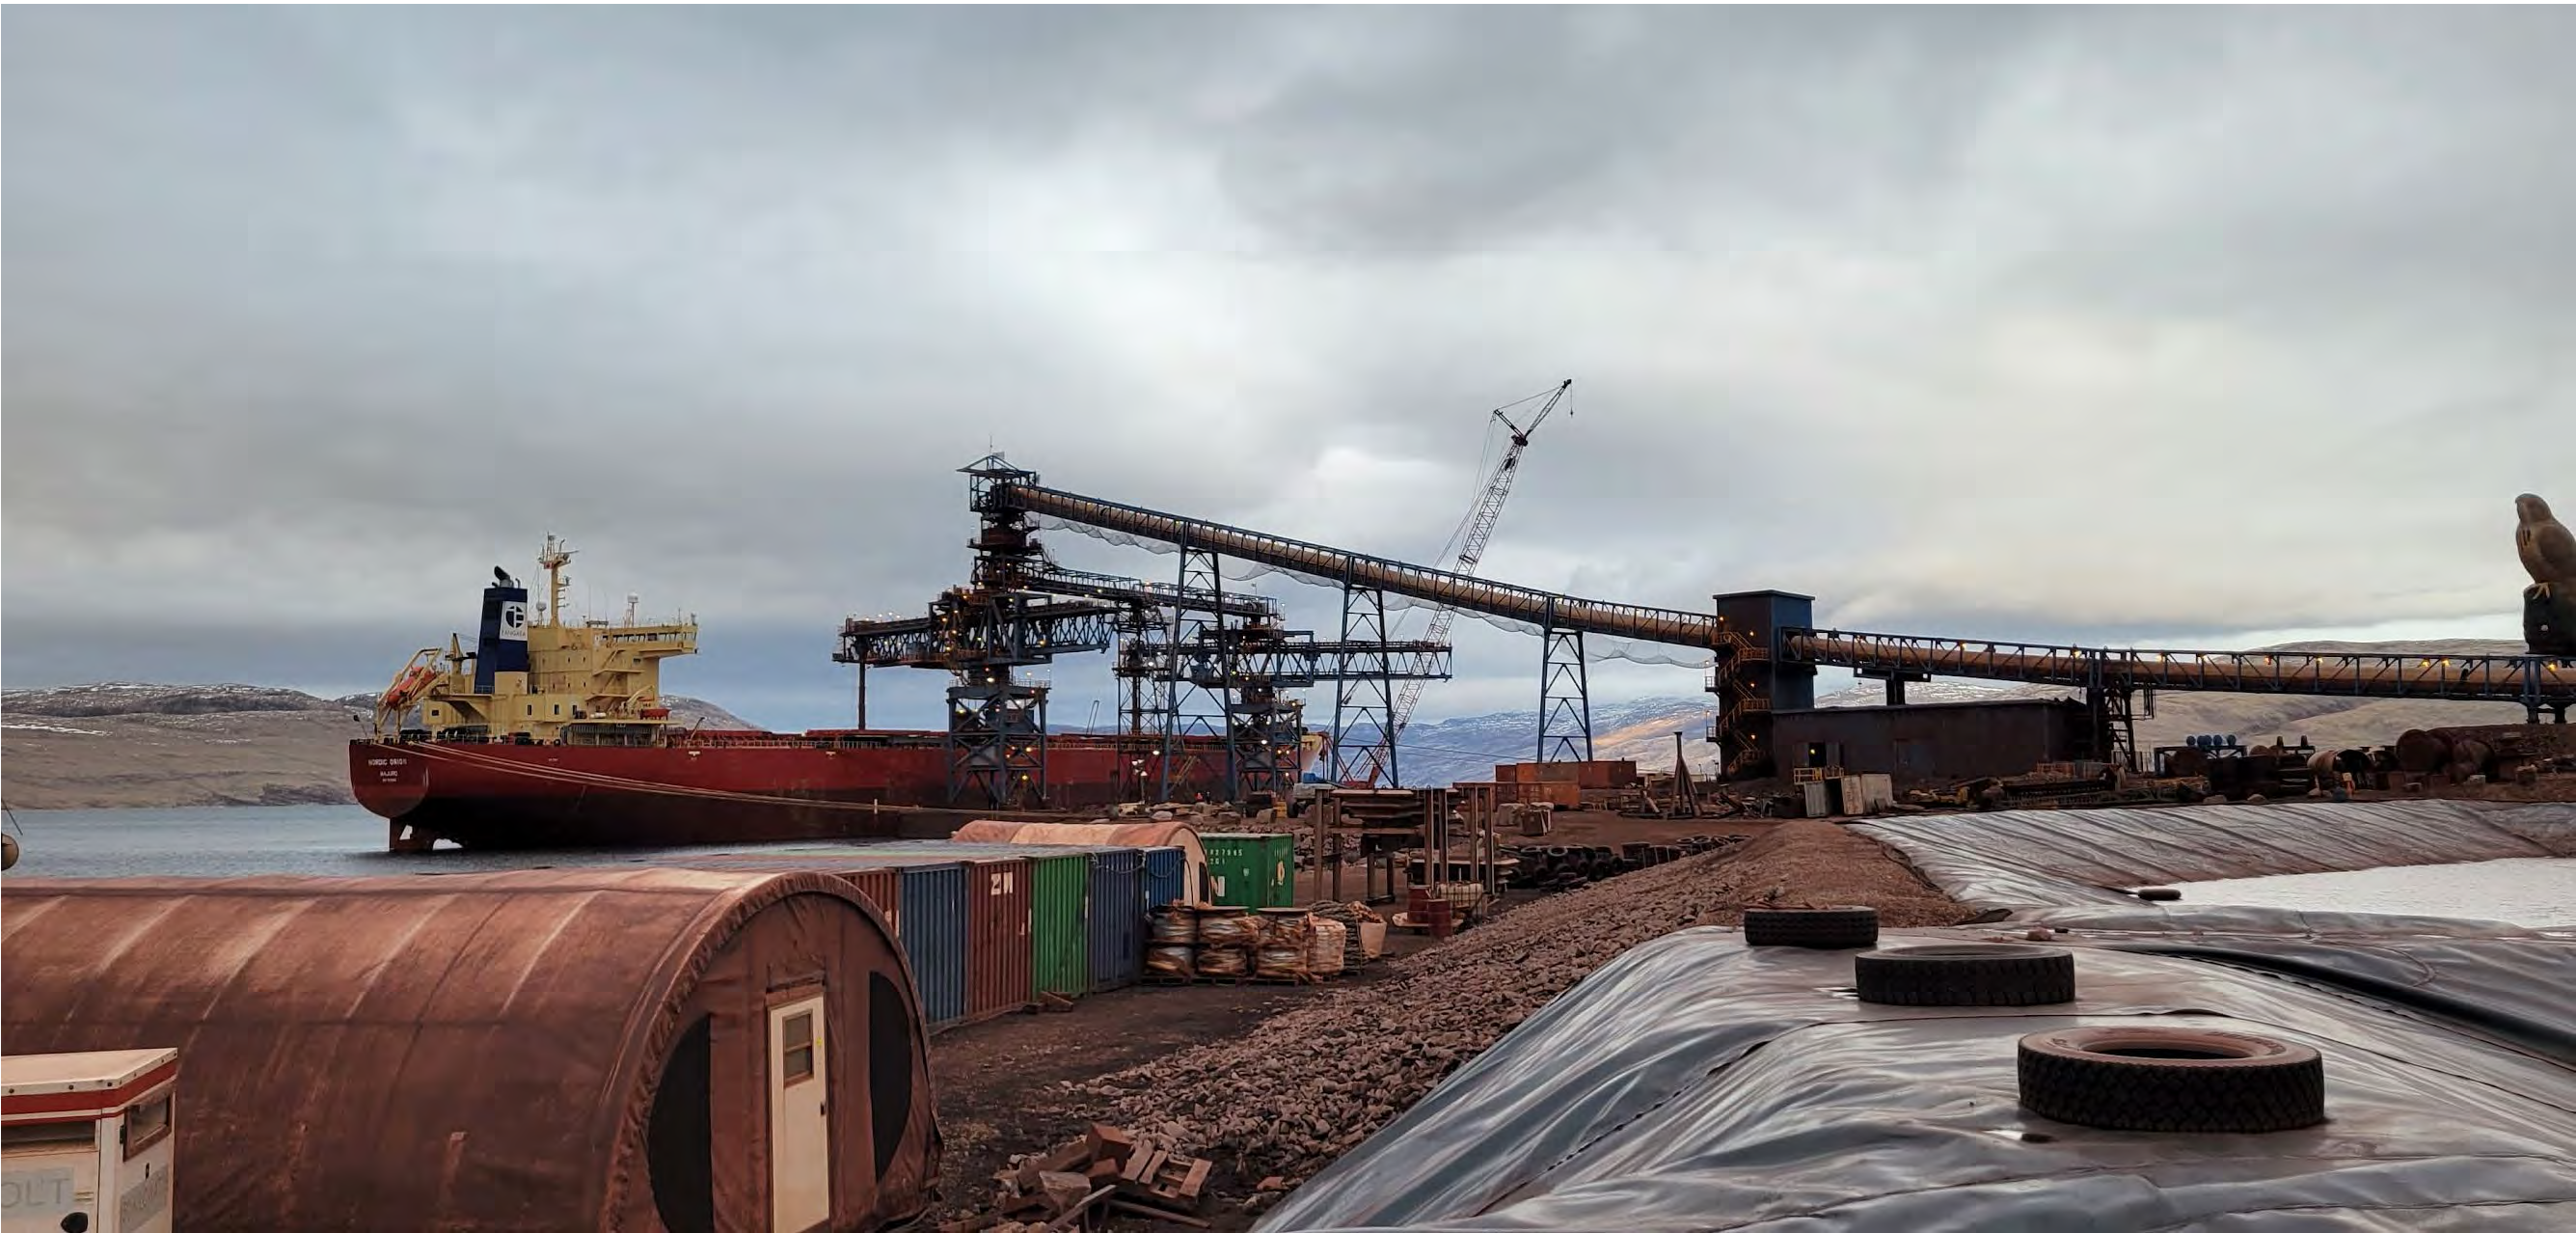
Photo 16: View (looking east) of west side of weather haven and ship loader caked with fine ore dust that has been transported by the wind from the fine ore stock pile locate south and west of the ship loader.

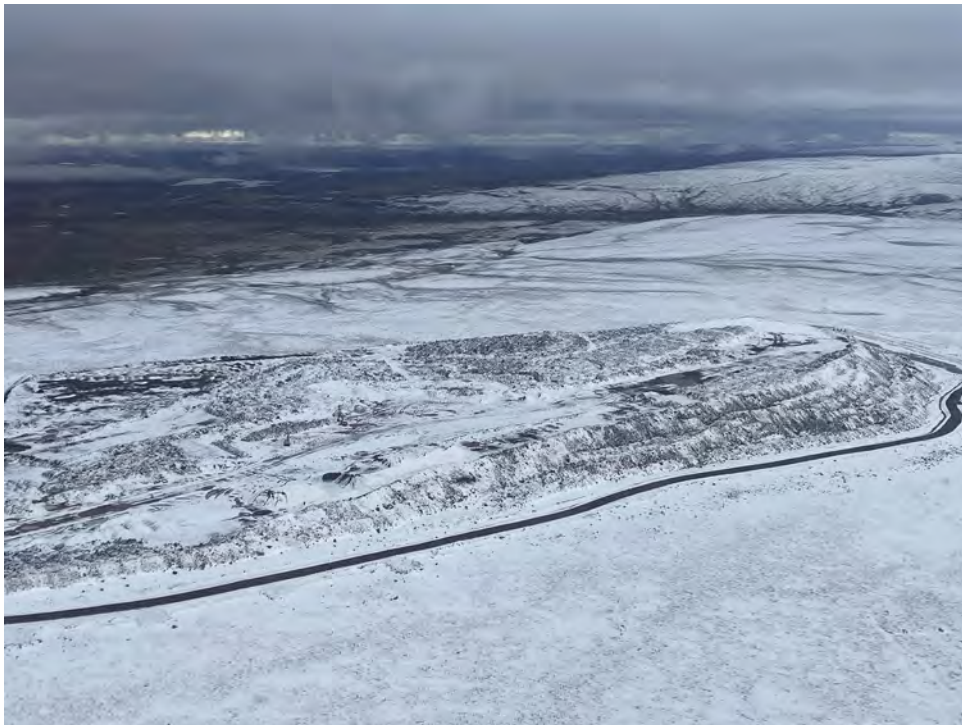
- There appeared to be several different areas where waste rock was being deposited at the time of the site visit, indicating separation of NAG and PAG material according to BIMs waste rock deposition plan (BIM, 2018). However, NAG vs PAG disposal locations within the WRF did not appear to be visually delineated (Figure 3.1)

Figure 3.1: WRF Plateau showing multiple deposition areas.

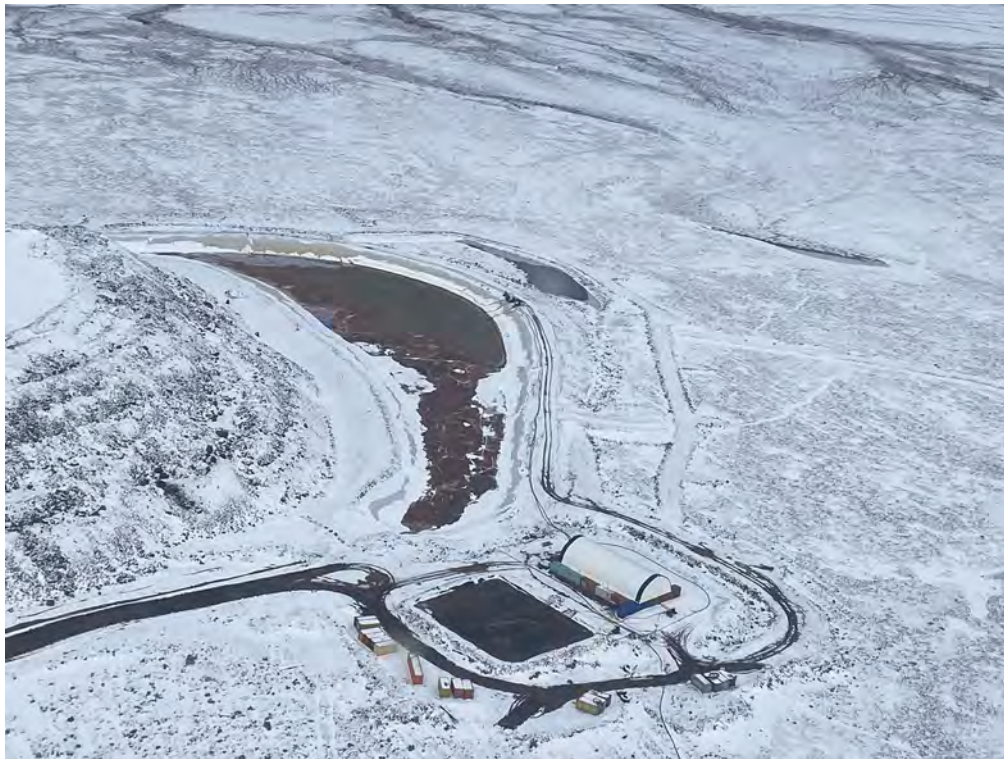
- A secondary containment berm containing standing water is present to the north of MS-08, indicating that either seepage is occurring from the WRF below MS-08 and into the secondary containment berm, or that the geosynthetic liner installed in MS-08 is allowing seepage through it (Figure 3.2).

Figure 3.2: MS-08 and secondary containment pond to the North.

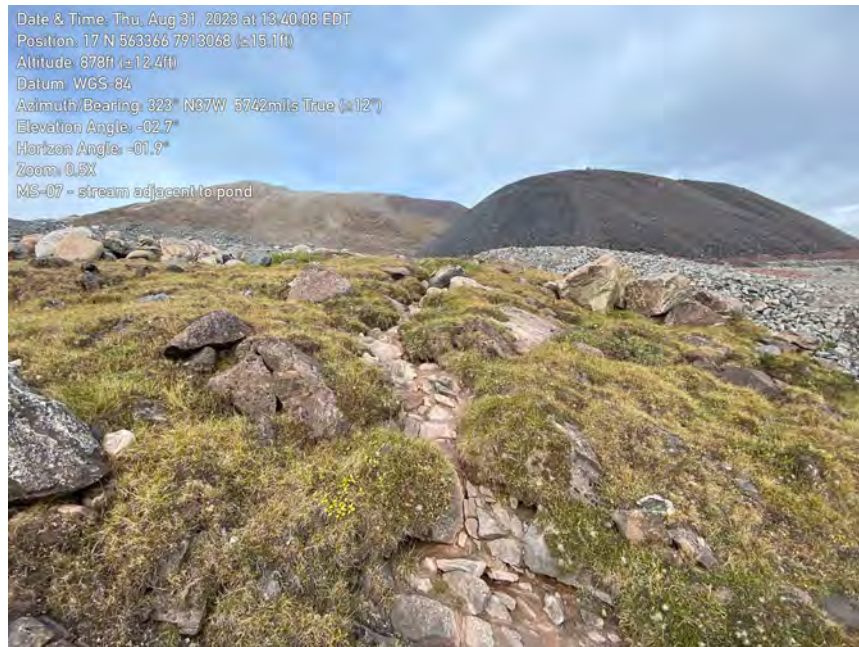
- A seepage path that appears to come from the stockpile that bypasses MS-07 completely (Figure 3.3)

Figure 3.3: Seepage path bypassing MS-07 sediment pond.

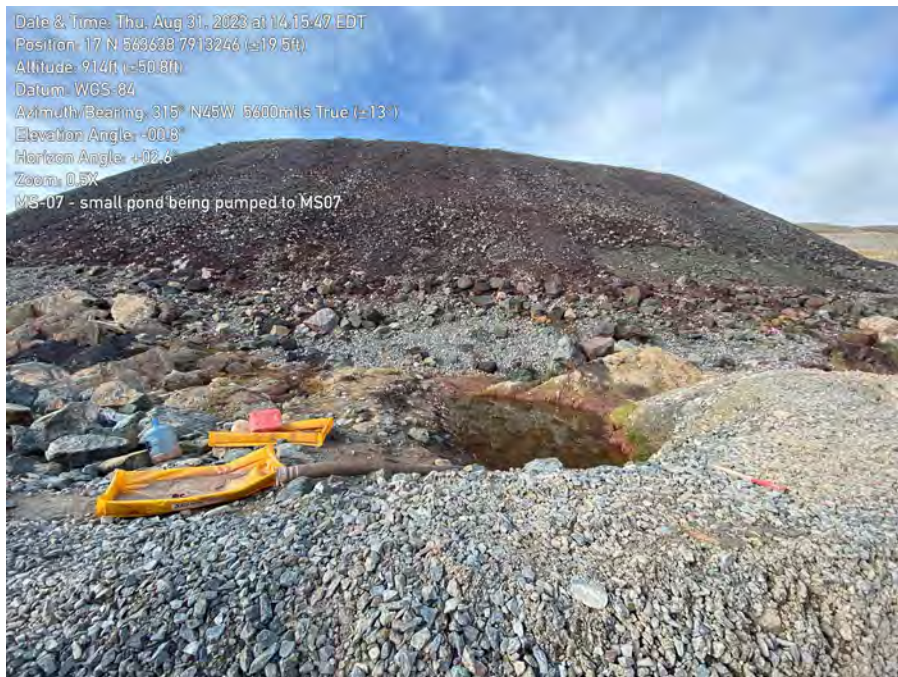
- A secondary containment pond to the east of MS-07 with standing water. A pump was present at the location but not currently operating (Figure 3.4). This, along with the seepage path noted in the above observation, indicate that contact water from the KM 106 stockpile is not collected in MS-07 in its entirety and that contact water is entering the surrounding environment.

Figure 3.4: Secondary containment pond east of KM 106 stockpile

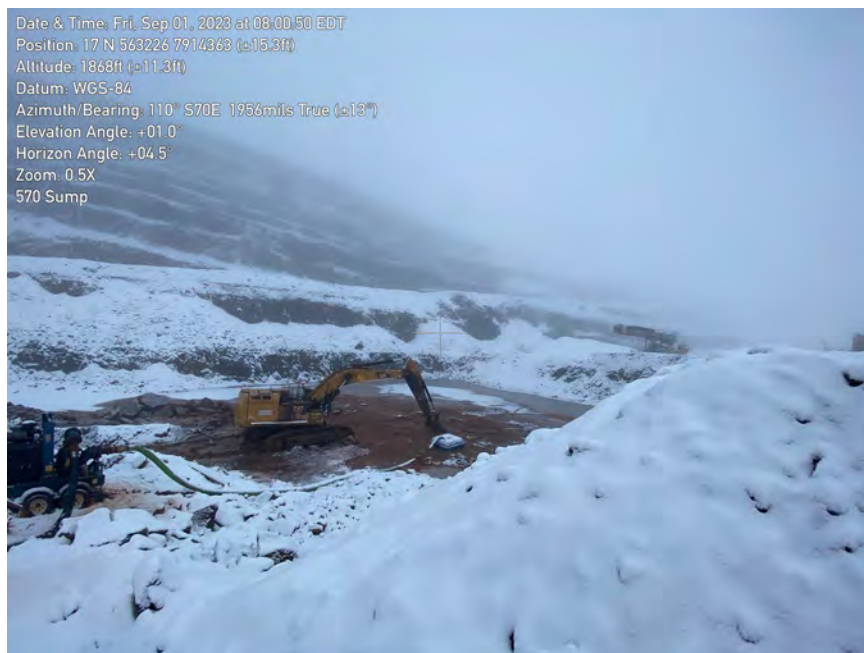
- Runoff from the active mine area above the elevation of 570 masl is collected in the 570 sump (Figure 3.5) and pumped to the MS-08 sediment pond to be treated indicating that PAG contact water from the active mine area may be contributing to low pH values observed in MS-08 (see Section 3.1.2).

Figure 3.5: 570 sump

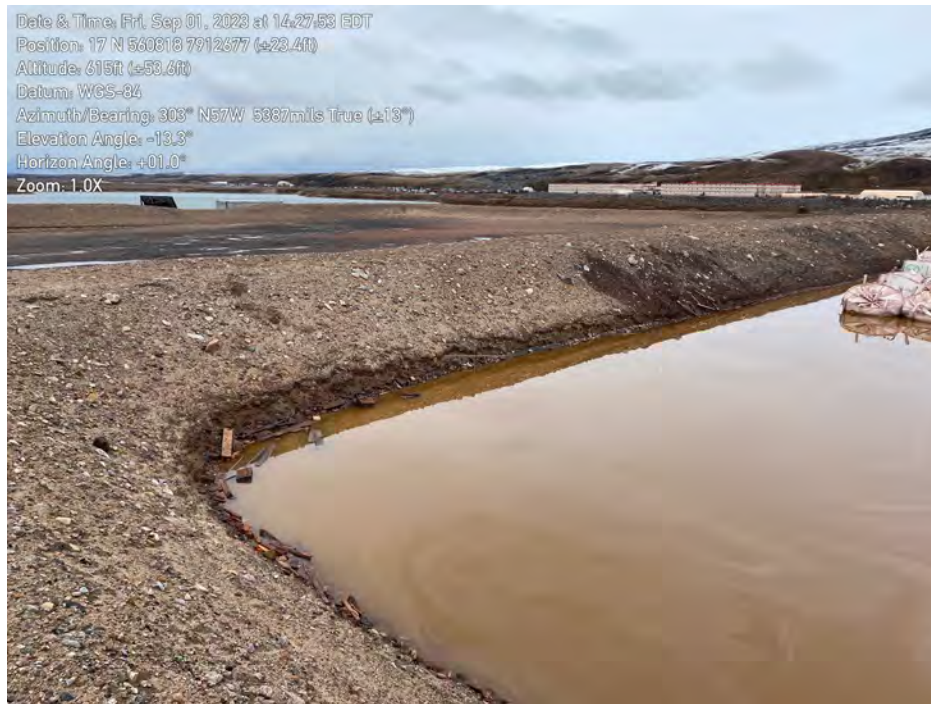
- The inner slopes of Landfarm containment berms are beginning to show signs of slumping (Figure 3.6)

Figure 3.6: Slumping beginning on inner berm of Landfarm.

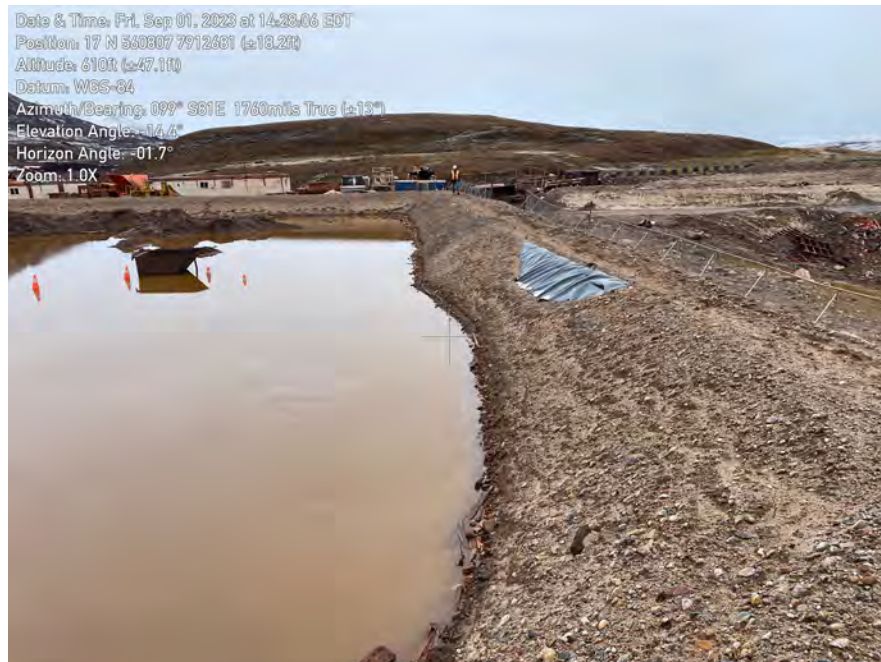
- A large section of geosynthetic liner material is exposed on the inner berm of the Landfarm (Figure 3.7)

Figure 3.7: Exposed geosynthetic liner on inside of Landfarm berm.

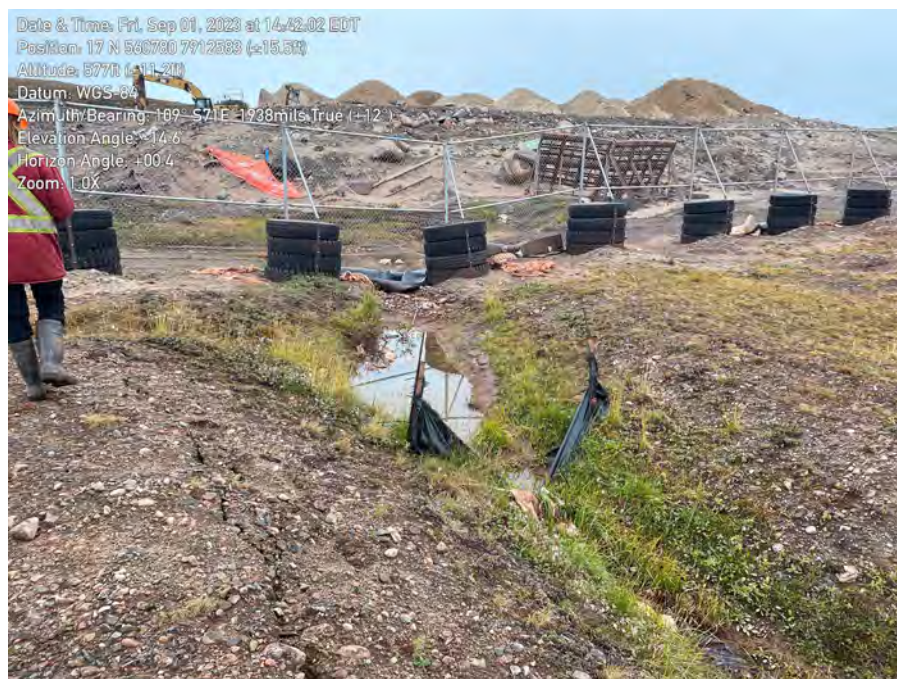
- Uncontrolled runoff to the surrounding environment was occurring to the West of Landfill (Figure 3.8)

Figure 3.8: Uncontrolled runoff from landfill to surrounding environment.

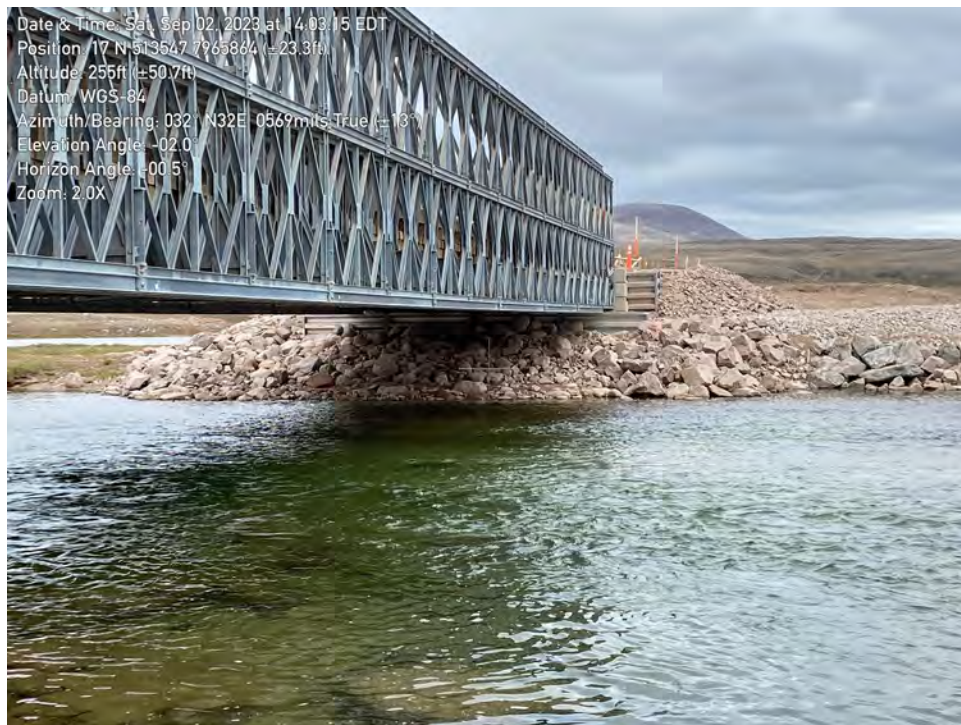
The Tote Road was inspected by QIA and Okane on September 2nd, with a focus on bridge crossings and their abutments. Scour protection on all crossings looked to be sufficient and in good condition (Figure 3.9). While the constructed retaining wall bridge abutments do appear to have settled (Figure 3.10) further settlement is inhibited by the bridge structures themselves.

Figure 3.9: Tote Road Bridge Abutment Armouring at most northern bridge
