MINING IMPACT SPECIALISTS LTD. <small>ENABLING CHANGE TO SERVE FUTURE GENERATIONS.</small>	  <small>EST. 1971 LIMITED environmental research associates</small>	2023 Mary River Project Site Visit #2		
		Key Photos from September 2023 Inspection		
Mining Impact Specialists Ltd.	LGL Limited	Date: 05 Dec 2023	Approved: LEB	Page: 17

KM105 SEDIMENTATION POND ---- GROUT CURTAIN PROJECT

955-221 Mary River Mine 2023 Environmental Audit

955-221-R-001

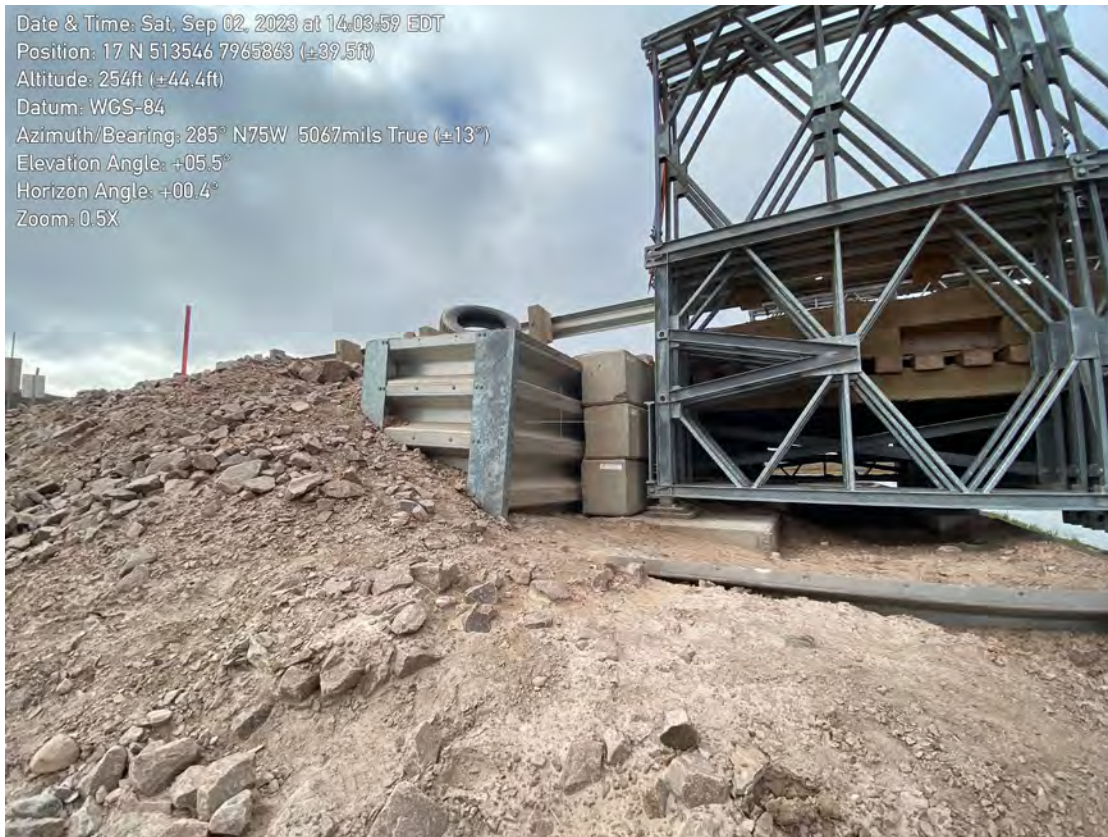
The Tote Road was inspected by QIA and Okane on September 2nd, with a focus on bridge crossings and their abutments. Scour protection on all crossings looked to be sufficient and in good condition (Figure 3.9). While the constructed retaining wall bridge abutments do appear to have settled (Figure 3.10) further settlement is inhibited by the bridge structures themselves.

Figure 3.10: Settlement in Bridge Abutment retaining wall
