## Nunavut Impact Review Board (August 2019)

**Report title:** 2019 Winter Site Visit Report for the Nunavut Impact Review Board's Monitoring of Baffinland Iron Mines Corp.'s Mary River Project (NIRB File No. 08MN053)

**Project:** Mary River Project

**Site visit dates:** March 26-28, 2019

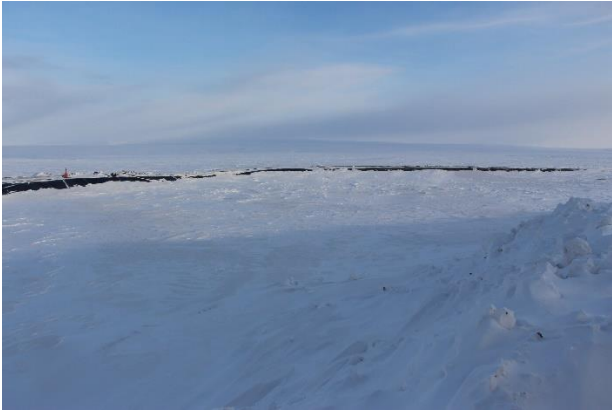
**Photo 3: Waste Rock Storage Area Pond**

The waste rock facility (WRF) is an open area where potentially acid generating (PAG) rocks are disposed and stored. At the time of the site visit, no apparent environmental issues or concerns were noted at the waste rock stockpiles area. No signs of runoff or uncontrolled seepage of potentially contaminated contact water was observed in the area. In addition, NIRB staff followed up with Baffinland staff on the repair status of the WRF sedimentation pond which overflowed during previous summers. Baffinland staff indicated that efforts have been made since the last overflow incident in 2017 to address the structural issues identified at the facility. NIRB staff was unable to fully assess the extent of the repairs or improvements made to the sedimentation pond because of snow accumulation within the facility.

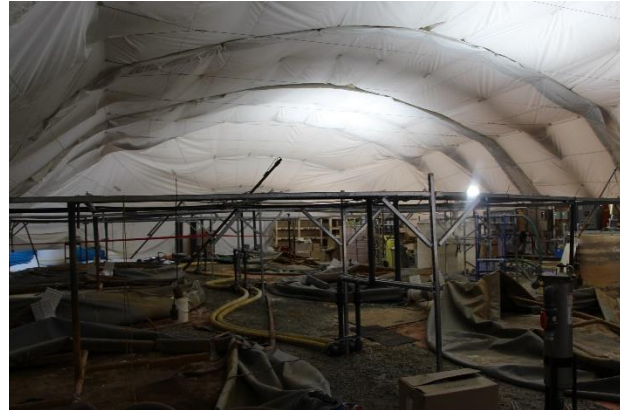
**Photo 4: Wastewater Treatment Plant**

NIRB staff also visited the wastewater treatment facility adjacent to the waste rock sedimentation pond, but the facility was not in operation as Baffinland was installing different equipment to support the operations of the facility in the future.

Baffinland indicated that it anticipates that the full operation of the new waste water treatment plant would help properly manage all the effluent discharges originating from the waste rock facility ([Photo 3](#) and [Photo 4](#)). In general, NIRB staff observed that progress has been made to address most of the environmental concerns associated with the waste rock area and the adjacent sedimentation pond.

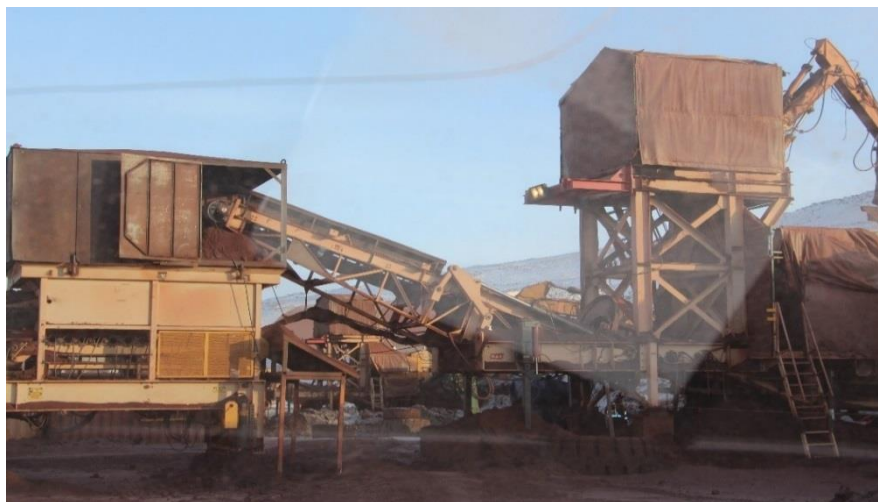
**Photo 8: Shroud installation at crusher facility**

NIRB staff also took a tour around the crusher facility ([Photo 7](#) and [Photo 8](#)) to follow-up on the Board's 2018 recommendation #21 pertaining to the implementation of proper engineering designs and controls to address the increased dust emissions from the crusher plant. The following were observed during the tours of the crusher facility:

- Hoods/shrouds were still in place on the crusher equipment similar to the observations in 2017 and 2018, which resulted in decreased emission of dust from the facility compared to previous years. Further, the use of dust control technology especially near the transfer point and the belts appear to have been effective to a certain degree in reducing and controlling dust emission from the crusher; however, in certain areas of crusher facility visible dust plumes continue to be observed. NIRB staff noted that in general dust emissions from the crusher plant appear to have improved.

The Monitoring Officer observed a general improvement in relation to dust emission from the crusher facility, Baffinland is still required to adopt for technologically sound measures and engineering designs to reduce or prevent dust dispersion from the crusher facility. Therefore, the Monitoring Officer will be looking to discuss what adaptive management measures Baffinland will be using to reduce dust dispersion from ore stockpiles in Milne Inlet during the summer site visit and if these measures will need to be incorporated into its Dust Management and Monitoring Plan.

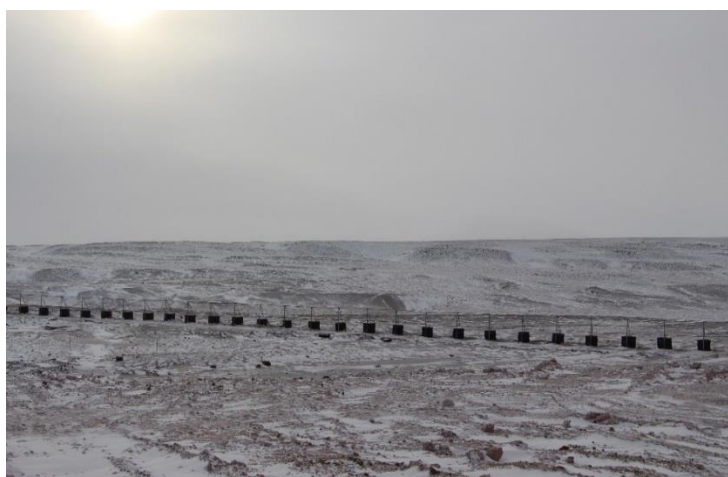
**Photo 9: Partial fencing around the landfill**

NIRB staff also visited the landfill site to follow-up on the Board's 2018 recommendation #20 pertaining to the need for Baffinland to address the recurring fencing issue around the landfill footprint. At the time of the site visit, NIRB staff noted that the landfill was still not fully enclosed with proper fencing thereby increasing the risk for offsite waste dispersion ([Photo 9](#)). NIRB staff also observed that one of the temporary laydown areas adjacent to landfill area continued to accumulate increased amount of unused materials and there are concerns that this laydown area may eventually become a permanent laydown area if these items are not properly cleaned out or relocated to an appropriate location for disposal. NIRB staff also observed a scrap vehicle ([Photo 10](#)) in the landfill site and this was brought to the attention of Baffinland site staff for immediate action. In addition, a bulldozer was also observed clearing wastes within the facility ([Photo 11](#)). The Monitoring Officer remains unsatisfied with the level of progress made by Baffinland since 2014 to address the fencing issue at the landfill site.

For example, at the landfill site, the fencing issue continue to remain an outstanding issue as no action has been taken by the Proponent since 2014 to fully enclose the facility to prevent off-site

dispersion of waste materials into the adjacent tundra. Partial enclosure of the landfill facility should not be considered a long-term strategy for the site and best practices should be adopted. There is also need for the Proponent to remove the scrap vehicle disposed of at landfill facility.

The Monitoring Officer is therefore requesting Baffinland to develop an action-plan for addressing the recurring fencing issue at the landfill and present a timeline for the full enclosure of the landfill prior to the NIRB's next site visit. The NIRB will be inspecting the site for progress on this topic during the summer site visit report.

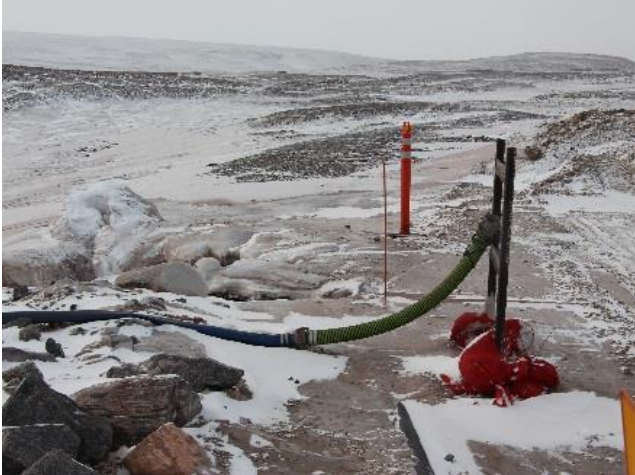
**Photo 14: Sewage Outfall area**

The sewage discharge area is an area where treated effluent from the waste treatment plant is discharged into the receiving environment ([Photo 14](#)). During the site visit, NIRB staff noted some terrain stability issues caused by erosion of the land where the discharge pipe was laid ([Photo 15](#)).

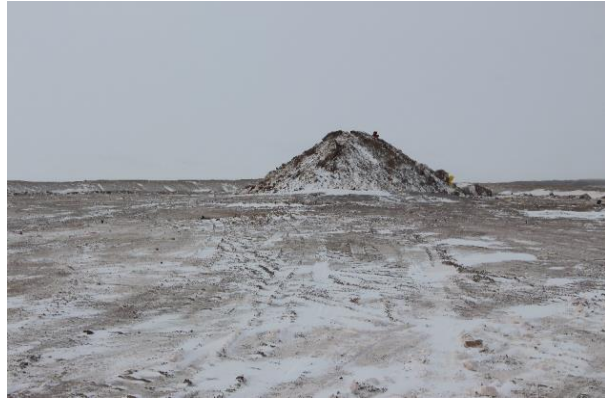
**Photo 19: Plastic materials in the landfarm facility**

NIRB staff visited the landfarm facility in order to follow-up with progress made to the facility in accordance with best practices. While some improvements have been made to the general operations of the facility, the entrenchment of synthetic liner materials within the facility continues to be an issue at the facility ([Photo 18](#) and [Photo 19](#)). NIRB staff also observed that salt bags had continued to be stored in a temporary laydown area near the landfarm and the Proponent was unable to outline what long-term storage options are being considered to ensure that salt bags in the area are not permanently stored in that location or damaged.

The Monitoring Officer notes that the landfarm will be inspected again in the summer site visit to observe the progress made in conducting landfarming and reduction of pieces of synthetic liner in the materials.

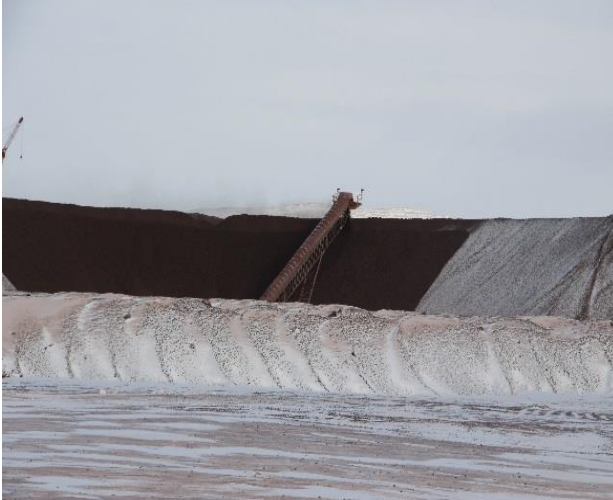
**Photo 20: Conveyor system at Milne Inlet**

NIRB staff also took a tour around the ore dock area and observed that ore stockpiling activities were taking place ([Photo 20](#)). It was observed that during ore stockpiling activities dust was being blown from the stockpile area towards Milne Inlet resulting in widespread deposition of dust particles into the snow and ice surface around Milne Inlet ([Photo 21](#)). NIRB staff also observed that one of the dustfall monitoring station near Milne Inlet was located too close to a laydown pad area and the Proponent indicated that various actions were being considered at that point to try to relocate the dustfall station to a farther location so as not to compromise the accuracy of dustfall monitoring at Milne Port ([Photo 22](#)).

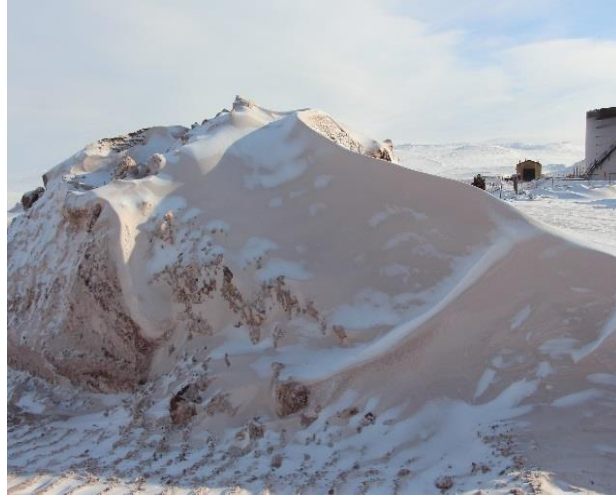
**Photo 21: Ore dust on snow around Milne Inlet**

At the time of the site visit, there was evidence of dust deposition and accumulation on sea ice around Milne Inlet and this was likely influenced by blowing ore dust during ore stockpiling.

Condition 10 requires the implementation of a dust management and monitoring plan at site to prevent impacts to air quality from dust dispersion. At the time of the current site visit, the Monitoring Officer noted that dust emissions from the orestock pile area posed an environmental risk to marine area around Milne Inlet. Specifically, during orestockpiling activities it was observed that ore dust was blown across the Milne Inlet surrounding causing widespread dust deposition on sea ice. While the issue of dust deposition on sea ice has been consistently raised by the community members of Pond Inlet and NIRB staff over the last 2 years, the NIRB notes that Baffinland has not taken any specific-site actions to reduce or prevent blowing ore dust from the ore stockpile area into the Milne Inlet environment.

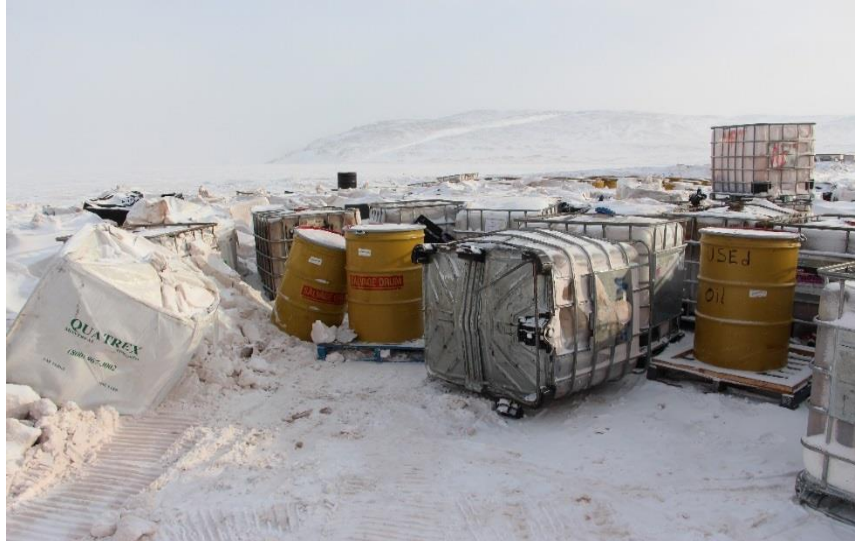
**Photo 23: Hazardous waste storage area**

The hazardous waste storage area was observed to be located adjacent to Milne Inlet and the pad that was used as the base for the facility was low and near the marine area. NIRB staff asked some questions regarding the operations and maintenance of the facility including what measures are in place to prevent berm failures and runoff of hazardous waste into the marine area ([Photo 23](#)).

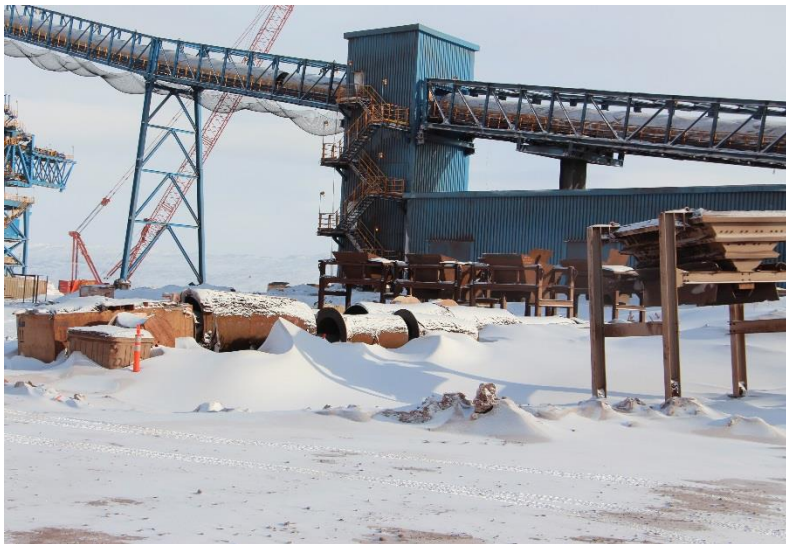
**Photo 24: Piles of metal scrap around shiploader in Milne Port**

NIRB staff noted that some historical laydown areas around Milne port, which were known to have accumulated tires piles and scrap materials, were fully cleaned out thereby improving the aesthetics of the area. However, specific areas near the shiploader were observed to still accumulate scrap metal materials ([Photo 24](#)). Baffinland staff indicated that a site wide clean-up is being planned during and after freshet to address waste management issues onsite.

NIRB staff noted during the site visit that several locations around the project site, particularly around the shiploaders, landfarm and landfill area require improved waste management actions as many waste materials was found to have accumulated there.

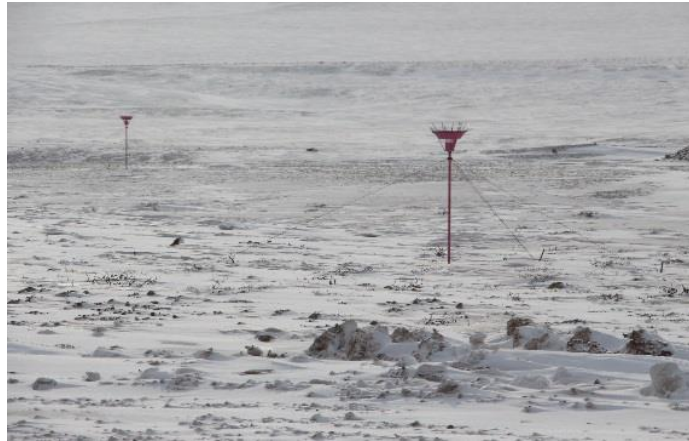
**Photo 25: Dustfall Monitoring Station**

The Proponent is required pursuant to Condition 10 and 58 of the Project Certificate to monitor the status of dust deposition on site. During the drive along the Tote Road, NIRB staff observed several dust fall stations along the Tote Road, which is noted as being in compliance to part c of Condition 10 ([Photo 25](#)). NIRB staff also noted that vehicular traffic also resulted in the generation of dust plumes and widespread discolouration of the snowbanks along the road.
