Nunavut Impact Review Board

August 2019 Site Visit Report

The Mary River project

Baffinland Iron Mines Corporation

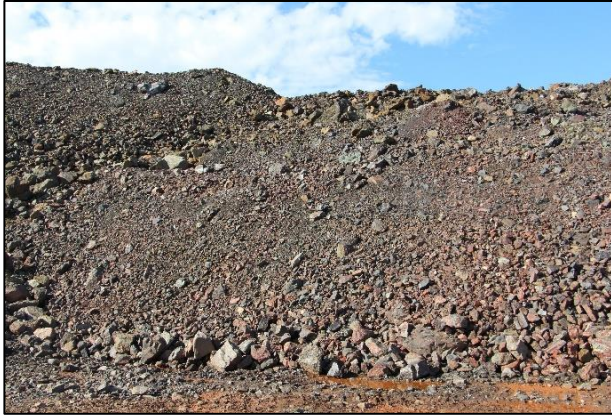
The waste rock storage facility (WRF) is an open area where potentially acid generating rocks are stored ([Photo 3](#)). At the time of the site visit, no apparent environmental issues or concerns were noted at the waste rock stockpiles. No signs of runoff or uncontrolled seepage of potentially contaminated water was observed in the area. NIRB staff were able to see visible improvements in the depth of the settling pond since the overflow in 2017, specifically, new synthetic liners had been laid at the base of the pond to reduce the risk of a leak ([Photo 4](#)). While on site, NIRB staff were also able to observe loaders and equipment actively working on improvements of the pond.

Photo 3: Waste Rock Storage Pile

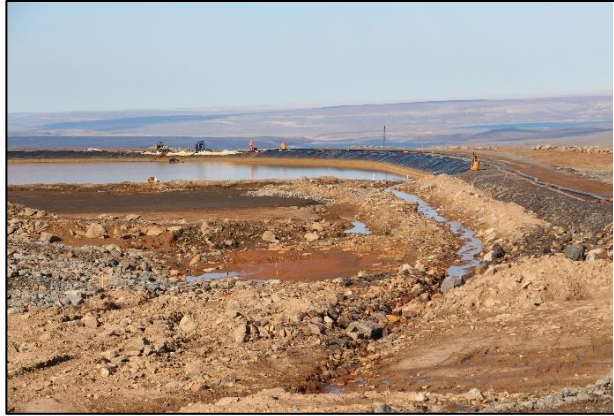
Photo 4: Settling Pond

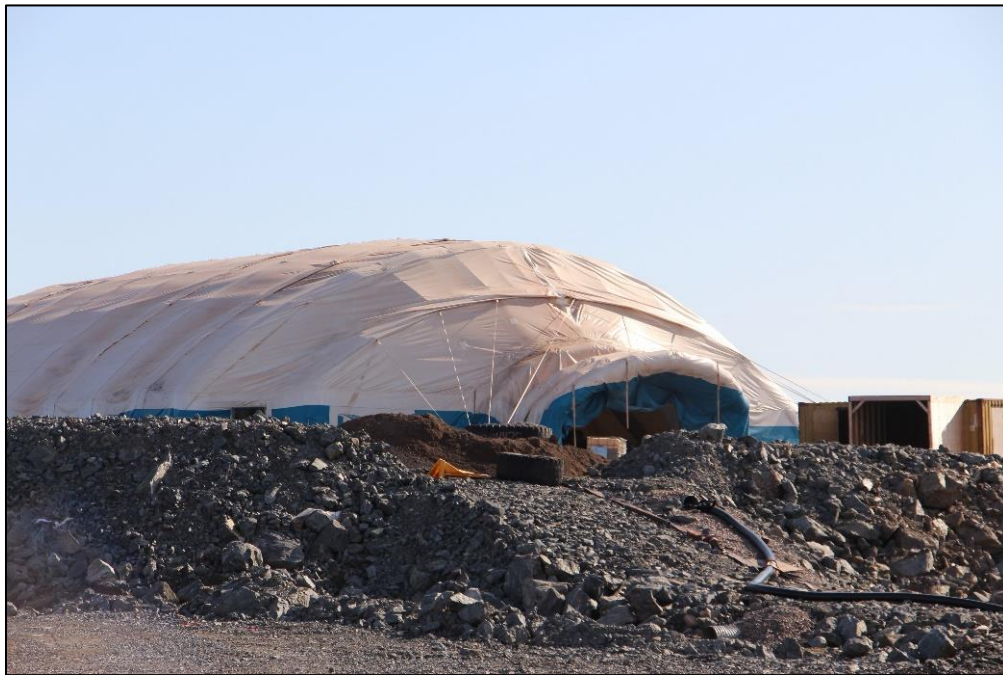
NIRB staff visited the wastewater treatment facility adjacent to the waste rock settling pond (Photo 5) where waste water was collected prior to treatment and discharge as this facility was in full operation. Baffinland staff indicated that the facility was actively treating waste rock effluent through both chemical treatment ([Photo 6](#)) and physical treatment using a bladder system ([Photo 7](#)), before it is released to the tundra. In general, NIRB staff observed that progress was made to address most environmental concerns associated with the waste rock area and the adjacent sedimentation pond.

Photo 5: Waste Rock Water Treatment Facility

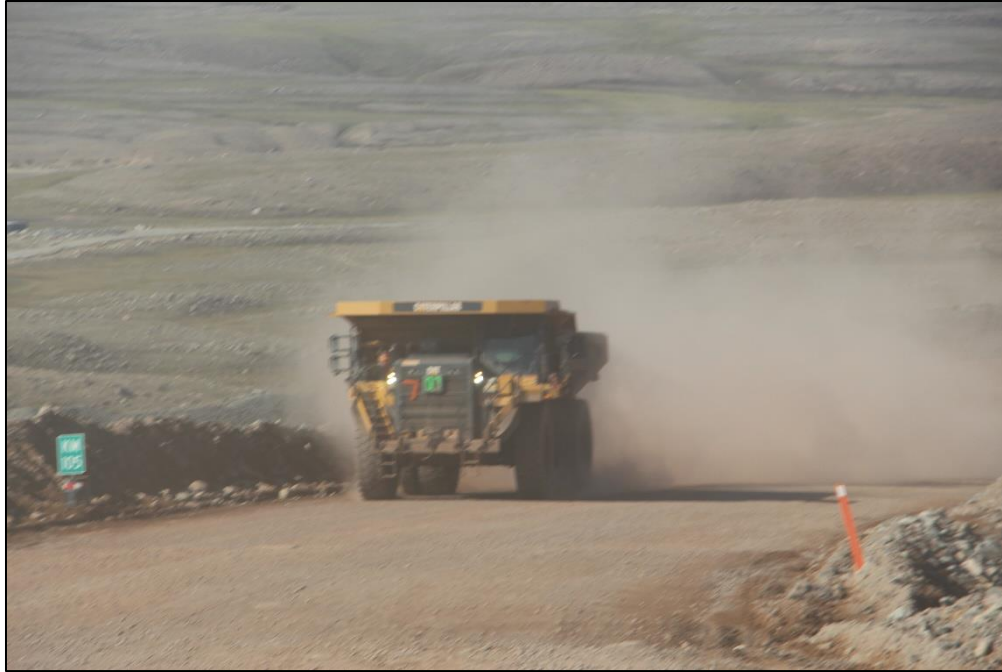
NIRB staff visited the Deposit No.1 pit ([Photo 8](#)) and noted that ore extraction and mining activities were underway ([Photo 9](#)). Heavy trucks, loaders, and drill equipment were observed within the mine pit area as consistent with other site visits. NIRB staff noted that water was pooling within the mine pit ([Photo 8](#) see arrow); Baffinland staff indicated that the water present within the mine pit was acidic and that it was being pumped to the storage pond at the treatment facility. It was observed that while haul trucks were travelling to and from the pit area towards the crusher facility, a large amount of dust was produced by the trucks causing low visibility along the Haul road ([Photo 10](#)).

Photo 10: Dust Plume from Haul Truck along the Haul Road.

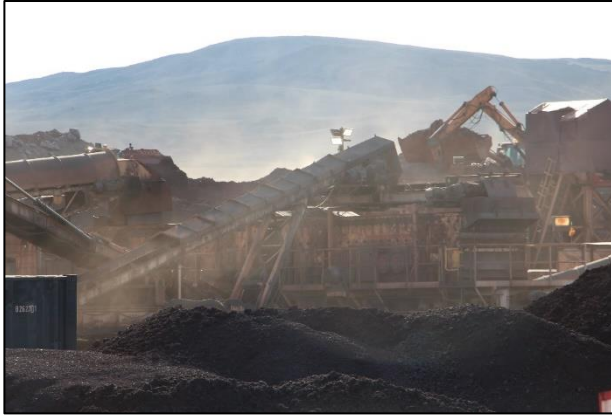
Photo 14: Dust Emissions from the Crusher Facility at the Mine Site

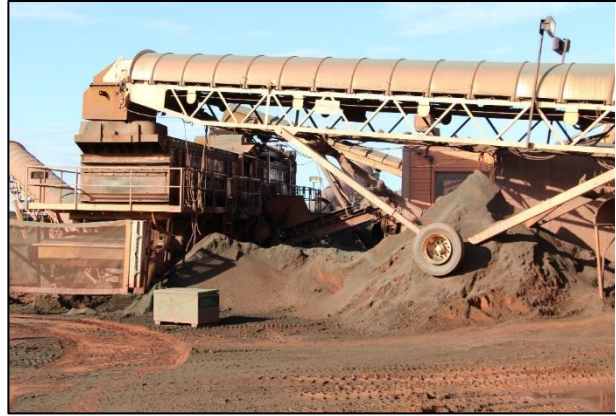
- NIRB staff noticed significant buildup of both lump and fine ore underneath the crusher equipment and discussed with Baffinland the operation of those sites. Baffinland stated that it had a crew responsible to do daily cleanup of ore build up. ([Photo 15](#)).

Photo 15: Fine Ore Build-Up Beneath the Crusher Conveyor Belts

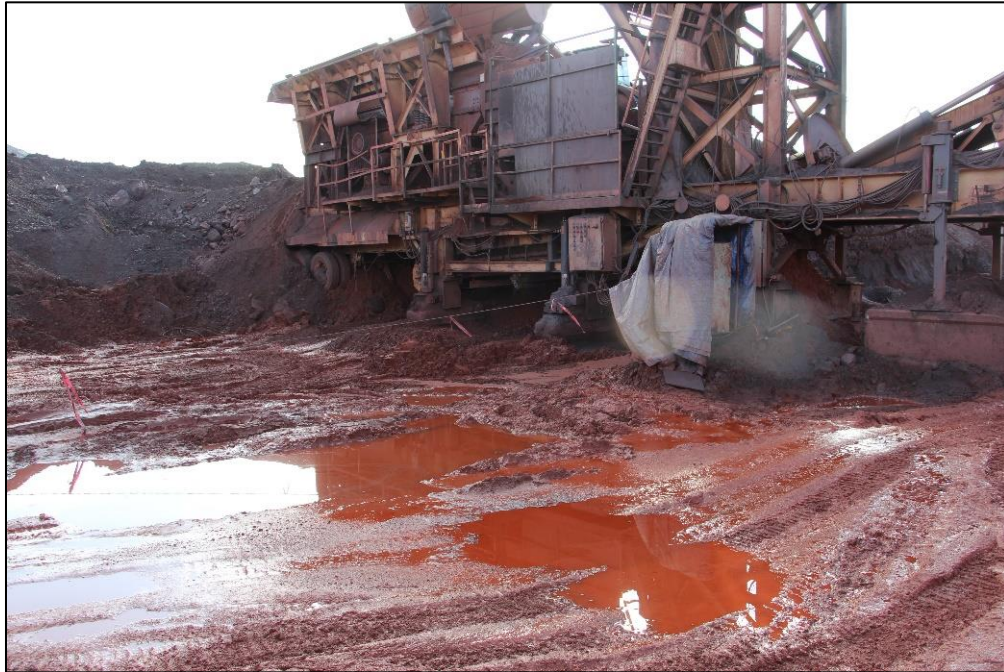
- NIRB staff also noted water pooling issues in various parts of the crusher pad and underneath some equipment ([Photo 16](#)). Baffinland staff noted that the water build-up was due to a recent rainfall and that they would monitor any water pooling on the crusher pad, correcting any grade issues should it become necessary.

Photo 16: Water Collection throughout the Crusher Pad

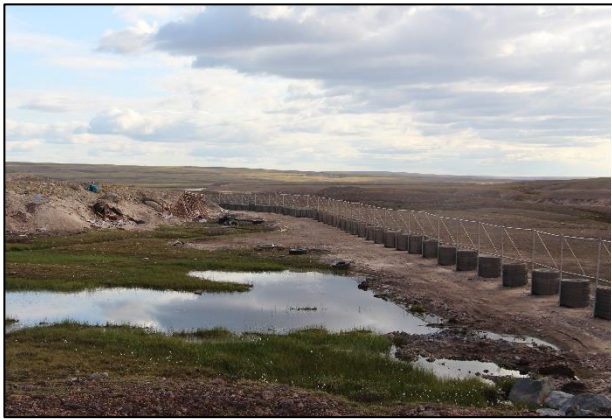
At the time of this site visit, NIRB staff noted that the landfill was still not fully enclosed with proper fencing ([Photo 17](#)) thereby increasing the risk for waste to be dispersed across the tundra. There was only a 300-meter segment of fence installed at the landfill along the Western edge. NIRB staff also observed that the scrap vehicles which had been noted at the landfill in March had

Photo 17: Partial Landfill Fence

During the NIRB's August 2019 site visit, it was again noted that solid waste materials were generally properly contained within the landfill, although the incomplete fencing of the landfill continues to be a recurring issue and this lack of fencing does not meet the requirements of Term and Condition 64 of the amended Project Certificate.

Baffinland staff stated that additional chain-link fencing was being shipped and would arrive during the 2019 sealift; however, fencing would only be used on the north and west sides of the landfill given the prevailing wind conditions. The fence has been partially installed in a 300 metre segment only along the west side of the landfill.

On August 8, 2019 during the site close out meeting, the Monitoring Officers recommended that Baffinland provide updated information on how to address the recurring fencing issues. The Monitoring Officers discussed that the information should include details on Baffinland's progress made to date on the fence, along with a plan outlining dates for when the landfill will be permanently enclosed. Baffinland committed to supplying this information by August 23, 2019. The NIRB received Baffinland's response on August 26, 2019 ([Appendix B](#)) along with information related to other topics discussed during the site visit including dust suppression, Steensby Camp update, Incinerator Building status, Tote Road and effluent line stability, and landfarm update.

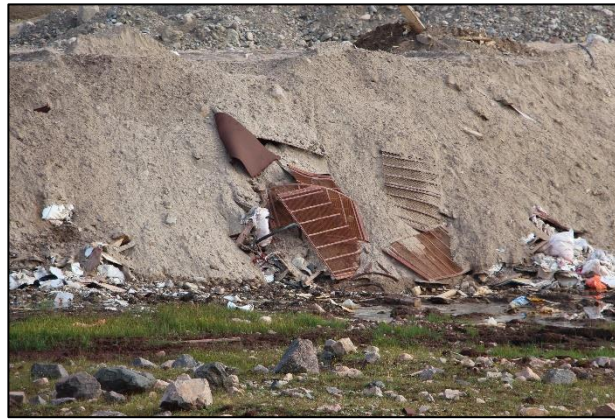
since been removed; however, there was now some scrap metal buried into the landfill and not segregated by material type as detailed in Baffinland's 2018 Waste Management Plan ([Photo 18](#)). During the NIRB's site visit, there were foxes digging through the landfill ([Photo 19](#)), increasing the need for a complete fence around the landfill. NIRB staff was unsatisfied with the level of progress made by Baffinland since 2014 to address the fencing issue at the landfill site and made this known at the close-out meeting. Baffinland committed to fully addressing the landfill issues in a document by August 23, 2019 with their plans.

Photo 18: Scrap Metal Disposed in the Landfill

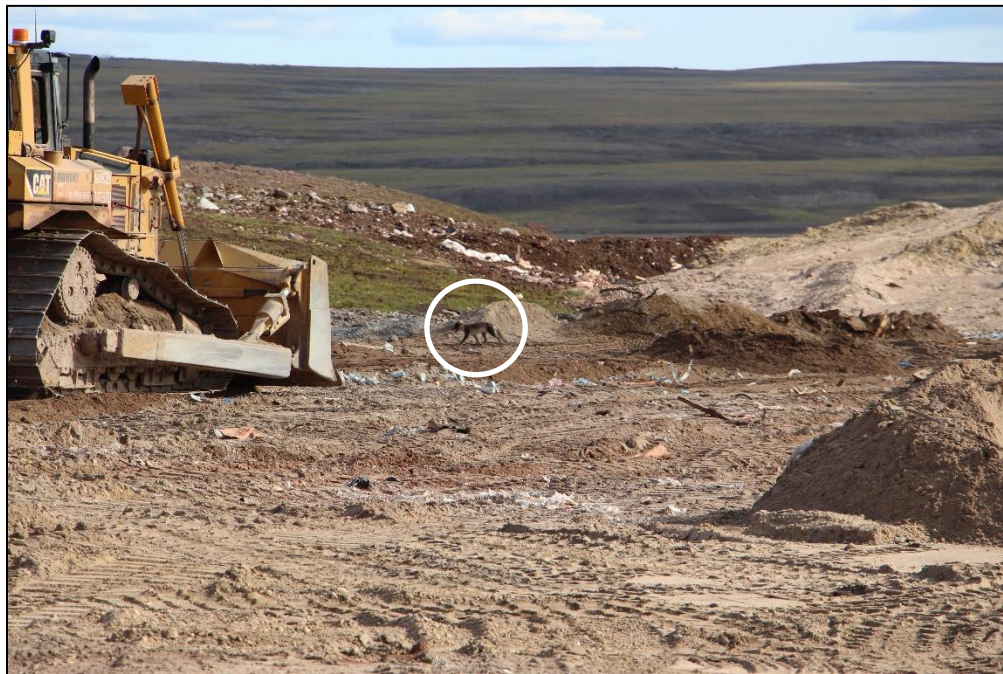
Photo 19: Fox Digging through the Landfill

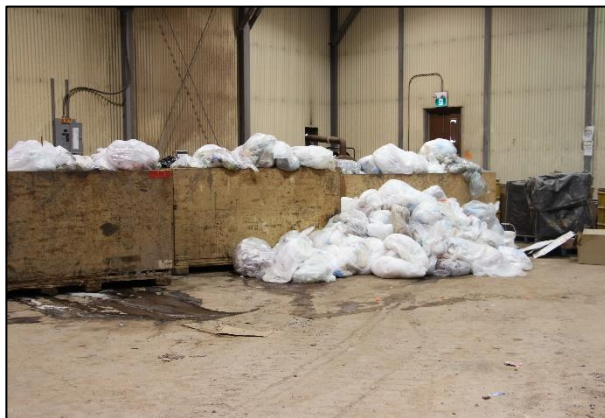
The incinerator facility at the Mary River mine site remains well maintained and most waste materials were observed to be segregated into labelled bins ([Photo 20](#)) for incineration (e.g., food and paper waste) or disposal off site (e.g., batteries, paint, oily rags, kitchen grease). However, the larger waste bins inside the incinerator facility were found to be overflowing ([Photo 21](#)) as the

capacity of bin has been exceeded with no space to accommodate additional waste materials. NIRB staff discussed that Baffinland could correct this issue by adding extra storage bins.

Photo 21: Overflowed Waste Storage Bin

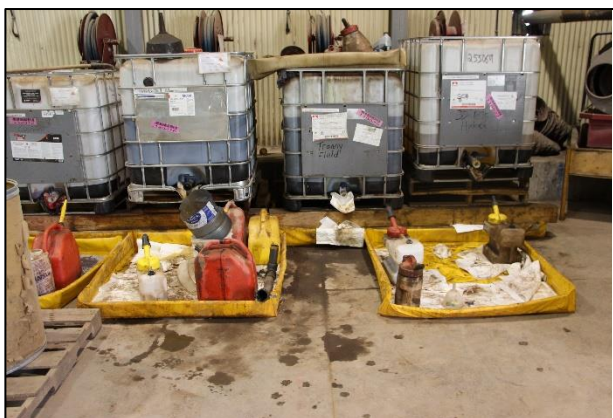
It was also noted by NIRB staff that the vehicle fluid storage needed to be improved and better organized to eliminate clutter around the filling station ([Photo 22](#)). Additionally, NIRB staff observed that these engine fluids were being stored immediately adjacent to a frost fighter heater ([Photo 23](#)), which could potentially pose a fire hazard.

Photo 22: Engine Fluid Filling Station

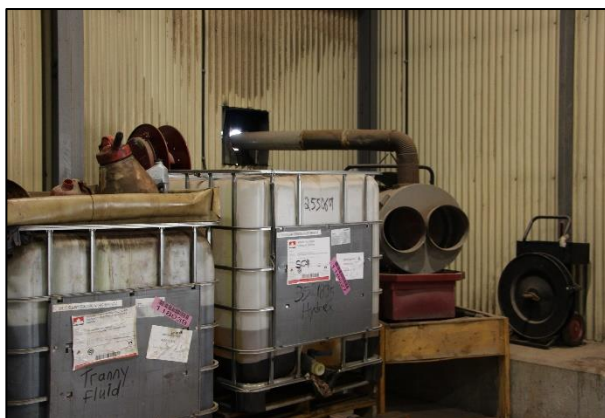
Photo 23: Engine Fluid Storage adjacent to Heater

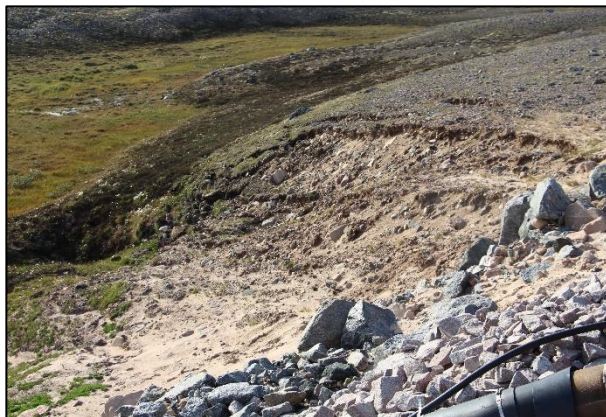
During the site visit, NIRB staff noted that the terrain around one of the discharge pipes was rip-rapped and stable ([Photo 24](#)), while there remained some erosion issues around the second pipe; possibly caused by permafrost decay around the sewage discharge pipe ([Photo 25](#)).

During the site visit, Baffinland noted that Tetrattech Engineering had been contracted to evaluate erosion issues across the entire project development area. It was noted by Baffinland that installation of rip-rap is an ongoing activity across the site based on the recommendations of the engineers. Tetrattech has stated that the terrain stability issues near the sewage outfall area were

not of immediate concern and that that it was likely a natural occurrence; however, Baffinland committed to continued monitoring the location for future improvements if necessary.

Photo 25: Unstable Terrain around the Sewage Discharge Pipe

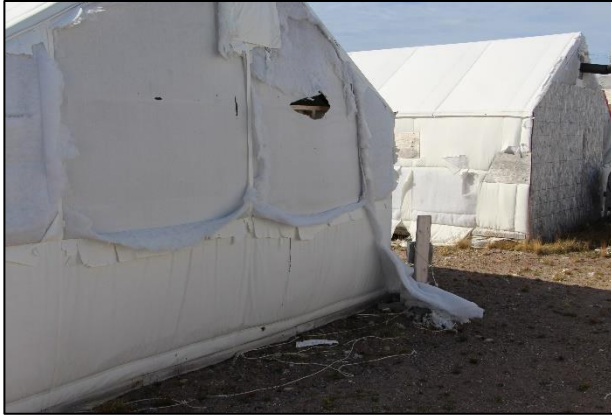
While on site, NIRB staff visited Steensby Inlet Camp ([Photo 26](#)) to observe any changes that have occurred since the last visit there in 2016. The camp located at Steensby Inlet is largely decommissioned and is solely being used as a fuel cache for the current monitoring programs and Ege Bay exploration activities by Baffinland (NIRB File No.18EN026). During the current site visit NIRB staff observed that several seacans had been removed since the last visit ([Photo 27](#)); however, the buildings on site were heavily deteriorating causing debris to be blown across the tundra ([Photo 28](#) and [Photo 29](#)). There also appeared to be chemicals and garbage bags left in Weatherhavens and/or seacans which can pose a risk to wildlife.

Photo 28: Deteriorated Steensby Camp Buildings

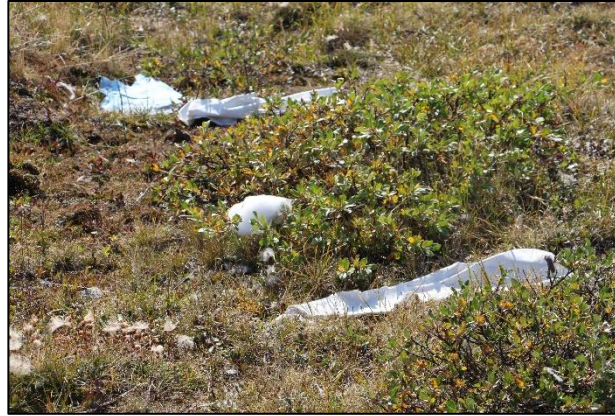
Photo 29: Debris Blown onto the Tundra

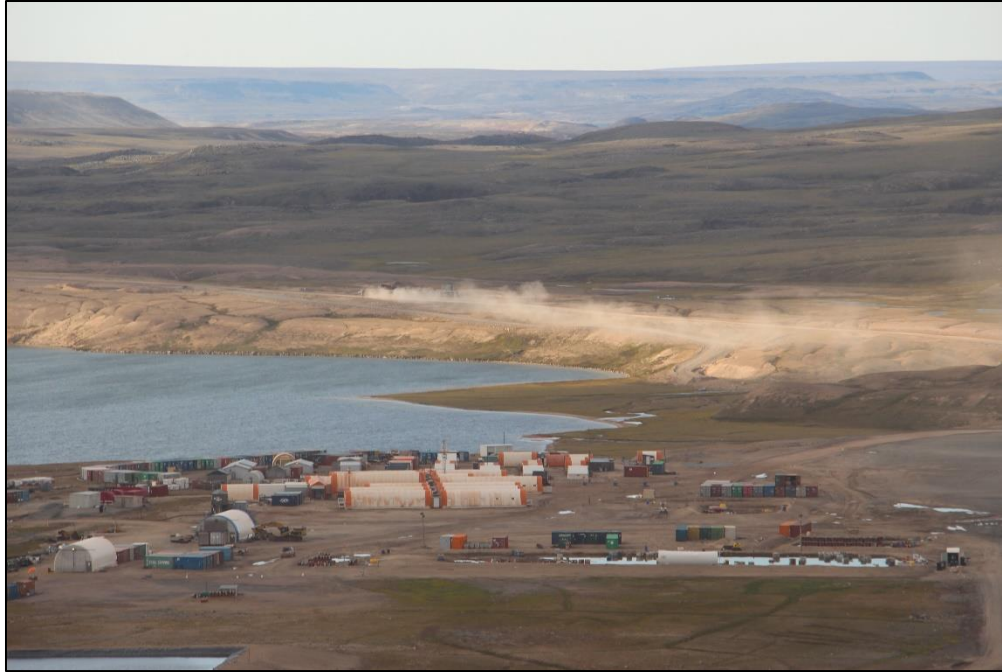
During the drive along the Tote Road NIRB staff noticed dust plumes at certain points causing low visibility on the road ([Photo 30](#)). Further, NIRB staff observed some minor erosion concerns ([Photo 31](#)), it was recommended that the Proponent use rip-rap to improve terrain stability at those locations. The Proponent indicated that Tetra Tech Engineering (Tetra Tech) was contracted to monitor and/or assist with actions to reduce erosion along the Tote Road and that installation of rip-rap is a regularly performed maintenance activity. Baffinland also committed to continued monitoring along the road for future improvements if necessary.

Photo 30: Dust Plume along the Tote Road

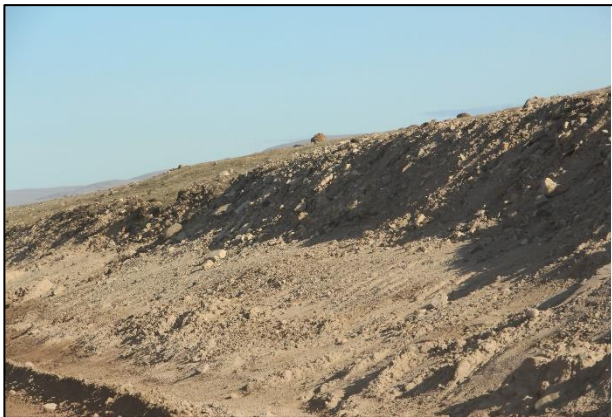
Photo 31: Erosion along the Tote Road

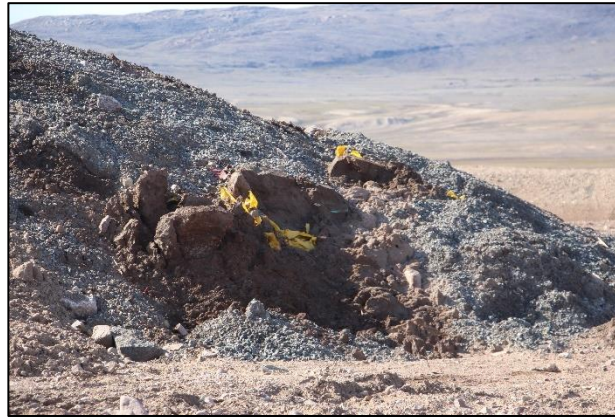
NIRB staff visited the landfarm facility in order to follow-up with progress made to the facility in accordance with best practices and past Board Recommendations. Baffinland has made significant improvements at the landfarm facility. Tilling has begun in the 2019 season and most synthetic liners have been removed ([Photo 33](#)); however, there is still progress to be made towards completing the cleanup of smaller pieces of entrenched liners ([Photo 34](#)).

Photo 34: Few Remaining Synthetic Liners in the Landfarm

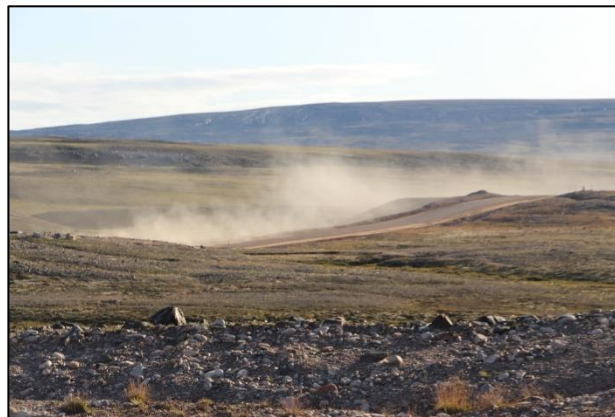
Dust emissions have been an ongoing issue at the Mary River site since 2014 and efforts have been made to lower the amount of dust being generated (e.g., shrouds at the crusher) but success has been limited, especially with regards to the Tote Road and Haul road towards deposit No. 1 and the ore stock pile area at Milne Inlet ([Photo 45](#)). The NIRB staff recognizes the efforts made by Baffinland to improve the concerns regarding dust on site; however, there is still improvements to be made regarding dust management.

Photo 45: Dust Generated along the Tote Road from Vehicle Traffic

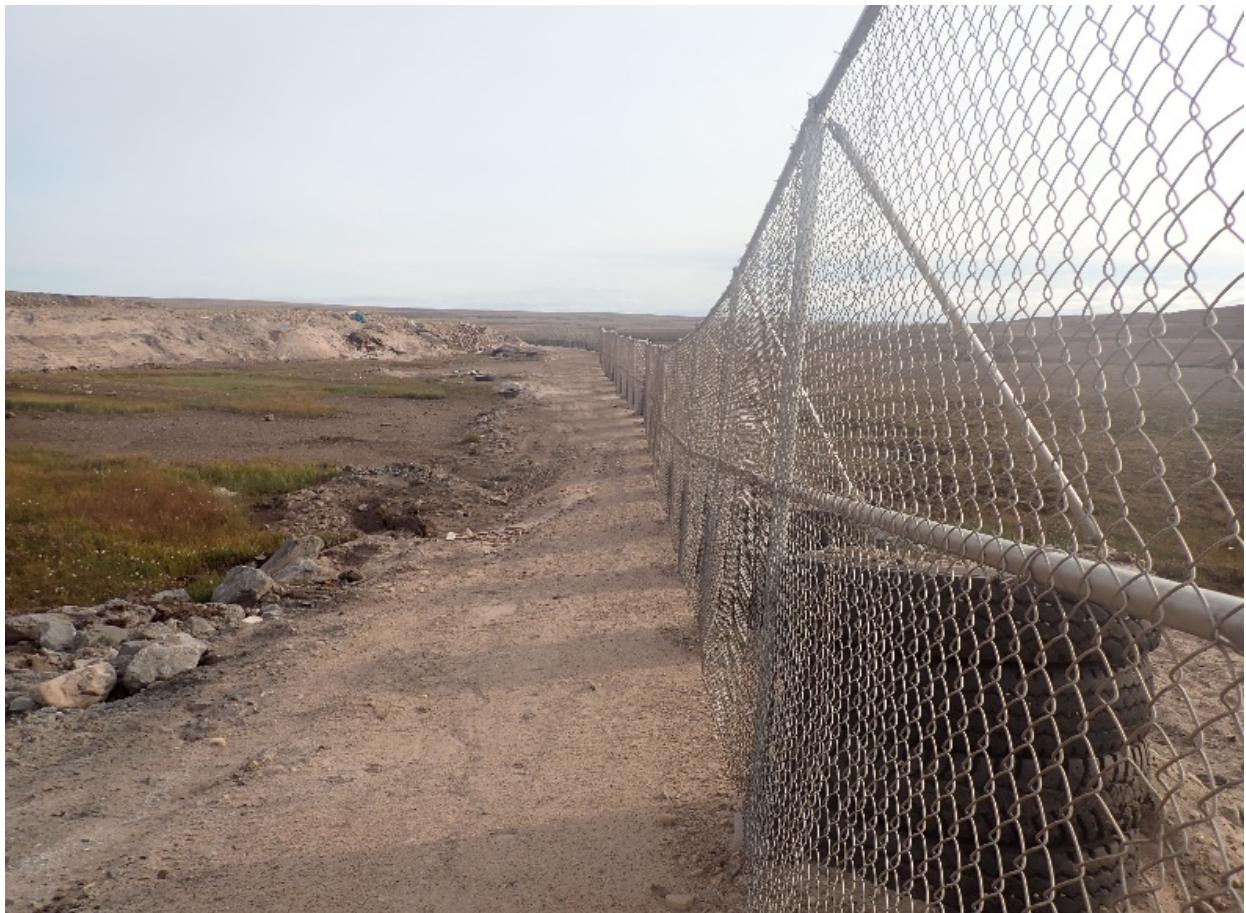
PHOTO 9 – Existing Fencing at Landfill
