2016-2017 Annual Monitoring Report for Baffinland Iron Mines Corp.'s Mary River Project

Report title: The Nunavut Impact Review Board's 2016-2017 Annual Monitoring Report for the Mary River Project (NIRB File No. 08MN053)

Project: Mary River Project

Monitoring Period: September 2016 – September 2017

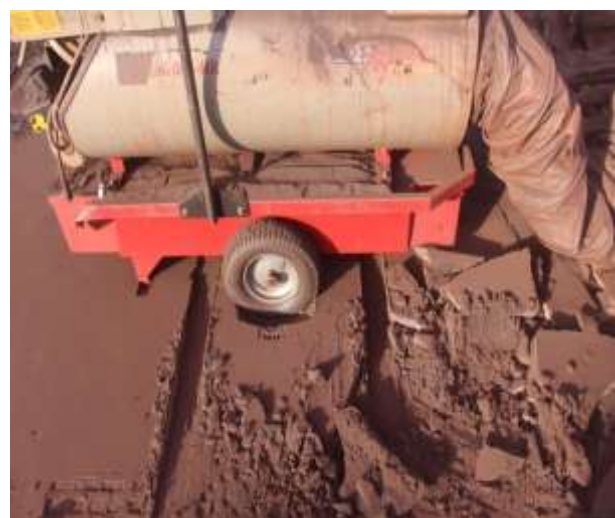
Picture 4: Dust accumulation on soil near crusher

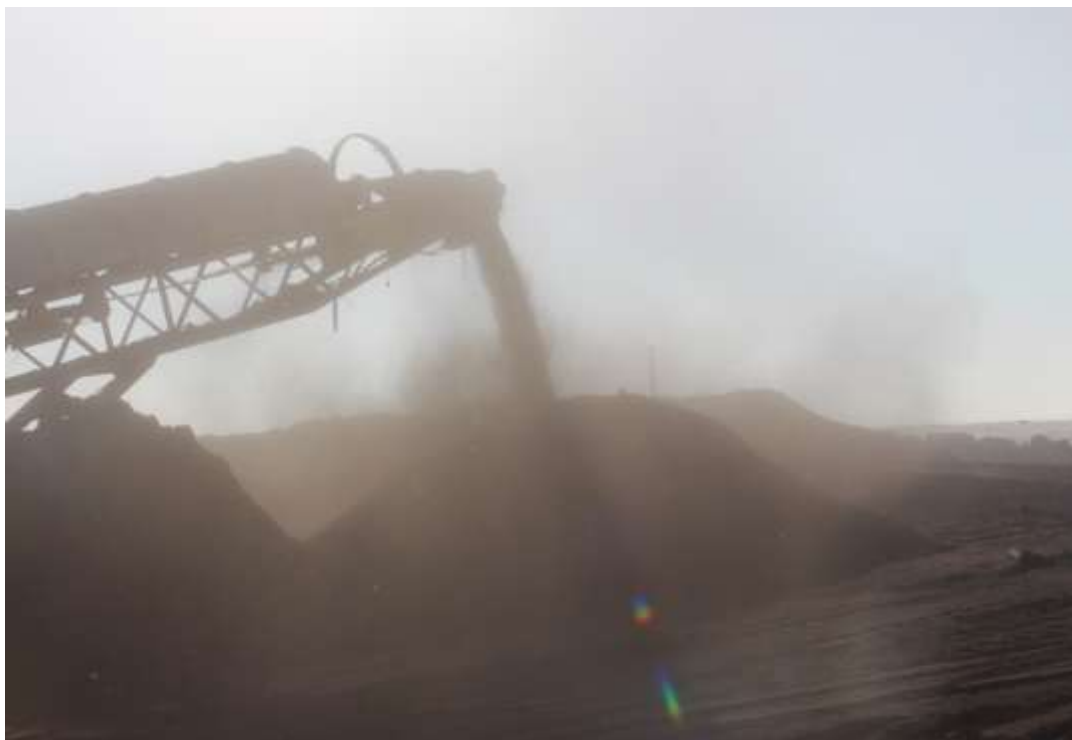
Picture 6: Dust emissions from crusher plant

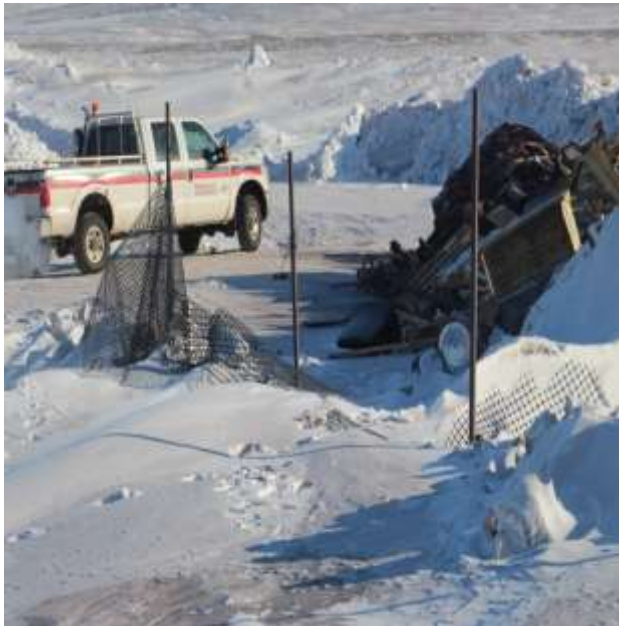
NIRB staff also viewed the landfill site in order to follow-up on the recurring issues noted during previous site observations pertaining to the deterioration of the landfill litter fences. The Monitoring Officer also followed-up on Baffinland's progress towards implementing best management practices regarding proper landfill operations, and the NIRB's Recommendation 18 regarding maintenance of the fencing system to ensure that waste materials are not dispersed offsite. During the March site visit, it was noted that most of the protective mesh around the landfill footprint was completely removed from the supporting poles similar to previous site observations ([Pictures 12, 14, and 15](#)). The Monitoring Officer further noted that the wooden fences utilized at the site did not fully enclose the landfill footprint, thereby increasing the risk for offsite waste dispersion ([Picture 13](#)).

Picture 12: No litter fencing in some areas of landfill

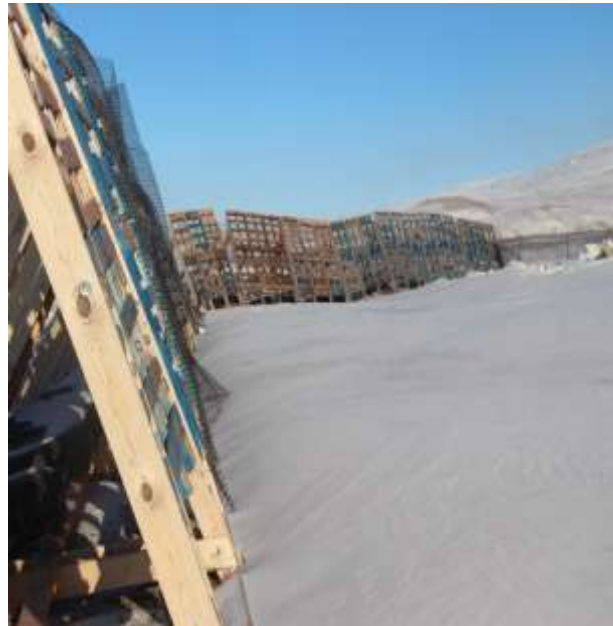
Picture 13: Wooden fencing in landfill

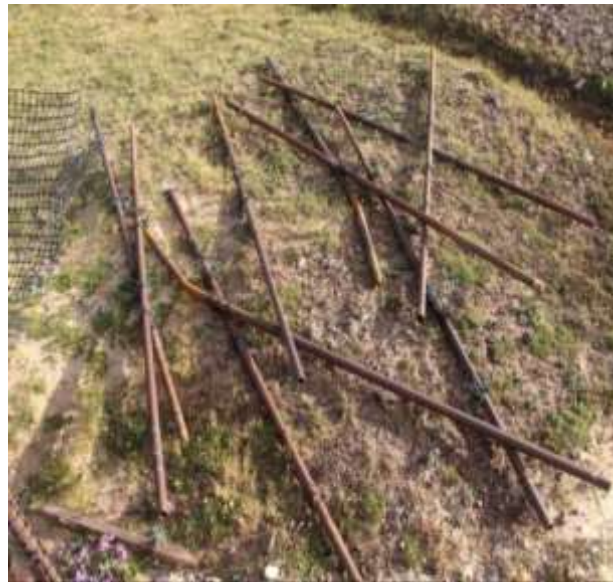
Picture 15: Damaged poles (2016 observation)

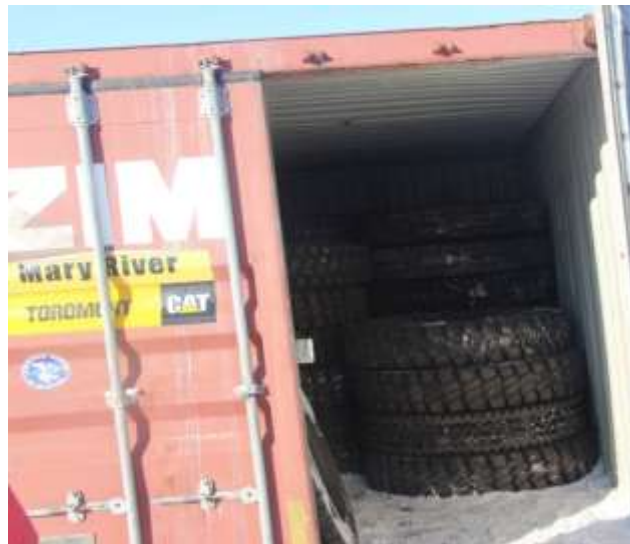
Based on the 2016 site observations and the 2017 March site visit, the Monitoring Officer noted that the incinerator in use at the Mine site continue to remain well maintained except for the minor pooling of drainage water within the incinerator facility ([Pictures 16 and 17](#)). The NIRB's 2016 Recommendation 21 specifically requested that Baffinland take immediate steps to remove unused scrap materials, tires and synthetic materials currently stored temporarily at various Project locations, including around the immediate vicinity of the incinerator facility in order to improve the visual quality of the site. During this site visit, the Monitoring Officer observed the ongoing effort of Baffinland staff in relocating most of the historical tires into seacans for offsite disposal ([Picture 18](#)).

Picture 18: Historical tire removal into a seacan

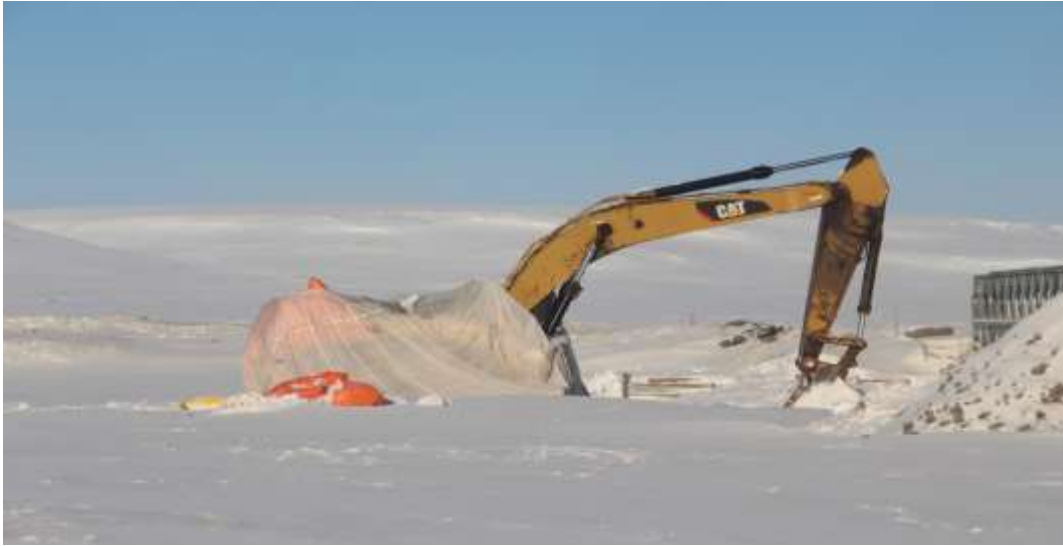
Picture 19: Excavator on frozen lake at Km 80 bridge

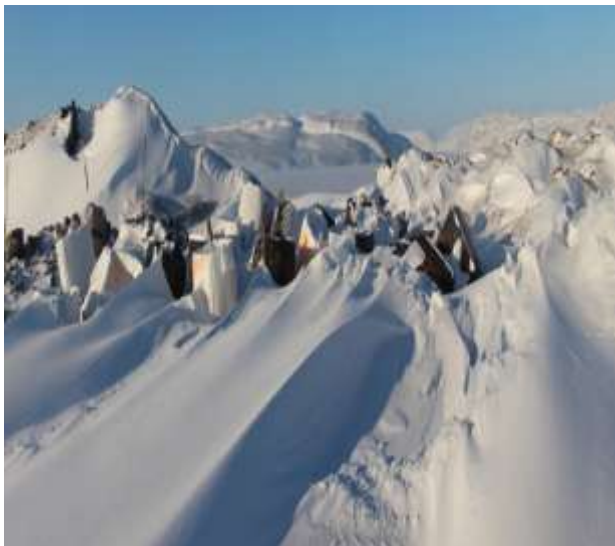
Since 2014, the Monitoring Officer consistently reported on the deteriorating condition of the landfarm facility, and has raised concerns that the disposal synthetic liners, contaminated snow and soils have not been properly managed in accordance with industry best practices. Even though snow covered the area, NIRB Staff observed similar conditions to those noted in 2015 and 2016 where synthetic liners were mixed in with contaminated snow, and disposal of waste batteries including disposal of unused tires was occurring near the landfarm. The NIRB's 2016 Recommendation 20 specifically requested that Baffinland implement best practices for landfarm operations, including for management of contaminated snow, waste synthetic liners, including used tires ([Pictures 22, 23, 24, and 25](#)). Further observations would be made by the Monitoring Officer during the summer site visit to confirm items and make any suggestions if required.

Picture 22: Landfarm area with synthetic liners

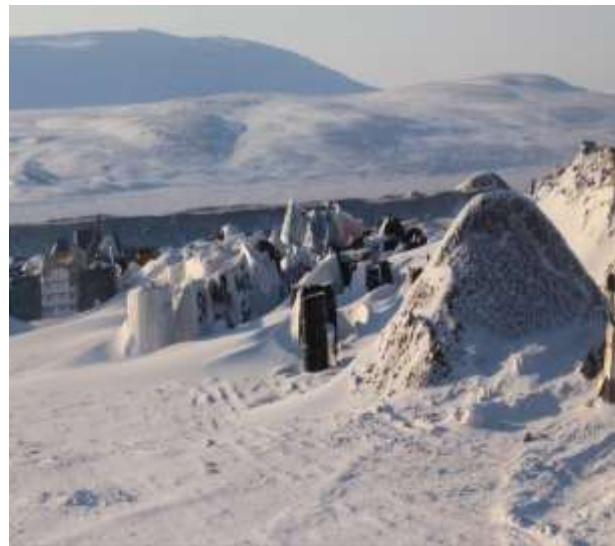
Picture 23: Landfarm area with waste materials

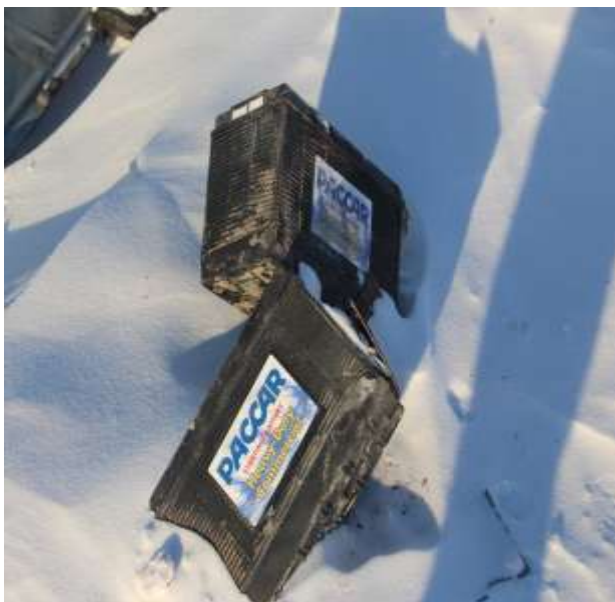
Picture 24: Waste batteries within landfarm footprint

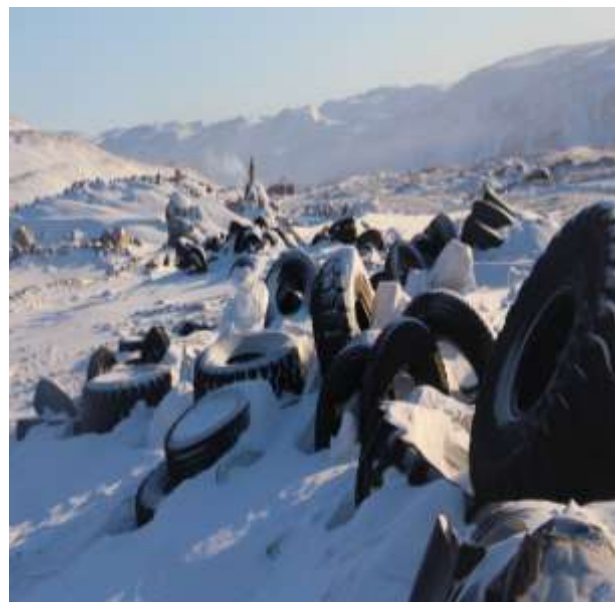
Picture 25: Waste tires near landfarm area

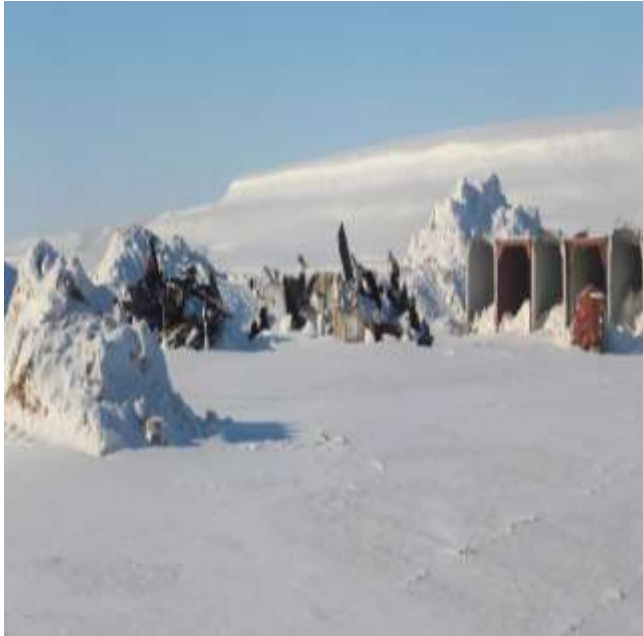
The Monitoring Officer observed that many areas within and surrounding the PDA, including the Mine site and Milne Inlet, would require additional waste management actions due to the increasing accumulation of scrap materials and unused items such as tires, steel pipes, wooden materials, and drums without proper waste management strategy ([Pictures 26, 27, and 28](#)).

Picture 26: scrap materials near Km 80 bridge

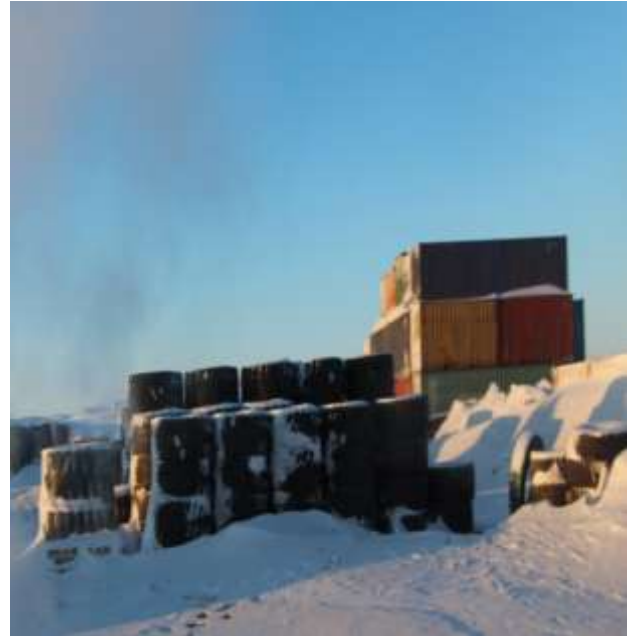
Picture 27: waste tires and seacans in Milne Inlet

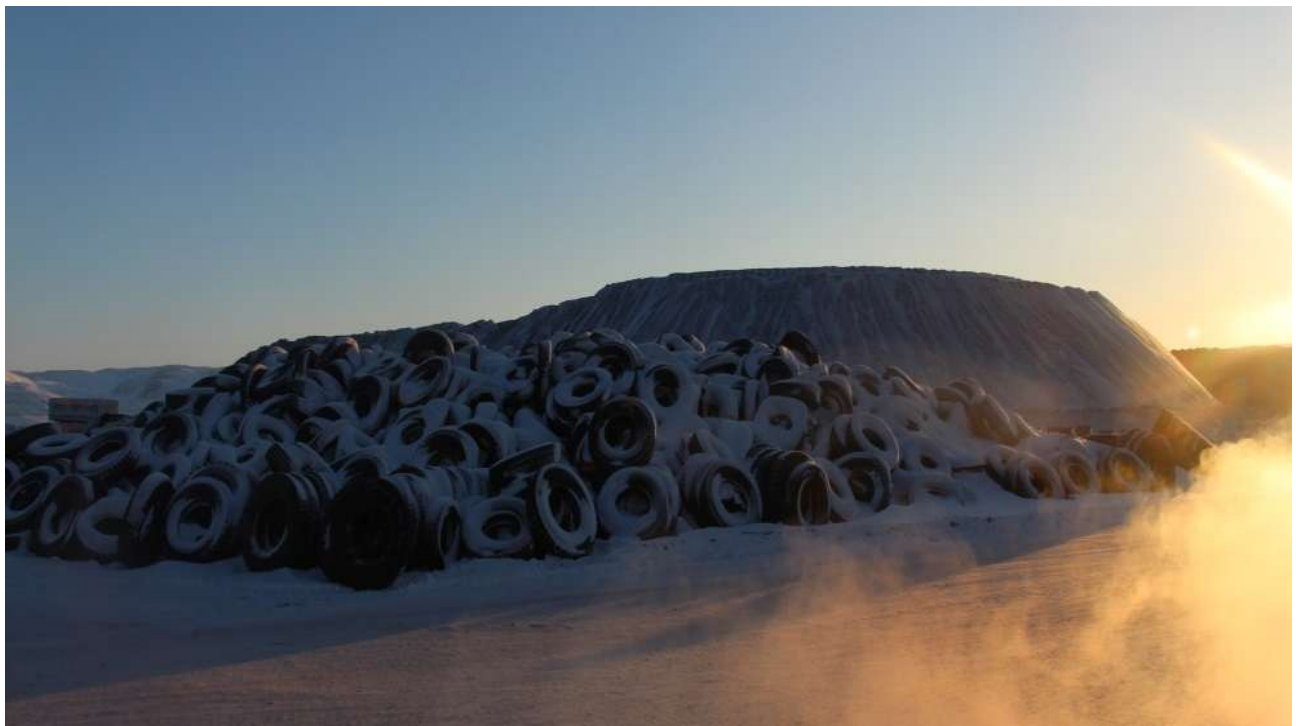
Picture 28: Piles of waste tires around ore stockpiles in Milne Inlet

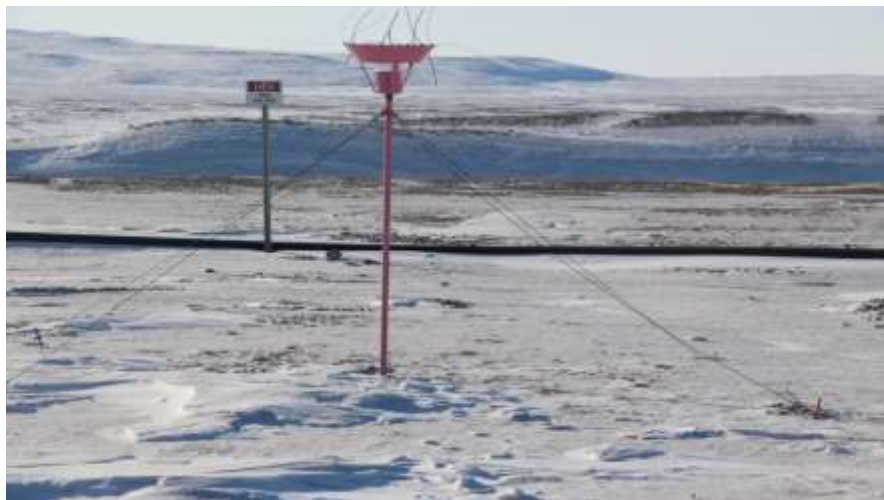
During the drive along the Tote Road, the Monitoring Officer observed the increased generation of dust plumes and widespread discolouration of snow areas, which was apparent in high traffic locations. As it is difficult to manage dust in the winter, NIRB Staff inquired about snow and ice management practices associated with winter dust control. While at Milne Inlet, the Monitoring Officer followed up on the previous 2015 observation of dust accumulation on sea ice; but at the time of the current site visit, no evidence of dust deposition or accumulation was noted on sea ice ([Pictures 31](#) and [32](#)). Dust fall stations were observed along the Milne Inlet Tote Road, which can be noted as being in compliance to part c of Condition 10 ([Picture 30](#)).

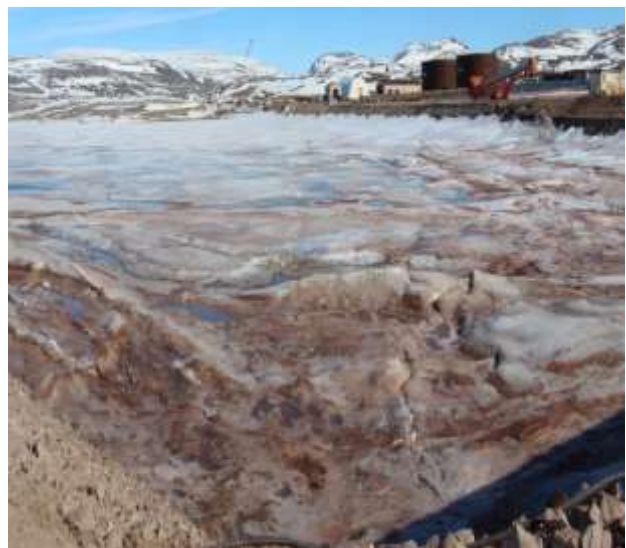
Picture 32: Dust deposition on sea ice (2015)

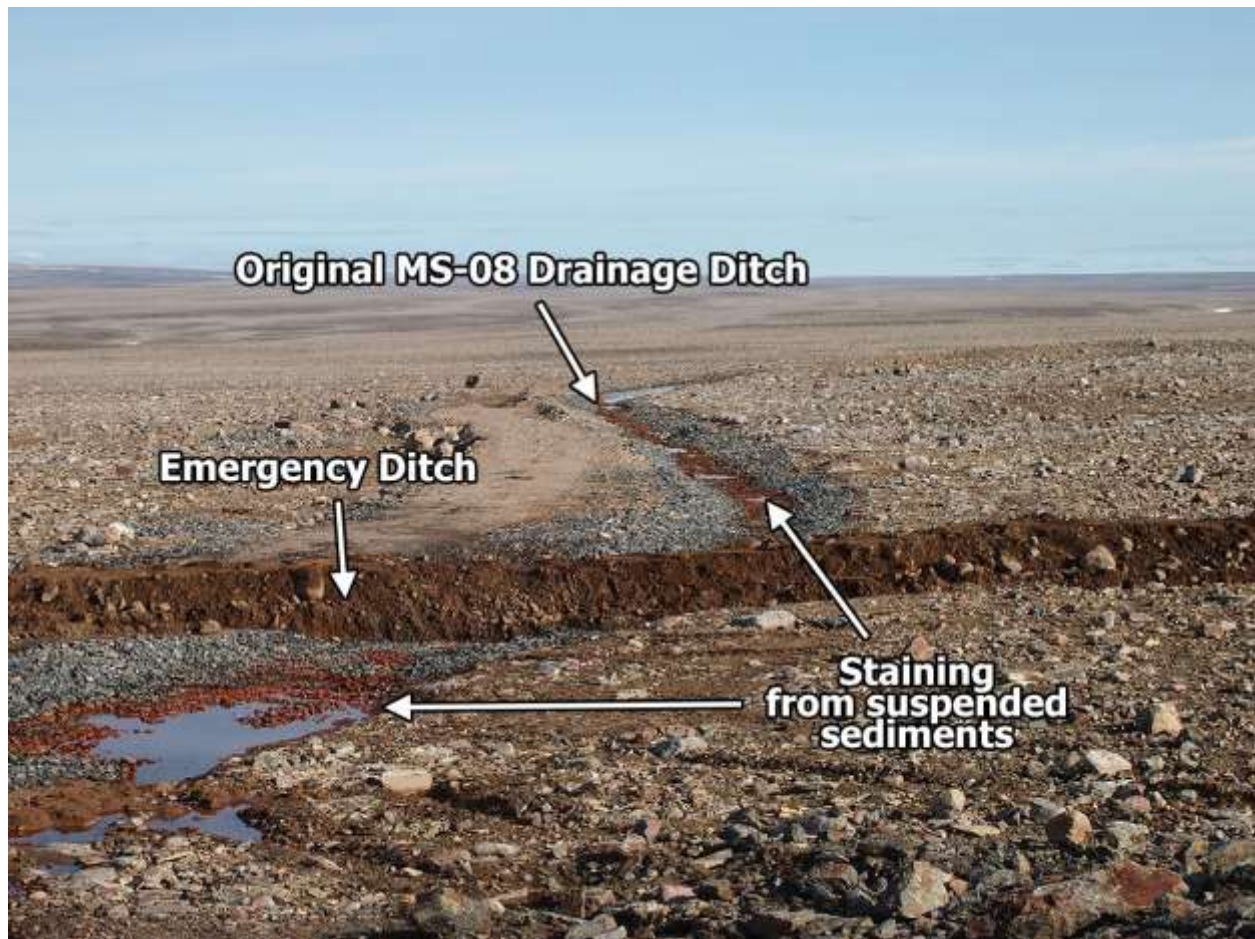
In the March 2017 site visit, the area of the ditch and sedimentation pond (MS-08) was covered in snow preventing close examination. Prior to the August 2017 site visit, MS-08 had been the subject of concern as per the Qikiqtani Inuit Association and Environment and Climate Change Canada inspections as not being adequate to contain contact water. Therefore, Baffinland had constructed emergency ditches to contain the seepage/overflow and intercept water not being diverted into MS-08 ([Picture 11](#)). In the August 2017 site visit it was noted that there were structural deficiencies in the pond design which would cause the pond to overflow, and that two (2) pumps were in place (but not operational) to pump excess water out of the pond. ([Picture 12](#)).

Picture 11: MS-08 Emergency Ditch

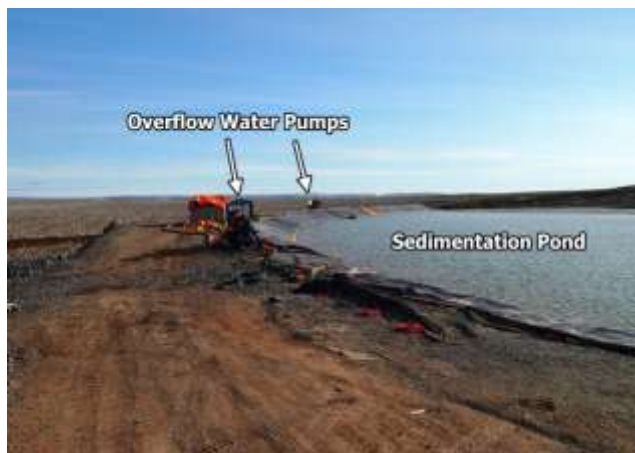
Picture 12: MS-08 Pumps

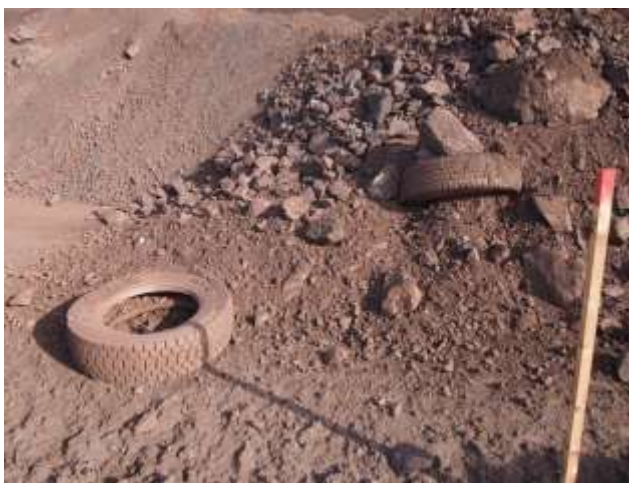
During the tour of the crusher pad sedimentation pond (MS-06), it was observed that tires and wooden stakes were embedded in the material of the crusher pad ([Picture 17](#) and [18](#)). From discussion with Baffinland staff on the issue, the source of the embedded debris were from the tires and stakes previously used to mark the edges of the pad and road that were not removed before earthmoving operations to expand the pad were conducted which resulted in their entrenchment.

Picture 17: Tires embedded in overburden

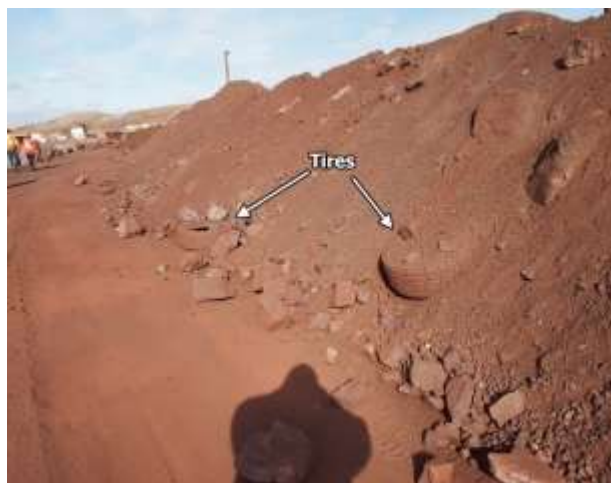
Picture 18: Tires embedded in overburden

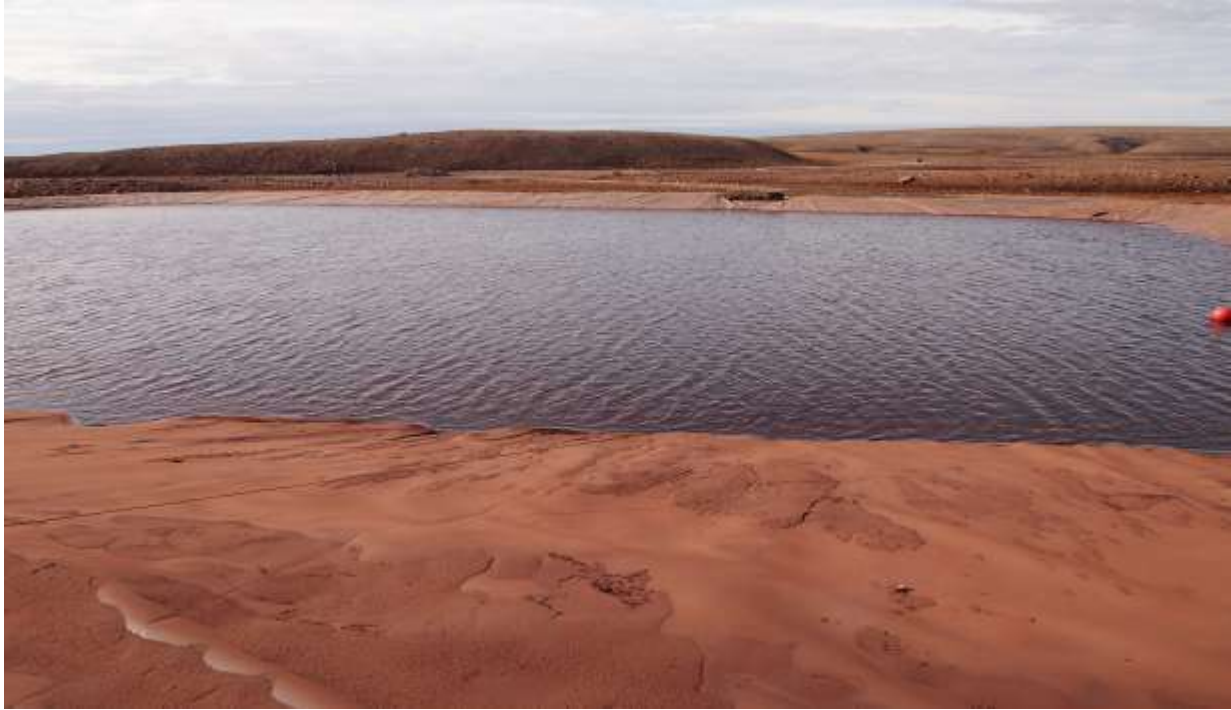
Observation of the MS-06 sedimentation pond indicated the pond had been filled to capacity, as had been reported by Baffinland, and was of insufficient size to contain the amount of runoff required ([Picture 19](#)). Further, it was observed that the ditch used to intercept runoff and direct it to the MS-06 sedimentation pond had no lining or other erosion control measures to maintain it, and that sections of the pad were eroding into the ditch ([Picture 20](#)). Some portions of the ditches were becoming blocked due to the expansion of the pad having pushed material into the ditch as well as the deposition of material carried off the pad due to erosion ([Picture 21](#)).

Picture 19: MS-06 Sedimentation Pond

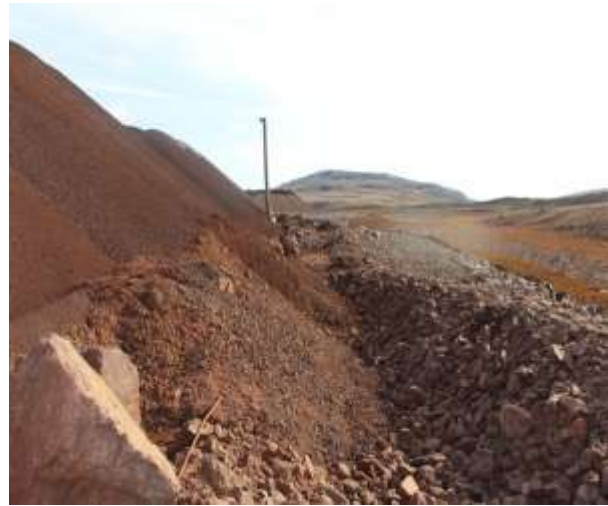
Picture 21: Ore pad expansion blocking drainage

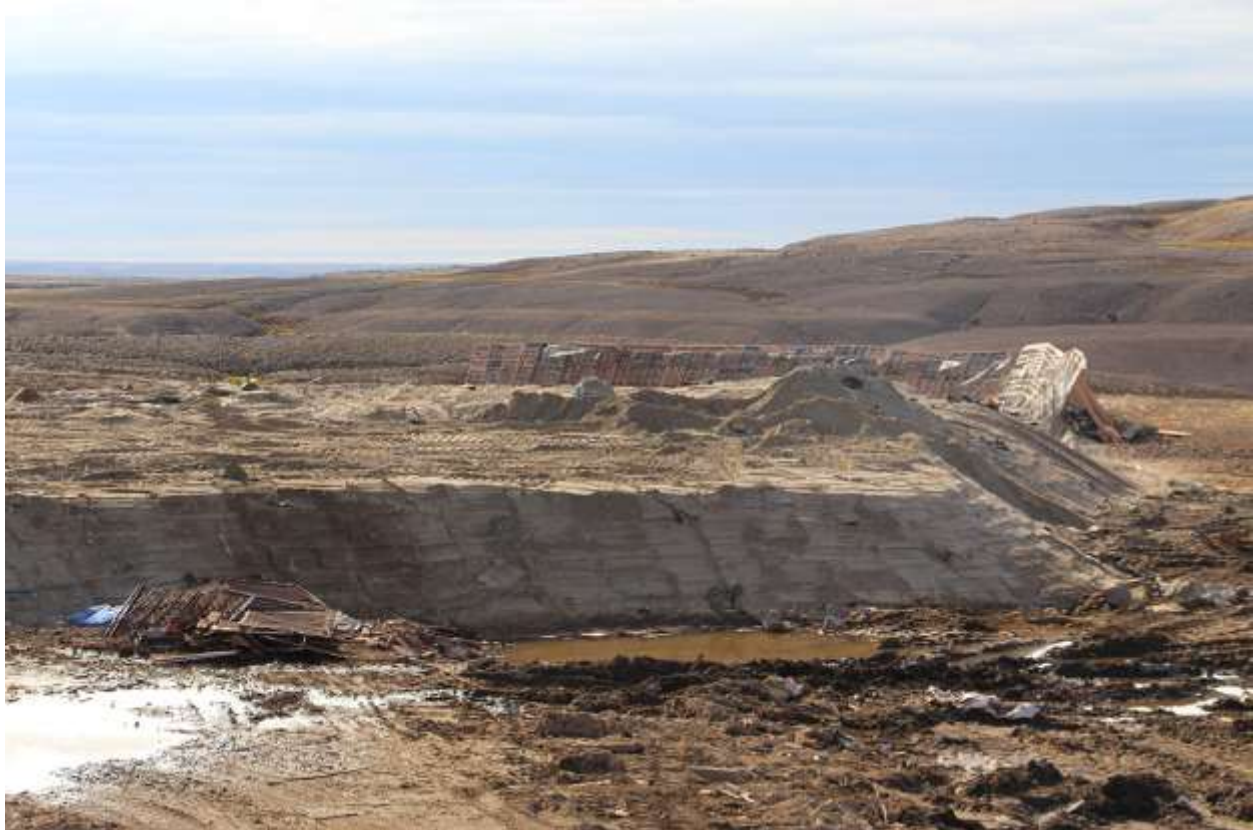
Picture 24: Landfill wooden fence

Baffinland indicated that the landfill had begun a second lift and noted its intent to request an expansion of the landfill site. As in previous site visits, the Monitoring Officer noted to Baffinland staff the continuing concern of the NIRB regarding the lack of appropriate fencing.

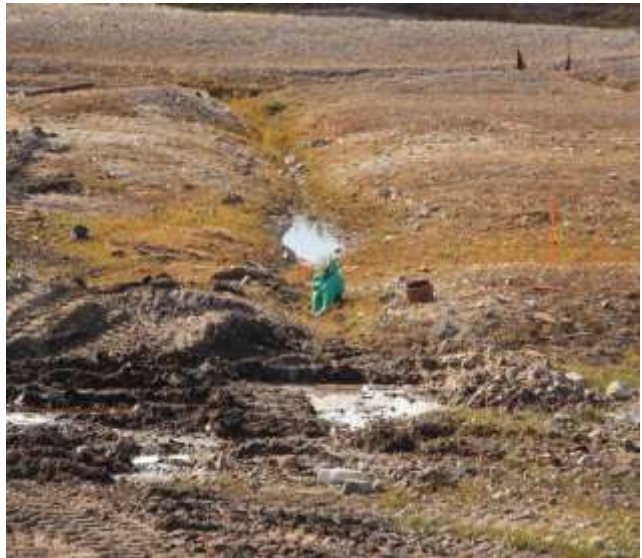
Picture 26: Refuse outside landfill

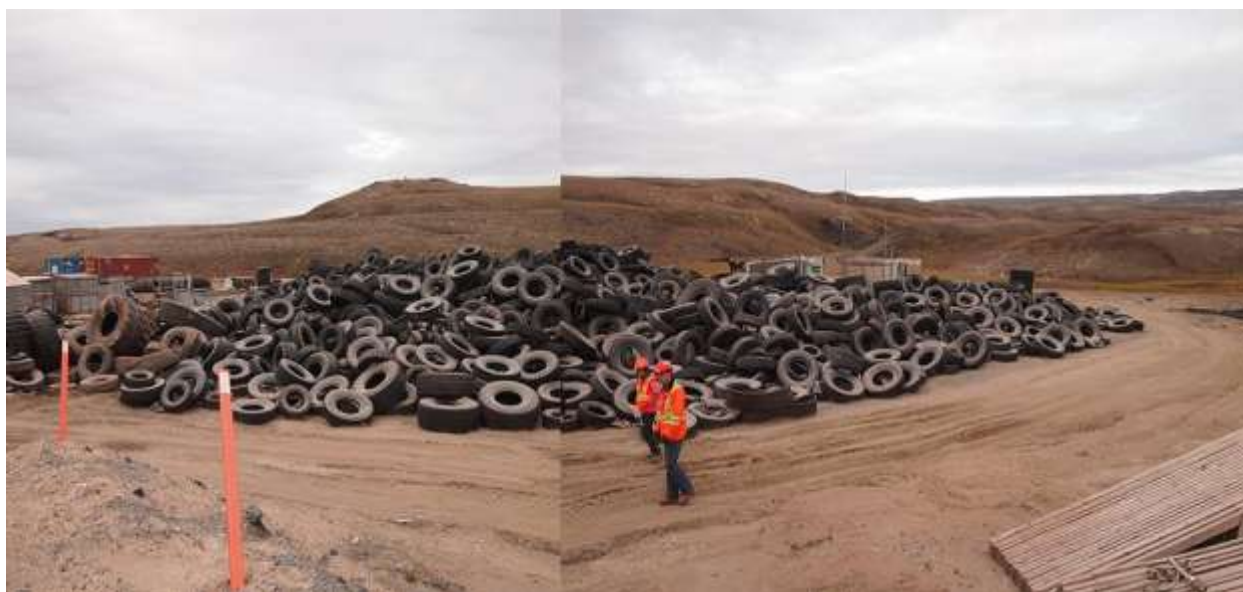
Based on the previous 2016 site observations and the most recent 2017 site visit, the Monitoring Officer noted that the incinerator in use at the Mine site ([Picture 27](#)) continues to remain well maintained. The NIRB's 2016 Recommendation 21 specifically requested that Baffinland take immediate steps to remove unused scrap materials, tires and synthetic materials currently stored temporarily at various Project locations, including around the immediate vicinity of the incinerator facility, in order to improve the visual quality of the site. During the August 2017 visit, it was noted that while the area around the incinerator showed improvement in the cleanup of scrap and synthetic materials, the large pile of scrap tires remained adjacent to the incinerator. ([Picture 29](#)). It was noted that aside from the visual issue, a single large mass of tires represented the potential for causing serious and difficult to control fire should the tires to ignite. Baffinland staff stated the same concern had been raised by the Mine Rescue Team who would be responsible to responding to such an incident.

Picture 29: Scrap tire pile at Mary River Incinerator (composite image)

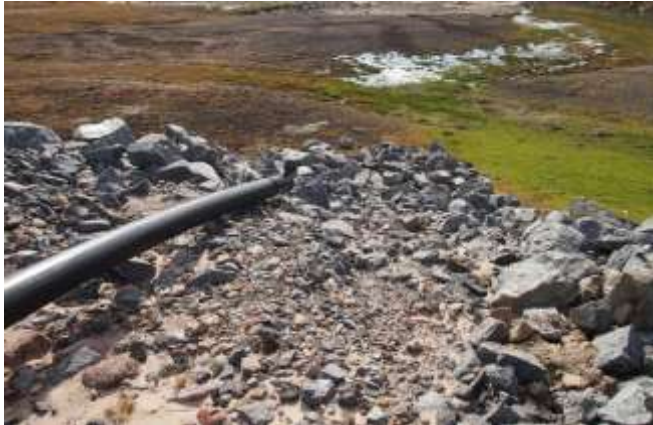
While the measures in place to reduce erosion at the effluent discharge appeared to be functioning as intended ([Picture 30](#)), it was noted in the 2016 site visit that the ground to the side of one (1) of the sewage lines was in the process of slumping due to erosion and lack of riprapping. ([Picture 31](#)). This issue remained apparent in the August 2017 site visit and had not been addressed. Visual investigation indicated that the slumping appeared to be natural and not associated with Baffinland's operations. It was suggested that Baffinland monitor the progress of the slump, if it was not already doing so, in able to monitor the progression and respond appropriately if issues should arise.

Picture 30: Effluent Discharge

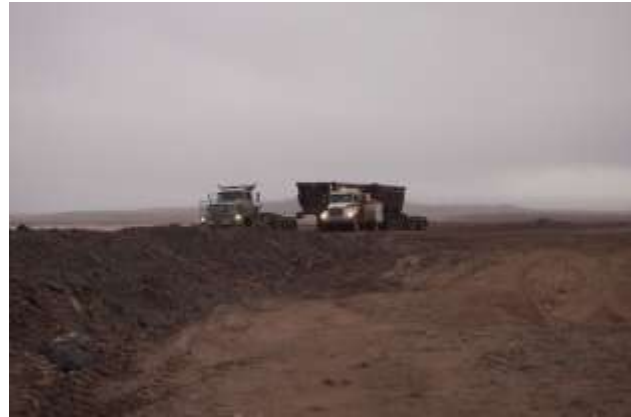
Picture 35: Repairs to B-Train on the Tote Road

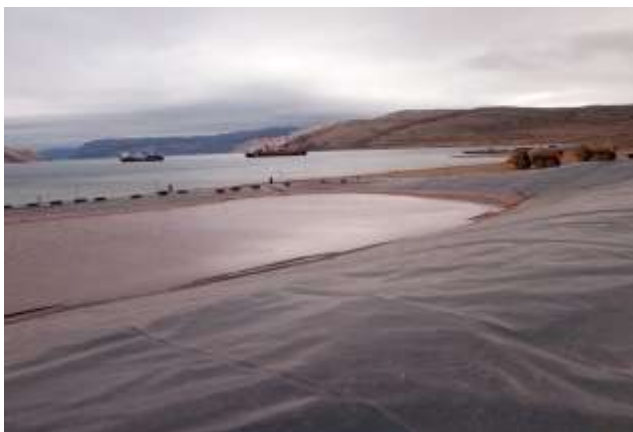
The sedimentation ponds located on the east ([Picture 38](#)) and west sides ([Picture 39](#)) of the ore stockpile pads were noted as having deposited sediment below the level of the surroundings berms indicating that they were of sufficient size to deal with the amount of runoff water currently present; however, the east pond was near capacity indicating it would be insufficient to deal with the quantities of water present during freshet. The ditch feeding the western pond showed a lack of protection against erosion ([Picture 40](#)) and observation of the ditch seemed to indicate that study of the grade of the ditch should be assessed in order to allow for water flow into the pond ([Picture 41](#)). It was suggested that Baffinland confirm that the ditch had a proper grade and consider some form of protection be applied to the sides of the ditch to prevent erosion which could dam water flow.

Picture 38: Stockpile East Pond

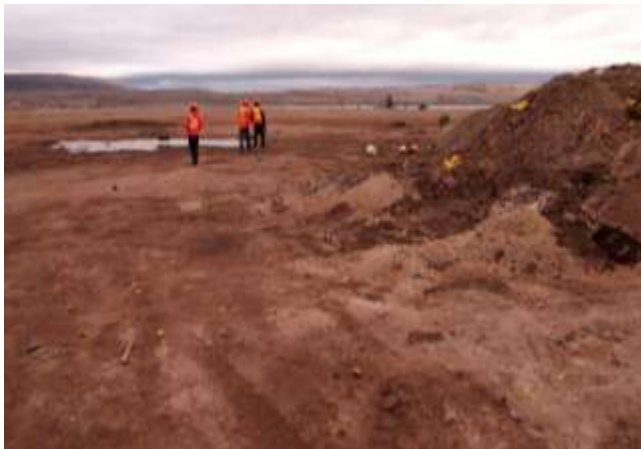
Since 2014, the Monitoring Officer consistently reported on the deteriorating condition of the landfarm facility, and has raised concerns that the disposal synthetic liners, contaminated snow and soils have not been properly managed in accordance with industry best practices. The NIRB's 2016 Recommendation 20 specifically requested that Baffinland implement best practices for landfarm operations, including for management of contaminated snow, waste synthetic liners, including used tires. At the time of this visit the landfarm showed some minor improvement compared to the March 2017 visit and significant improvement to that of the 2016 site visit; however, liner material continued to be observed to remain in the landfarm, as well as refuse such as plastic buckets and barrels ([Pictures 42, 43, and 44](#)). The waste water holding pond within the landfarm similarly had garbage and debris in it such as used petroleum containment booms and a portable spill berm ([Picture 45](#)).

Picture 42: Landfarm

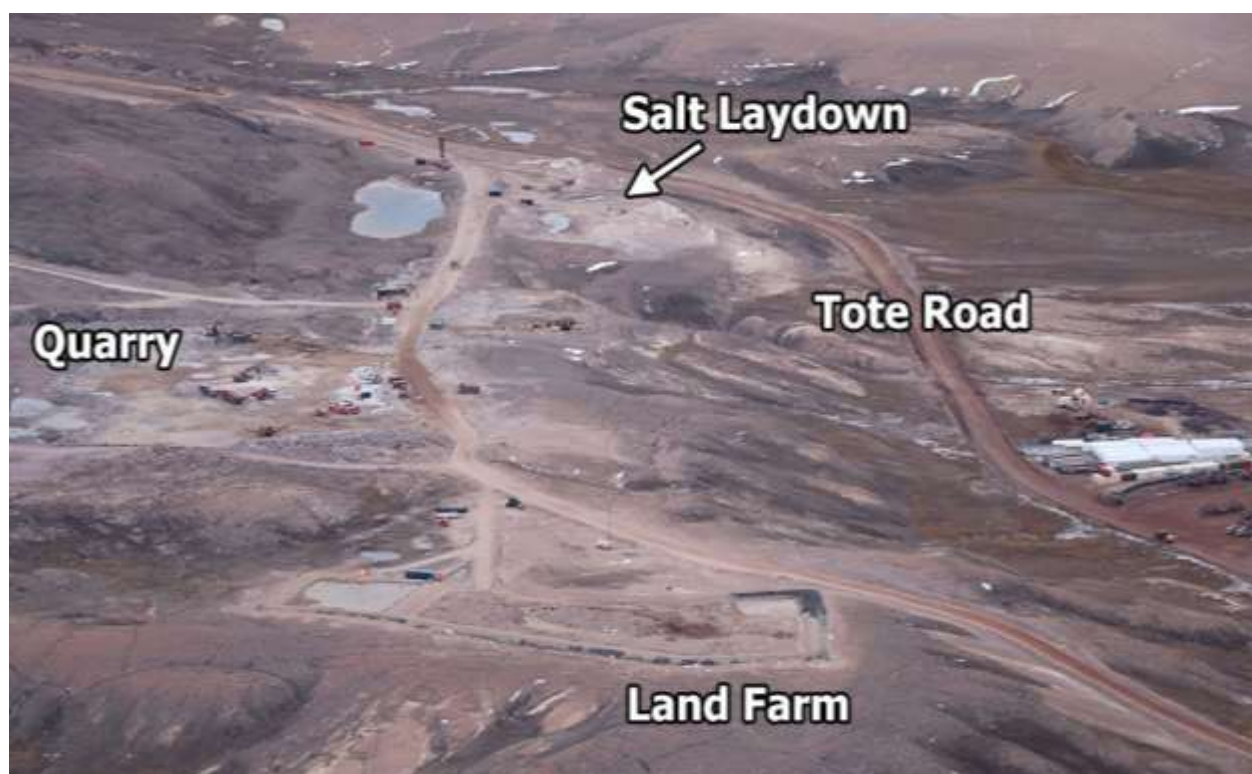
Picture 46: Salt laydown location

The laydown area at Milne Inlet used for storage of salt used as a dust suppressant ([Picture 46](#)) showed poor organization and a generally untidy appearance, with individual bags of salt falling out of the shipping packaging and the shipping packaging scattered at random over the pad. ([Picture 47](#) and [48](#))

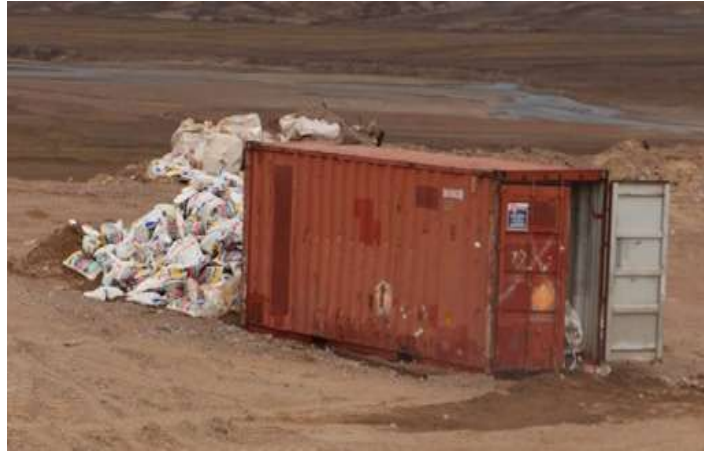
Picture 47: Bags of salt in laydown area
