RAIL CV-109-1

**BAFFINLAND IRON MINES
MARY RIVER PROJECT**

**North/South Consultants Inc.**
Aquatic Environment Specialists

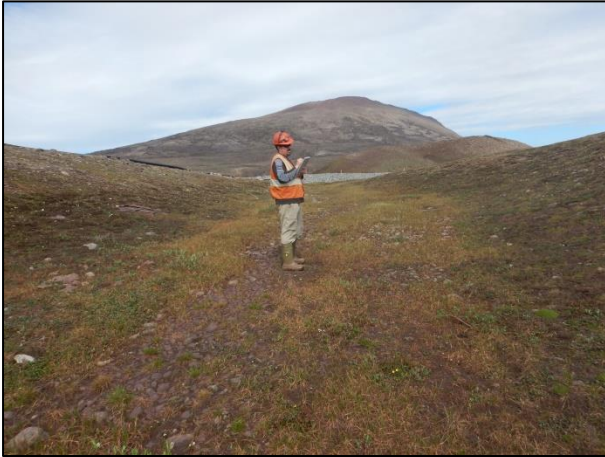
A

Photos 1. Photos taken at the crossing centreline in spring: (A) facing upstream; (B) facing downstream; and (C) across (right bank looking at left bank).
