# ROAD M-CULV-2A

**BAFFINLAND IRON MINES  
MARY RIVER PROJECT**

**North/South Consultants Inc.**  
Aquatic Environment Specialists

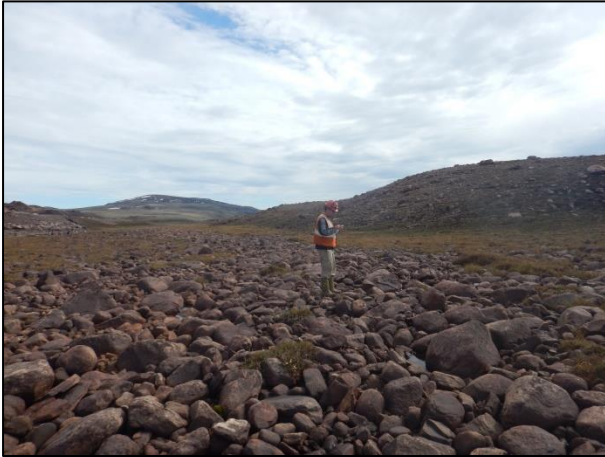
**A**

**Photos 1.** Photos taken at the crossing centreline in spring: (A) facing upstream; (B) facing downstream; and (C) across (left bank looking at right bank).
