LOCATION AND CROSSING DESCRIPTION

Site ID:	CV-4-3	Dates Surveyed:	15-Jun-19	Waterbody Type:	Stream
Project Interaction:	Rail Daylight + Culvert	Centreline UTM Coordinates:	17W 505842 E 7972438 N	Culvert Length (m):	12
Number of Barrels:	1	Culvert Diameter/Span (mm):	900	Slope (%):	1

BAFFINLAND IRON MINES MARY RIVER PROJECT

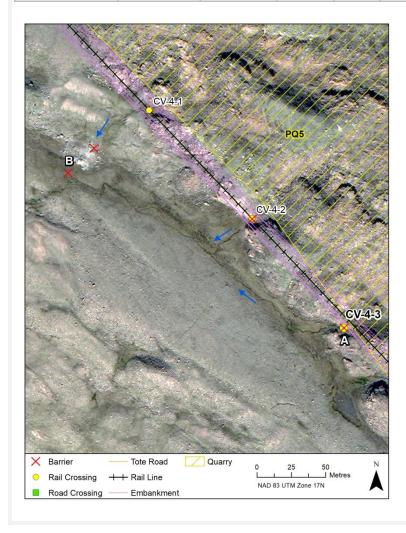
Upstream/	UT	М	Barr	ier Type		Height	Gradient	Description	Site
Downstream	Easting	Northing	1	2	3	(m)	(°)	Description	Label
Downstream	505836	7972435	SSF					Permanent Barrier: Subsurface flow through rock that begins 10 m downstream of the crossing	Α
Downstream	505635	7972548	SSF					Permanent Barrier: Sub-surface flow with no obvious channel	В

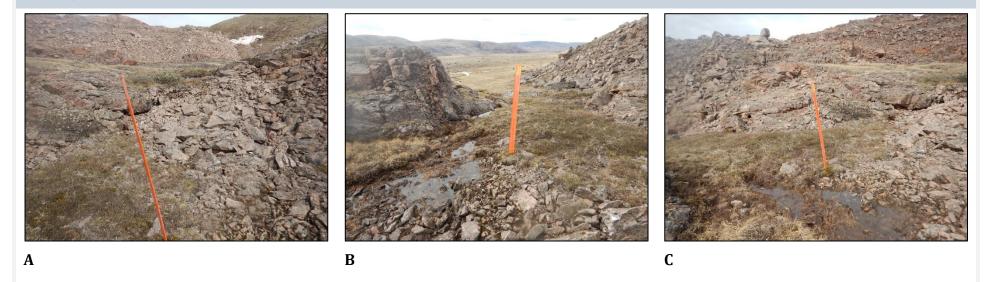
There is no overwintering habitat upstream of crossing CV-4-3, and fish access to the site from downstream habitat is blocked by two permanent barriers. The crossing itself contains boulders and sub-surface flows. There is no fish habitat at this crossing.

Photos 1. Photos taken at the crossing centreline in spring (A) facing upstream; (B) facing downstream; and (C) across (right bank looking at left bank).
