LOCATION AND CROSSING DESCRIPTION

Site ID:	CV-4-4	Dates Surveyed:	15-Jun-19	Waterbody Type:	Stream
Project Interaction:	Rail Culvert	Centreline UTM Coordinates:	17W 505898 E 7972378 N	Culvert Length (m):	36
Number of Barrels:	1	Culvert Diameter/Span (mm):	900	Slope (%):	1

BAFFINLAND IRON MINES MARY RIVER PROJECT

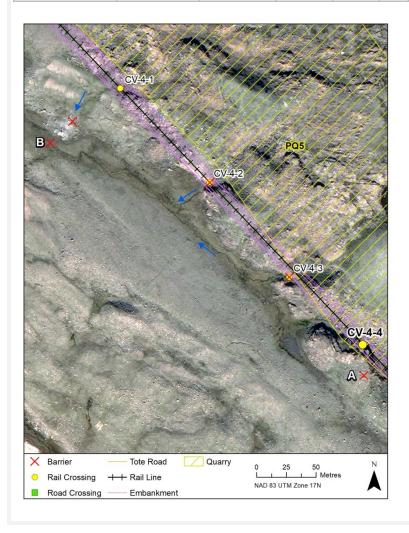
Upstream/	UT	·M	Barr	ier Type		Height	Gradient	Doggwinting	
Downstream	Easting	Northing	1	2	3	(m)	(°)	Description	Label
Downstream	505899	7972352	Other					Permanent Barrier: Dry channel with high grade beginning >75 m downstream	А
Downstream	505635	7972548	SSF					Permanent Barrier: Subsurface flow with no obvious channel	В

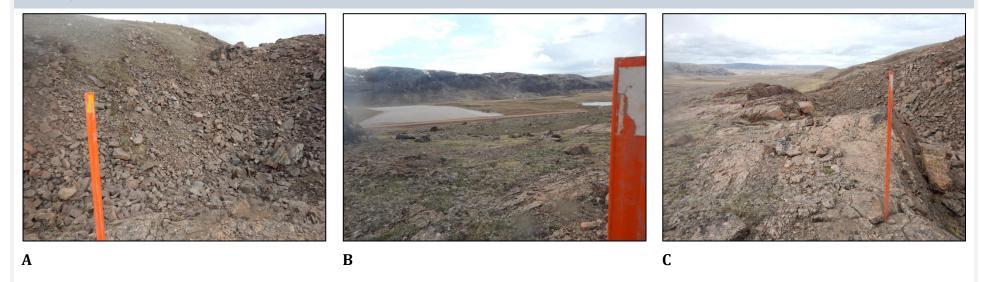
There is no overwintering habitat upstream of crossing CV-4-4, and fish access to the site from downstream habitat is blocked by two permanent barriers. The crossing itself is on a rocky outcrop with a steep grade and no water was present downstream for >75 m in spring 2019. There is no fish habitat at this crossing.

Photos 1. Photos taken at the crossing centreline in spring (A) facing upstream; (B) facing downstream; and (C) across (left bank looking at right bank).
