#### LOCATION AND CROSSING DESCRIPTION

Site ID:	CV-8-1	Dates Surveyed:	16-Jun-19	Waterbody Type:	Stream
Project Interaction:	Rail Culvert	Centreline UTM Coordinates:	17W 508304 E 7969709 N	Culvert Length (m):	38
Number of Barrels:	1	Culvert Diameter/Span (mm):	1200	Slope (%):	5

BAFFINLAND IRON MINES MARY RIVER PROJECT

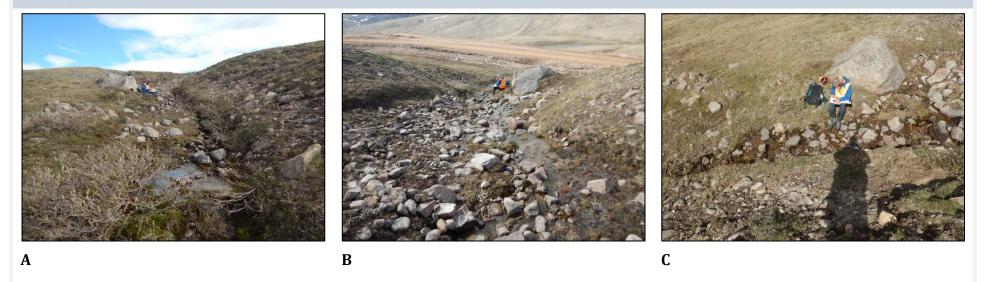
This stream does not connect to fish-bearing waters on its downstream end, and any upstream fish passage is blocked by a high gradient from the roadside ditch to the crossing. There is no fish habitat at this crossing.

**Photos 1.** Photos taken at the crossing centreline in spring (A) facing upstream; (B) facing downstream; and (C) across (right bank looking at left bank).
