#### LOCATION AND CROSSING DESCRIPTION

Site ID: CV-2-1 **Dates Surveyed:** 15-Jun-19 Waterbody Type: Stream **Project Interaction:** Rail Daylight+Culvert **Centreline UTM Coordinates:** 17W 505155 E 7973123 N Culvert Length (m): 18 Number of Barrels: Culvert Diameter/Span (mm): 900 **Slope (%):** 1

BAFFINLAND IRON MINES MARY RIVER PROJECT

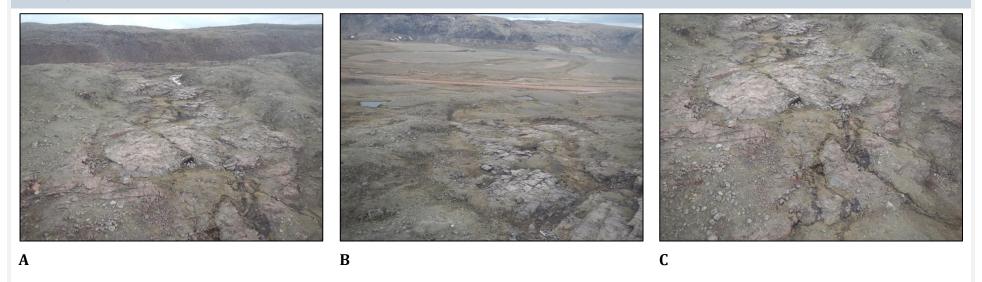
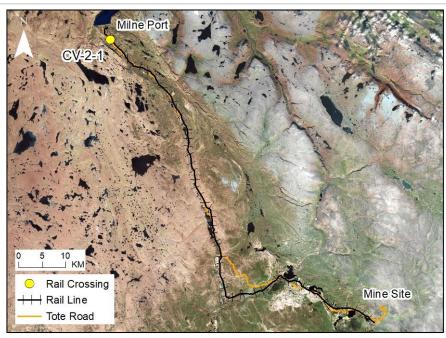
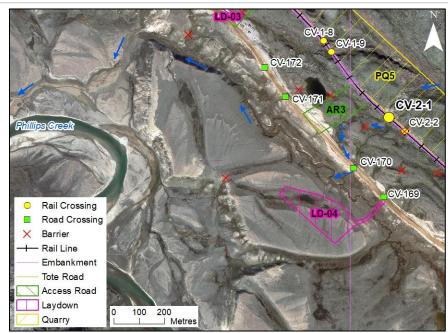
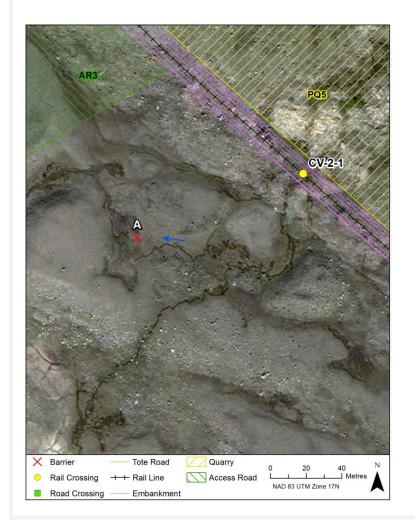
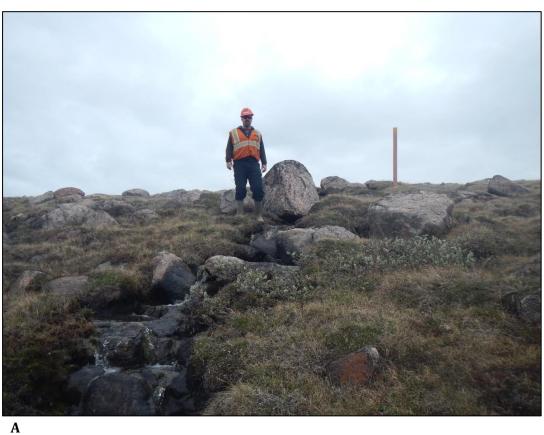
**Photos 1.** Aerial photos of the crossing in spring 2019: (A) facing upstream; (B) facing downstream; (C) at the crossing site. Ground photo from summer 2018 at the centreline facing upstream (D).
