## INDUSTRIAL WATER LICENCE INSPECTION REPORT

<b>Date:</b> April 15-16, 2014	<b>Licensee Rep. (Name/Title):</b> Tyler Myers, Environmental Superintendent
<b>Licensee:</b> Baffinland Iron Mines Corporation	<b>Licence No.:</b> 2AM-MRY1325

A compliance inspection was conducted on April 15-16, 2014 by Justin Hack, a Water Resource Officer of Aboriginal Affairs and Northern Development Canada (AANDC) for the Baffinland Iron Mines Corporation (BIMC) Mary River and Milne Inlet iron ore project, Water Licence No: 2AM:MRY1325.

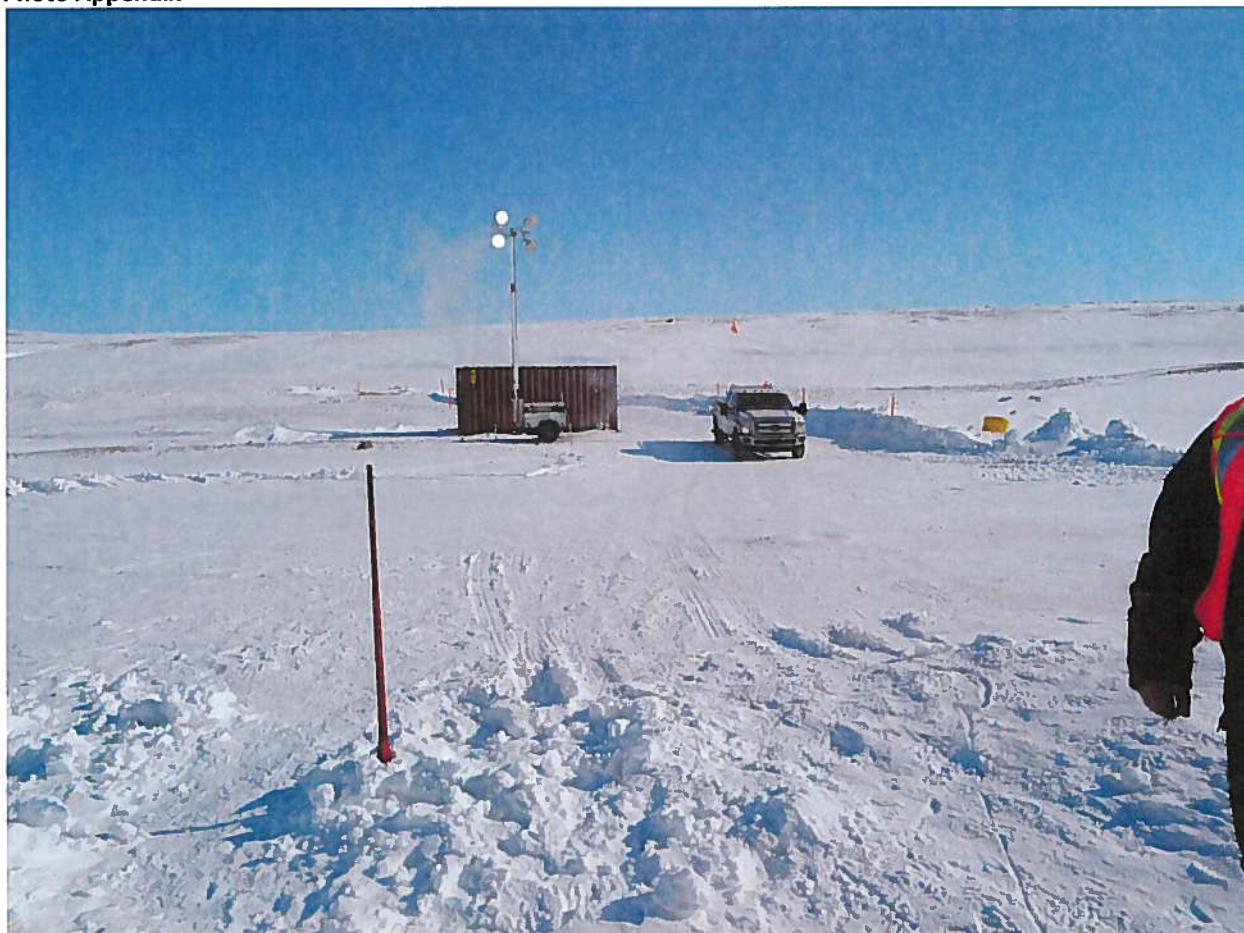
- Currently, potable water is sourced from two lakes for use at the Baffinland project. At the Mary River site, water is pumped from Camp Lake and piped directly to the Mary River camp; whereas, at the Milne Inlet site, water is pumped directly from Km 32 Lake for use at Milne Inlet using a Water Truck. The truck backs onto the ice and withdraws water on an as needed basis.
- At the Km 32 Lake facility, two pieces of equipment, a Terex Light Plant and a seacan were located next to the shoreline for use during the winter to provide light and the storage of equipment (see **Figure 1**). This equipment is within 31m of the high water mark and must be moved back as required in Part D-10 of the Licence.

**Figure 1: Terex Light Plant and seacan located on shoreline.**

- Move the Terex Light Plant and the seacan to within an approved distance of the high water mark at Km 32 Lake by June 1, 2014.
- All equipment shall be removed from the ice immediately to within an approved distance of the high water mark, except for that which is required for immediate use. All areas that were affected by hydrocarbons be scraped up and disposed of in a proper waste management facility. Photo evidence is to be submitted by June 1, 2014.

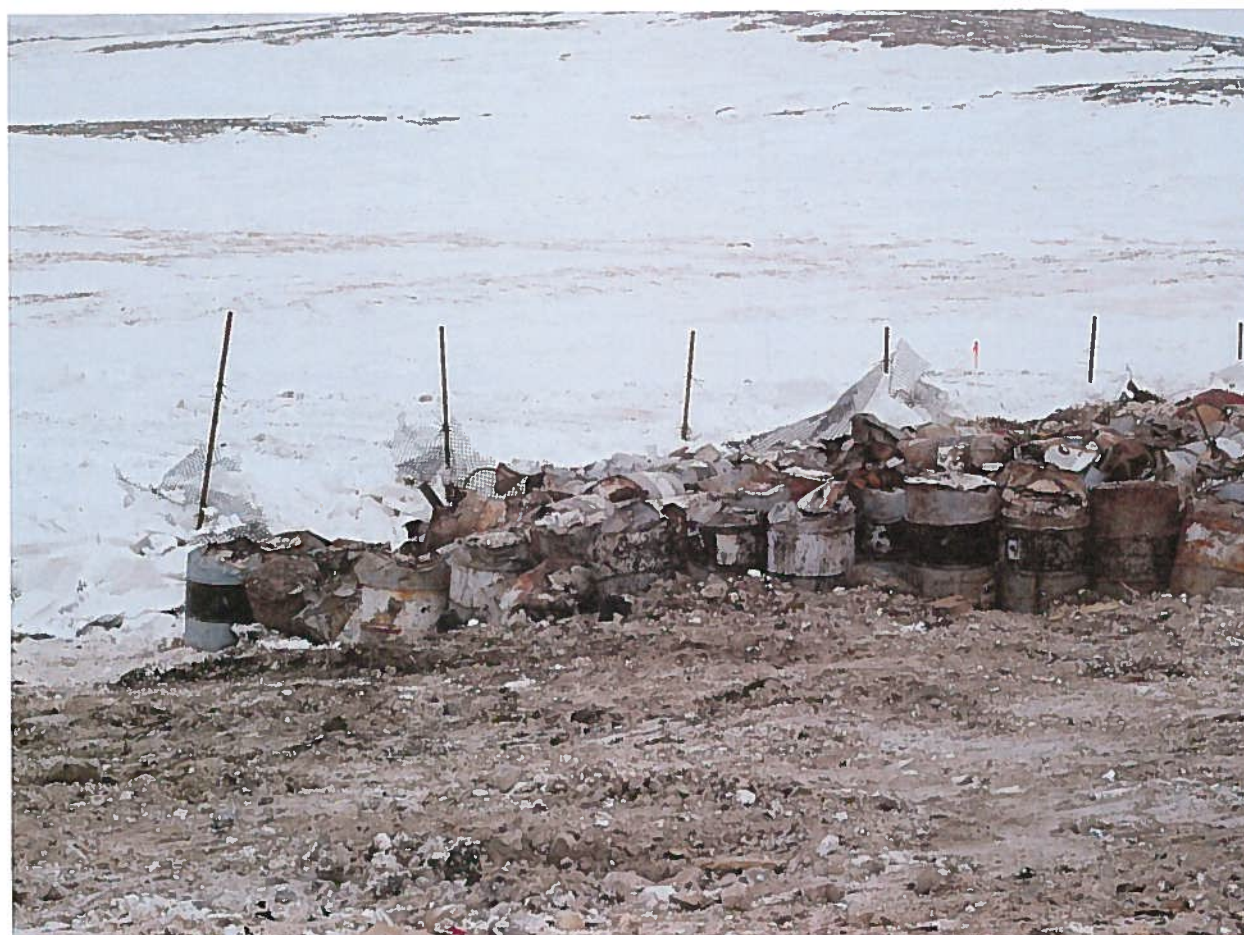
- Non-hazardous waste, including ashes from the incineration process and other unburned residue, is also approved to be deposited at the site. At the time of inspection, a number of ash barrels were waiting to be capped with appropriate cover material.

- Fencing around the facility was in disrepair. Mr. Myers explained that the fencing breaks annually due to the harsh winter and will need to be replaced with proper snow fencing that is less sensitive to winters (see **Figure 2**). Since this important windblown debris control measure is not functioning, Baffinland should monitor any windblown debris leaving the site, collect it and return it to the landfill.

**Figure 2: Blown down snow fencing and ash barrels at the inert materials landfill.**

- Replace the snow fencing with new fencing that is less sensitive to winters by June 15, 2014. Baffinland shall monitor any windblown debris leaving the landfill facility and return any debris that blew away back to the facility.

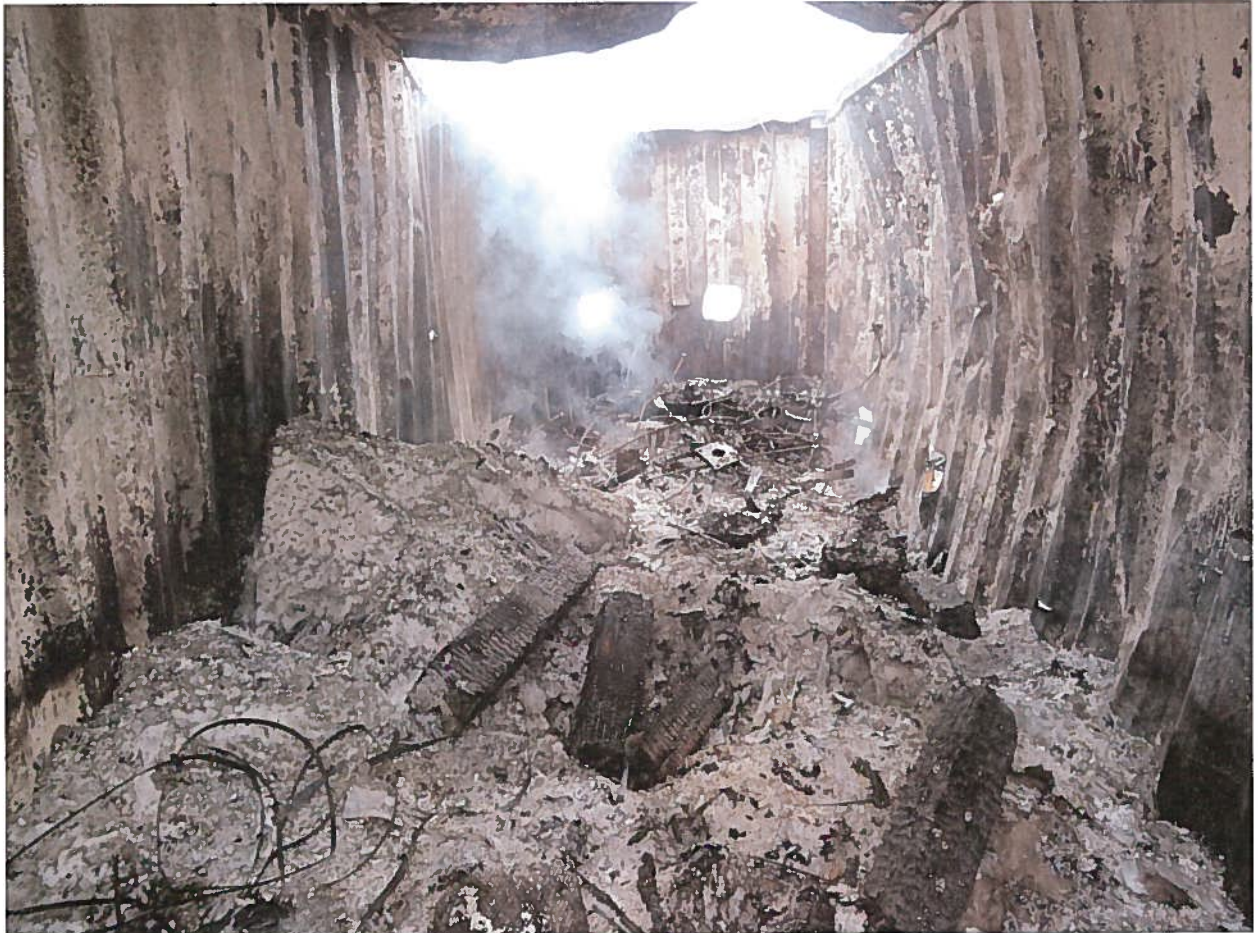
- The open burn facility contained elements not authorized under the Waste Management Plan including the remnants of an air filter, likely from a piece of heavy equipment, and a significant amount of metal strapping (see **Figure 3**).

- It appeared that during the previous burn, there was a significant amount of snow within the facility. As outlined in their Open Burning Procedure, Baffinland is to ensure a hot burn in order to create an efficient burn. Snow within the facility must be monitored and managed before a burn.

**Figure 3: Inside view of Open Burn Facility. Note the unapproved waste located in the facility (snow, metal strapping, and air filter).**

- Properly secure all ash on site by July 1, 2014.
- The inspector requests that the Licensee re-evaluate the effectiveness of Quality Assurance and Quality Control plan for the Open Burning Facility, and provide this to the inspector by July 1, 2014.

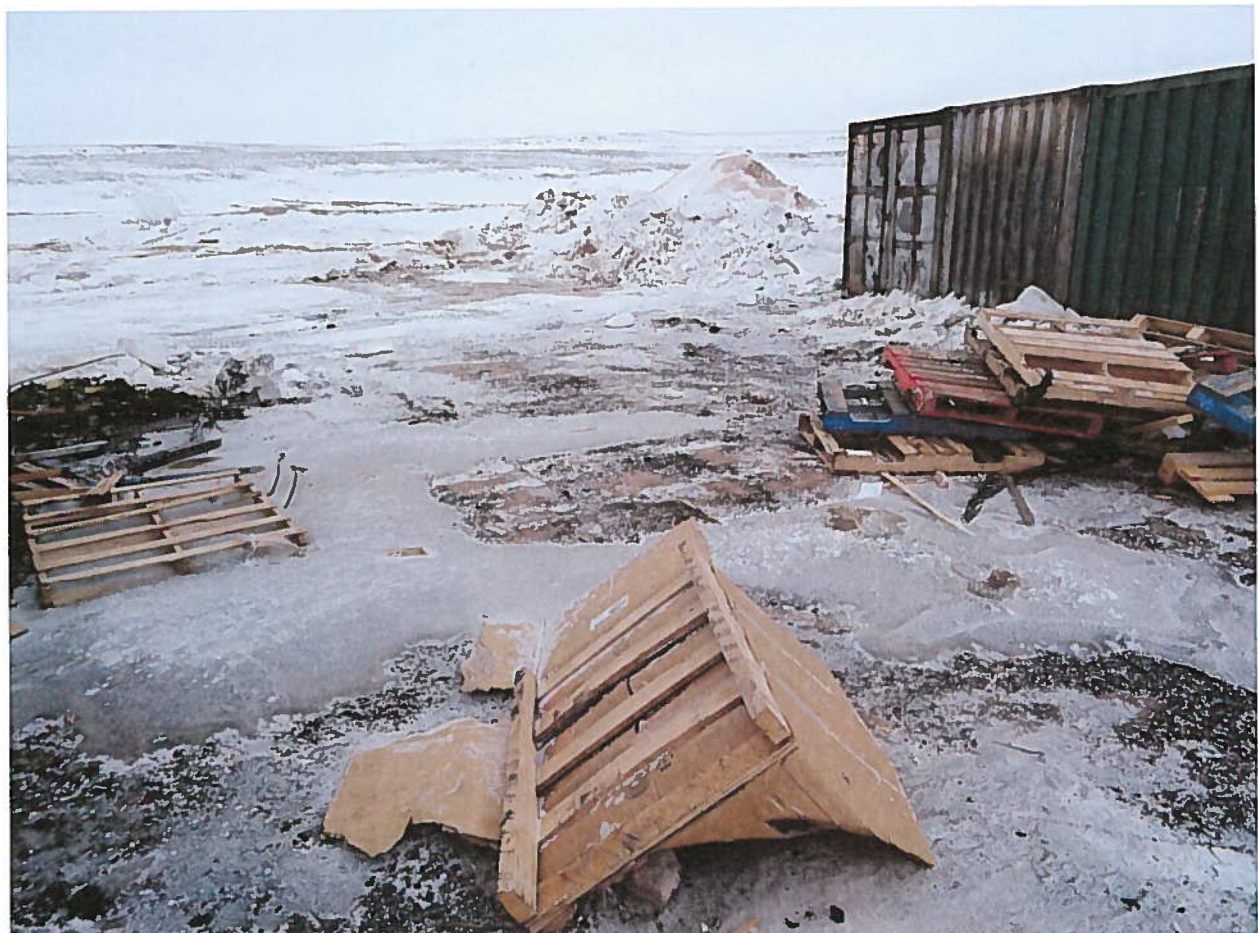
- Outside the facility, there was a significant amount of ash on the tundra (see **Figure 4**). It is not clear how so much ash accumulated here, but material should not be burned on windy days to avoid ash from accumulating on the tundra. As per the *Open Burning of Untreated Wood, Cardboard and Paper Products Procedure, 2014*, all ash is to be disposed of at an approved facility. The Licensee must clean up the spilled ash and secure it at an approved facility.

- Domestic waste was identified outside the facility and is not approved to be burned. Baffinland should ensure the facility is secured to only authorized personnel.

**Figure 4: Outside view of Open Burn Facility. Note the ash on the tundra and unapproved waste.**

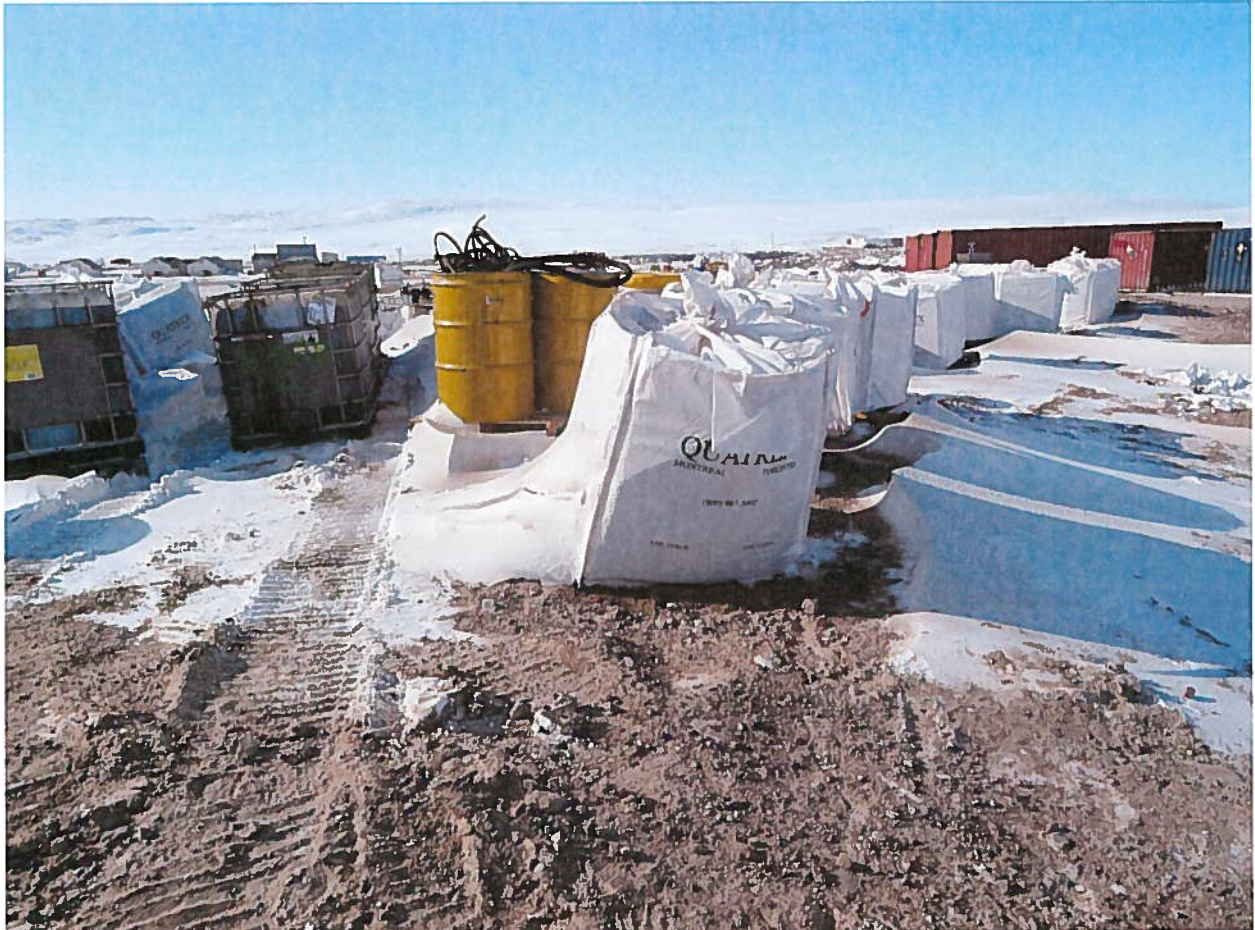
- Hazardous waste berm (Milne Inlet) N71° 19' 53".01, W80° 53' 48".81.
  - It was noted that some hazardous materials were situated outside the bermed area and a spill was noted coming from one of the Megabags located outside the berm (see **Photo 5**).

- As per the *Materials and Hazardous Waste Management Plan, 2013*, all hazardous waste are to be in lined and bermed facilities.
- Fuel Storage and Transfer Area

**Figure 5: Improperly stored hazardous waste located outside an approved hazardous waste storage facility.**

- Remove inappropriately dumped materials from the Landfill before by June 1, 2014.
- Due to the number of issues related to hazardous waste and materials management on site, the inspector requests Baffinland to review their spill management practices and demonstrate that measures are being taken to reduce the amount of spills on site.

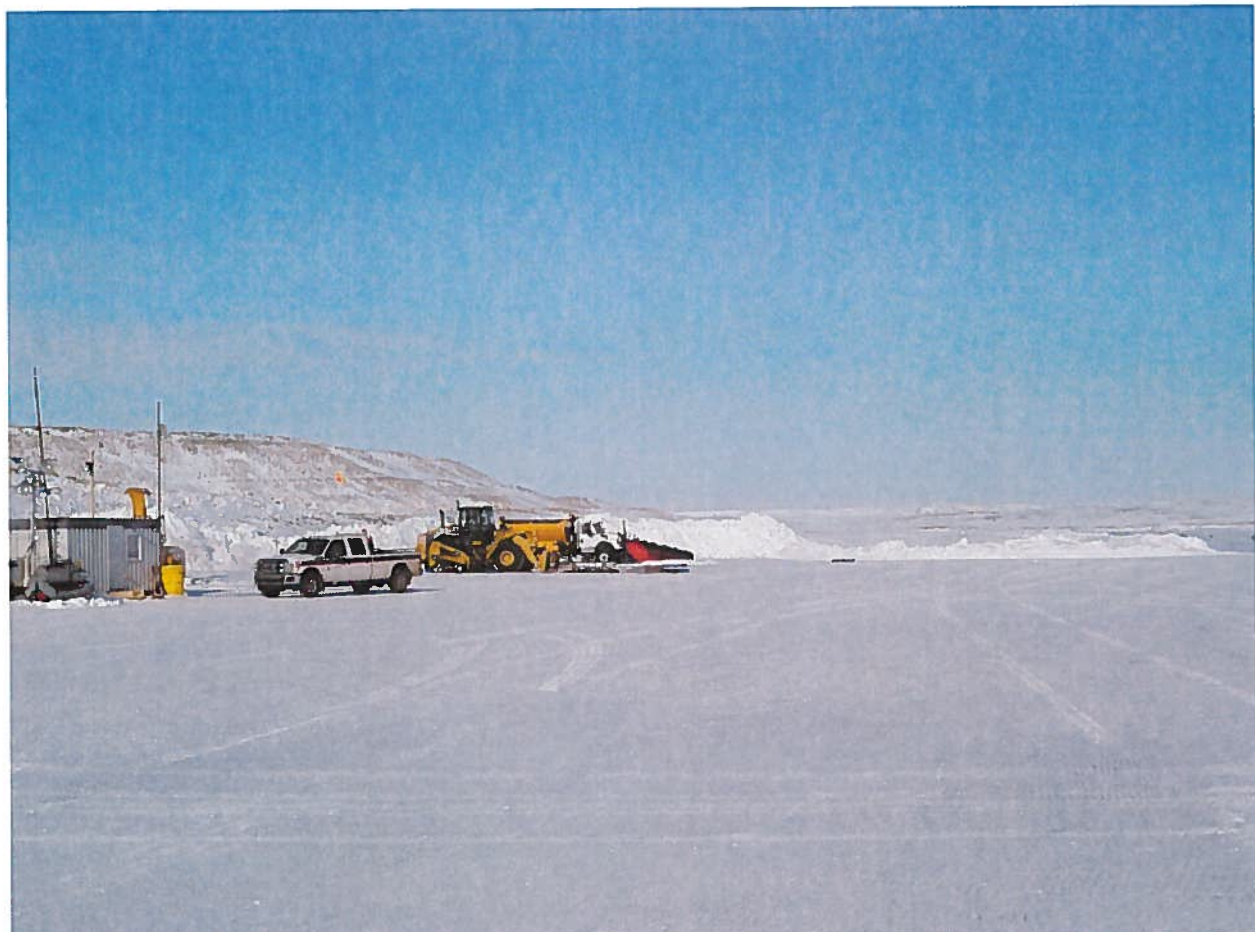
- Unfortunately, at the time of inspection the Lake was being used as a lay-down area for heavy machinery (see **Figure 6**), temporary office structures, and frost fighters. After inspecting these areas, not only was numerous machines stored on ice, there was evidence of hydrocarbon leaking. Specific equipment that showed evidence of leaking on ice were noted, including:

- Workstar Snowplow – Tag#: HTP016. N71° 21' 56.861", W79° 36' 39.838".
  - 950H Cat – Tag#: LDR018. N71° 21' 56.152", W79° 36' 27.911".
  - 247B3 Cat – Tag#: SKD001. N71° 21' 56.152", W79° 36' 27.911".

- As per Part D Item 21, the Licensee shall not store materials on the surface of frozen lakes, including immediate banks, except what is for immediate use.

**Figure 6: Storage of equipment on David Lake.**

- As such, the inspector requests that all equipment be removed from the ice immediately, except for that which is required for immediate use. All areas that were affected by hydrocarbons be scraped up and disposed of in a proper waste management facility. Photo evidence is to be submitted by June 1, 2014.
