WATER LICENCE INSPECTION FORM

Licensee	Licensee Representative
Baffinland Iron Mines Corporation	Jim MILLARD/Allan KNIGHT
Licence No. / Expiry	Representative's Title
2AM-MRY1325	Environmental Manager
Land / Other Authorizations	Land / Other Authorizations
2BC-MRY1416	
Date of Inspection	Inspector
August 21-25, 2014	Robert SAVARD /Justin HACK
Activities Inspected	
<input checked="" type="checkbox"/> Camp <input checked="" type="checkbox"/> Roads/Hauling	<input type="checkbox"/> Drilling <input type="checkbox"/> Other: <input type="checkbox"/> Mining <input checked="" type="checkbox"/> Construction <input type="checkbox"/> Other: <input type="checkbox"/> Reclamation <input checked="" type="checkbox"/> Fuel Storage

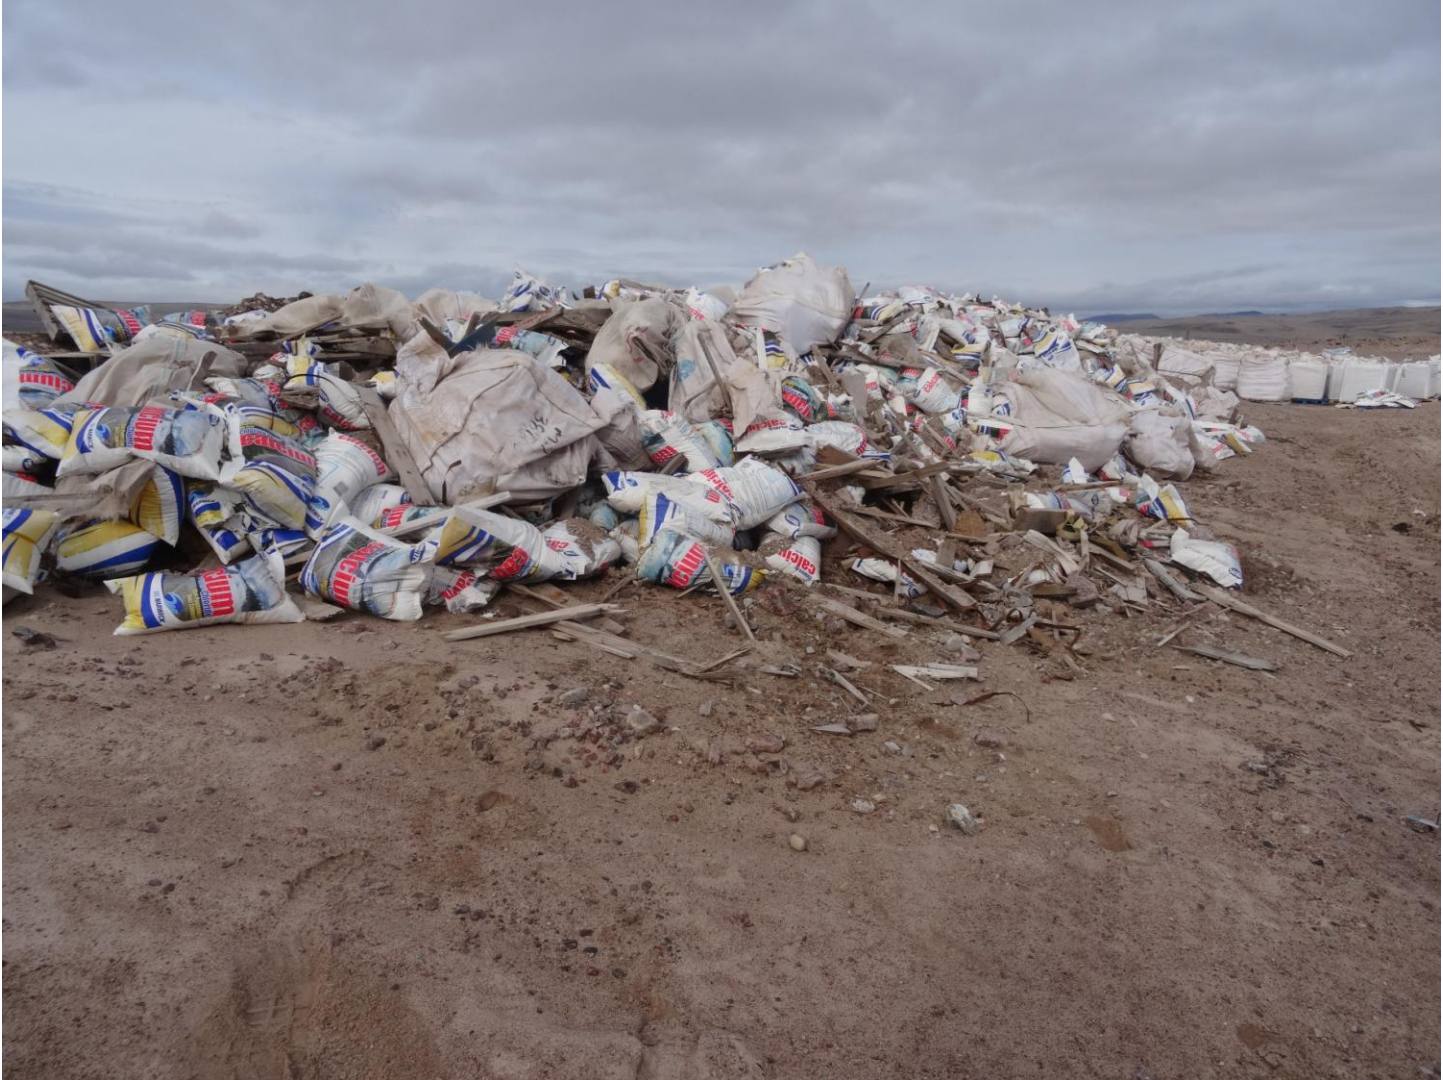
- Since the previous inspection, the salt has been moved to the bottom of the Quarry Q1 to make room for the ore lay-down area. Please ensure proper interim storage of salt and waste materials.
- Please see *Section 3-Plans*.

Drilling/Road Salt (Calcium Chloride) is stored near the quarry site at Milne Inlet site. This product is used primarily for drilling or dust suppression and is currently stored on pallets, in Quatrex bags on pallets and also on the ground in piles of debris which include wood, earth and broken bags (see **Photo 1**). Bags and debris associated with this storage were noted to be blowing around the site.

Photo 1: Salt bags contained with piles of debris.

It was agreed at the close-out meeting that an action plan would be developed to address the storage of this product. This plan would outline segregate of the useable salt from the debris piles in order to continue to store and potentially use the salt for purposes related to the project. It was further agreed that the plan would be submitted to Water Inspectors Hack and Savard prior to **September 12, 2014**.

This plan would include activities with milestones to meet the overall objective of having the salt storage area sorted and managed in a way to prevent excess material being distributed around the site, and to be congruent with the waste management plan. This plan would have a completion date on or before September 30, 2015.

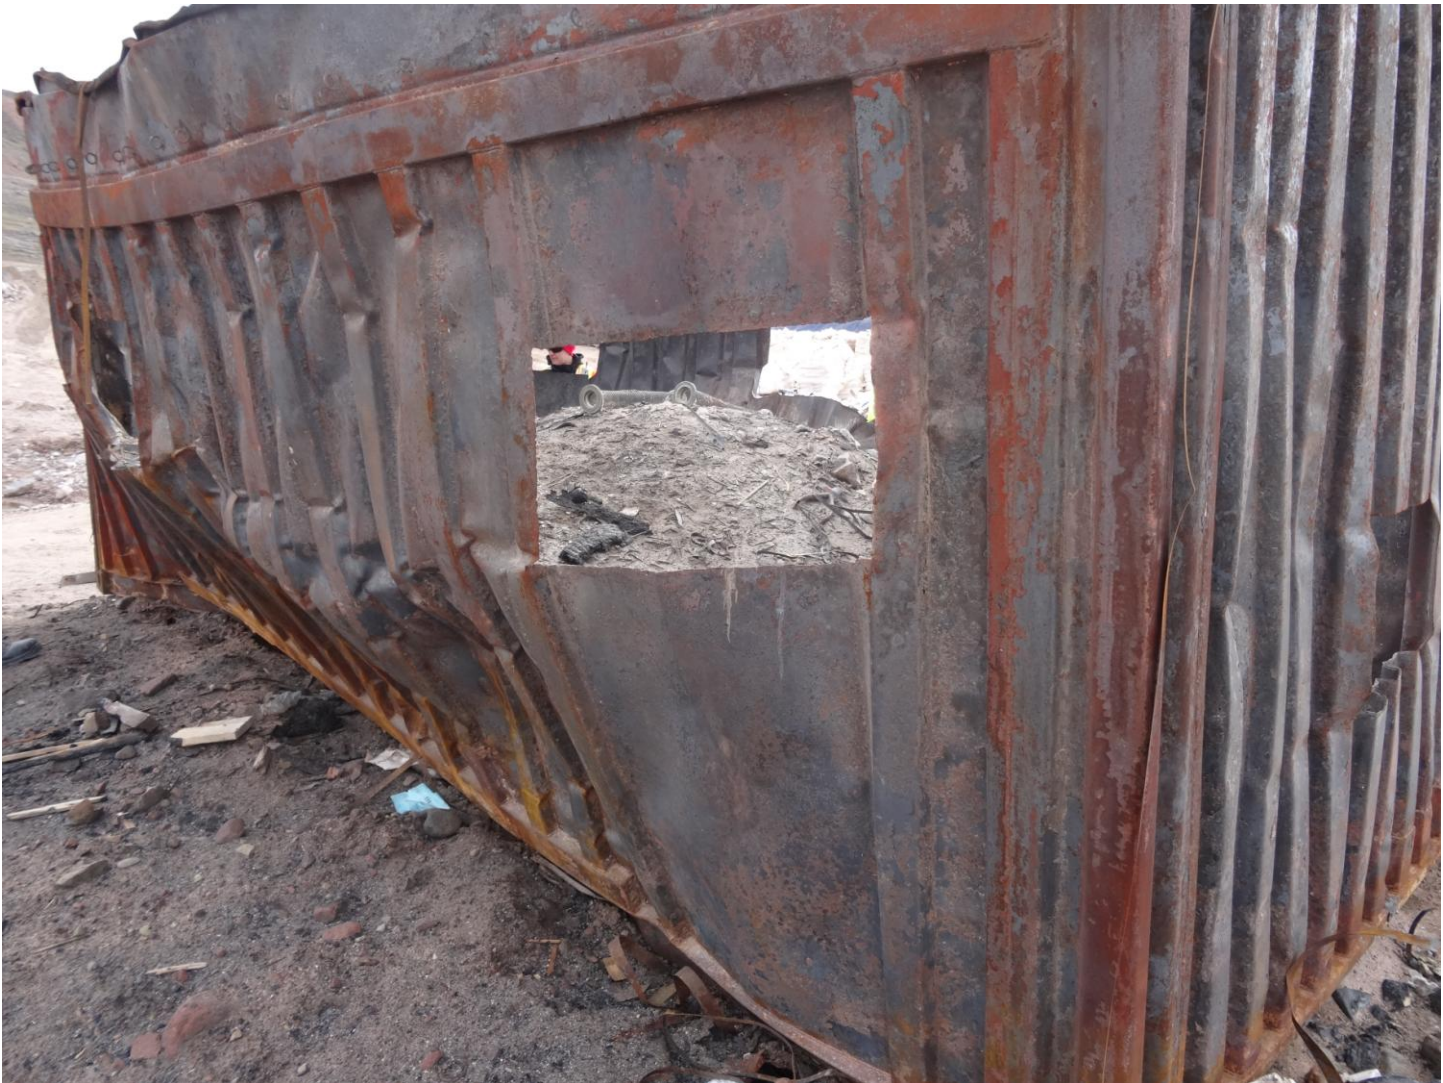
This is the third time seeing unapproved non-combustibles in the burn box at both the Mary River and Milne Inlet facilities. There was also debris from the burn box on the surrounding ground. See **Photo 2**.

Photo 2: Open burn facility at Milne showing debris outside facility and unapproved contents inside.

During a discussion with Mr. Jim Millard, Baffinland Environmental Manager and site services representatives, it was agreed that Baffinland would temporarily cease all open burning at both locations. It was also agreed that Baffinland would clean all ash and material from both open burn boxes and clean all debris in the area around the open burn area.

Furthermore, it was agreed that a plan would be created and submitted to Water Inspectors Hack and Savard by **September 12, 2014** or prior to continuing open burning whichever date would be sooner. This plan would outline a process to ensure compliance with the waste management plan and would include site security, improved waste segregation procedures, education to staff and contractors, self compliance audits, and an adaptive management strategy to ensure compliance on an ongoing basis.
