**Re: Follow up March 9-12, 2015 AANDC Water Licence Inspection**  
**Mary River Project – Water Licence No. 2AM-MRY1325**

WATER LICENCE INSPECTION FORM

**Table A.1 - Response to AANDC Water Licence Inspection - March 9 to 12, 2015**

**Re: Follow-up to Spill #15-089, Reported on March 12<sup>th</sup>, 2015**  
**Mary River Project - Water Licence No. 2AM-MRY1325**

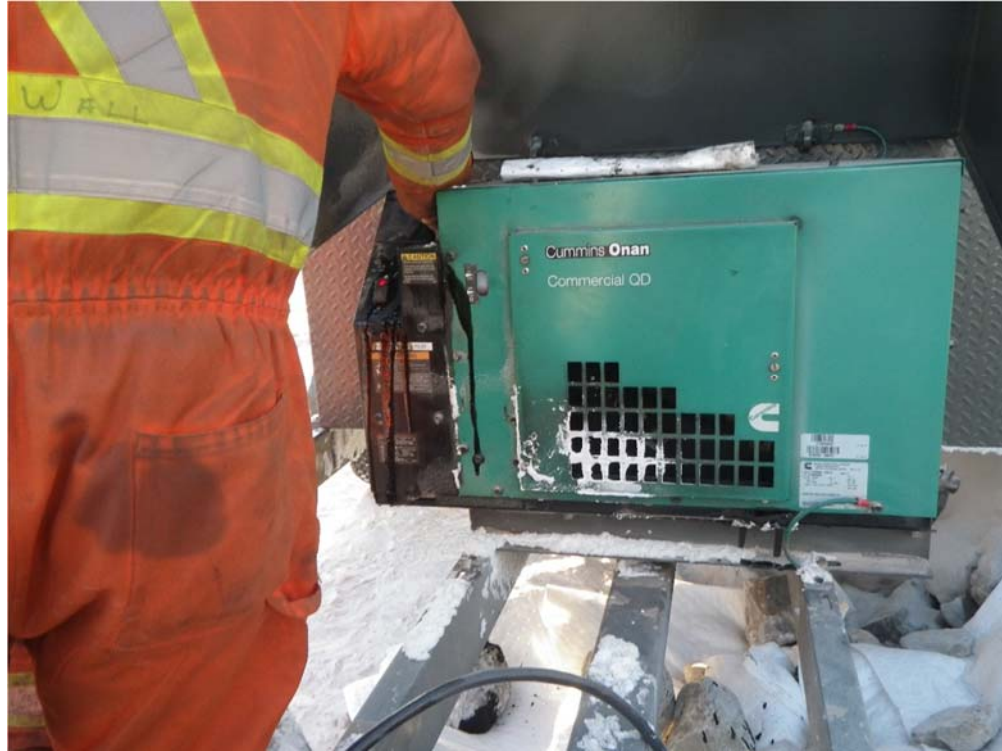
On March 11, 2015 at 17:00, a leak was observed under a ground thawing unit located at Km 38 of the Tote Road. The unit was positioned on the frozen stream at crossing CV099. Approximately 1L of engine oil escaped from an improperly positioned dip stick and was released onto the frozen stream ice surface. There was no spill tray in place to prevent the oil from leaking directly onto the stream bed.

**Photo 1** - Spill location- Oil dripping from the unit (left)

Upon discovery, a spill tray and absorbent material was put underneath the leak to prevent further release to the receiving environment. Repairs were then made to the unit to stop the leak. Approximately 0.2 m<sup>3</sup> of impacted snow and gravel was recovered and transported/disposed of in the landfarm facility at Milne Port. The ground thawing unit was subsequently inspected, found to be in good working order with no further leaks, and put back into service by the maintenance department. A large spill tray was installed to protect the ground / stream bed under the unit. The Operations Group, who are responsible for the operation of the ground thaw unit, were reminded that ongoing utilization of spill trays and monitoring of same are key requirements of our environmental permits.

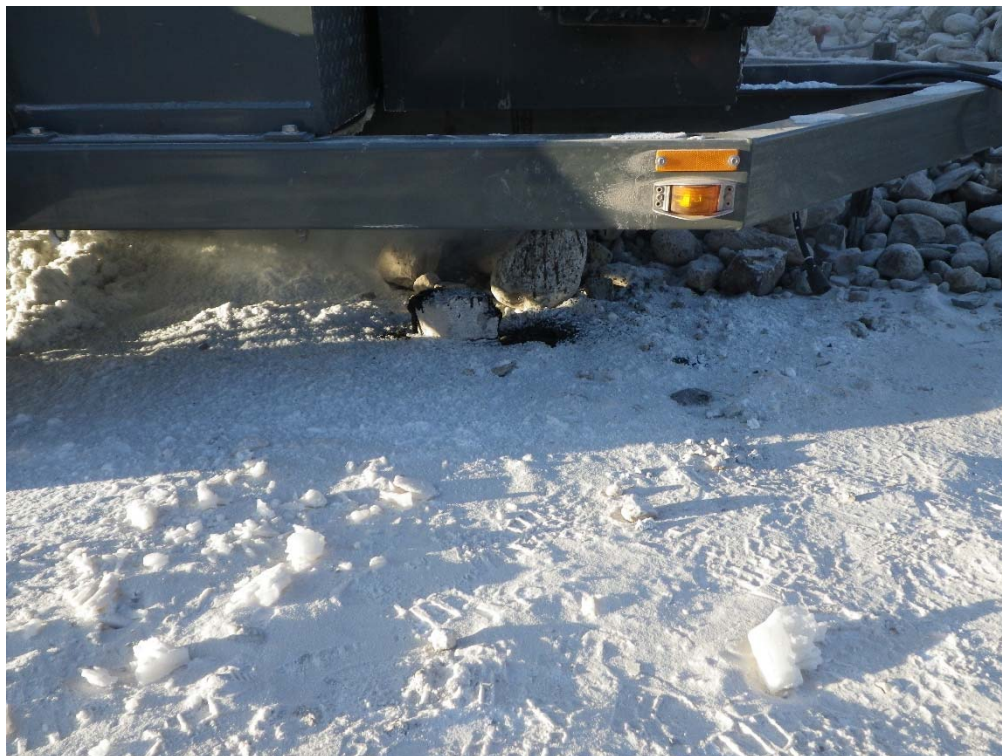
**Photo 2** – Engine oil onto ground – less than 1L
