WATER LICENCE INSPECTION FORM

Licensee	Licensee Representative
Baffinland Iron Mines Corporation (BIMC)	Jim MILLARD/Allan KNIGHT
Licence No. / Expiry	Representative's Title
2AM-MRY1325	Environmental Manager
Land / Other Authorizations	Land / Other Authorizations
8BC-MRY1416, 2BE-MRY1421	N2014X0012, N2014Q0016, N2014C0013
Date of Inspection	Inspector
May 18-20, 2016	Justin HACK
Activities Inspected	
<input checked="" type="checkbox"/> Camp <input checked="" type="checkbox"/> Roads/Hauling	<input type="checkbox"/> Drilling <input type="checkbox"/> Other: <input checked="" type="checkbox"/> Mining <input type="checkbox"/> Construction <input type="checkbox"/> Other: <input type="checkbox"/> Reclamation <input checked="" type="checkbox"/> Fuel Storage

SECTION 1	<input checked="" type="checkbox"/> Comments	<input type="checkbox"/> Non-Compliance with Act or Licence	<input type="checkbox"/> Action Required
<b>Inspectors Statement</b>			
<p>On May 18-20, 2016, a water licence inspection was conducted at the Mary River Project, Qikiqtani Region, Nunavut. Sites inspected included the Mary River Mine Site, the Tote Road and related infrastructure, and the Milne Port area.</p> <p><b>Weather

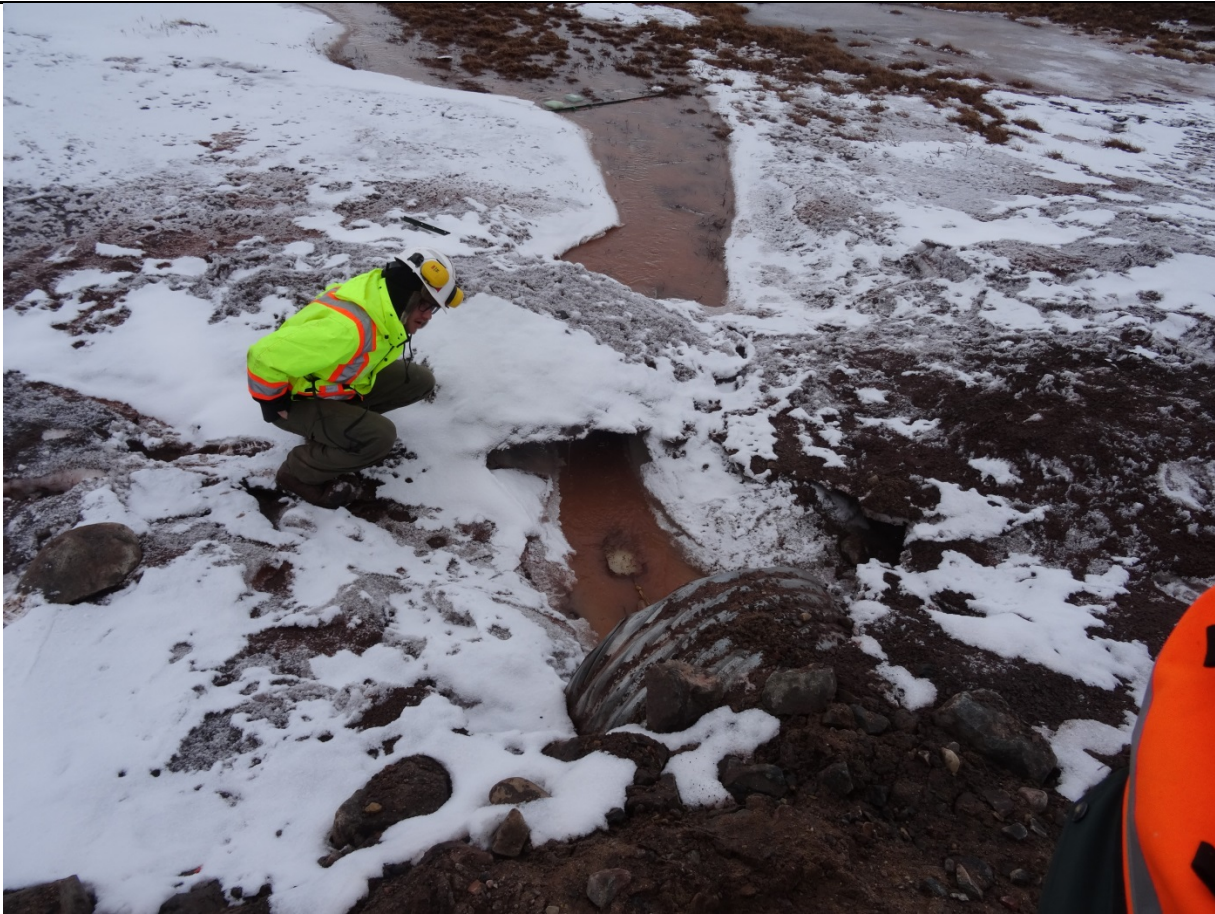
Photo Log # 1

- 6. During the inspection, there were significant sedimentation and erosion events (as indicated by red rust coloured water) actively occurring within watercourses along the Tote Road and entering David Lake, Mural Lake, Kabikok Lake, Sheardown Lake (see *Photo 1*), Camp Lake (see *Photo 2*), Mary River and Phillips Creek.

- a. The cause of this sedimentation and erosion events is likely loose soils becoming suspended during higher flow events, run-off of water from the Tote Road, and from dust entrained within snow (resulting the crusher, the tote road and the ore stockpile) melting and entering the watercourses.

- d. Water samples were taken by the Inspector to confirm water quality at Sheardown Lake Tributary 1, and a small tributary entering Camp Lake.
  - i. The water quality sample at Sheardown Lake Tributary 1 had a Total Suspended Solid (TSS) result of 50.4mg/L. This level is within the Effluent Quality Limits for Surface Runoff during the Construction phase as construction was occurring directly upstream of this sample location.

Location: Sheardown Lake Tributary #1

Description: Water laden with sediment entering Sheardown Lake

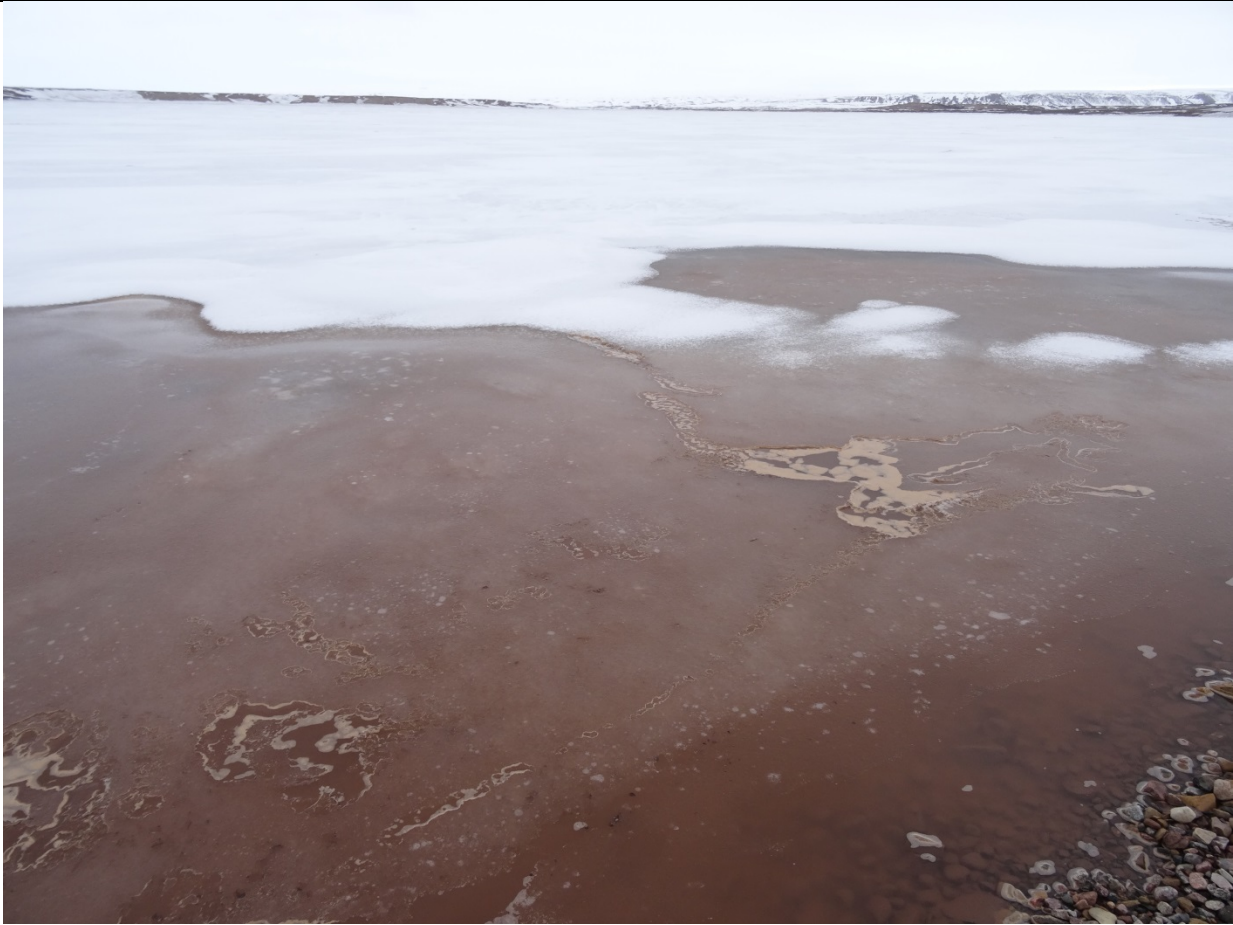
Photo Log # 2

- ii. The water quality sample taken at the stream entering Camp Lake near the monitoring location MS-MRY-1 had a TSS result of 114mg/L. This sample exceeded all effluent quality limits within the licence.

- iii. **A letter of Non-Compliance has been issued as a warning to BIMC because previous commitments were not addressed to mitigate the effects of sediment loading to water.**

Location: Camp Lake near Water Intake

Description: Sedimentation entering Camp Lake from small camp lake tributary downstream of exploration camp

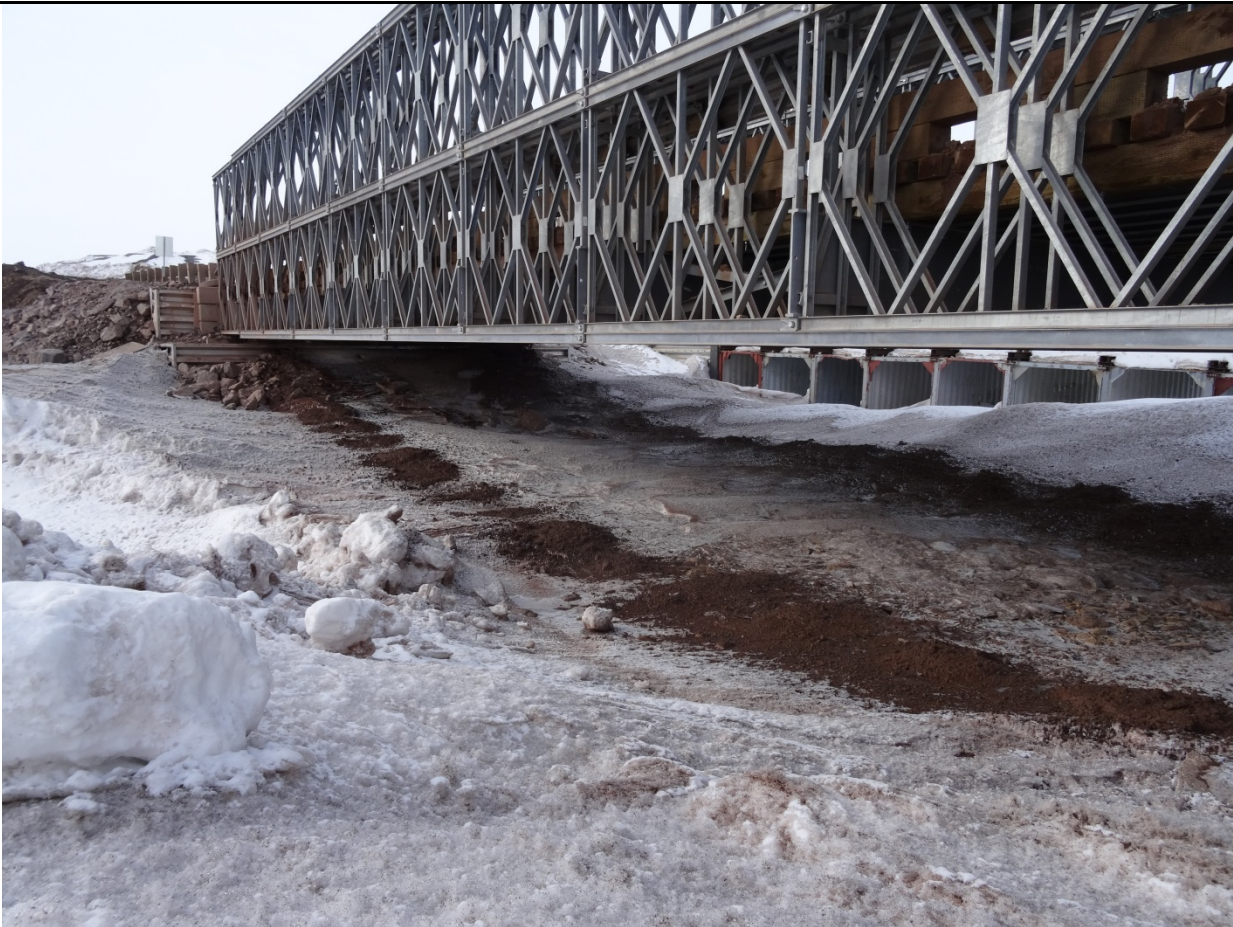
Photo Log # 2

7. Bridges along Tote Road
  - a. During wet conditions on the Tote Road, it was noted that road material is being pushed into all water courses that are crossed by a bridge.

- b. During the inspection, there was significant sediment on snow below the bridge (see *Photo 3*).
  - c. It is requested that BIMC address this concern in their plan due June 22, 2016 which is to address sedimentation issues along the Tote Road.

Location KM62 Bridge

Description: Road material entering stream at KM62 Bridge
