WATER LICENCE INSPECTION FORM

Licensee		Licensee Representative	
Baffinland Iron Mines Corporation (BIMC)		Laura TAYLOR/Allan KNIGHT	
Licence No. / Expiry		Representative's Title	
2AM-MRY1325		Environmental Manager	
Land / Other Authorizations		Land / Other Authorizations	
8BC-MRY1416, 2BE-MRY1421		N2014X0012, N2014Q0016, N2014C0013	
Date of Inspection		Inspector	
May 29 - June 1,2017		Jonathan MESHER	
Activities Inspected			
<input checked="" type="checkbox"/> Camp	<input type="checkbox"/> Drilling	<input checked="" type="checkbox"/> Mining	<input checked="" type="checkbox"/> Construction
<input checked="" type="checkbox"/> Roads/Hauling	<input type="checkbox"/> Other:		<input type="checkbox"/> Reclamation
		<input type="checkbox"/> Other:	<input type="checkbox"/> Fuel Storage

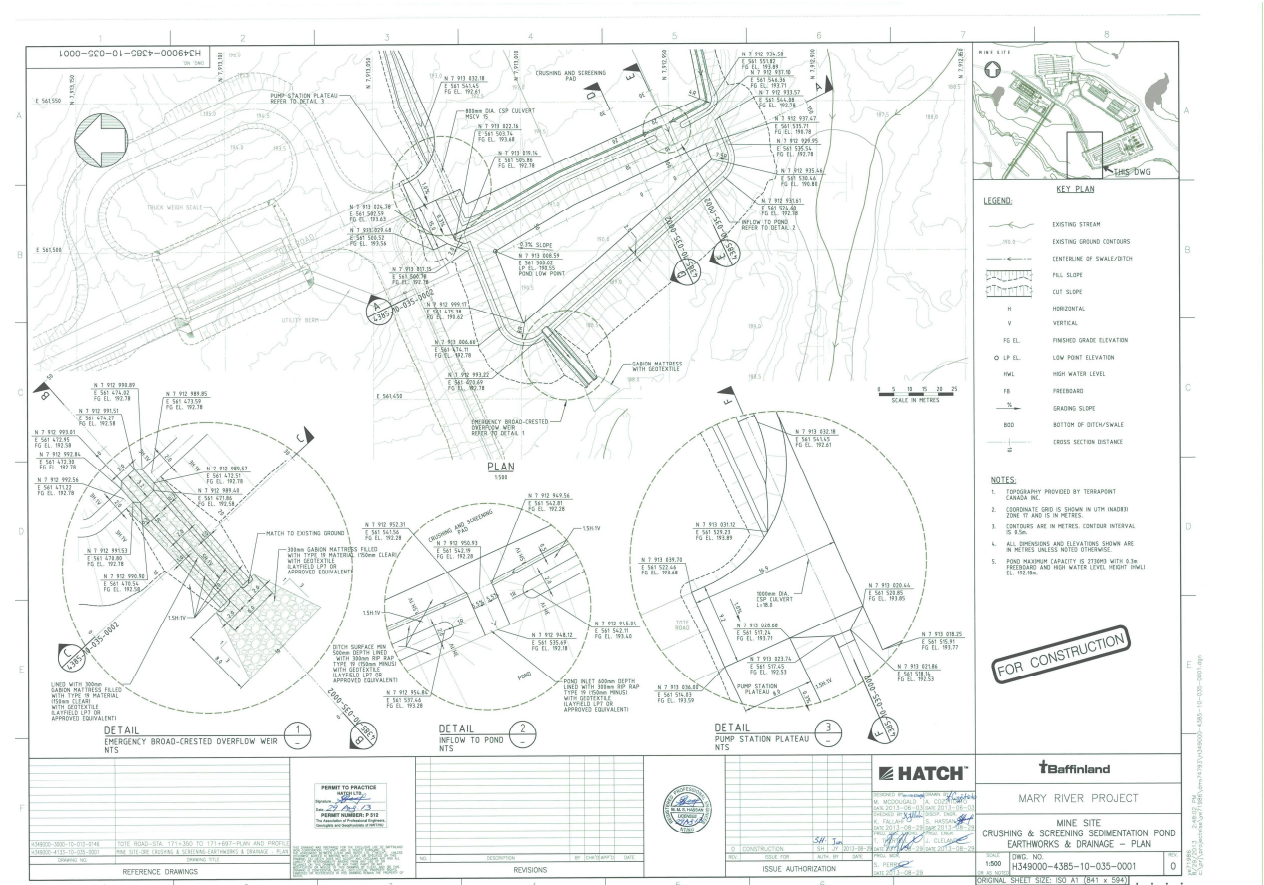
- c. During the Inspection it was noted that there was no culvert in place to allow water from the North West unlined ditches to enter the sedimentation pond, this is a concern to the inspector because in the HATCH for construction drawings below (Figure 1) it shows that there should be a 1000mm DIA CSP culvert installed.

- i. The inspector is requesting that the culvert be installed before freshet 2018.
 - ii. Samples were collected by the inspector to ensure no waste has entered the surrounding environment.

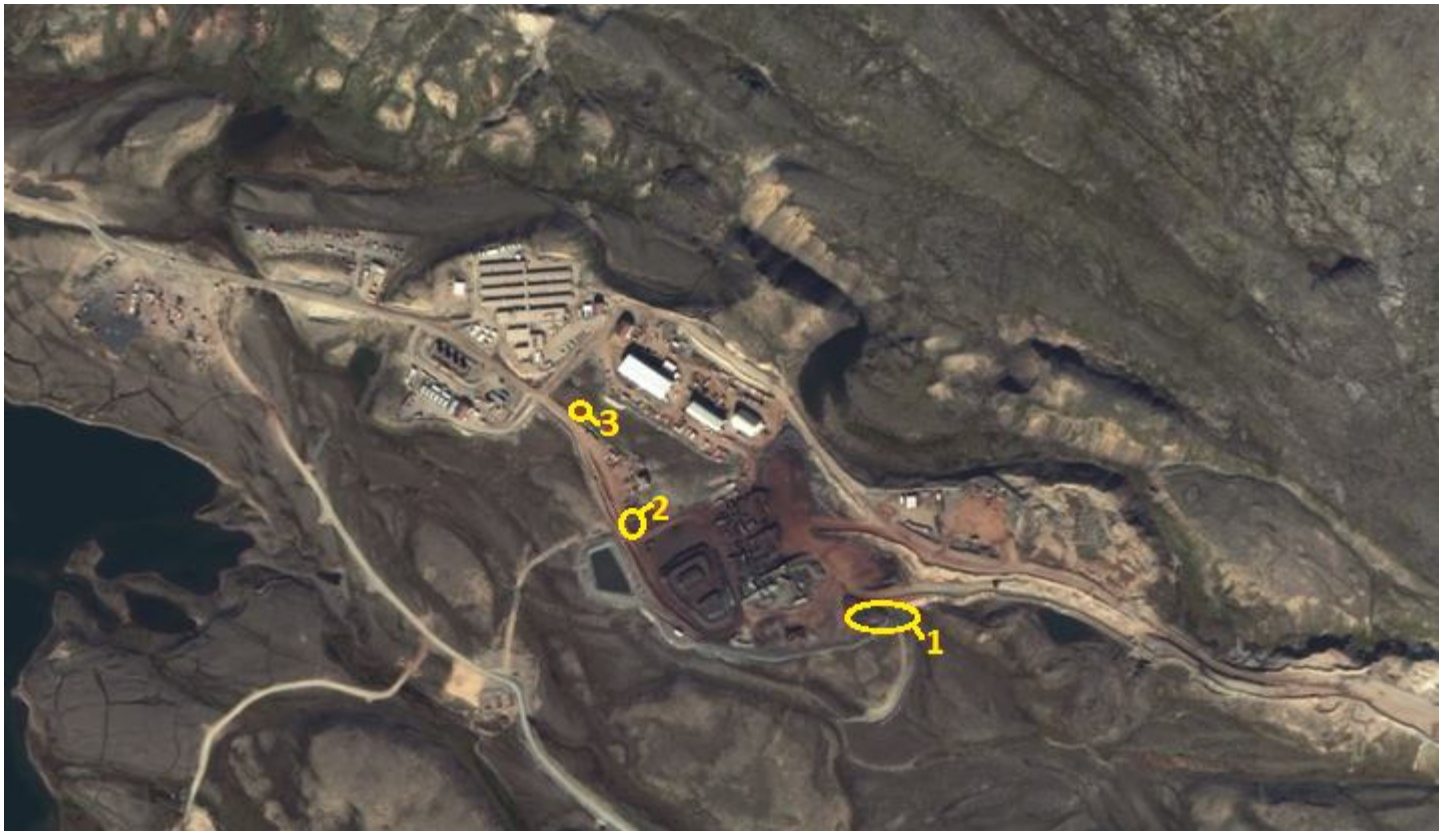
Figure 2 (**Item 1**: Oversized Ore stockpile location. **Item 2**: sampling location. **Item 3**: snow dump sampling location.

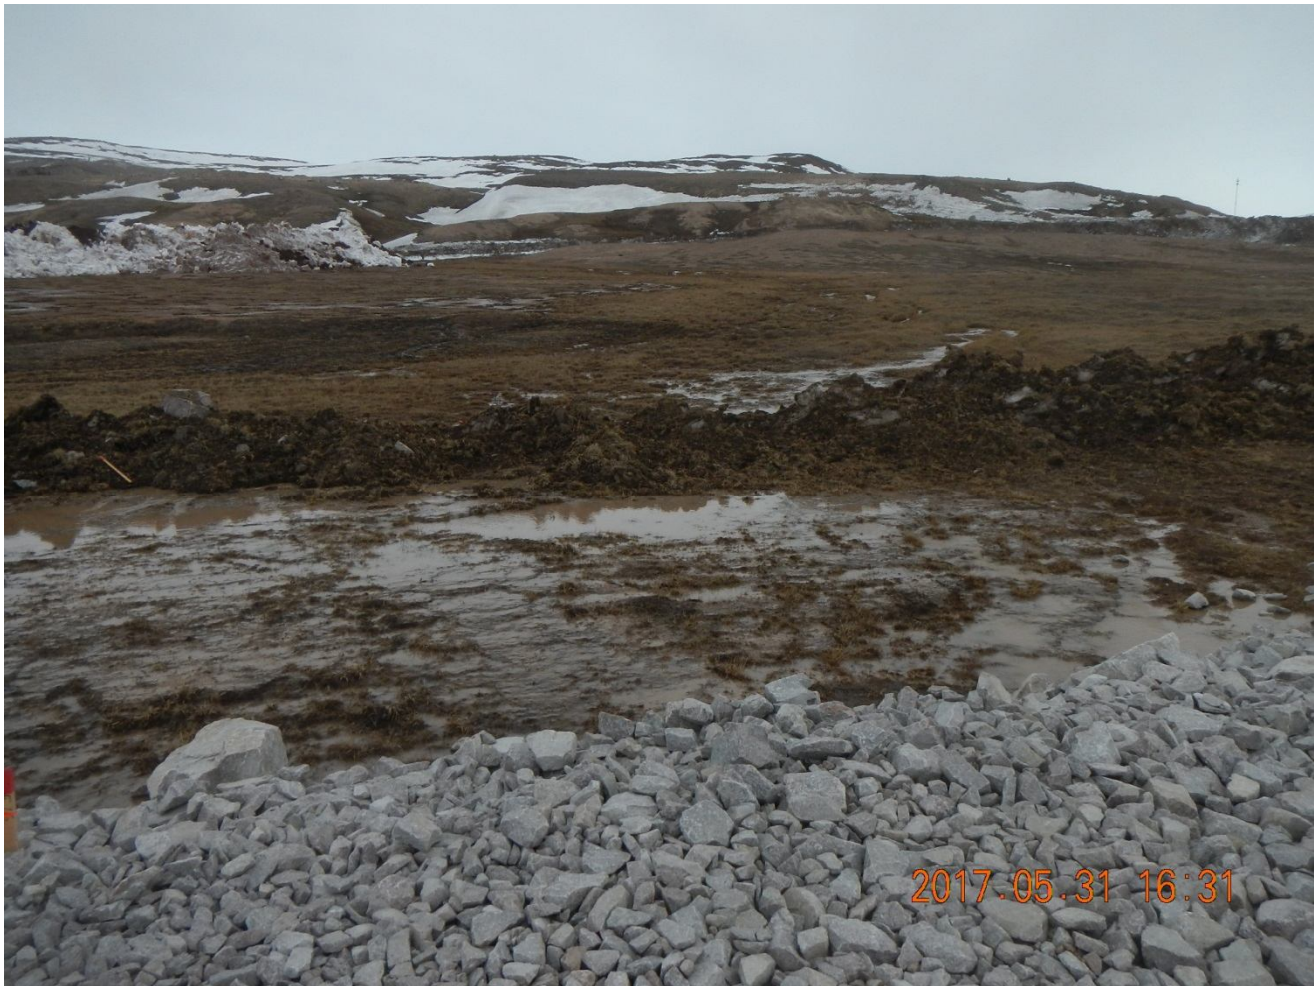
- c. The ditches surrounding the facility do not appear to be graded properly due to water pooling within the unlined ditches.
 - d. The Licensee is removing snow mixed with crushed ore from within the containment facility and dumping it outside of the facility (figure 3).

Figure 3: Snow Dump area, top left of the picture

- i. The inspector is requesting that BIMC discontinue this practice and allow the facility to contain the snow/water that comes in contact with the ore stockpile pad.

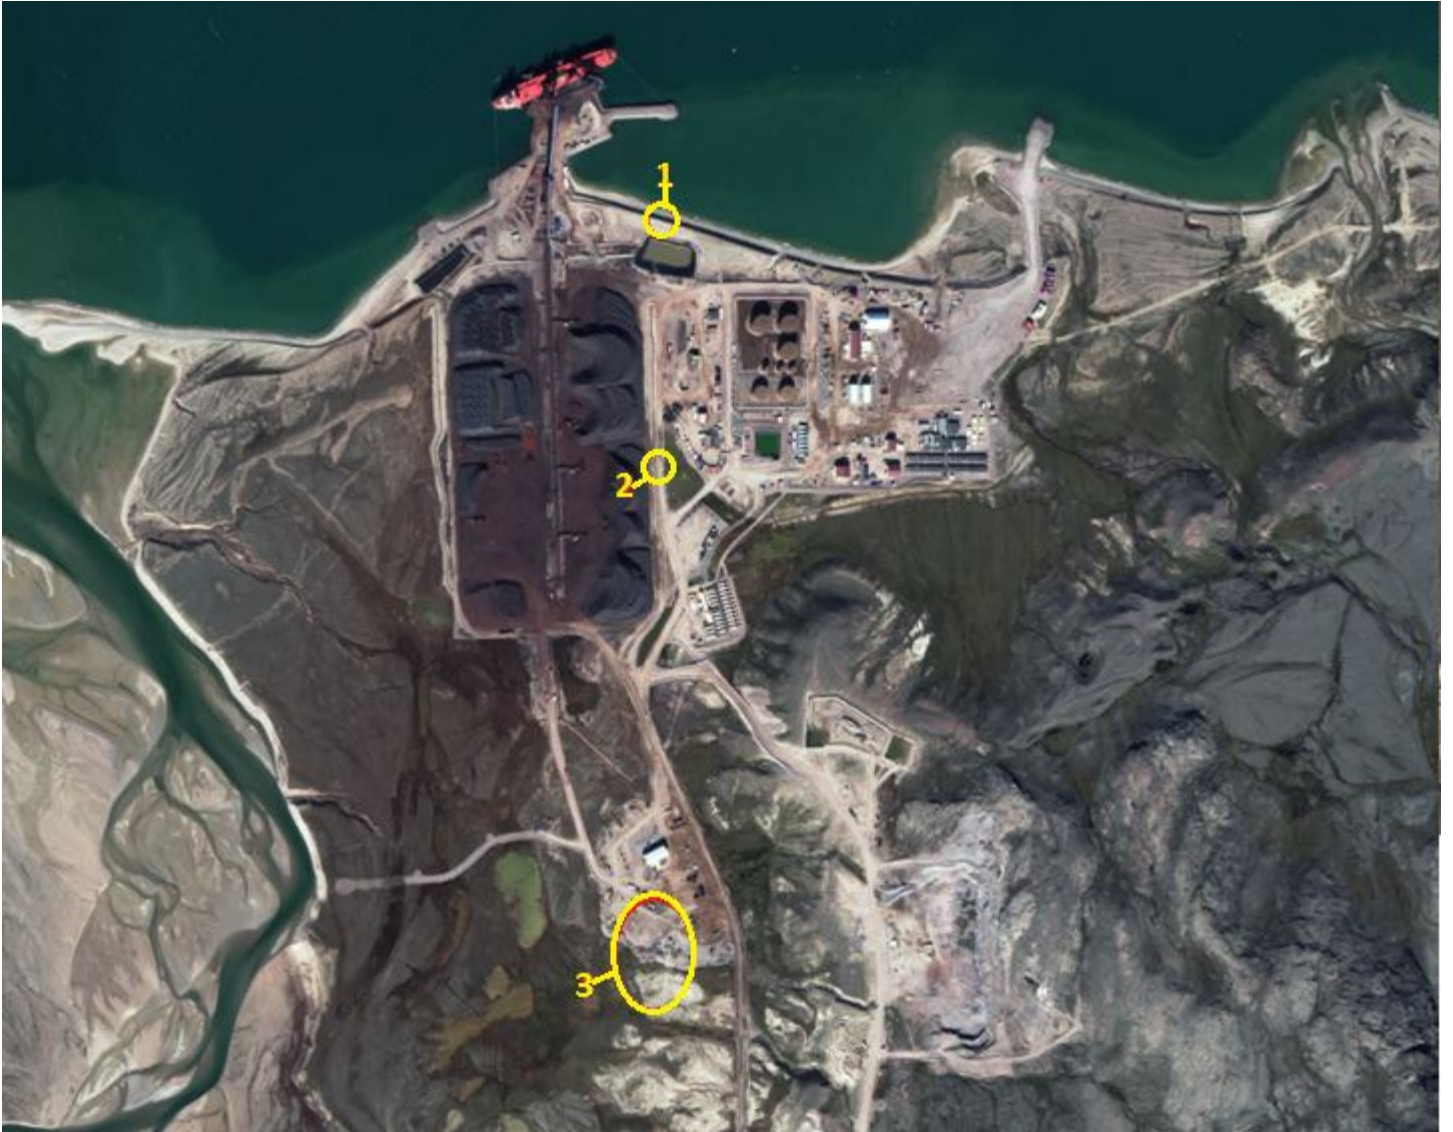
- b. At the time of the inspection there was water infiltrating the ore stockpile pad, see figure 4 Item 2 below. This appears to be the reason of the unauthorized discharge from the east sedimentation pond.

Figure 4: **Item 1:** Washout from East sedimentation pond. **Item 2:** location of water infiltrating ditches, the old snow dump and sampling location. **Item 3:** approximate location of the Camp lay-down Pad

- i. INAC Inspectors have expressed concern with this area where water is pooling before.
 - ii. It's advised that BIMC find a way to properly divert the water away from this area.

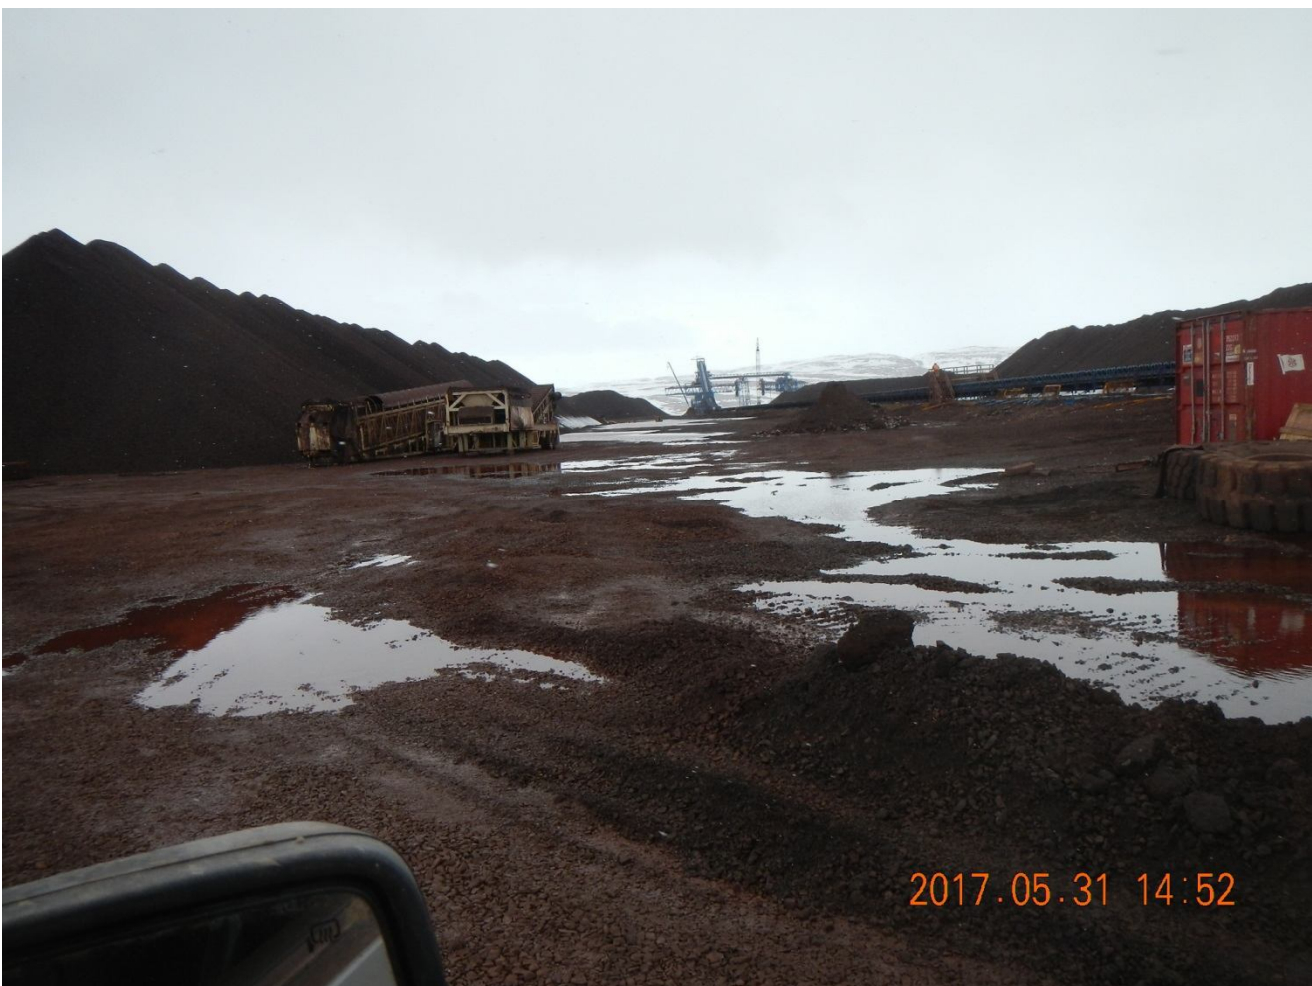
1. Ore Stockpile Pad and associated water management structures
 - a. The Ore Stockpile Pad had significant pooling inside the facility (figure 5 below); this leads the inspector to believe the facility is not being maintained properly.

Figure 5: water pooling inside the ore stockpile pad

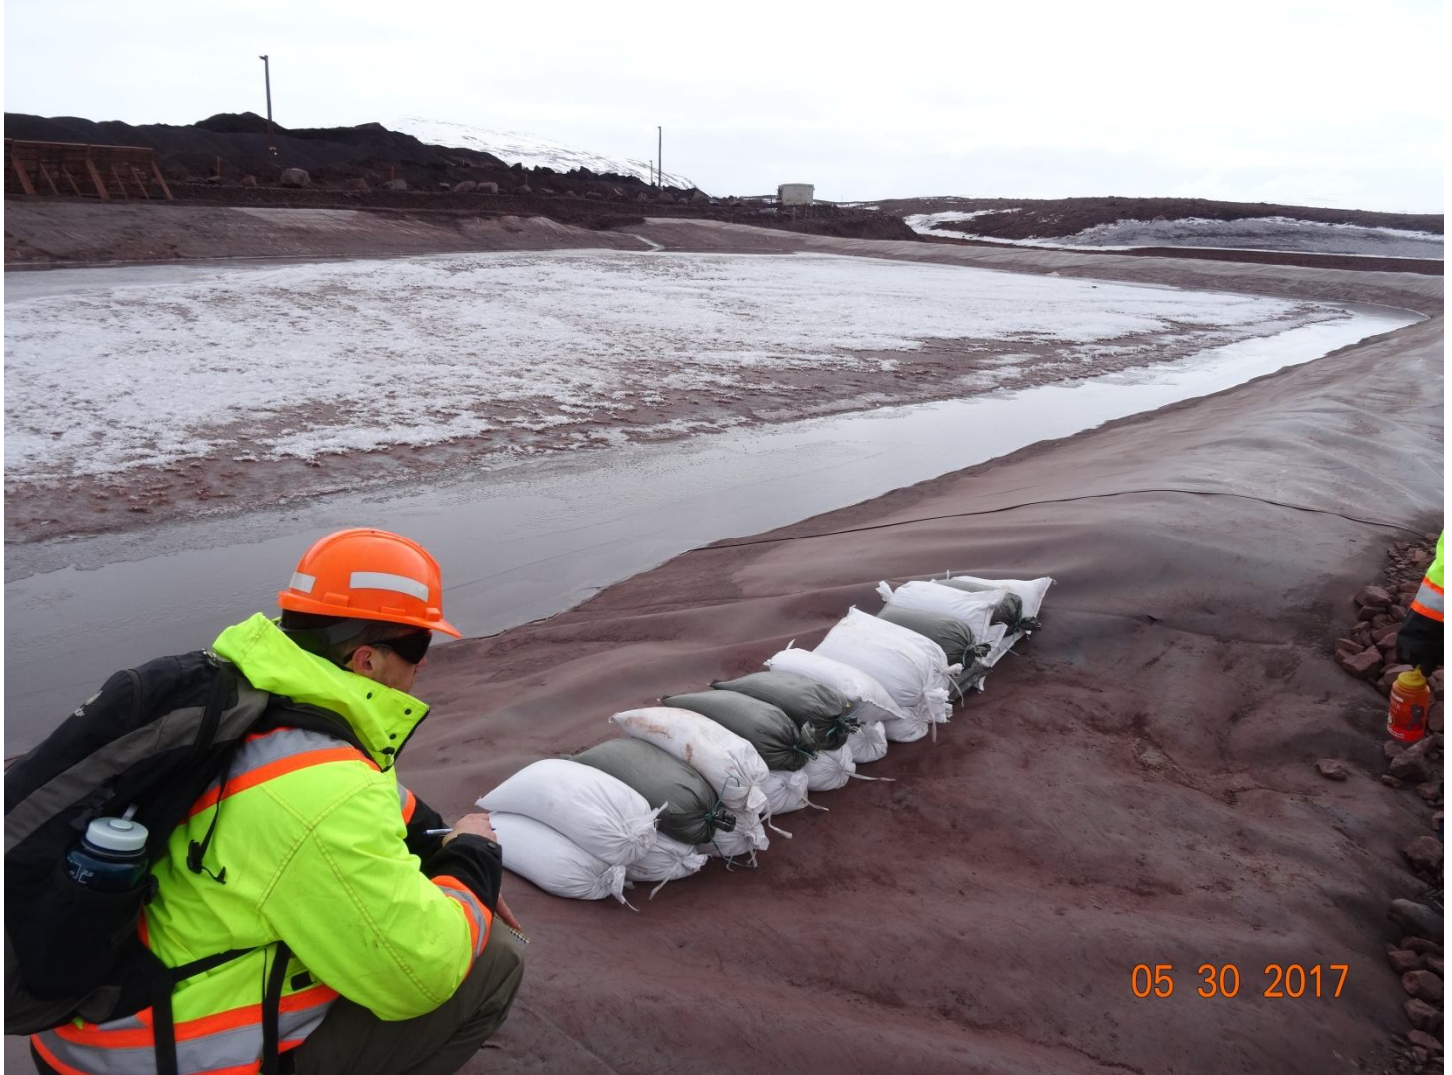
- e. Sand Bags along the spill way have not been installed as agreed upon by the NWB and BIMC as a short term fix in order to increase capacity.
 - f. The Licensee must ensure that all water generated on the facility is captured by the diversion ditches and sedimentation pond.

Figure 6: sandbags improperly installed

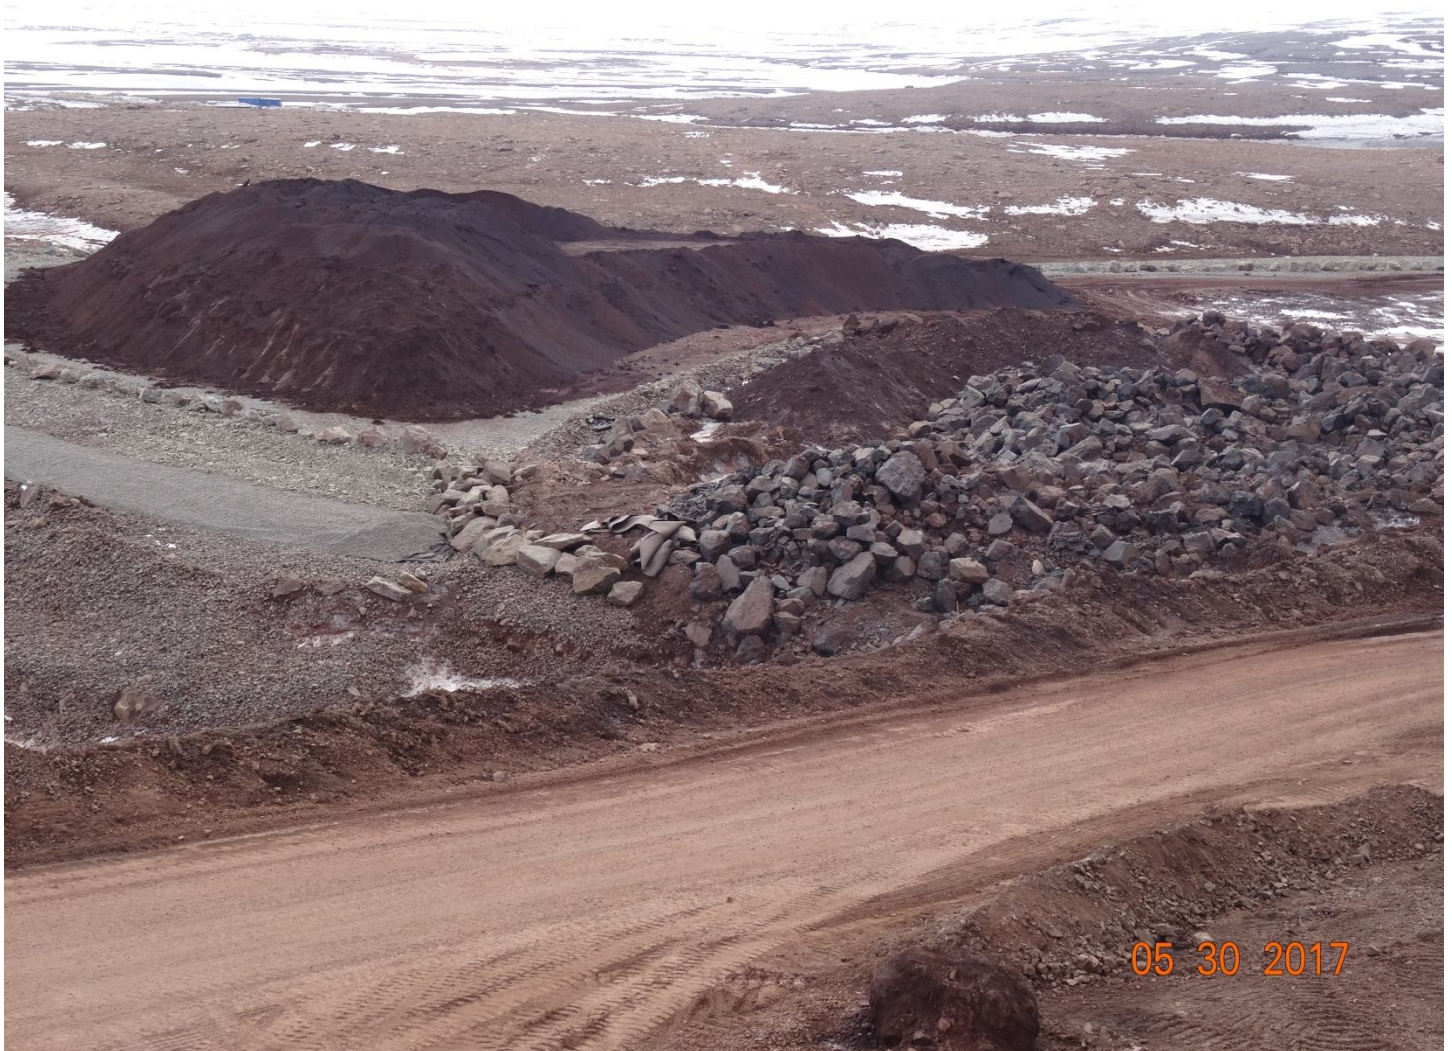
- i. In the drawings provided to the Nunavut Water Board, the "oversized" ore storage area is not identified and does not appear to be surrounded by ditches as you can see in figure 7 below.

- ii. Considering the information provided the inspector is concerned that the sedimentation pond is under capacity because, the surface area/surface water calculations do not appear to be capturing the actual storage area of the crusher pad.

Figure 7: Oversized Ore outside of ditching

- iii. The inspector is requesting that the BIMC review the 2017 Mine Site Crusher Pad Expansion (Modification Request) Water Licence 2AM-MRY1325 – Amend. No. 1, provide the NWB with the correct storage area of ore and provide the NWB with revised data regarding the; surface water runoff, ditching capacity and sedimentation pond capacity.
