WATER LICENCE INSPECTION FORM

SECTION 1	<input checked="" type="checkbox"/> Comments	<input type="checkbox"/> Non-Compliance with Act or Licence	<input type="checkbox"/> Action Required
Inspectors Statement			
On November 8, 2017, a water licence inspection was conducted at the Mary River Project, Qikiqtani Region, Nunavut. Sites inspected included the Mary River Mine Site, the Tote Road and the Milne Port area.			
Weather Conditions on Site			
Mainly cloudy with temperatures between -15 and -20 degrees Celsius. There was significant snow cover on the ground at the time of the inspection, making it difficult to determine the condition of most water and waste management structures.			
Summary of Report			
At the time of inspection, the Licensee was undertaking activities related to the operation of an open-pit iron ore mine at the Mine site (Mary River), Milne Port (Milne Inlet), and Tote Road. BIMC is primarily mining ore and transporting it to Milne Port in preparation for open water season. Construction activities on site include; Construction of an 800 man camp at Mary River site and work on problematic areas along the tote road.

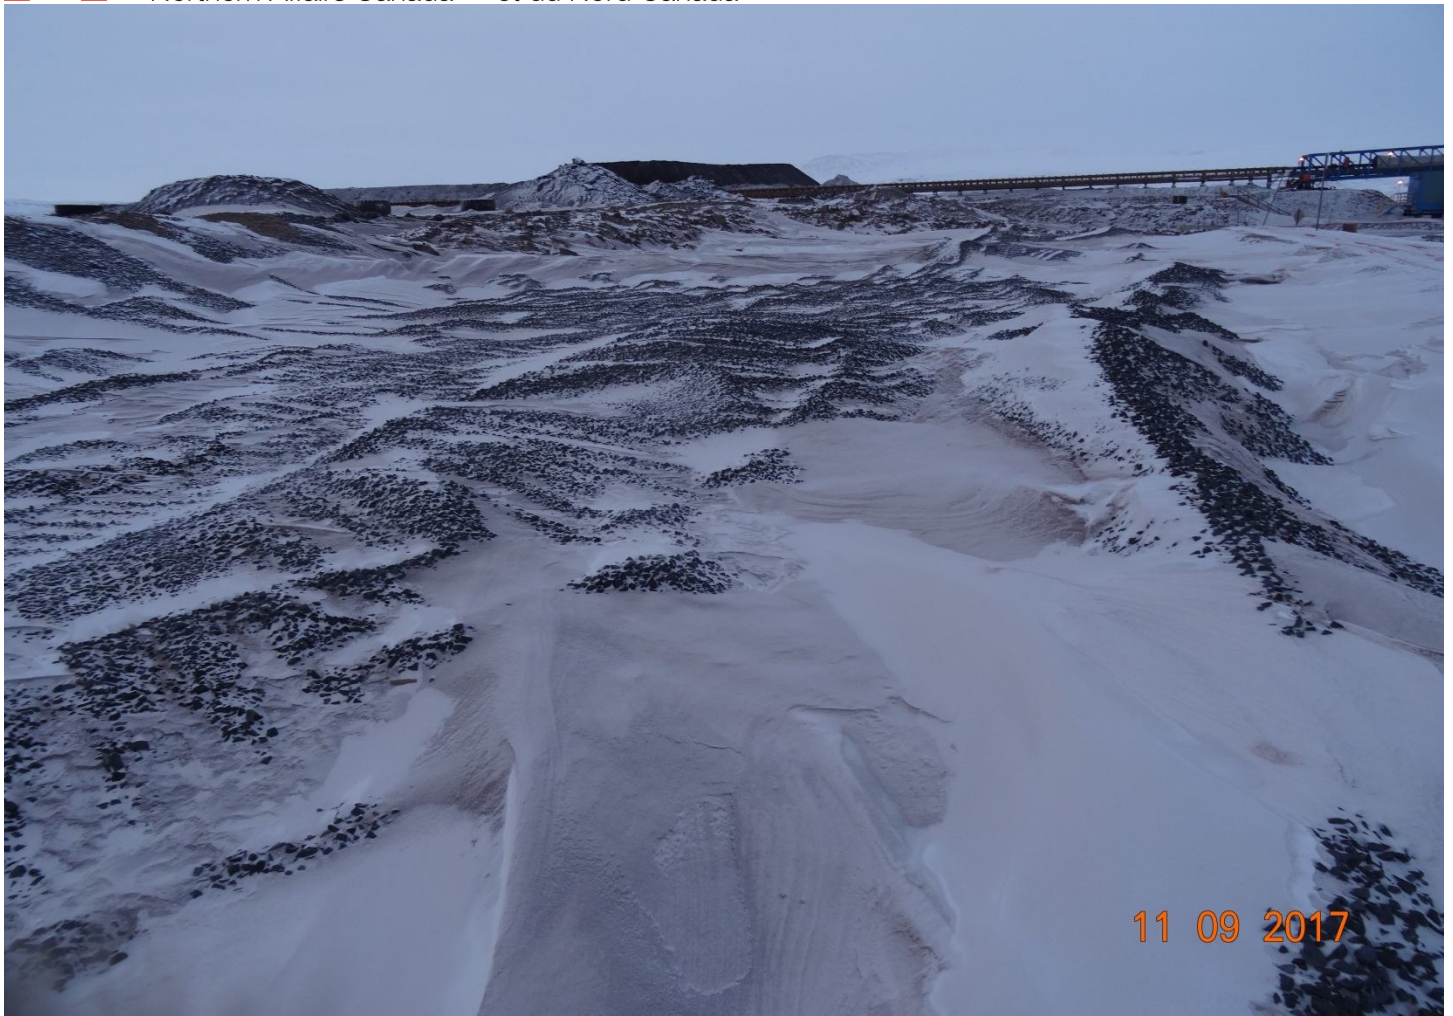
- b. During inspection a large area on the West side of the East sedimentation pond had significant ore used to level an area outside of containment.
 - I. Part D, Item 13 of the licence 2AM-MRY1325 states: The Licensee shall use fill material for construction from approved sources that been demonstrated by appropriate geochemical analyses to not produce Acid Rock Drainage and to be Metal Leaching properties.

Figure 1: crushed ore being used for fill.

- II. Please provide proof to the inspector that this ore had been approved for the use in construction.
 - III. If this ore has not been approved for construction the licensee shall remove the ore from the identified area before May, 2018. See figures 1 and 2 below for pictures of the area of concern.

2. To provide the inspector with proof that the ore in figure 1 and 2 has been approved for the use as fill material.			
Relevant information			
PART D CONDITIONS APPLYING TO CONSTRUCTION AND OPERATIONS

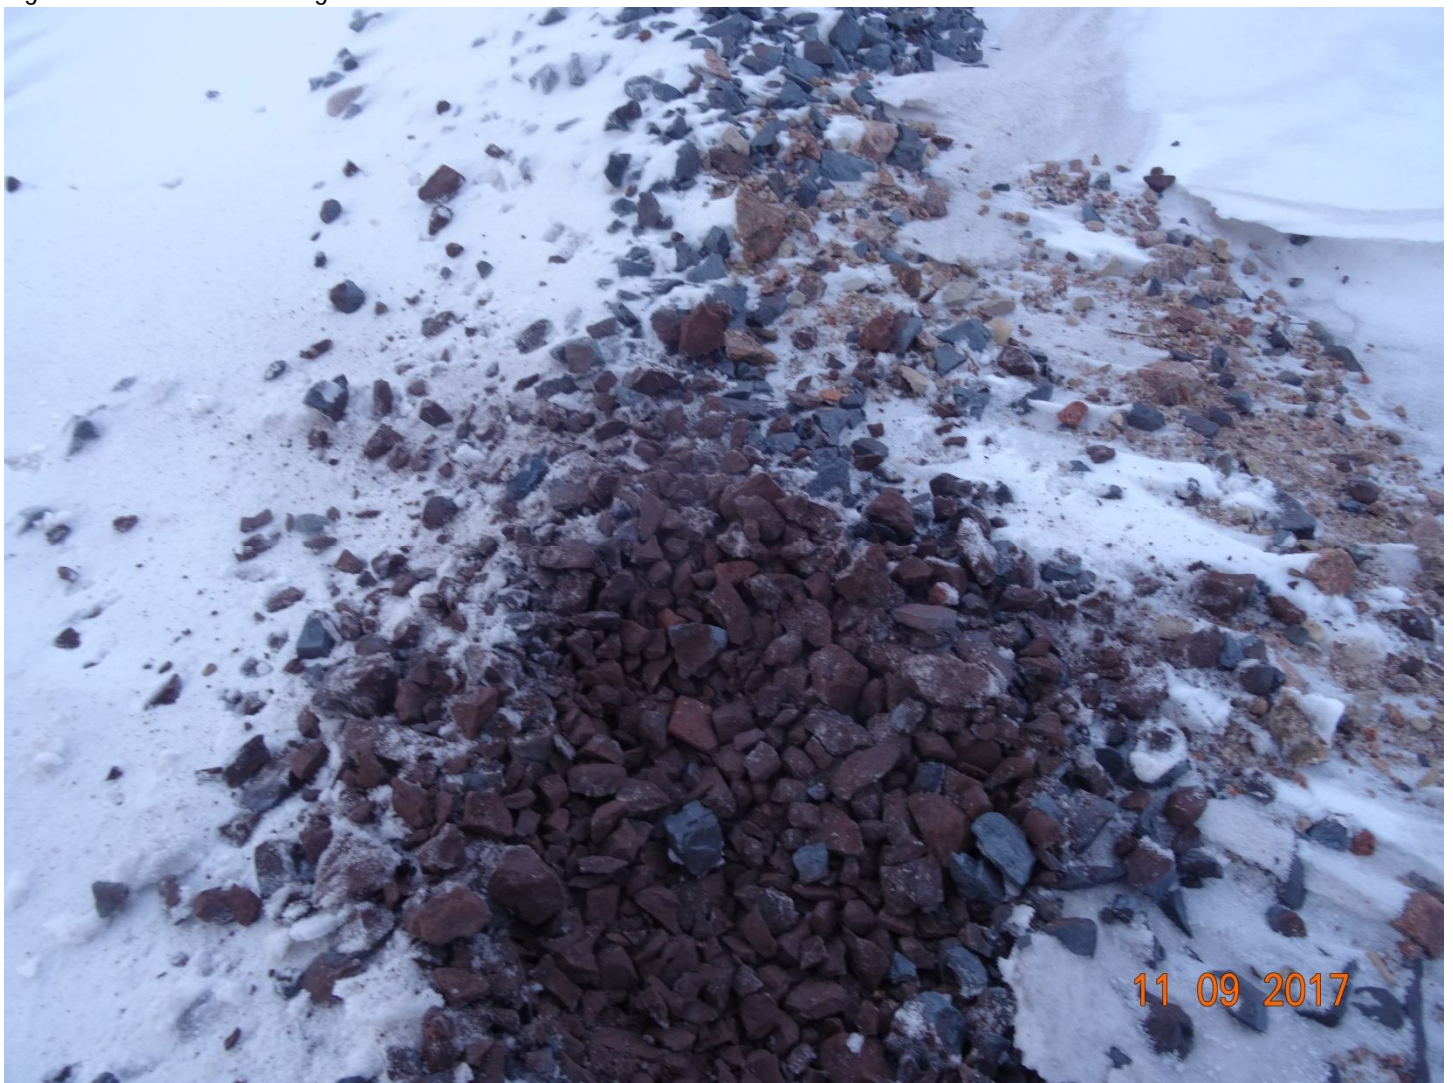
Figure 2: ore being used for fill

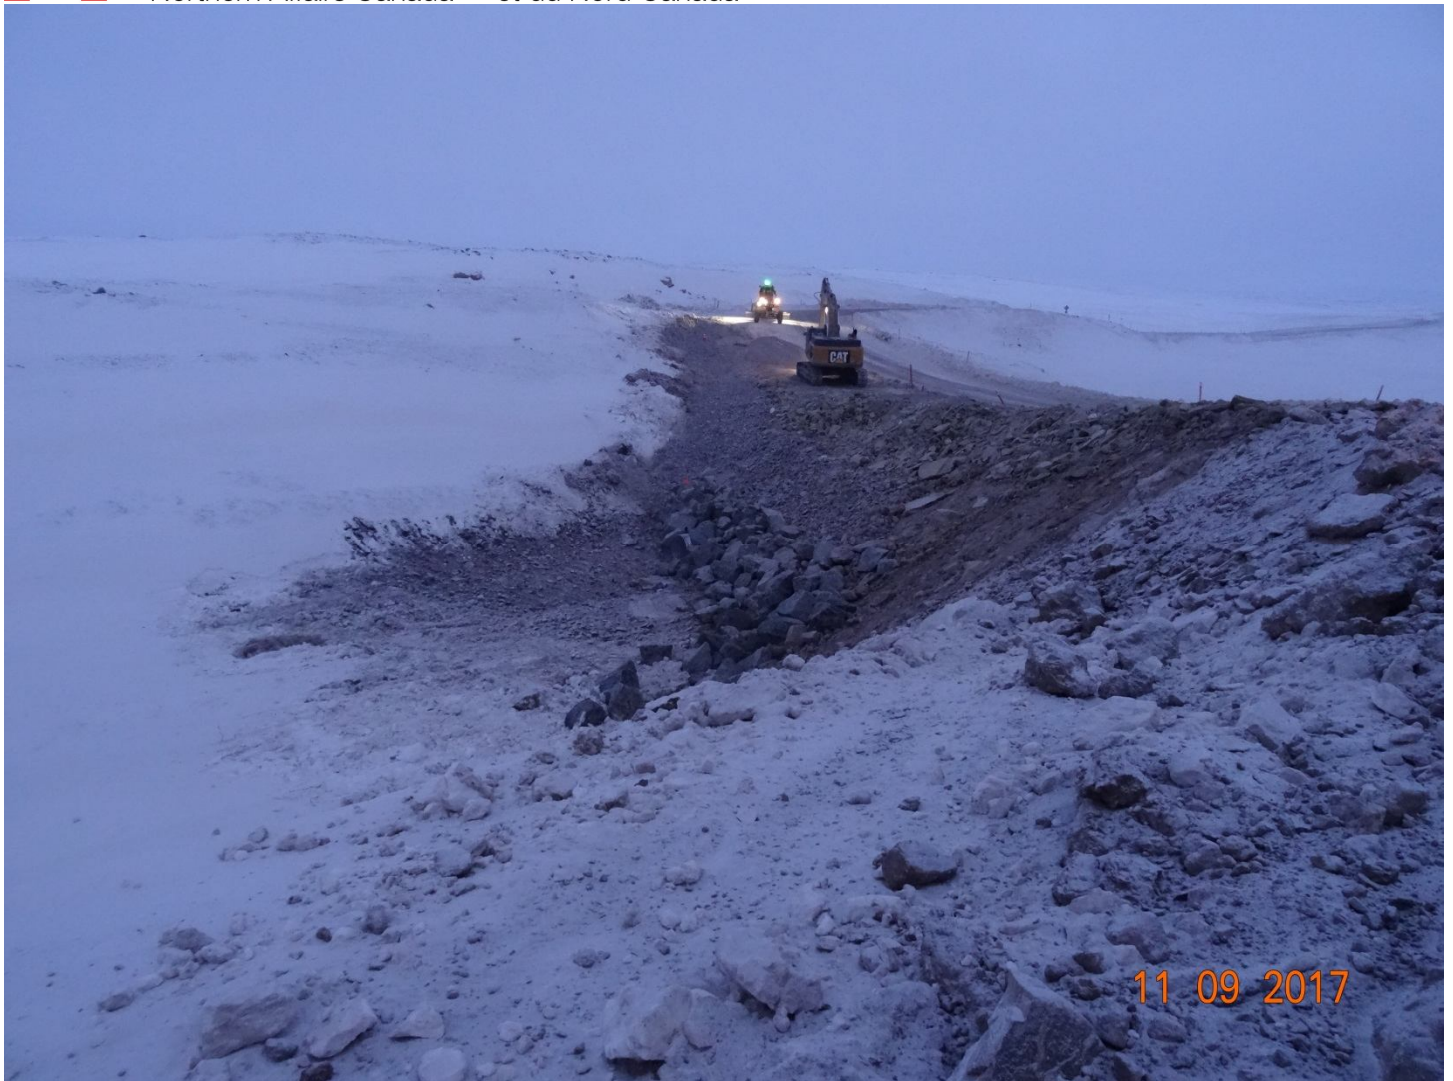
- b. At the time of the inspection the licensee was working on armouring ditches and culverts at kilometer 85.
 - I. INAC's senior engineer raised concerns with the size and layout of the rip rap, It does not appear to the engineer that the placement and size is compliant with best practices.

Figure 3: Km 85 construction

- II. This issue will be monitored during future inspections by the senior engineer to ensure that this is adequate. See Figure 3 for a picture of the area of concern.

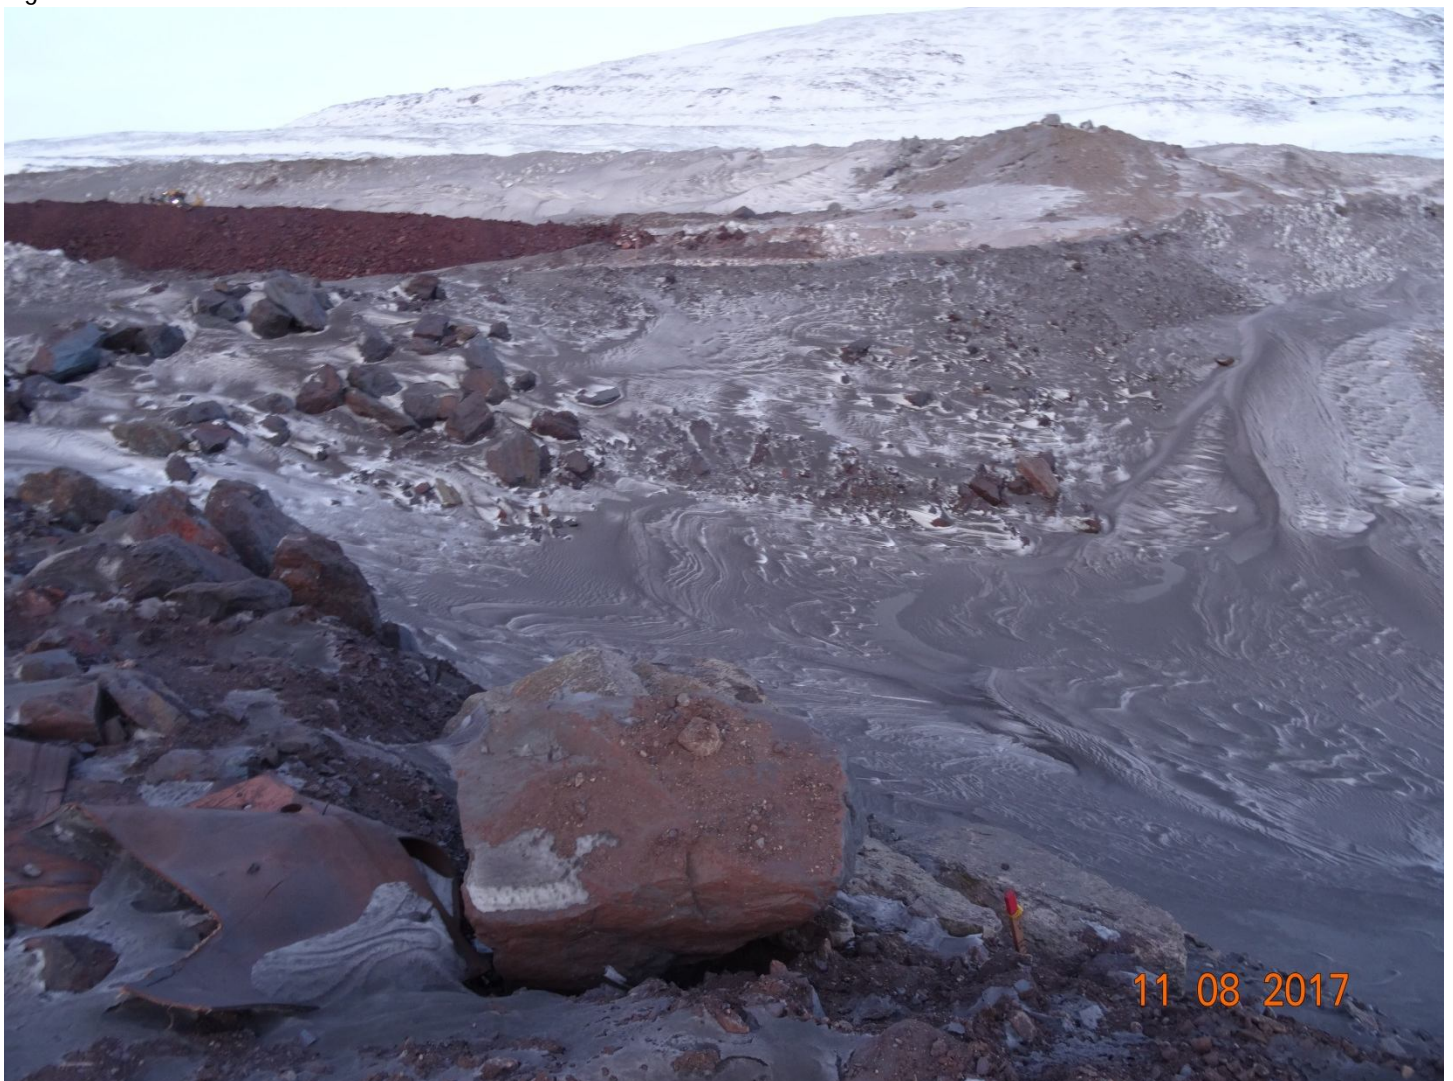
3. **Ore Crushing Area and associated water management structures**
 - a. As noted in the previous inspection, the diversion ditches around this facility do not appear to fully surround the ore crusher pad. See figure 4 for the area that is not contained by ditches.

Figure 4: Crusher pad-There is no diversion ditches below this “oversize” ore.

- b. Until the facility is fully surrounded by ditches, INAC is requesting that the Licensee start bi-weekly sampling down gradient from the area where no ditches are present. The licensee is to provide the inspector with the following;

- I. Lab results for all criteria set out in PART F, Item 25 in the water licence 2AM-MRY1325.
 - II. Photos of the sampling being conducted.
 - III. Time, Date, GPS coordinates.

- IV. Name and position of the person sampling.
 - c. During the inspection there was crushed ore and a boulder pushed into the ditches around this facility.

3. INAC is requesting that the Licensee start bi-weekly sampling down gradient from the area where no ditches are present at the Ore Crusher Pad. The licensee is to provide the inspector with the following: Lab results for all criteria set out in PART F, Item 25 in the water licence 2AM-MRY1325.Photos of the sampling being conducted, Time, Date, GPS coordinates, Name and position of the person sampling.

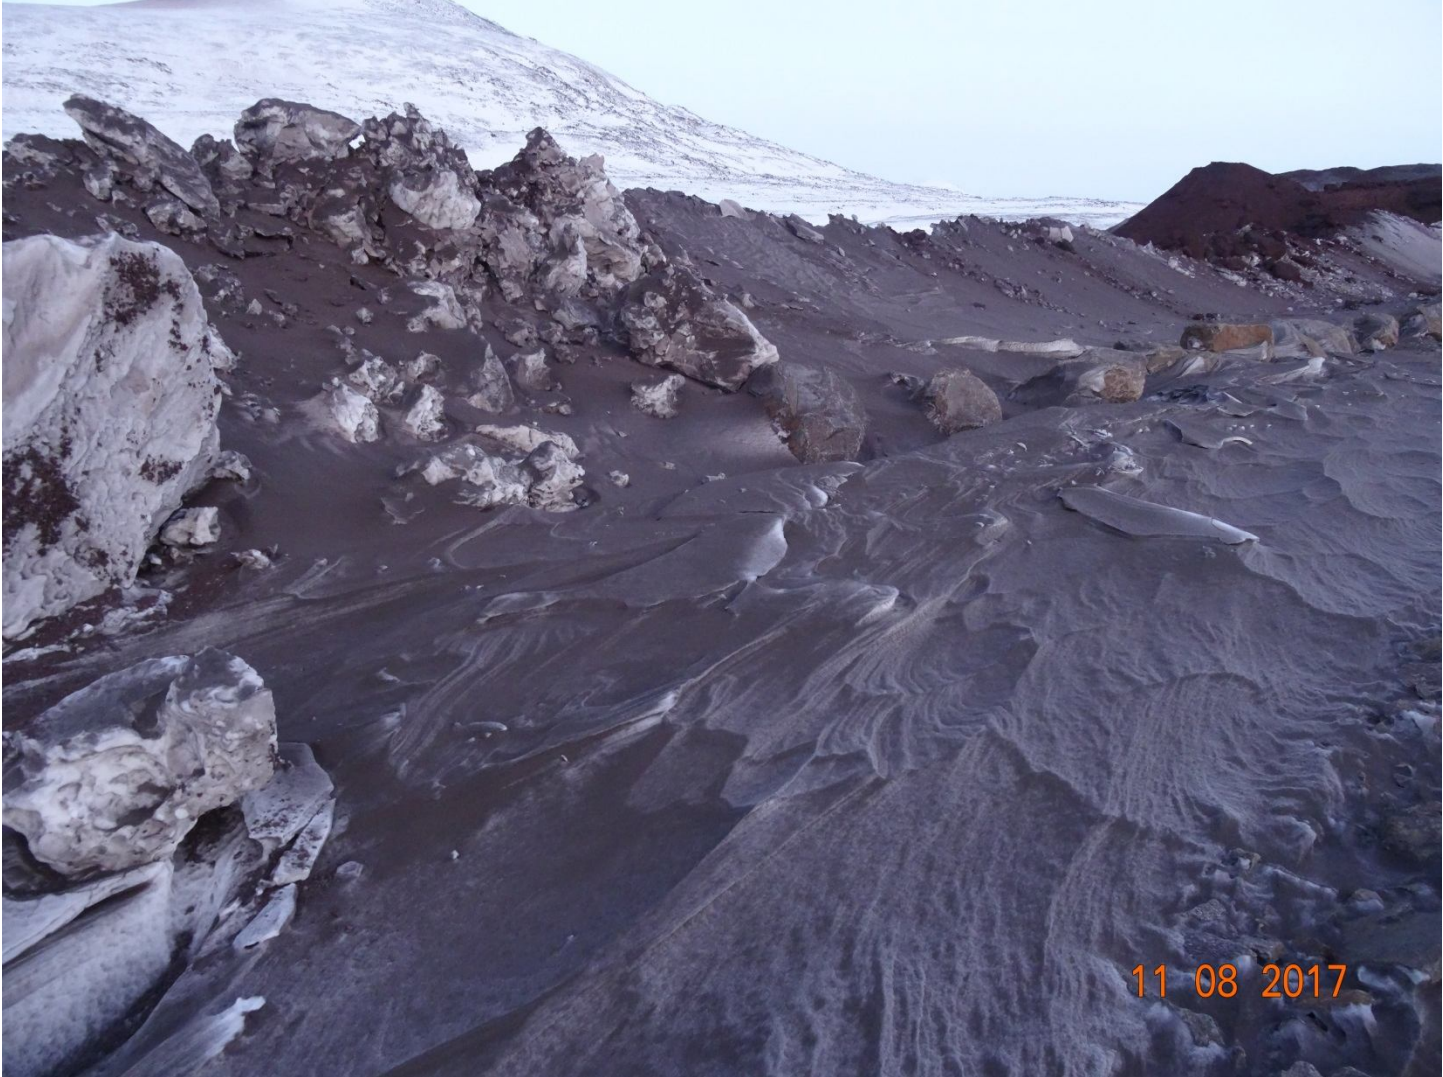
Figure 5: snow pushed into the ditches.

- I. This debris is to be removed prior to freshet 2018 to allow proper flow of water to the sedimentation ponds. See figures 5-7 for photos of debris in the ditches.

4. To remove all debris from all diversion ditches prior to freshet 2018, so that surface water flows as intended to the sedimentation ponds.			
5. To come in compliance with Items 1 and 2 of the Inspectors Direction written on September 5, 2017 to Baffinland Iron Mines Corporation.

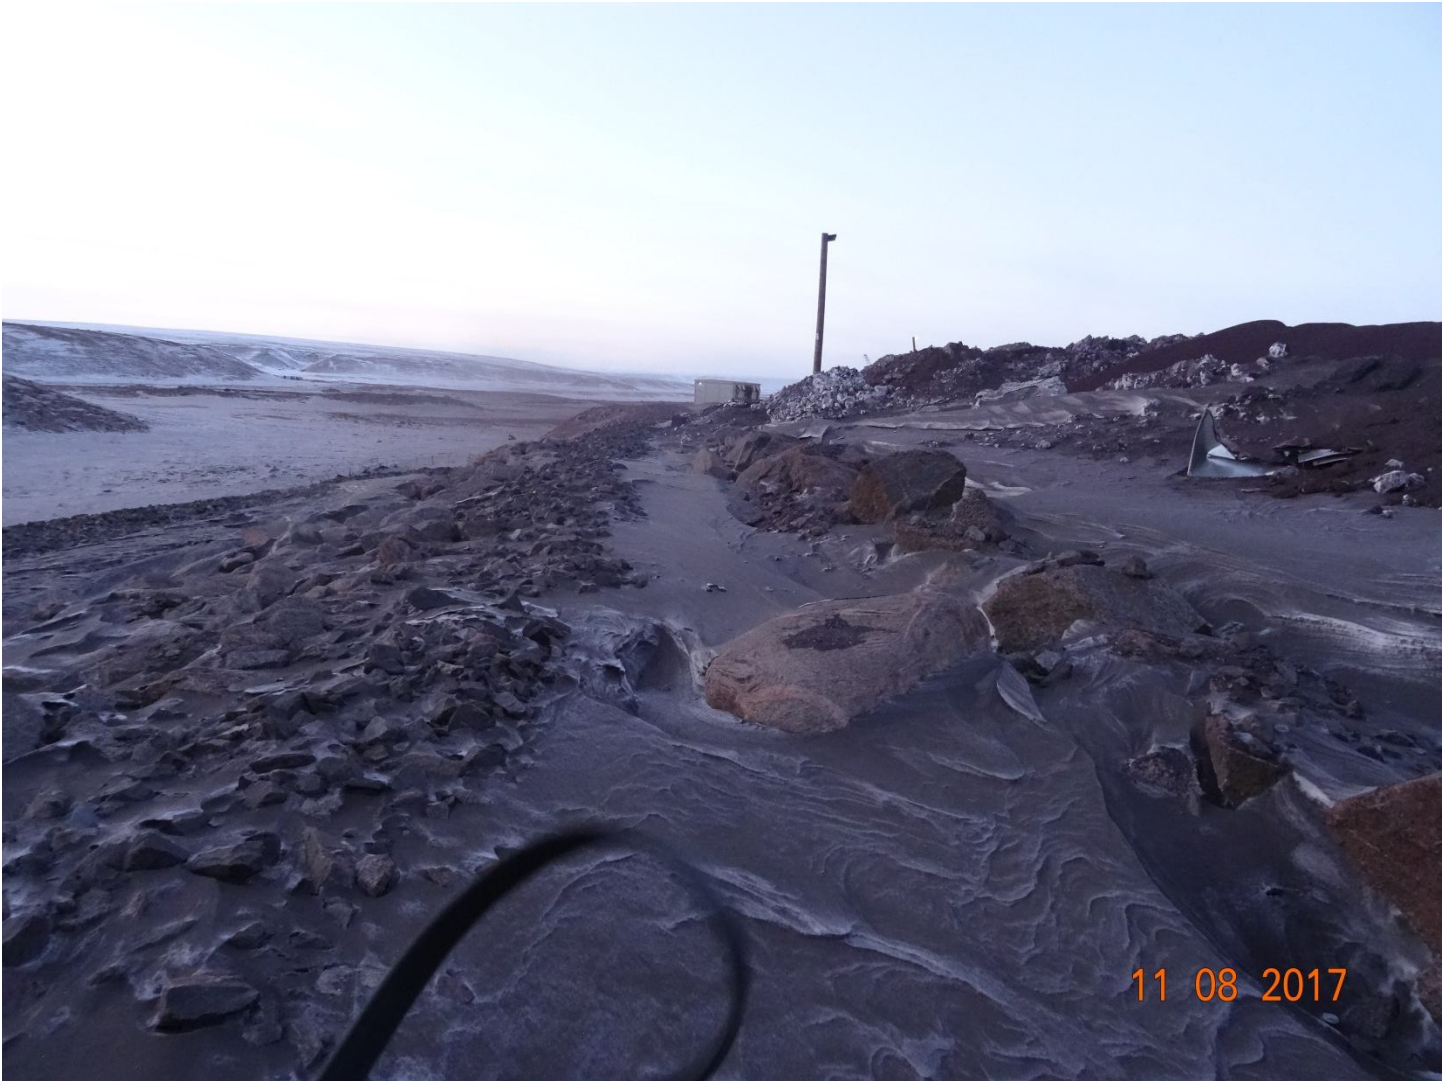
Figure 6: Boulder pushed into the ditch.

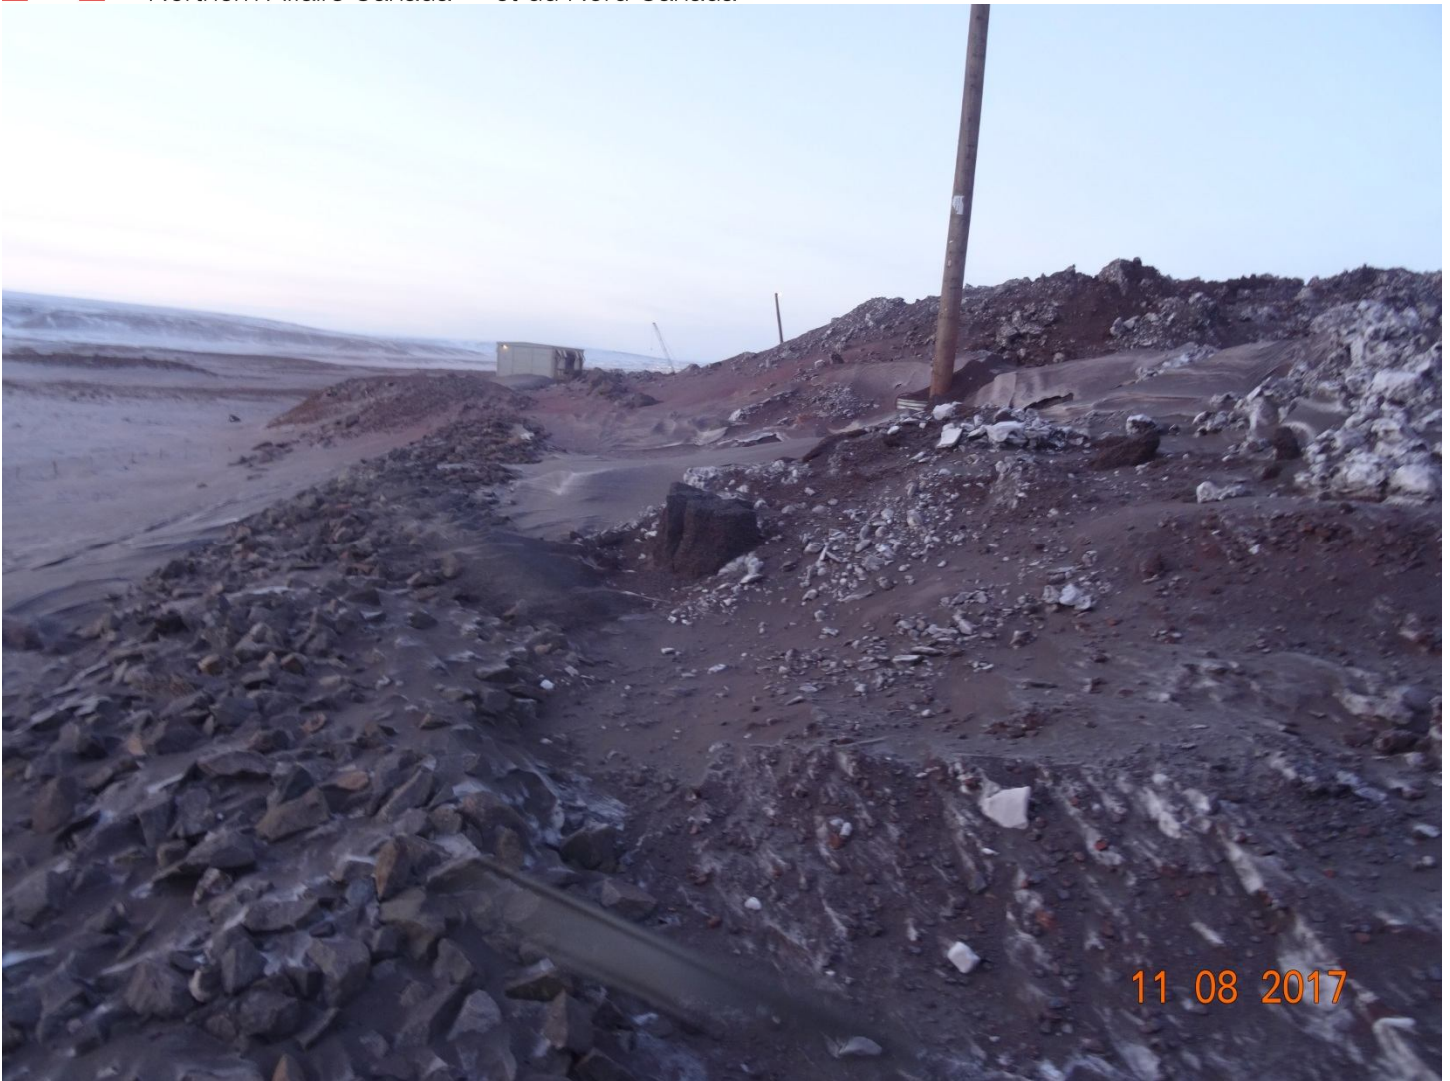
Figure 7: crushed ore pushed into the ditch.
