WATER LICENCE INSPECTION FORM

| Baffinland Iron Mines Corporation (BIMC) | | William Bowden | |
| 2AM-MRY1325 | | Environmental Superintendent | |
| June 22 – 24, 2018 | | Jonathan Mesher | |

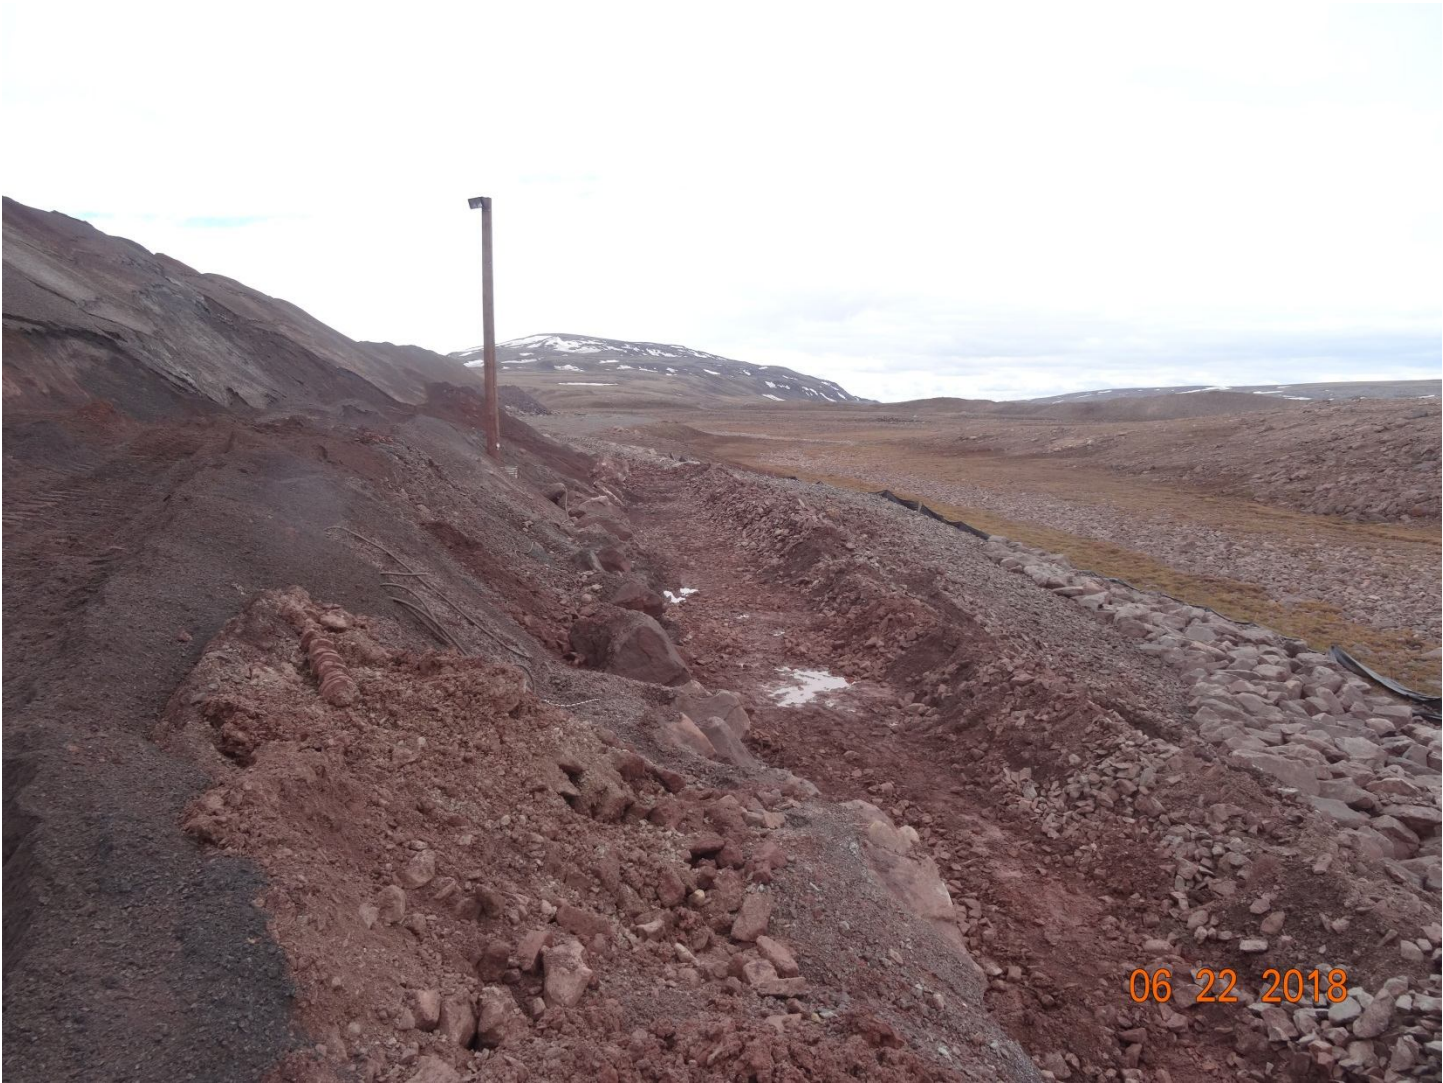
| a. The height of the outer berm wall of the ditches that surrounds the crusher pad appears to be inconsistent in height and in inconsistent with the approved design drawings. See figure 1. | | | |
| b. The ditches surrounding this facility appear to have low points. | | | |
| I. This observation leads the inspector to believe that the water management structures surrounding the ore crusher pad are not built to the approved design drawings. See figure 1. | | | |

- d. In the drawings developed by Golder Associates Corporation and BIMC it shows that there should be eight metres (8m) of space between the stockpile and the ditches for single lane traffic. See figure 1. When the inspector questioned the Baffinland employees of required 8m/ single lane road between the stockpile and the ditches, the Baffinland employees were unaware of this requirement.

Figure 1: Inconsistent ditch height, land of 8m between ditch and stockpile, ditch inconsistent with approved drawings.

- I. Baffinland is required to ensure that all water and waste management structures are operating as approved by the Nunavut Water Board.
  - II. The inspector is requesting that Baffinland review the construction drawings developed by Golder Associates and provided by Baffinland to ensure that this facility is built in accordance with the specifications originally provided to CIRNAC and the.

| SECTION 2 | <input type="checkbox"/> Comments | <input type="checkbox"/> Non-Compliance with Act or Licence | <input checked="" type="checkbox"/> Action Required |
|---|---|---|---|
| 2. The inspector is requesting that Baffinland review the construction drawings developed by Golder Associates and provided by Baffinland to ensure that Ore crusher pad and water management structures are built in accordance with the specifications originally provided to CIRNAC and the NWB. | | | |

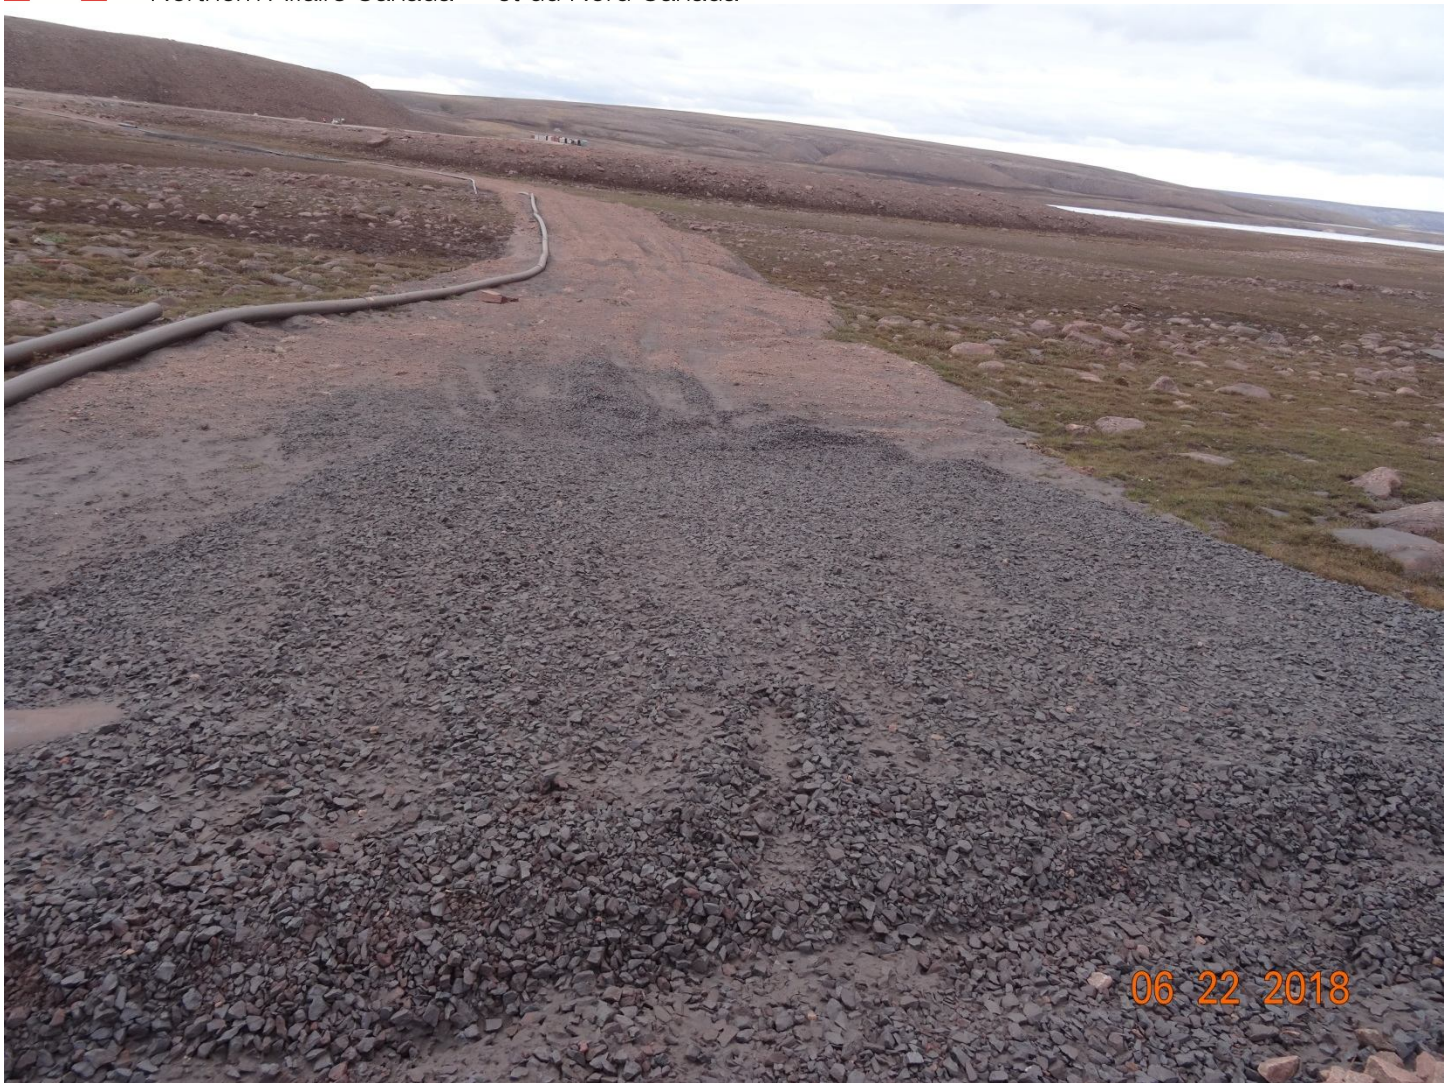
- e. It appears that Iron Ore is being used as construction material near the Crusher Pad. BIMC is to remove this Iron Ore or provide the required study/technical evidence that this ore has been approved for the use of Iron Ore as construction material.

Figure 2: Ore being used as construction material.

| SECTION 2 | <input type="checkbox"/> Comments | <input type="checkbox"/> Non-Compliance with Act or Licence | <input checked="" type="checkbox"/> Action Required |
|---|---|---|---|
| 3. It appears that Iron Ore is being used as construction material near the Crusher Pad. BIMC is to remove this Iron Ore or provide the required study/technical evidence that it has been approved for the use as construction material. See figure 3. | | | |

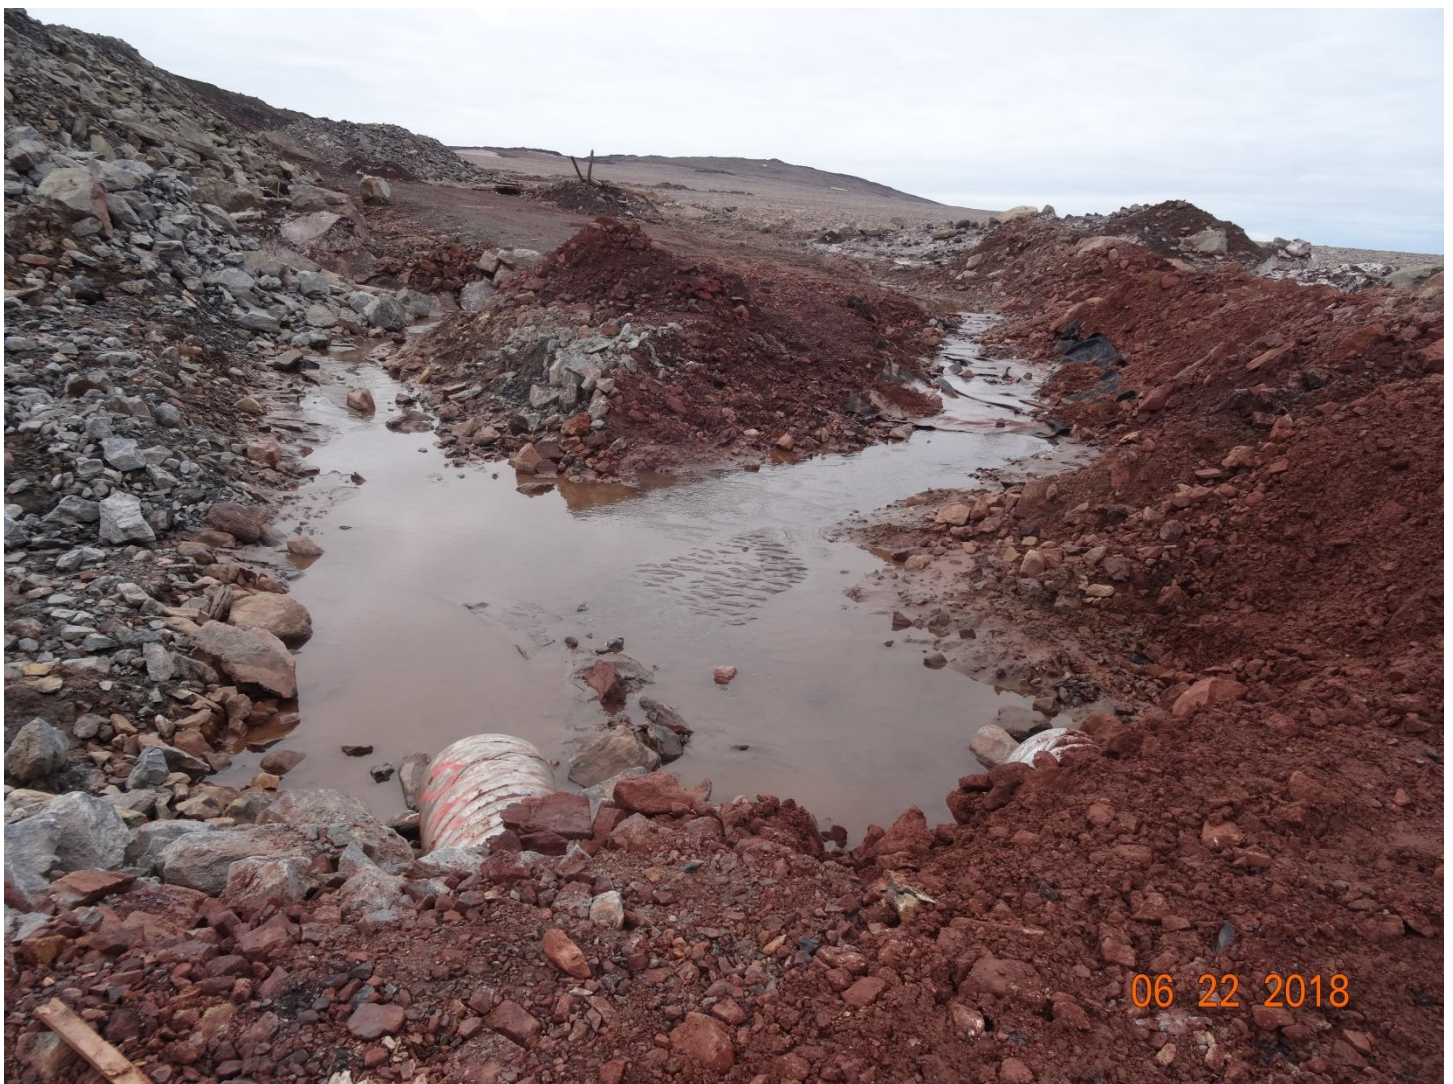
- a. At the time of the inspection the licensee was treating water from the leaking sedimentation pond for low levels of PH and TSS.
- b. Prior to the inspection the Licensee had reported a spill (spill report # 18-244) that occurred at the waste rock stockpile West drainage ditch of the, this location was identified as an area of concern in the past two Water Licence Inspection reports November 2017 and May 2018. The licensee has made two modifications to this water management structure; one being the construction of the road over the ditch to access the emergency ditch constructed to collect seeping waste, the second being the increase of capacity of the ditch. See figure 3 for the spill location.

Figure 3: area of the spill from the Waste Rock Stockpile and modification of ditch.

- I. The licensee is to submit a modification request for the two modifications made to this water management structure and ensure that no modifications are made to water management structures unless authorized by the Nunavut Water Board (NWB).

| SECTION 2 | <input type="checkbox"/> Comments | <input type="checkbox"/> Non-Compliance with Act or Licence | <input checked="" type="checkbox"/> Action Required |
|---|---|---|---|
| 5. The licensee is to submit a modification request for the two modifications made to the waste rock stockpile ditches and ensure that no modifications are made to water management structures unless authorized by the Nunavut Water Board (NWB). | | | |

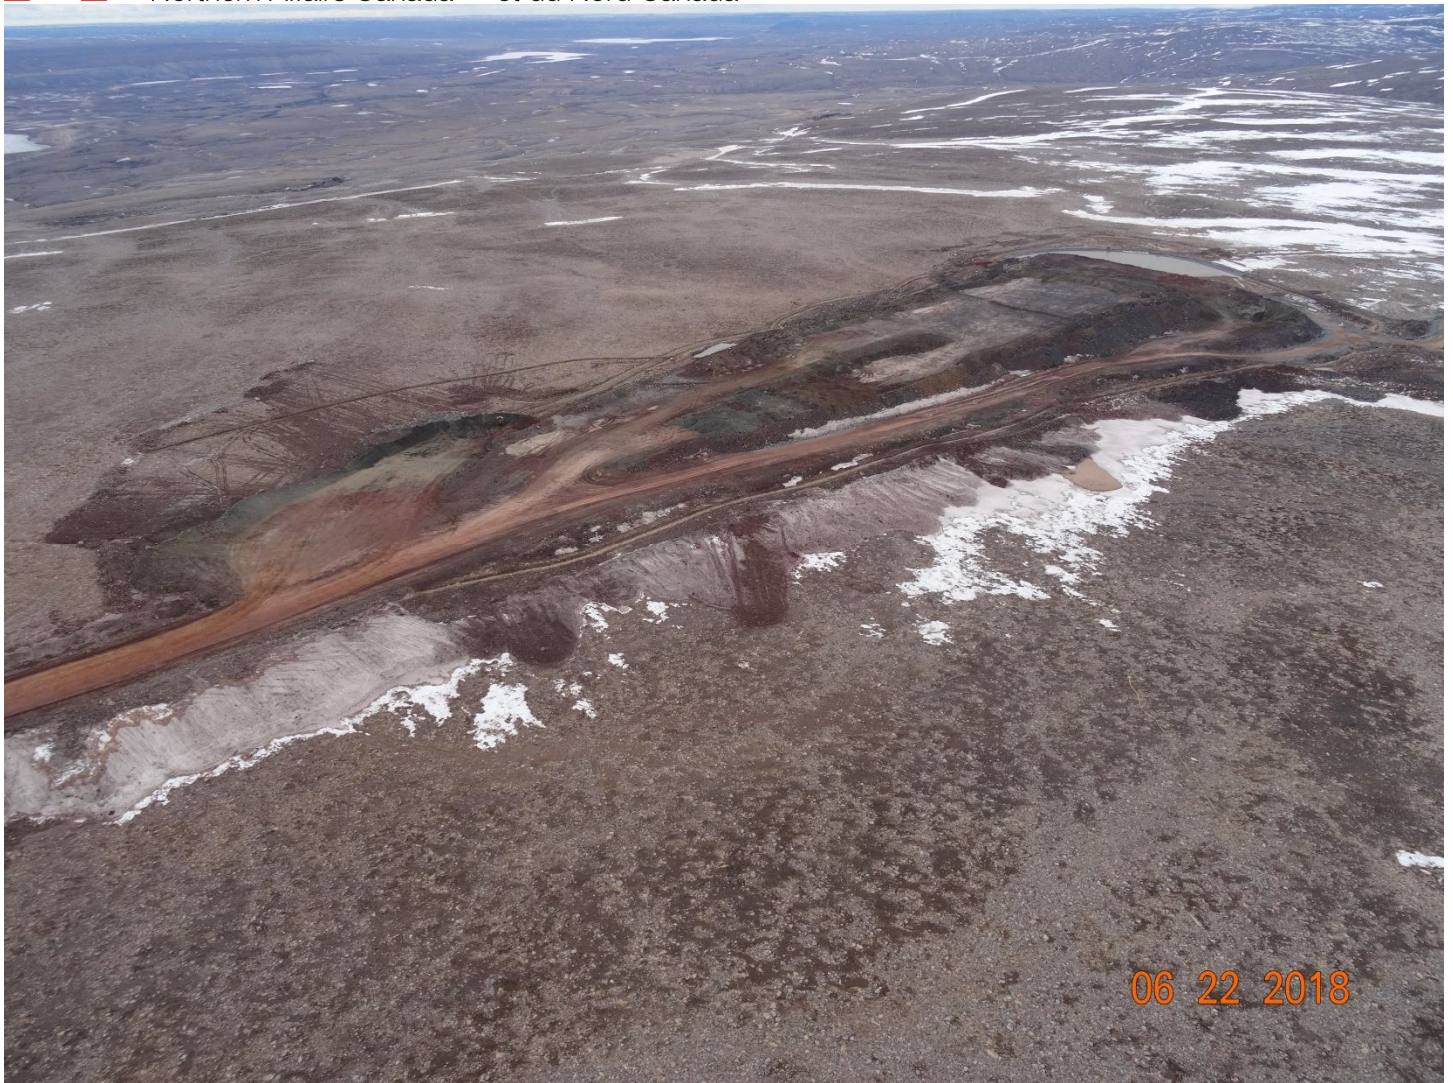
Figure 4: East side of Waste Rock Stockpile.

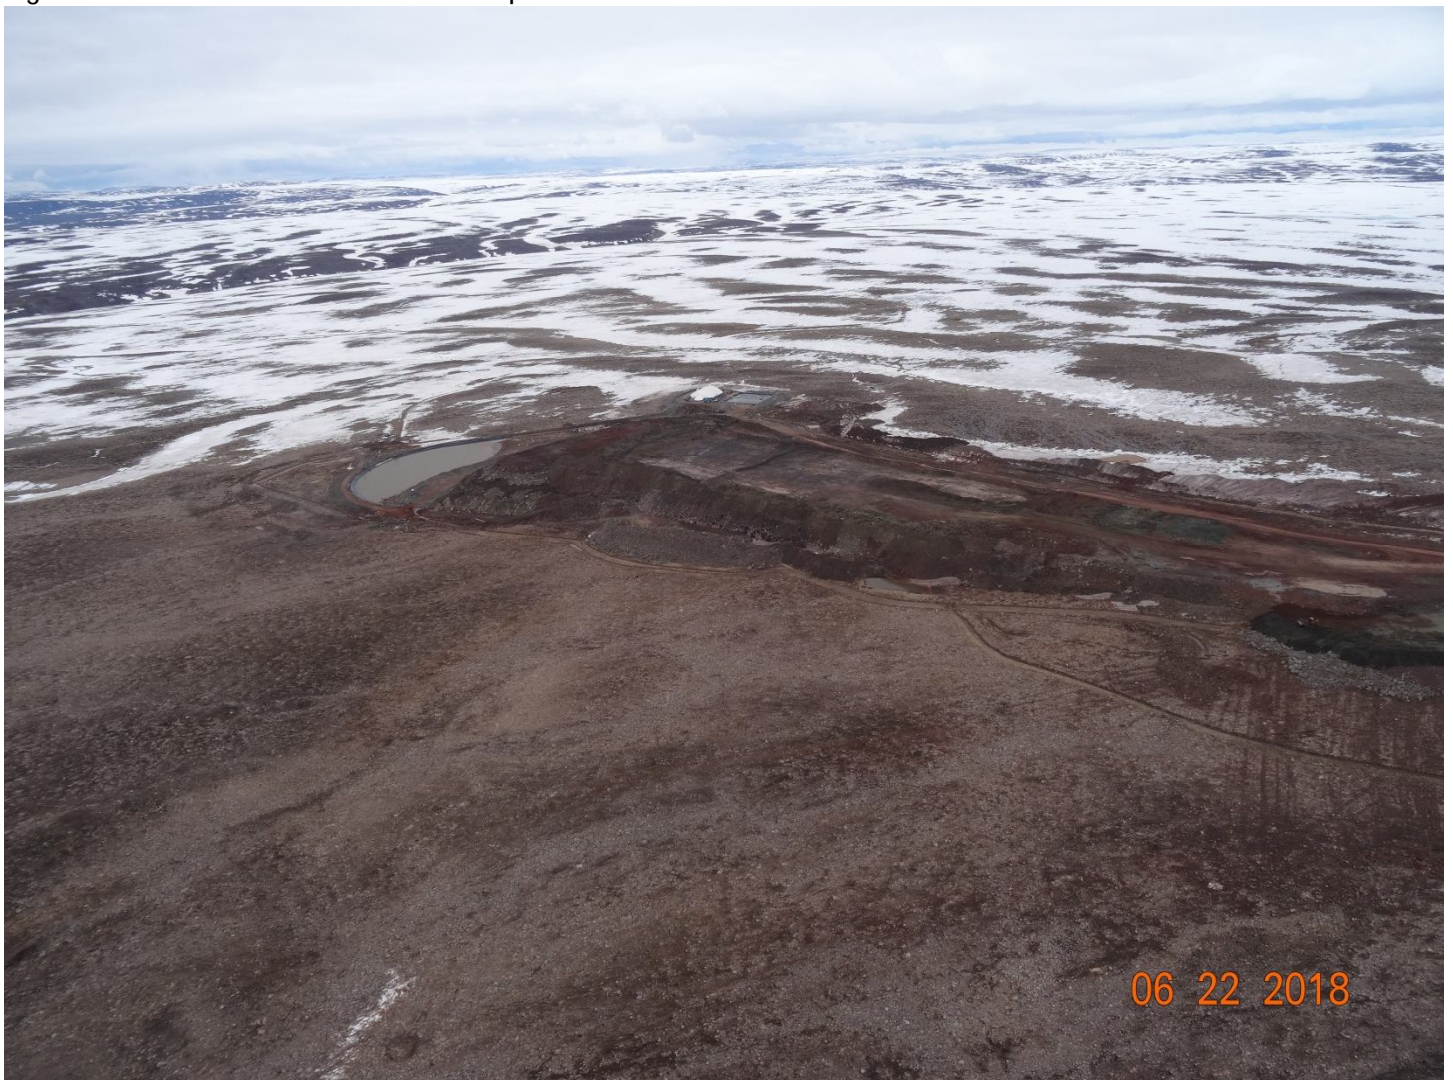
Figure 5: West side of Waste Rock Stockpile.

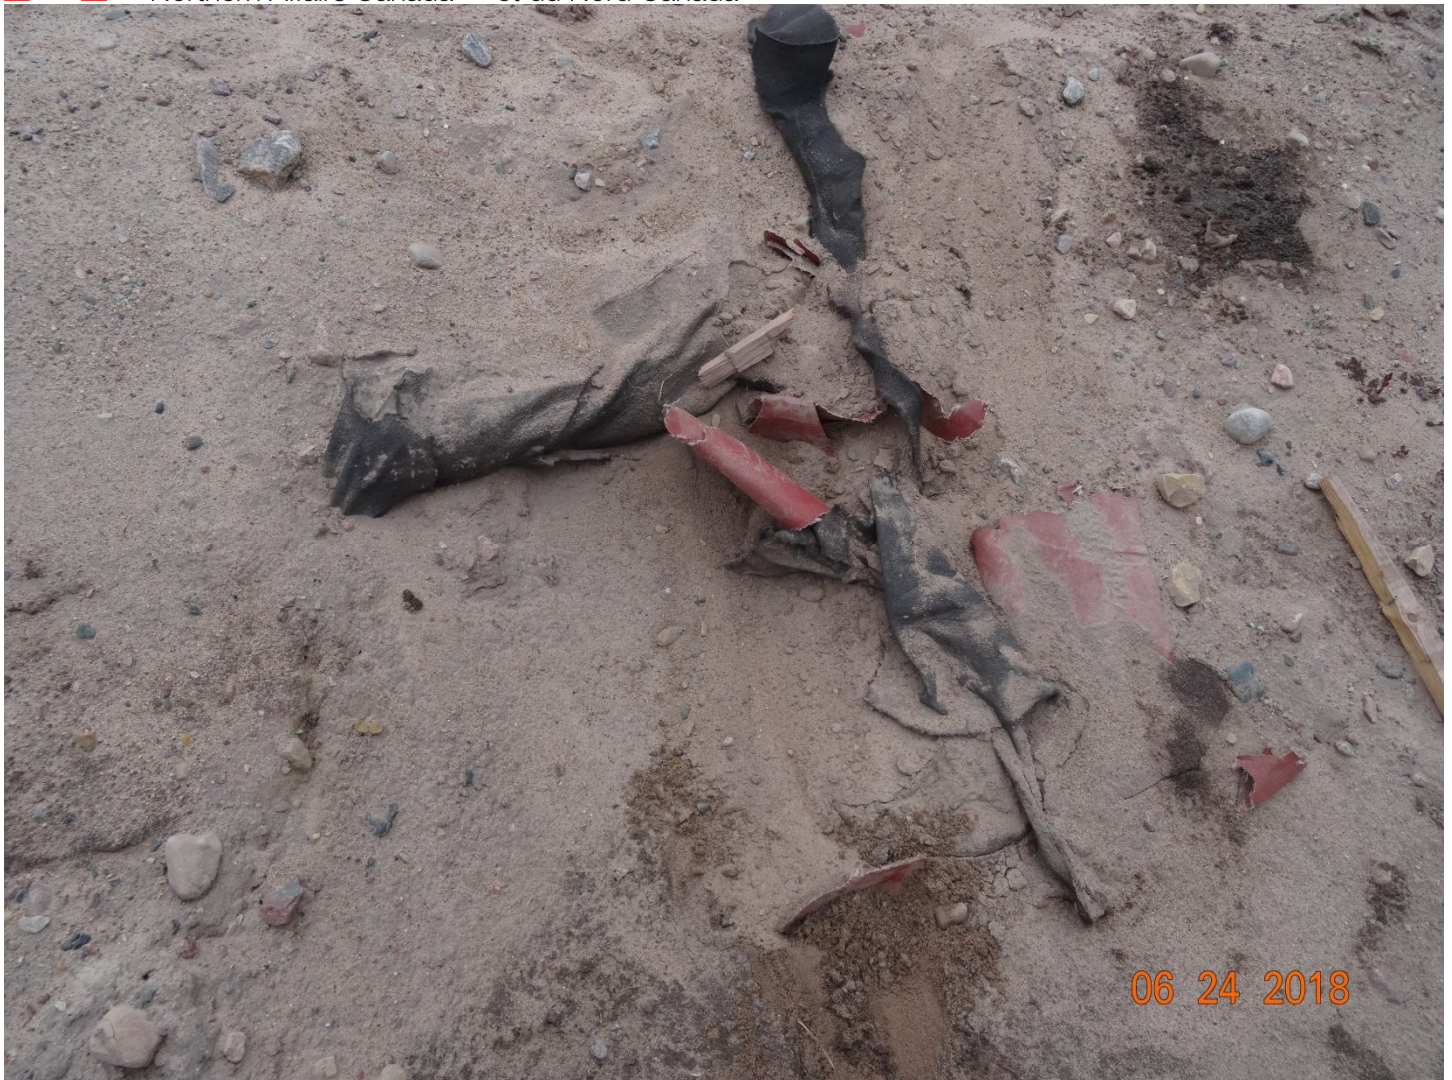
- a. The Hazardous Waste Berm HWB #7 has rips in the liner. See Figure # 6 .
  - I. The licensee is to remove all hazardous waste from this facility until the liner is repaired or provide the inspector and the NWB with a report outlining short term measures put in place to ensure that no waste is capable of leaving this facility.

Figure 6: Hazardous waste secondary containment liner rip.

| SECTION 2 | <input type="checkbox"/> Comments | <input type="checkbox"/> Non-Compliance with Act or Licence | <input checked="" type="checkbox"/> Action Required |
|---|---|---|---|
| 6. The licensee is to remove all hazardous waste from the ripped hazardous waste berm until the liner is repaired or provide the inspector and the NWB with a report outlining short term measures put in place to ensure that no waste is capable of leaving this this facility. See figure 6 for a photo of the rip. | | | |

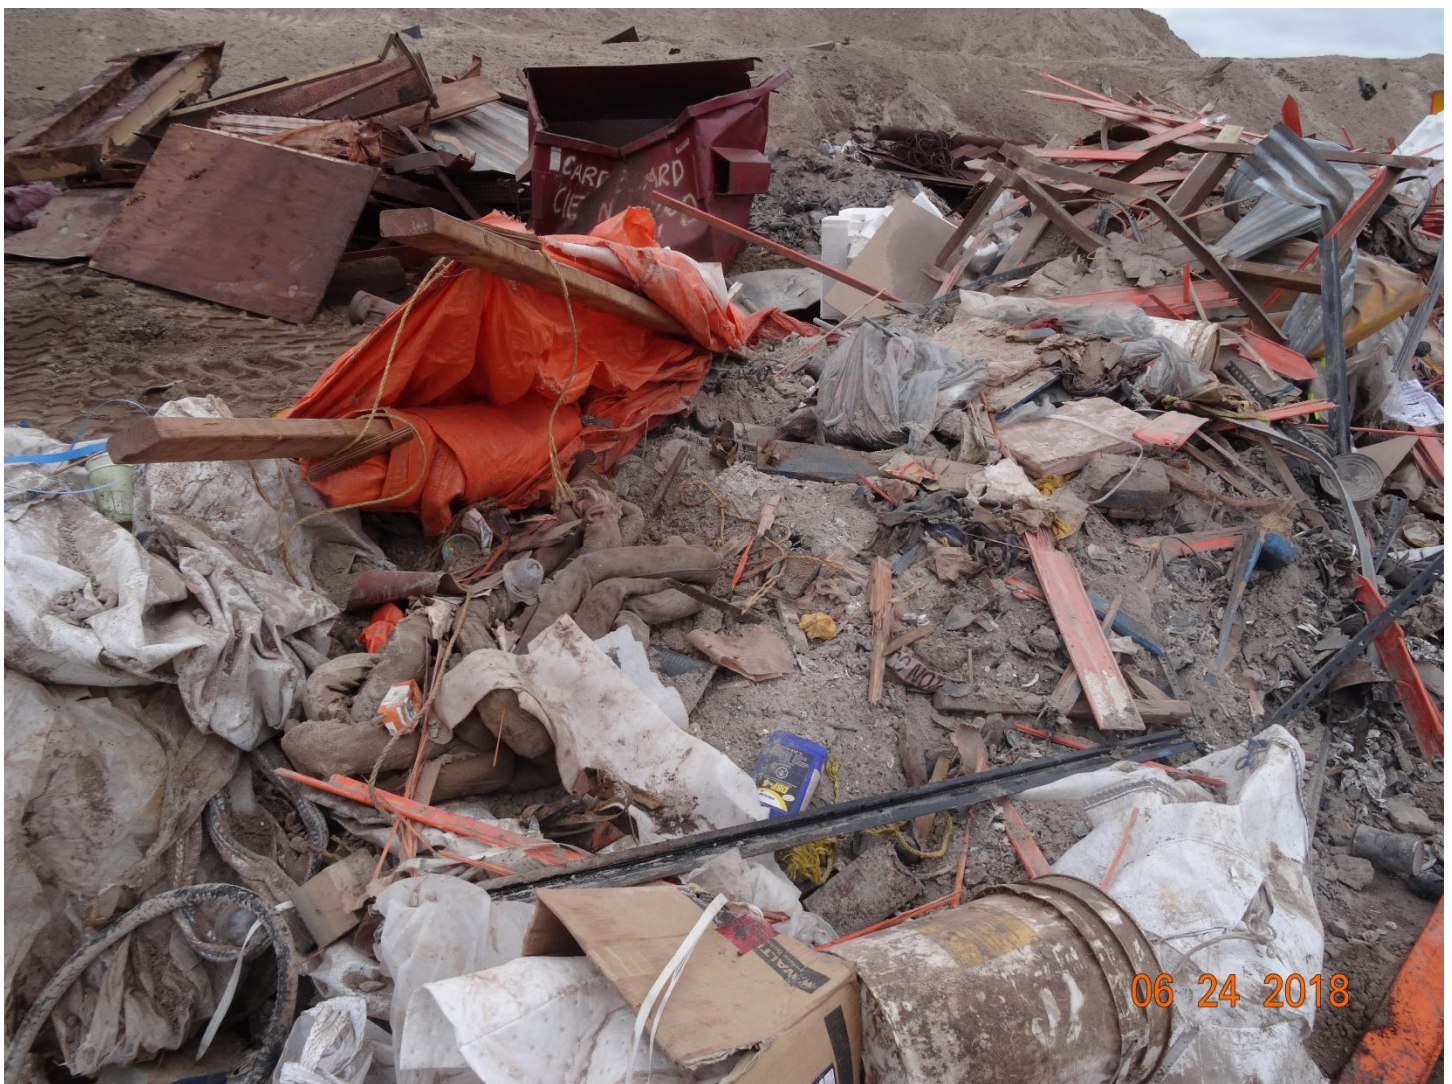
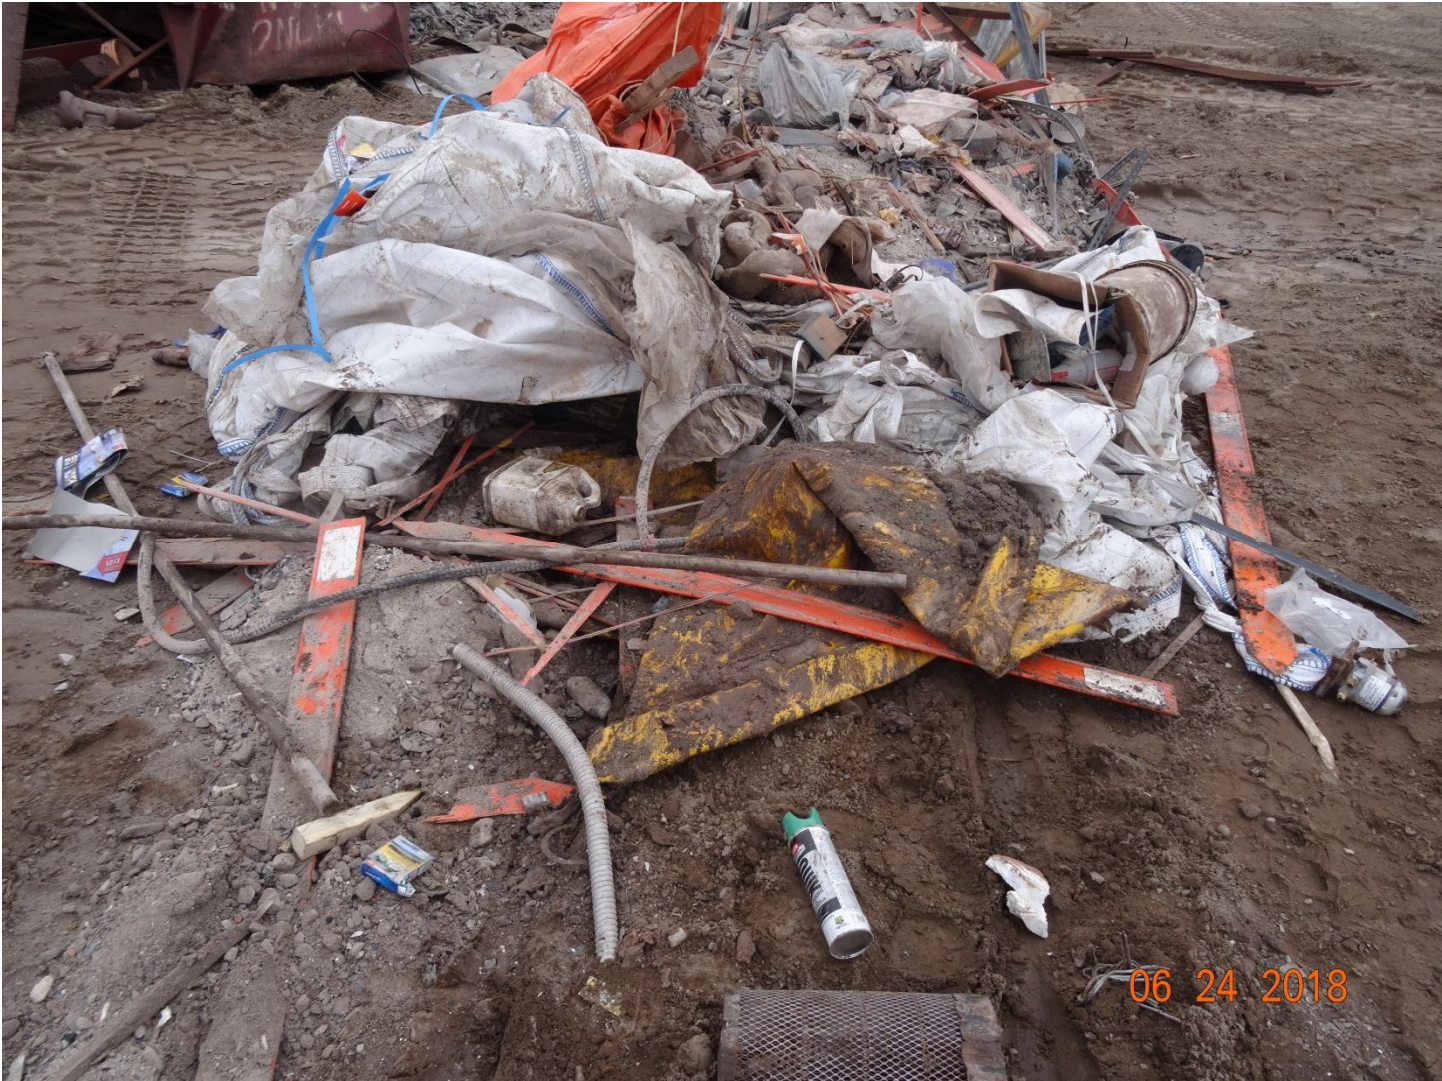
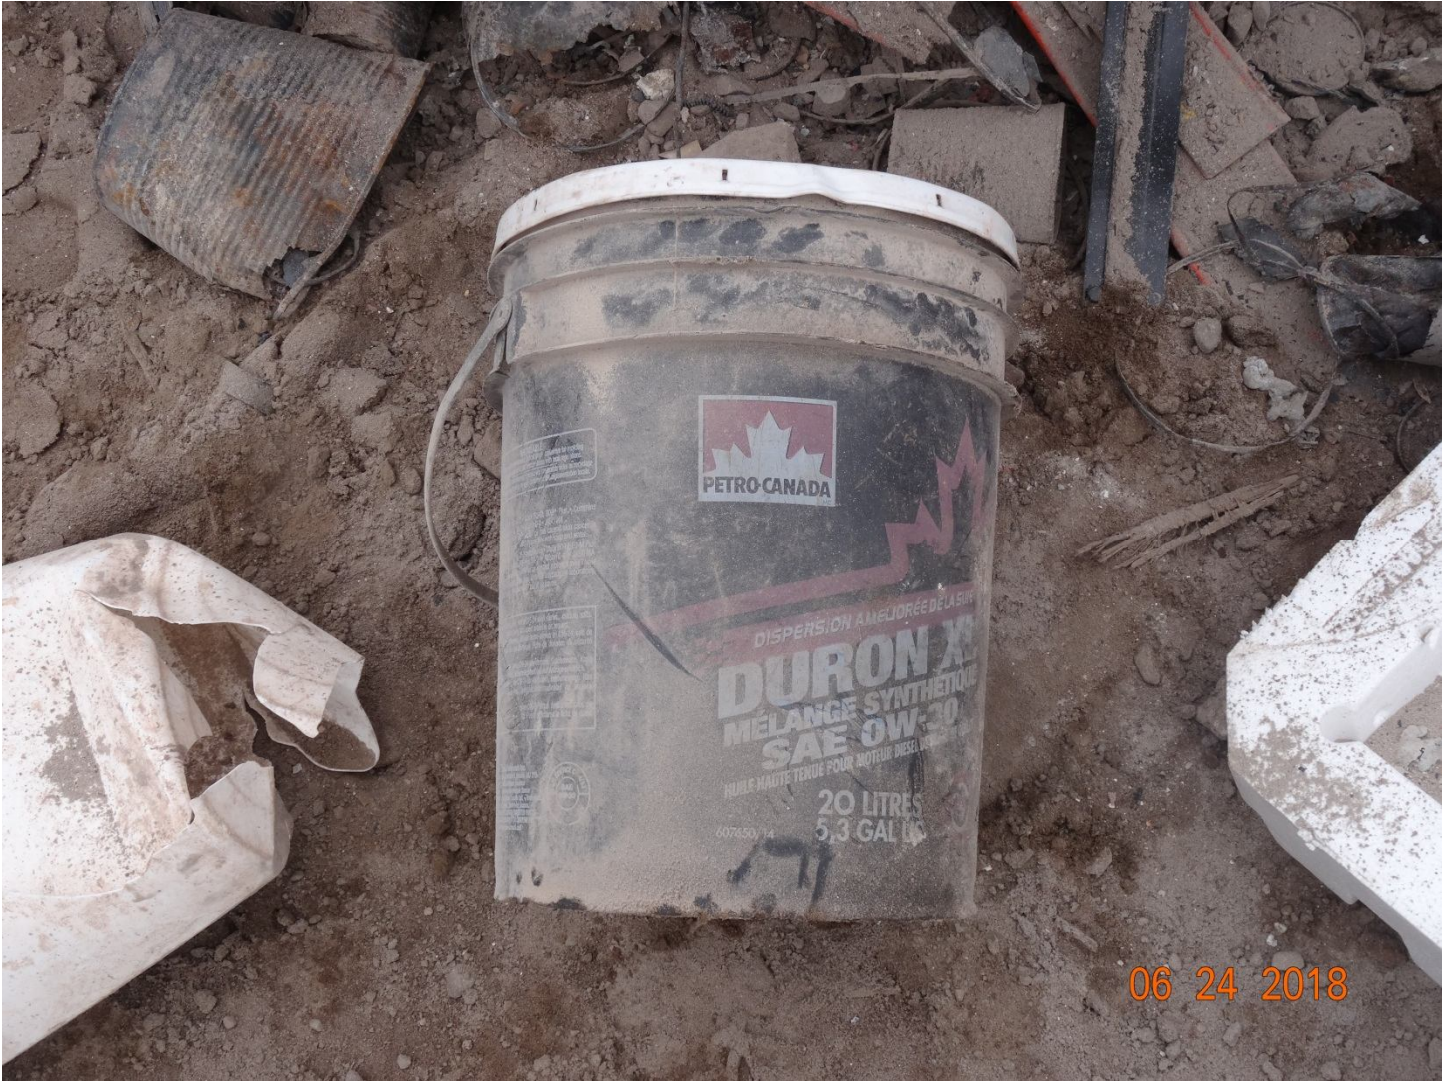
- a. Land fill appears to be properly capped.
- b. Inspector noted that the fence is in poor condition.
- c. The inspector noted potentially hazardous material in the land fill. The waste found in this facility consisted of; drip trays, aerosol canisters, absorbent pads, oil jugs and gas containers.

- I. This is the second time this summer that the inspector has noted potentially hazardous material in the non-hazardous landfill. Baffinland continues to blame other departments for this failure to comply with the licence, in the eyes of the NWB and CIRNA Baffinland is a single cooperation and blaming other departments is no excuse.
- II. The inspector is requesting that Baffinland develop a plan to prevent this non-compliance issue from reoccurring. If the licensee fails to comply with the licence CINRAC may proceed with further enforcement action in the future. See figure 7-9 for photos of the waste mentioned.

Figure 7: landfill waste

Figure 8: Landfill waste

Figure 9: Landfill waste

| SECTION 2 | <input type="checkbox"/> Comments | <input type="checkbox"/> Non-Compliance with Act or Licence | <input checked="" type="checkbox"/> Action Required |
|---|---|---|---|
| 8. The inspector is requesting that Baffinland develop a plan to prevent the deposit of potentially hazardous waste in the non-hazardous landfill from reoccurring, if the licensee fails to comply with the licence CINRA may proceed with further enforcement action in the future. See figure 7-9 for photos of the waste mentioned. | | | |

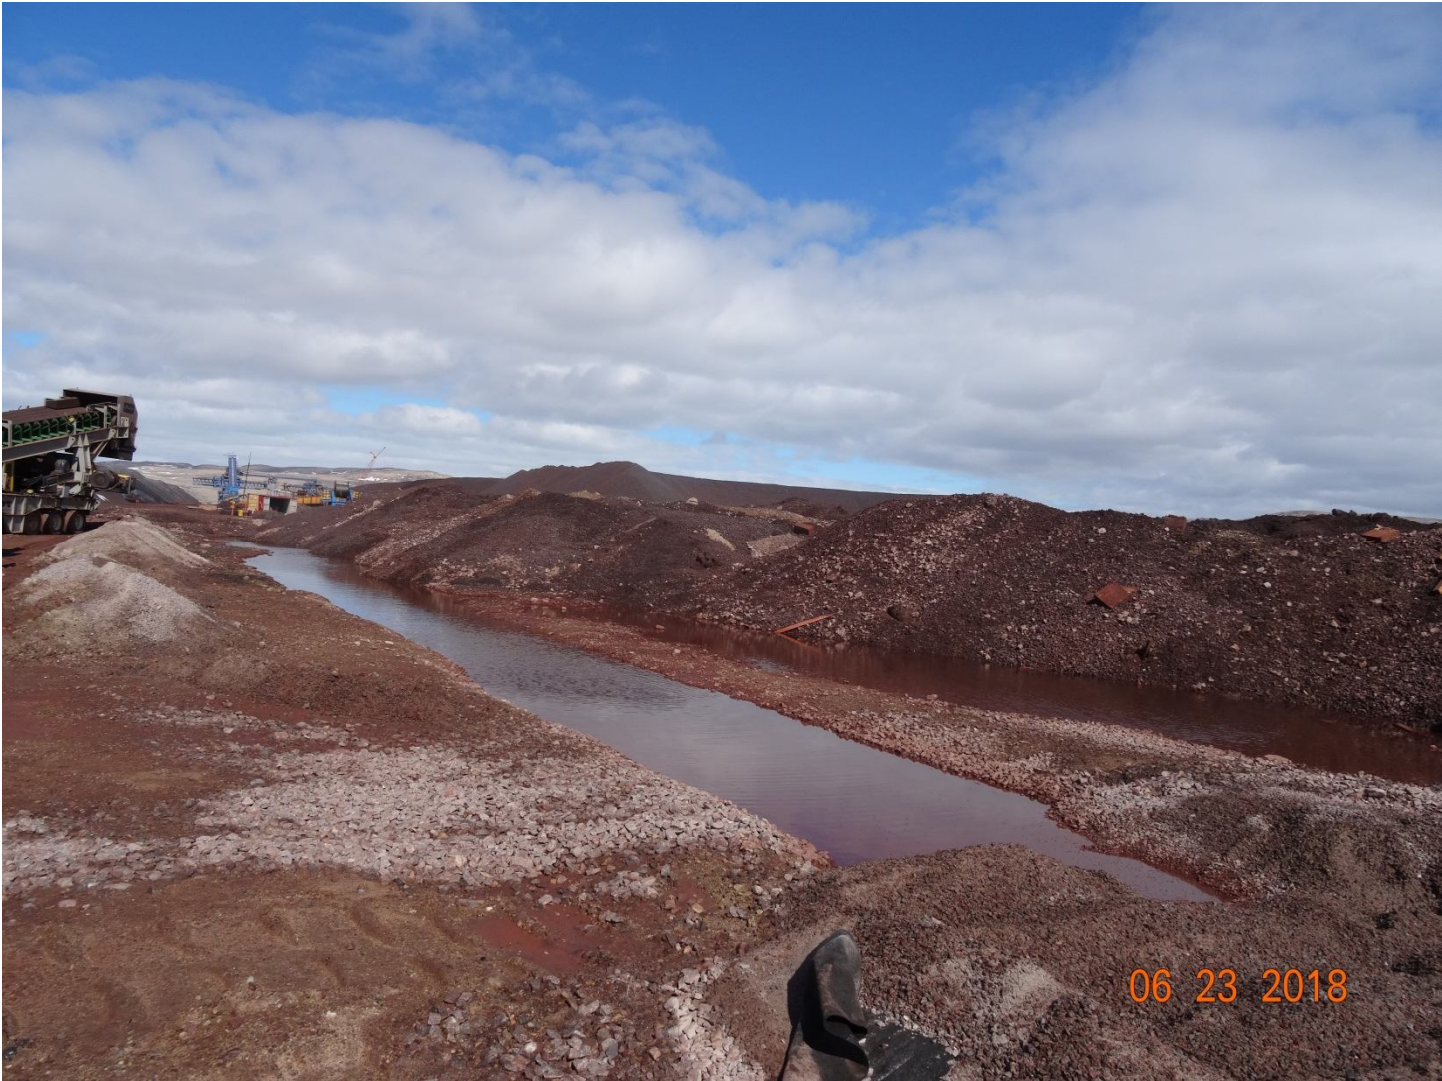
- b. The Licensee is currently dumping snow at the south end of this facility. This snow is laden with Ore and the water generated from this snow dump does not appear to be flowing to the sedimentation ponds.

Figure 10: snow dump melt entering the environment.

- II. The inspector is requesting that BIMC relocate the snow stockpile to ensure that this contact water/snow flows into the sedimentation ponds and not to the surrounding environment. See figure 10 for ore stockpile snow dump.

| SECTION 2 | <input type="checkbox"/> Comments | <input type="checkbox"/> Non-Compliance with Act or Licence | <input checked="" type="checkbox"/> Action Required |
|---|---|---|---|
| 10. The inspector is requesting that BIMC relocate the snow stockpile to ensure that this contact water/snow flows into the sedimentation ponds and not to the surrounding environment. See figure 10 for ore stockpile snow dump. | | | |

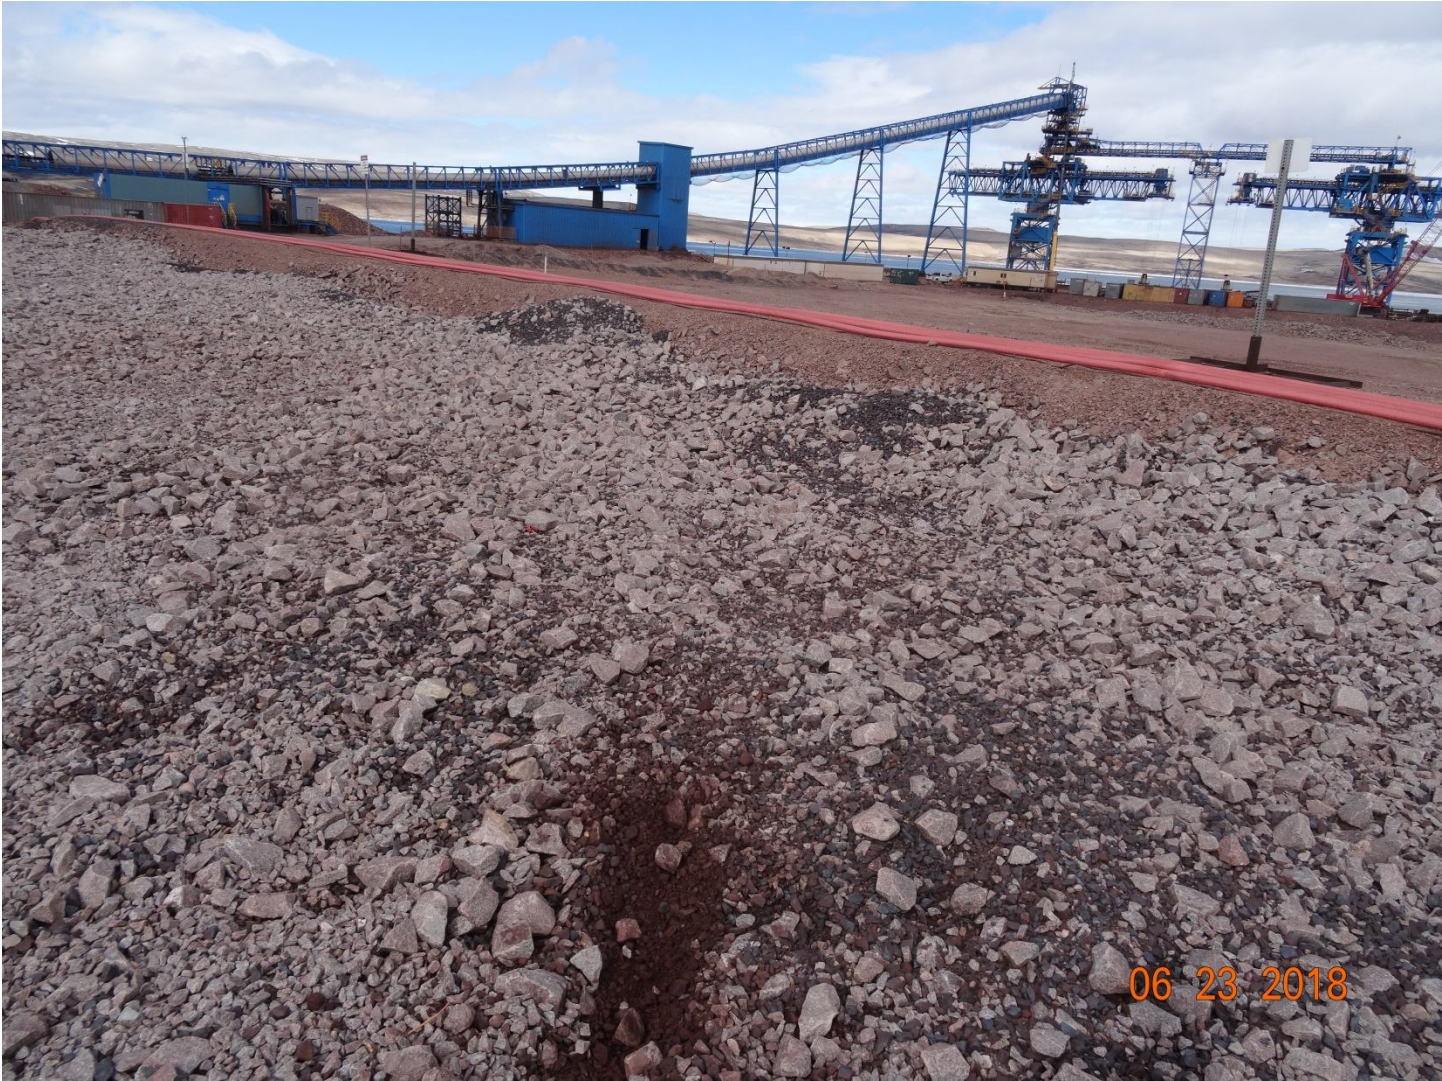
- c. In the previous inspection the inspector noted, "Ore bulk sample remains appear to be removed as requested by the inspector in a previous inspection." During this inspection more snow has melted exposing more Ore, it appears the licensee has removed some ore and covered the rest with crushed rock. See Figure 11.

Figure 11: left over ore from the bulk sample to be remediated.

- III. The licensee is to remove all Ore from this location or provide the required study/technical evidence that it has been approved for the use as construction material

| SECTION 2 | <input type="checkbox"/> Comments | <input type="checkbox"/> Non-Compliance with Act or Licence | <input checked="" type="checkbox"/> Action Required |
|---|---|---|---|
| 11. The licensee is to remove all Ore from bulk sample location or provide proof that is has been approved for construction material. | | | |

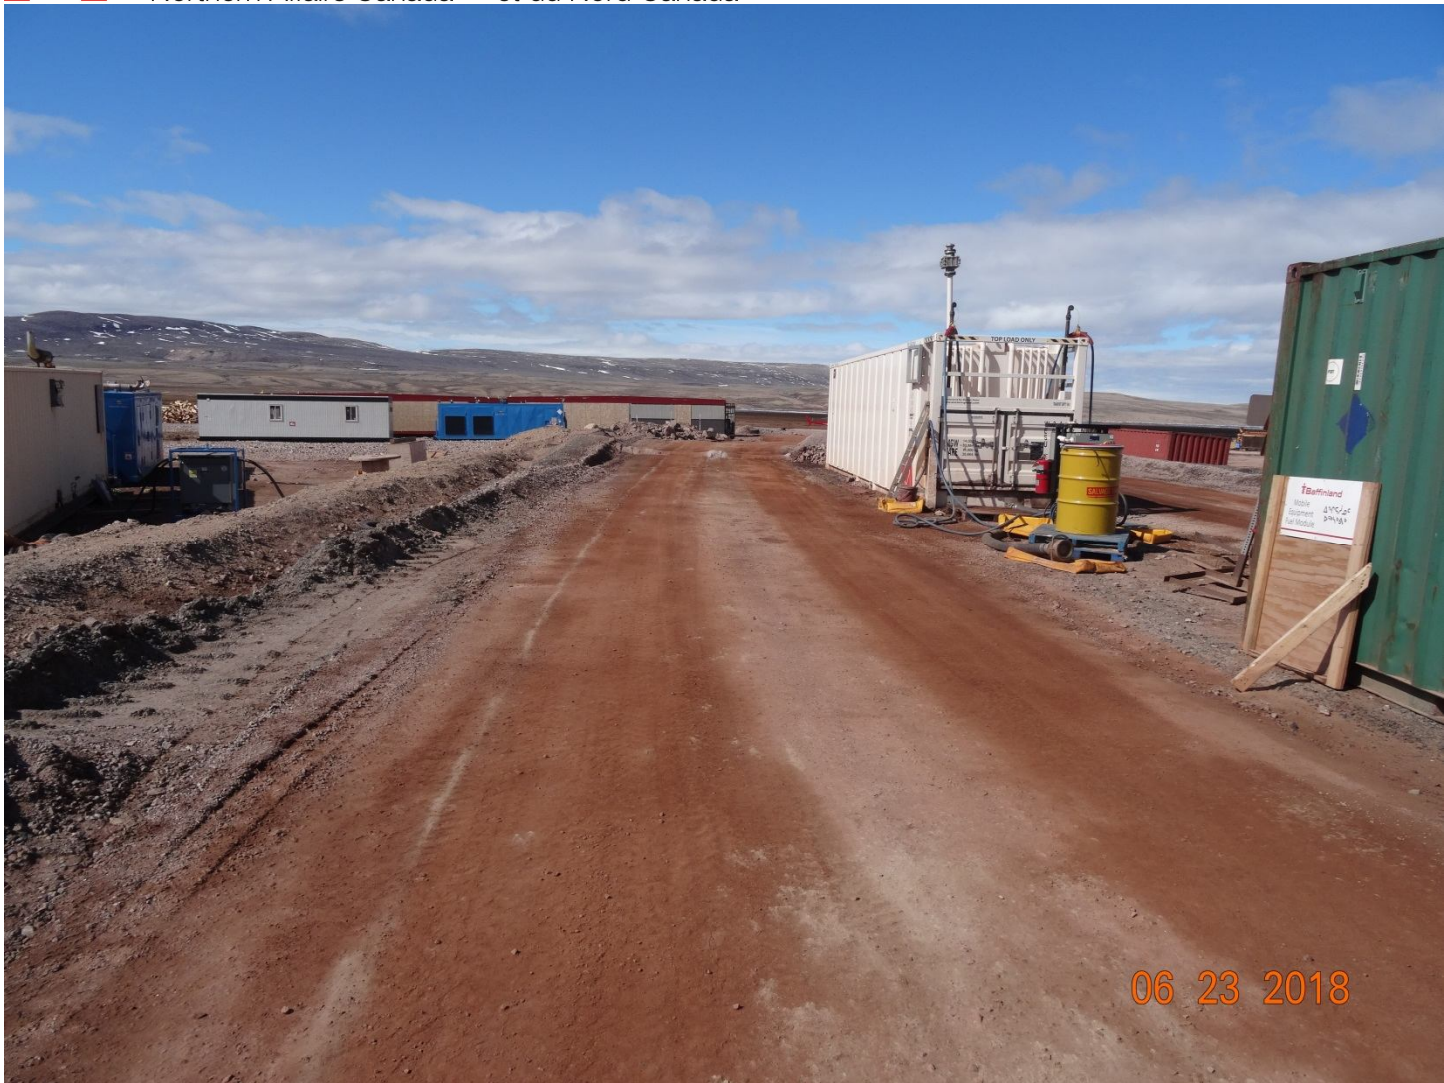
- a. During the last inspection the inspector noted surface water leaving this facility and requested the as built drawings for this facility, nothing has been provided to the inspector.
- b. The Licensee is to return this facility to its approved design. See figure 12 for the fuel module.

Figure 12: fuel module in Milne port.
