WATER LICENCE INSPECTION FORM

| Baffinland Iron Mines Corporation (BIMC) | | William Bowden | |
| 2AM-MRY1325 | | Environmental Superintendent | |
| June 22 – 24, 2018 | | Jonathan Mesher | |

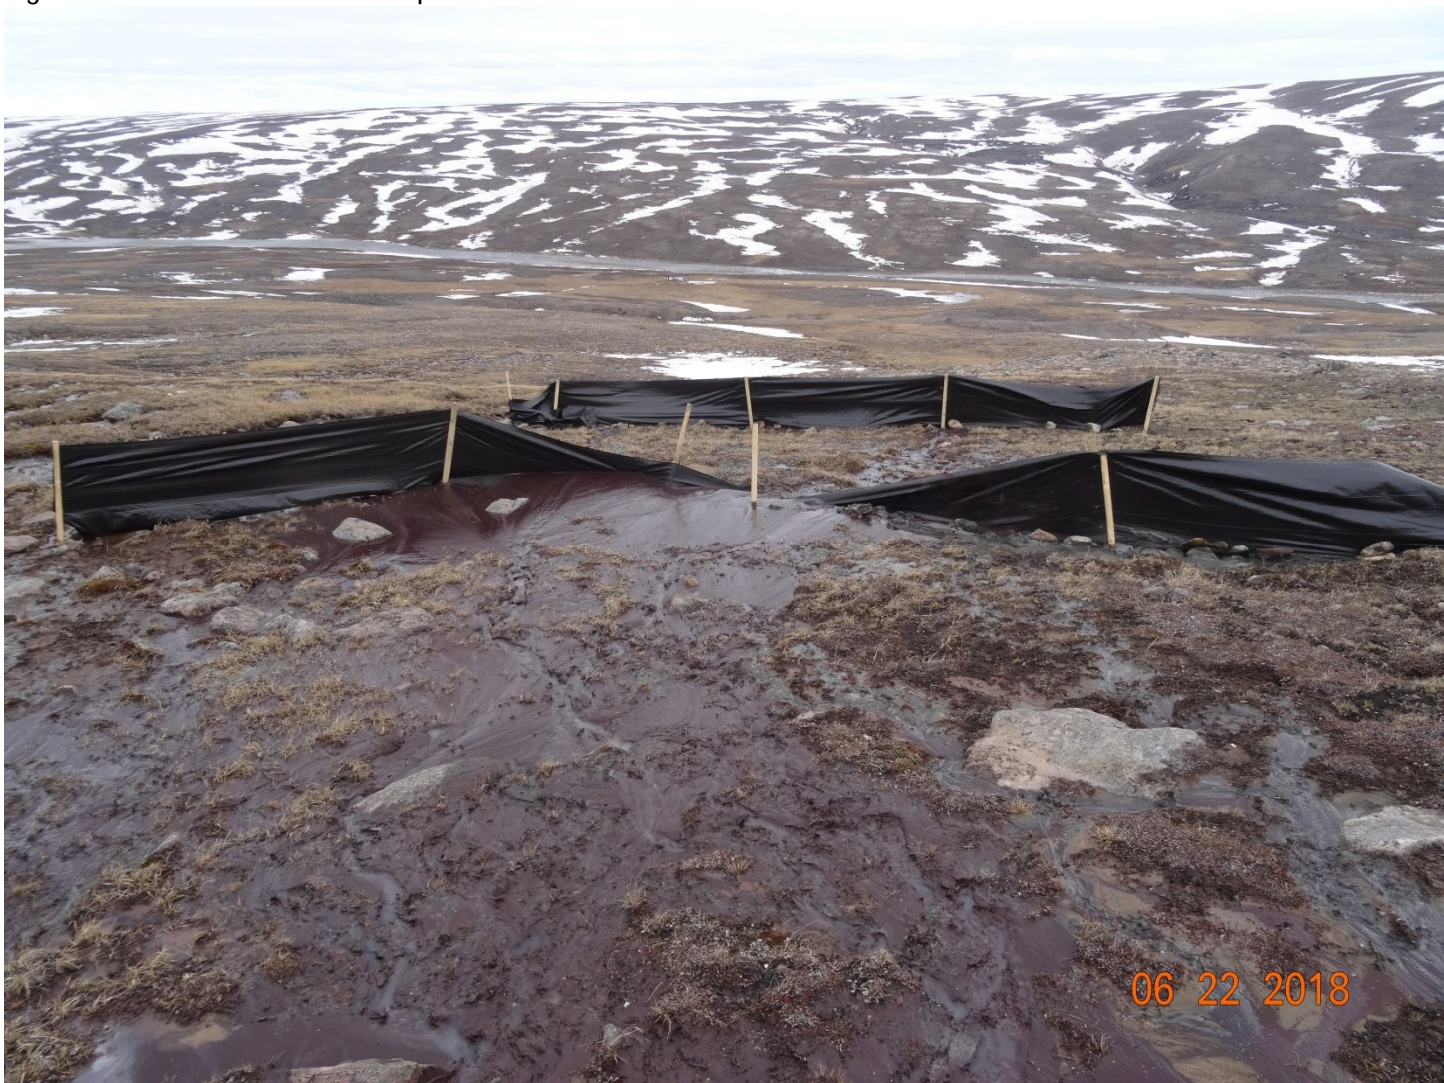
- a. At the time of the inspection the licensee was drilling on deposit No. 2.
- b. The Licensee was improperly handling the drill waste. PART F, Item 4 of the licence 2BE-MRY1421, states that; "The Licensee shall dispose of all drill waste, including water, chips, muds and salts (CaCl<sub>2</sub>) in any quantity or concentration, from land-based drilling, in a properly constructed Sump or an appropriate natural depression located at a distance of at least thirty one (31) metres from the ordinary High Water Mark of any adjacent Water body, where direct flow into a Water body is not possible and no additional impacts are created."

- c. The drill waste was not being deposited in a properly constructed sump or natural depression. The licensee is to discontinue their current practice of depositing drill waste, to ensure the licensee is adhering to the licence and not improperly depositing waste the inspector is requesting that the licensee provide photos of all sumps form the 2018 Exploration drilling program. See photo 13 for the improper deposit of waste.

Figure 13: Lack of a sump as required in the licence.

| SECTION 2 | <input type="checkbox"/> Comments | <input type="checkbox"/> Non-Compliance with Act or Licence | <input checked="" type="checkbox"/> Action Required |
|---|---|---|---|
| 13. The licensee is to discontinue their current practice of depositing drill waste, to ensure the licensee is adhering to the licence and not improperly depositing waste the inspector is requesting that the licensee provide photos of all sumps form the 2018 Exploration drilling program. See photo 13 for the improper deposit of waste. See Figure 13 for the licensee’s lack of a sump. | | | |
