RE: Water Licence 2AM-MRY1325 January 2019 Inspection Report

WATER LICENCE INSPECTION FORM

Table A.1 - Response to CIRNAC Water Licence Inspection - January, 2019

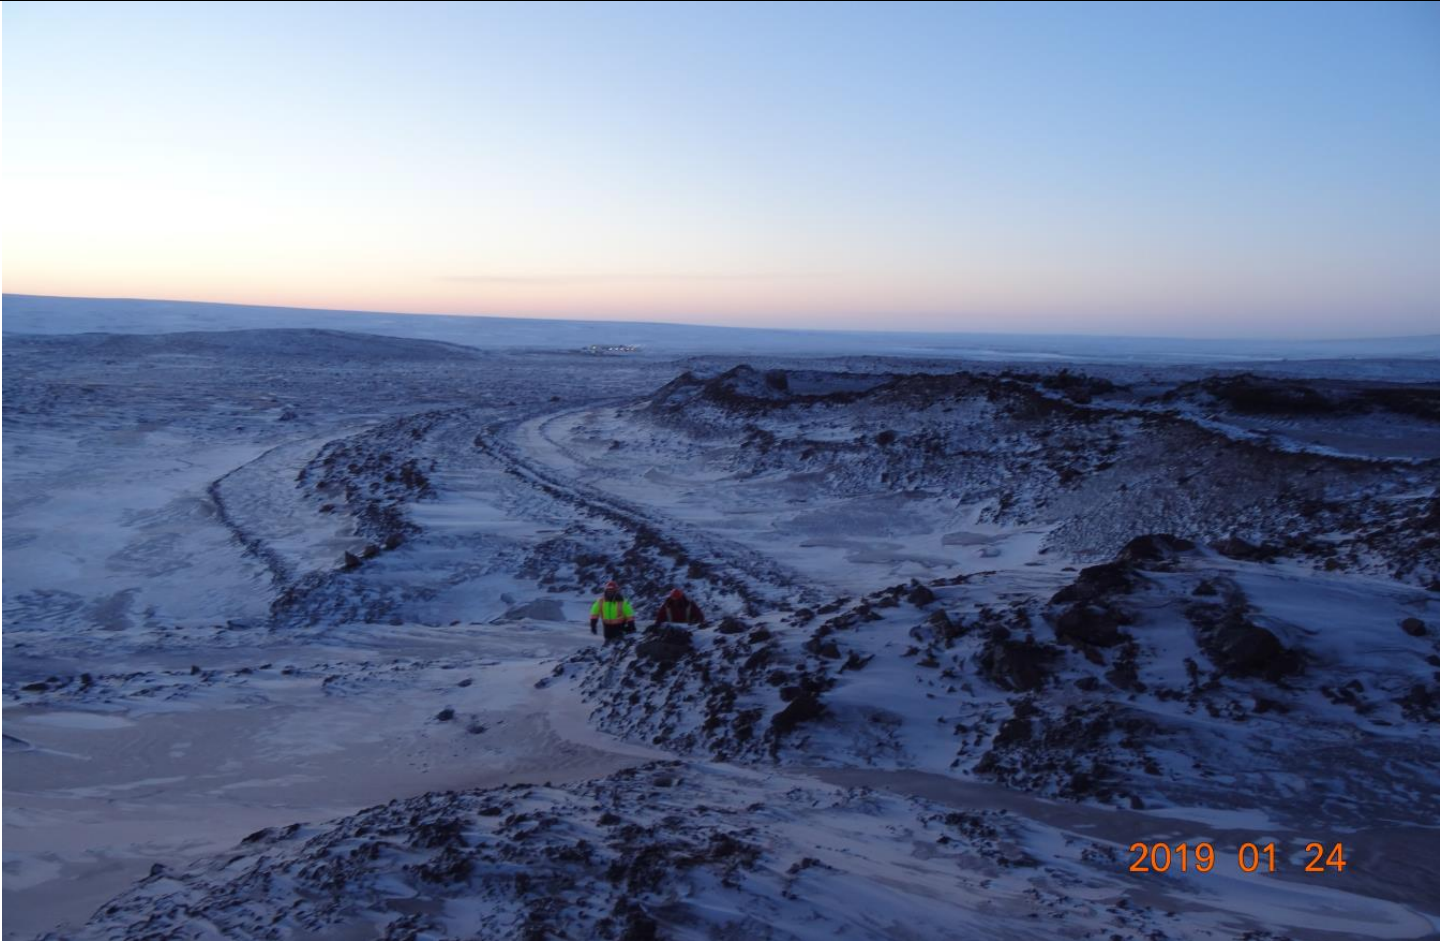
Photo 1

b. The licensee is currently in the process of clearing iron ore away from the ditches and is re-installing the required buffer zone between the ditches and the stockpile to allow single lane traffic. The licensee has committed to completing this work prior to May 15, 2019.

Description: Inspector Jeremy FRASER and Chase, Manager of Ore crusher pad, walk parameter of crusher pad. Managers have verbally agreed to have Ditching and single lane traffic road to be constructed prior to May 15 2019.

ITEM No. ¹	Action Required with Observation or Item of Concern	Baffinland Responses
Section 1		
1.b.	The licensee is currently in the process of clearing iron ore away from the ditches and is re-installing the required buffer zone between the ditches and the stockpile to allow single lane traffic. The licensee has committed to completing this work prior to May 15, 2019. (see photo 1)	Baffinland continues to remove ore stockpiled within 3m of the perimeter ditch and re installing the required buffer zone between the ditch and ore stockpile. Work was carried out following the January 2019 inspection, however due to frozen conditions encountered, work was suspended. This is an ongoing activity as conditions permit, and will be assessed in spring 2019. Baffinland endeavors to reinstate this 3m buffer over the 2019 season once temperatures are favourable.

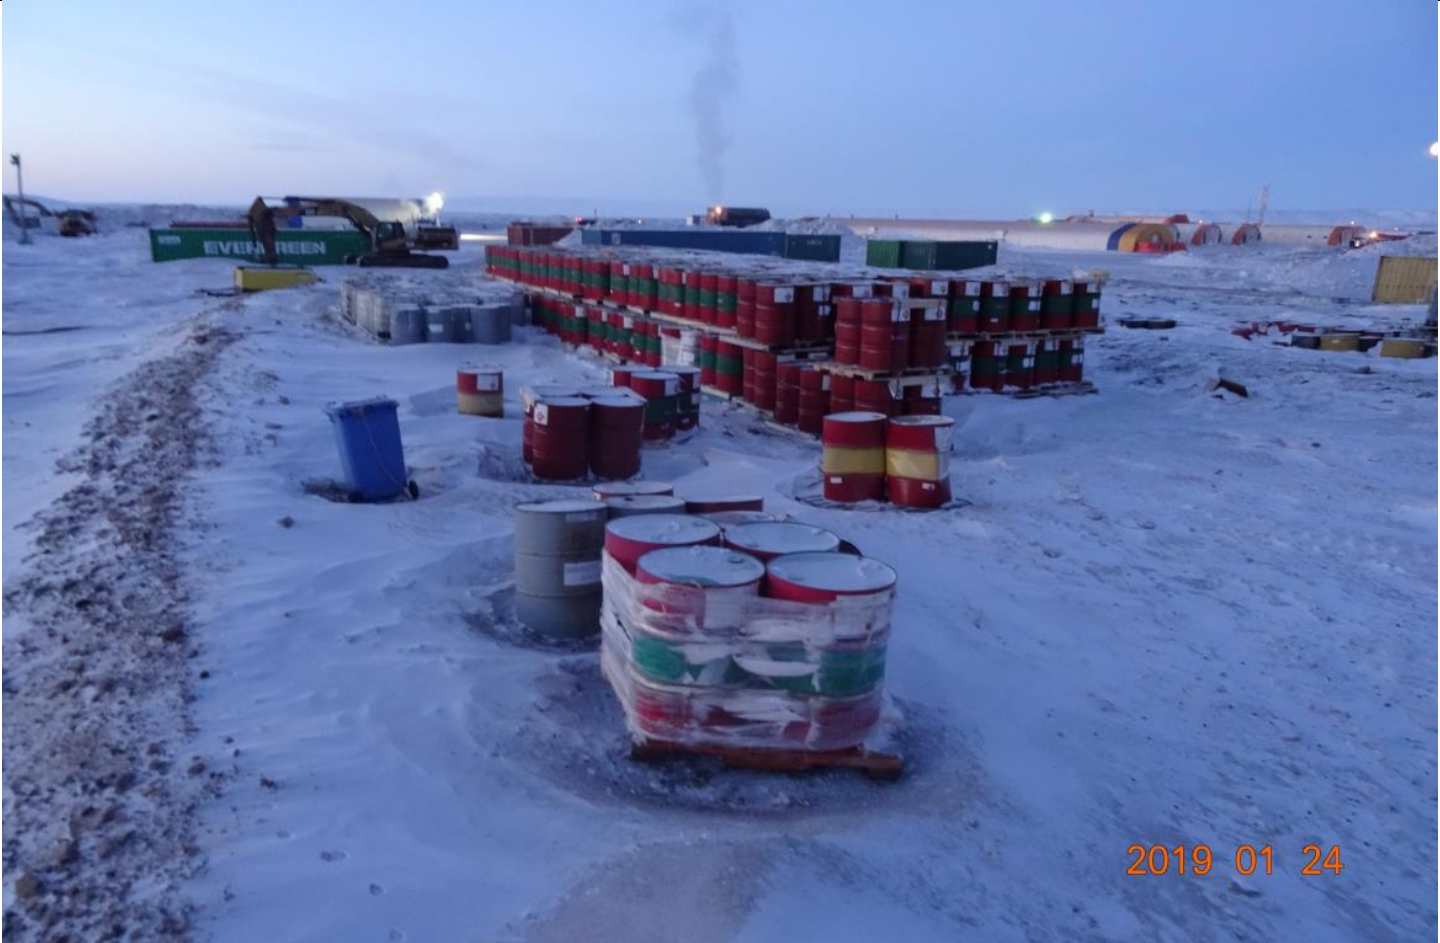
Photo 2

- a. At the time of the inspection the majority of the waste and water management structures at this facility were snow covered making it difficult to identify any potential concerns. No concerns were noted.

Description: Snow covered hazardous waste storage facility

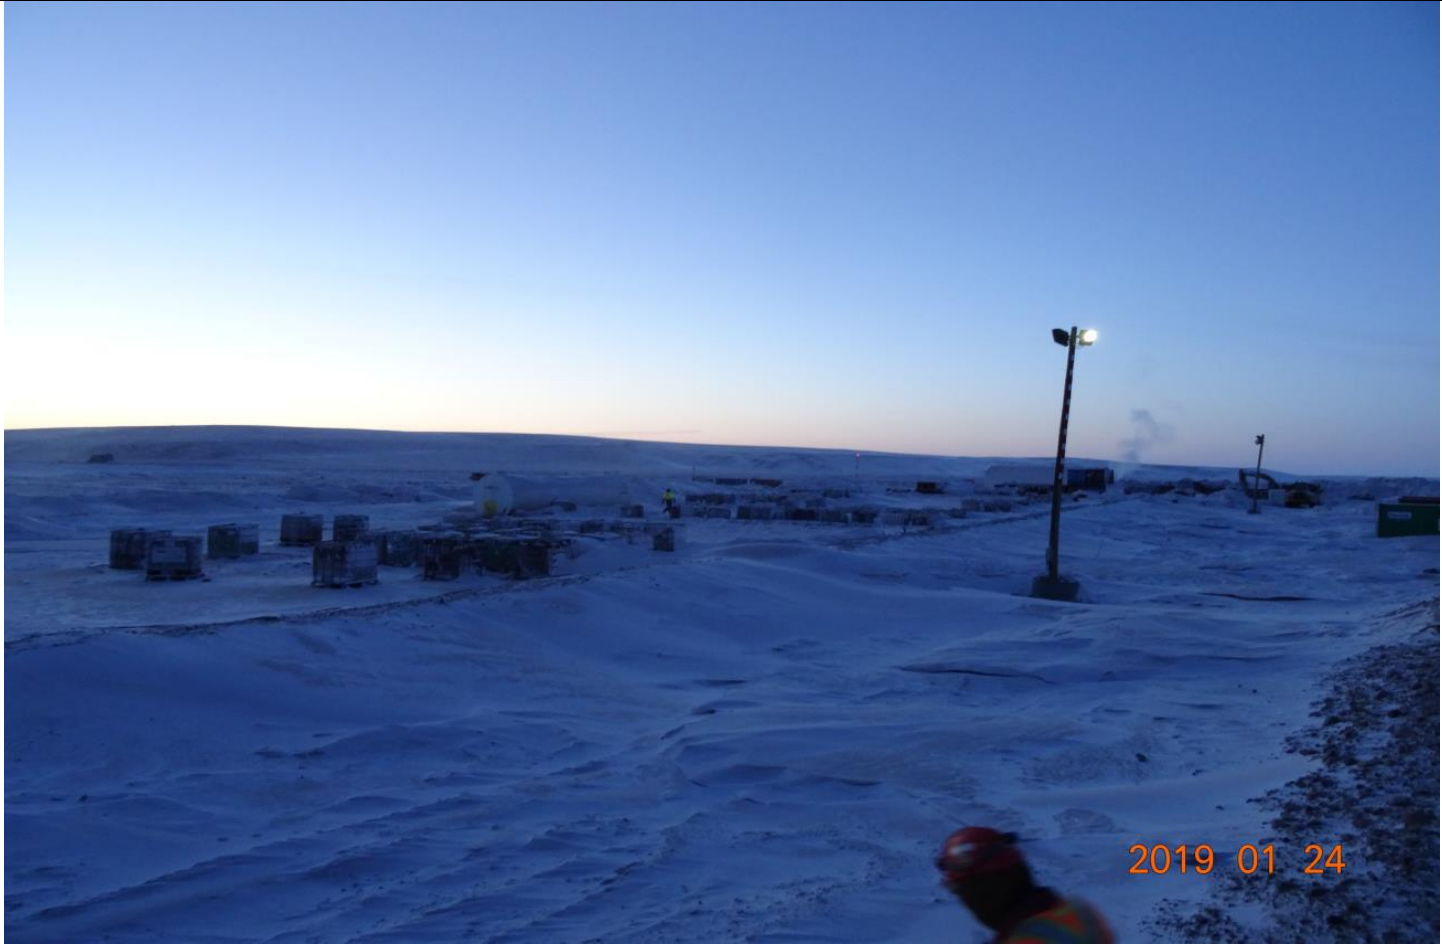
Photo 3

Description: Snow covered facility

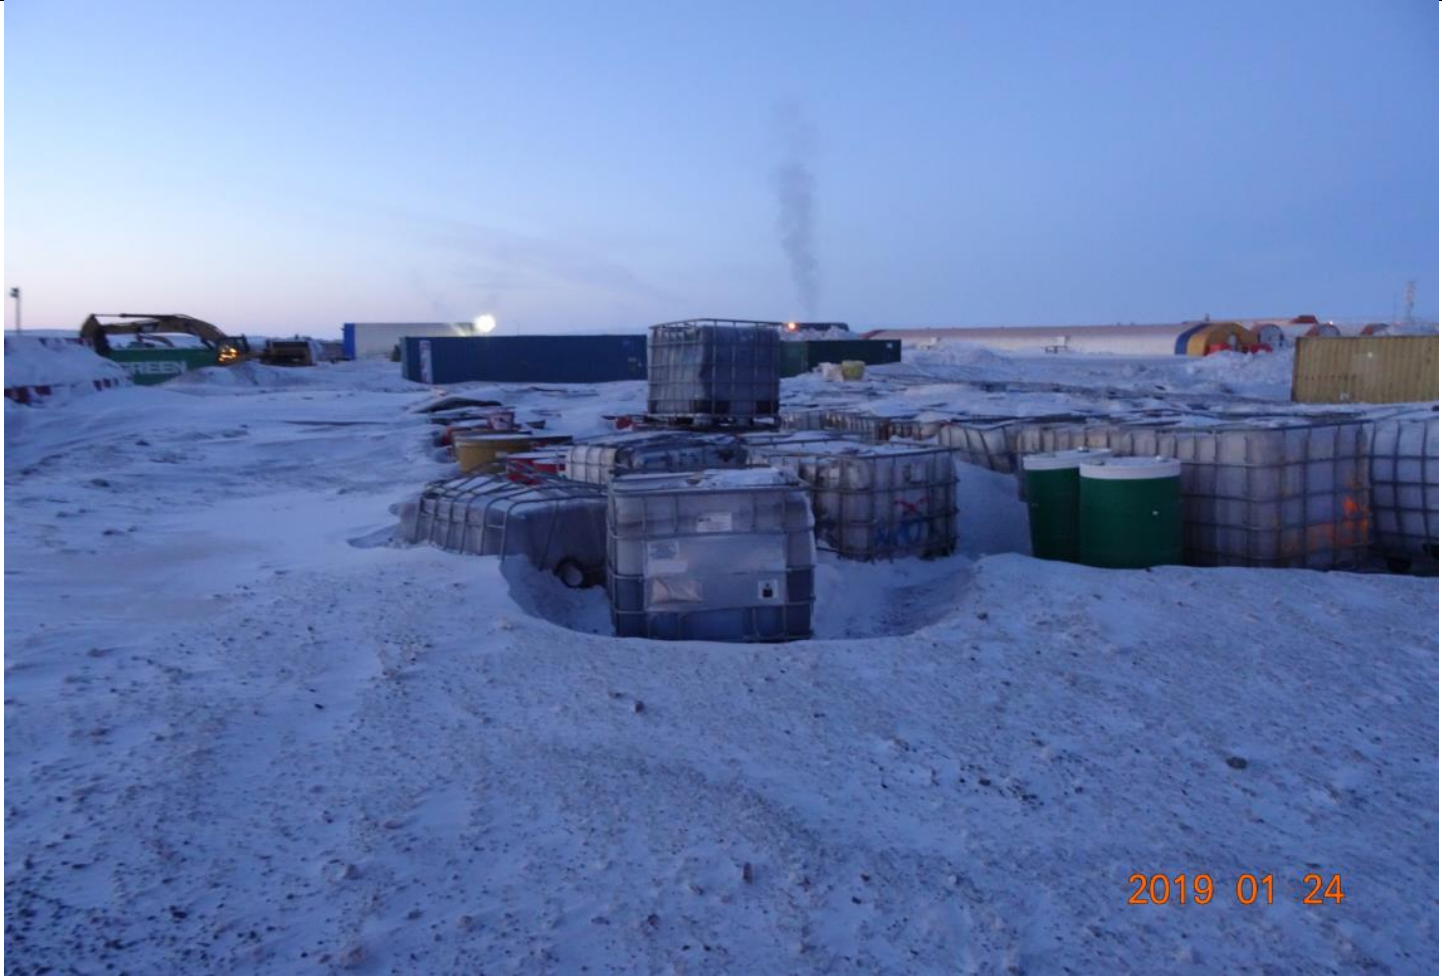
Photo 4

Description: Snow covered waste management facility.
