WATER LICENCE INSPECTION FORM

Licensee	Licensee Representative
BAFFINLAND IRON MINES CORPORATION	Connor Devereaux
Licence No. / Expiry	Representative's Title
2AM-MRY1325	Environmental Superintendent
Land / Other Authorizations	Land / Other Authorizations
8BC-MRY1416, 2BE-MRY1421	N2014X0012, N2014Q0016, N2014C0013
Date of Inspection	Inspector
May 22-23, 2019	Jonathan Mesher
Activities Inspected	
<input type="checkbox"/> Camp	<input type="checkbox"/> Drilling
<input type="checkbox"/> Roads/Hauling	<input checked="" type="checkbox"/> Mining
	<input type="checkbox"/> Construction
	<input type="checkbox"/> Reclamation
	<input type="checkbox"/> Fuel Storage
	<input type="checkbox"/> Other:

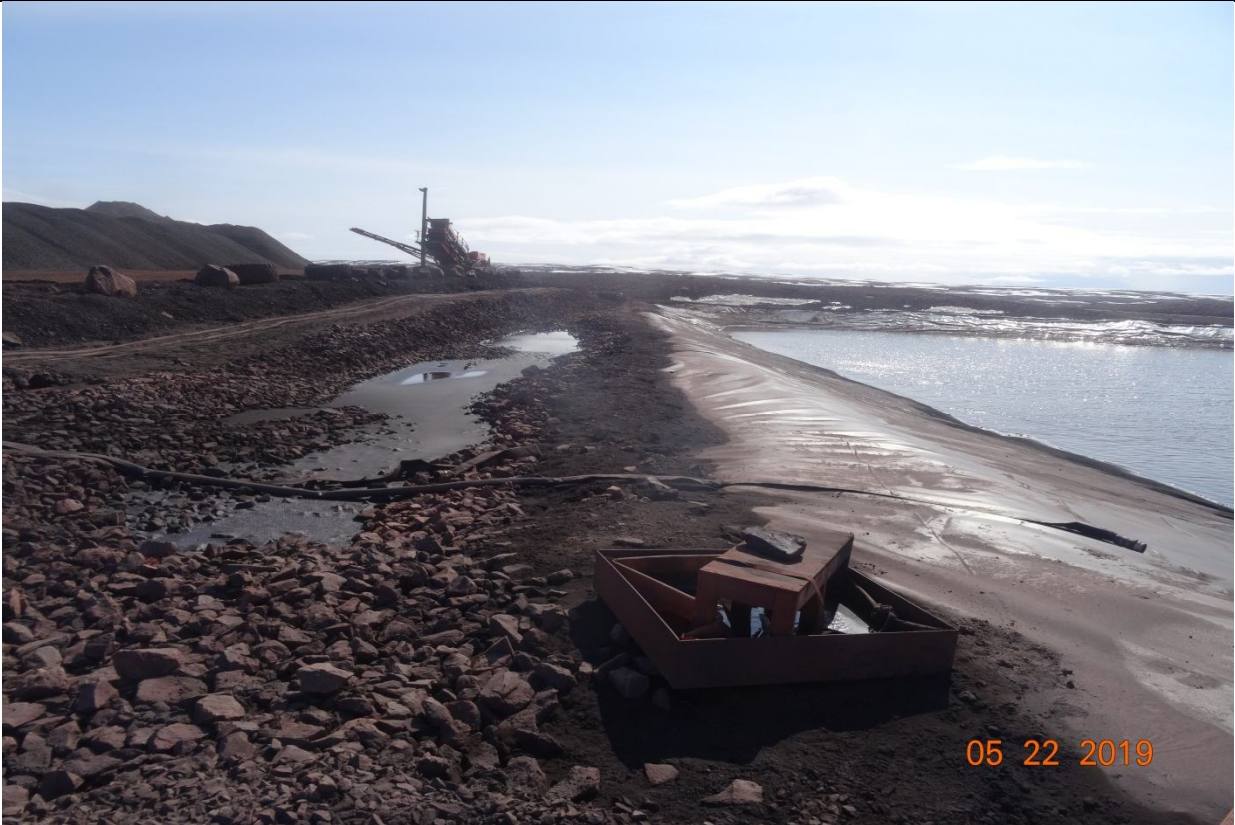
Photo 1

- c. As mentioned in previous inspection reports the slope of the ditches surrounding this facility do not appear to be consistent with the approved design and the construction material does not appear to be the approve size. (see Photo 1).

Description: Pooling in unlined ditches of the Crusher pad

surrounding Ore Crusher Pad are constructed with the approved materials in the approved design.

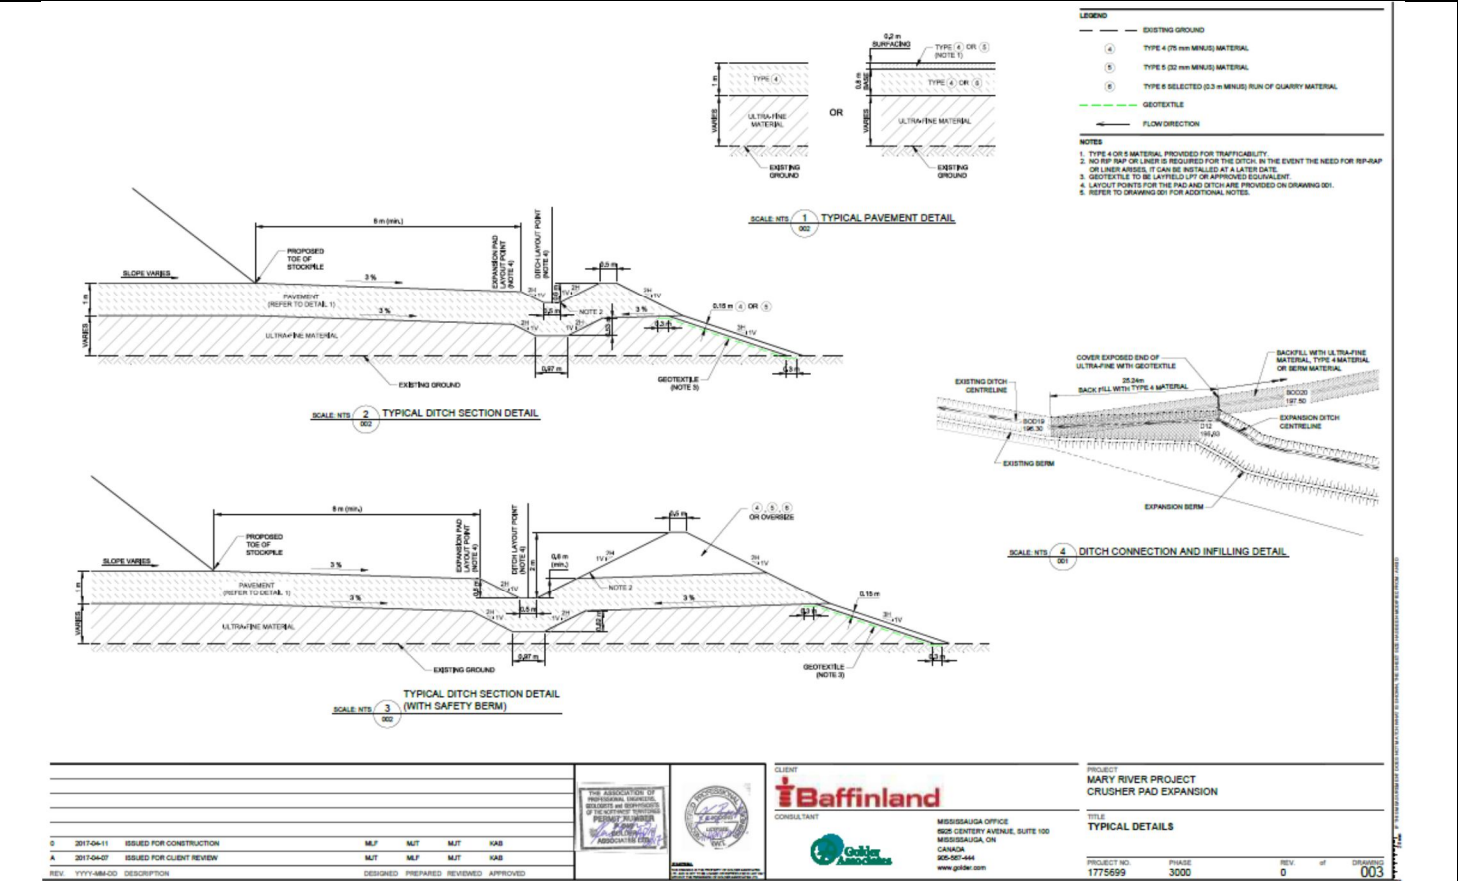
- b. The licensee continues to express to the Inspector that the perimeter road is designed to be 3m wide, in the "For Construction" drawing below produced by Golder Associates for BIMC it clearly shows there should be 8m gap between the stockpile and the ditch. (See Photo 2 )While on site it was noted that the material used to construct the ditches are significantly larger than the approved material mentioned in the For Construction drawing.

Description: Crusher Pad expansion For Construction

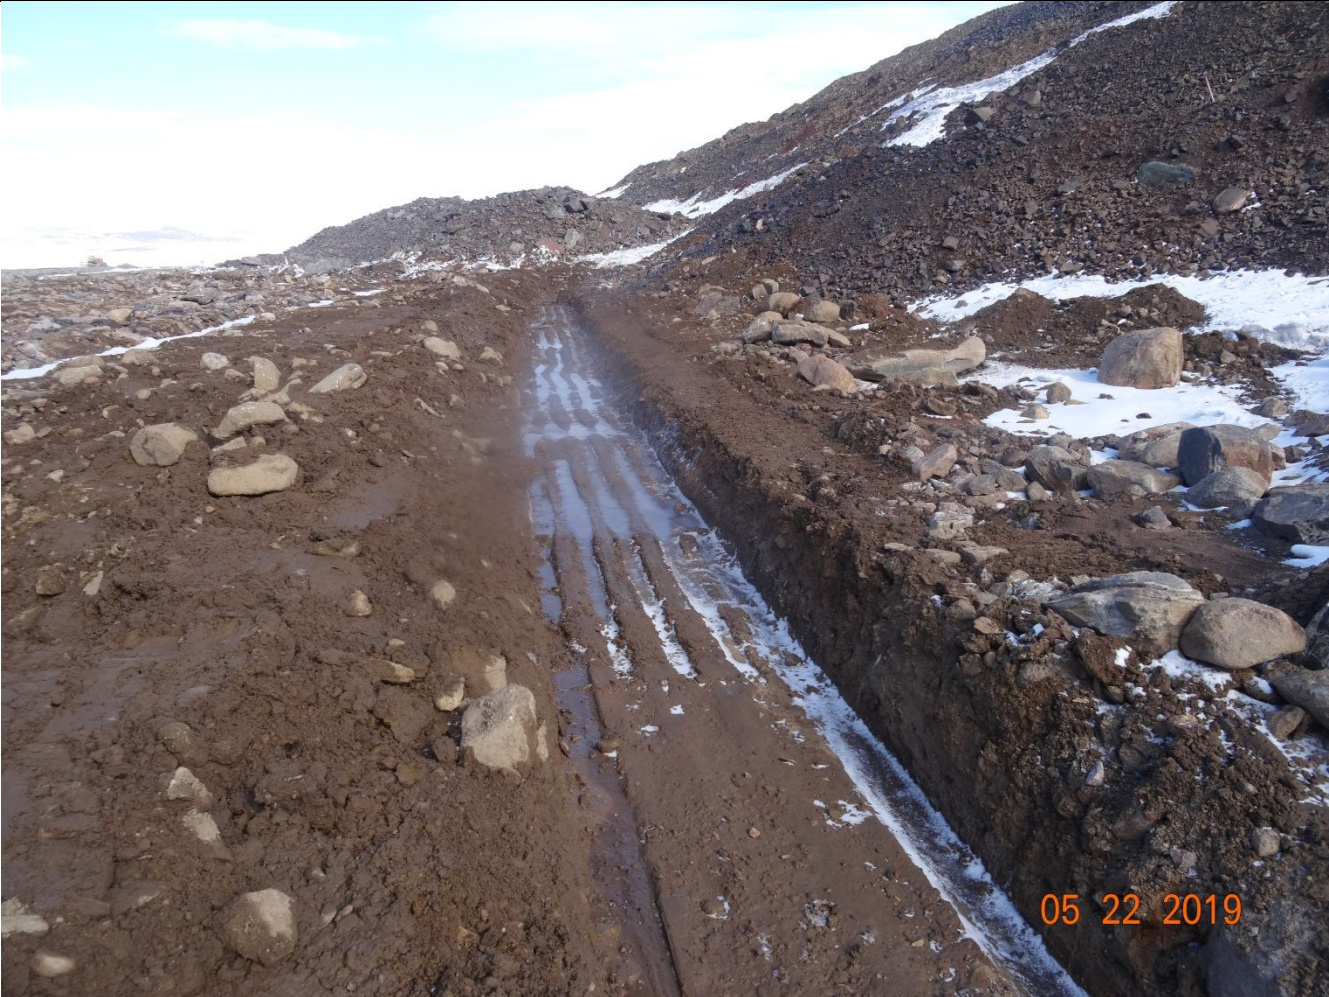
Photo 5

Description: Waste Rock Stockpile improperly constructed Ditches

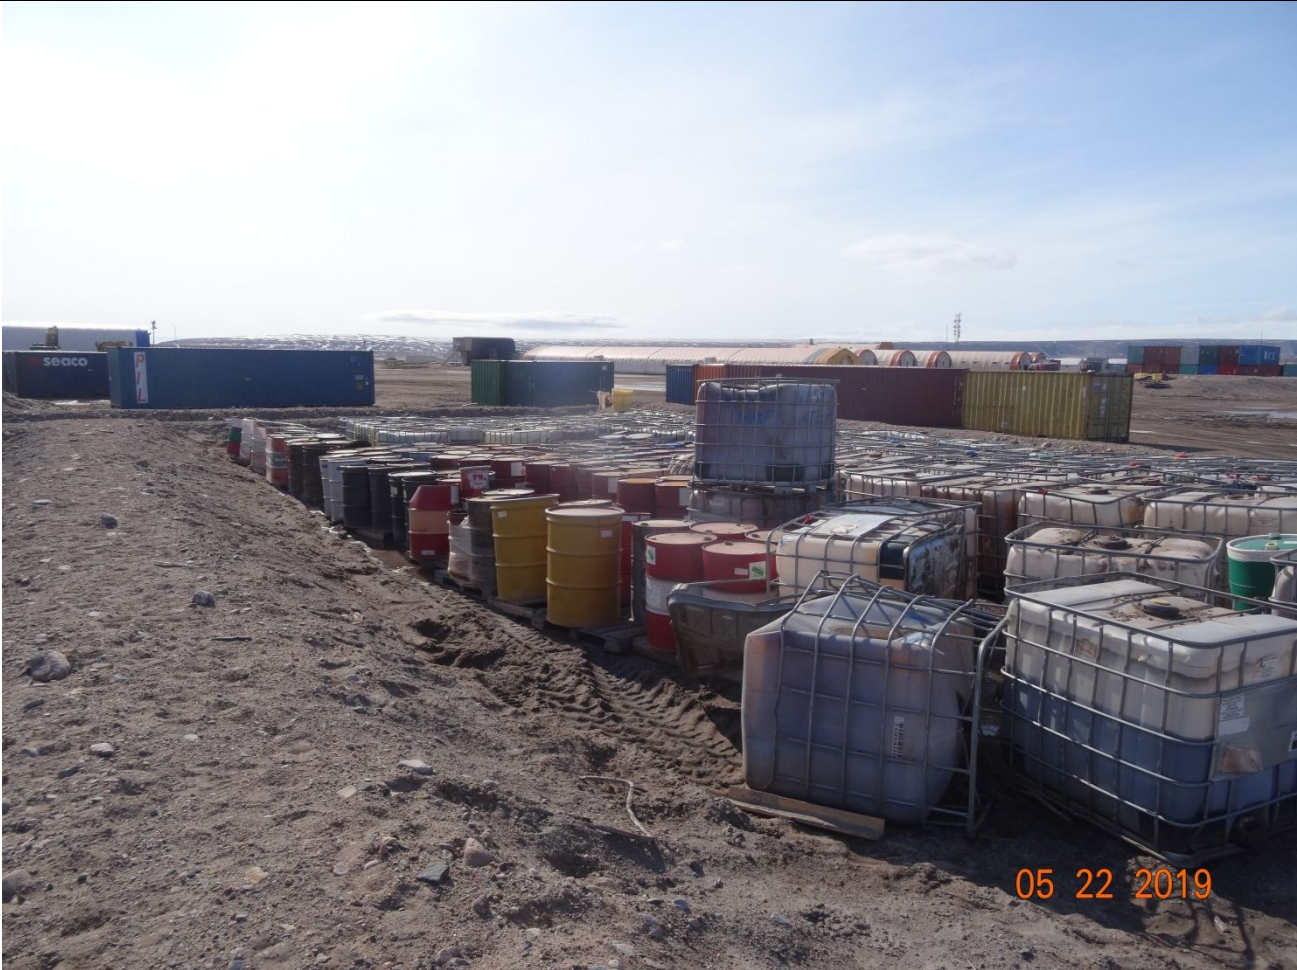
Photo 6

- a. The inspector noted that Hazardous waste berm #7 had limited capacity and the berm walls were inconsistent, the inspector is requesting that the licensee provide the for construction and As-built drawings for all Hazardous waste berms.
- b. The inspector noted damaged containers within the Hazardous Waste Berm, Section 4.4.2of the Hazardous Material and Hazardous waste Management Plan states that; "Regular inspections are performed and recorded. Containers are placed so that each container can be inspected for signs of leaks or deterioration. Leaking or deteriorated containers will be removed and their content transferred to a sound container." The Licensee is to remove all damaged containers and transfer the hazardous material to sound containers. ( see Photos #6 )

Description: Damaged Hazardous waste containers.

3. The licensee is to remove all Hazardous material from any damaged containers and place it in sound containers.
4. The licensee is to repair/ Key-in the liners at MP-05 and MP-06 to ensure all runoff is proper captured.

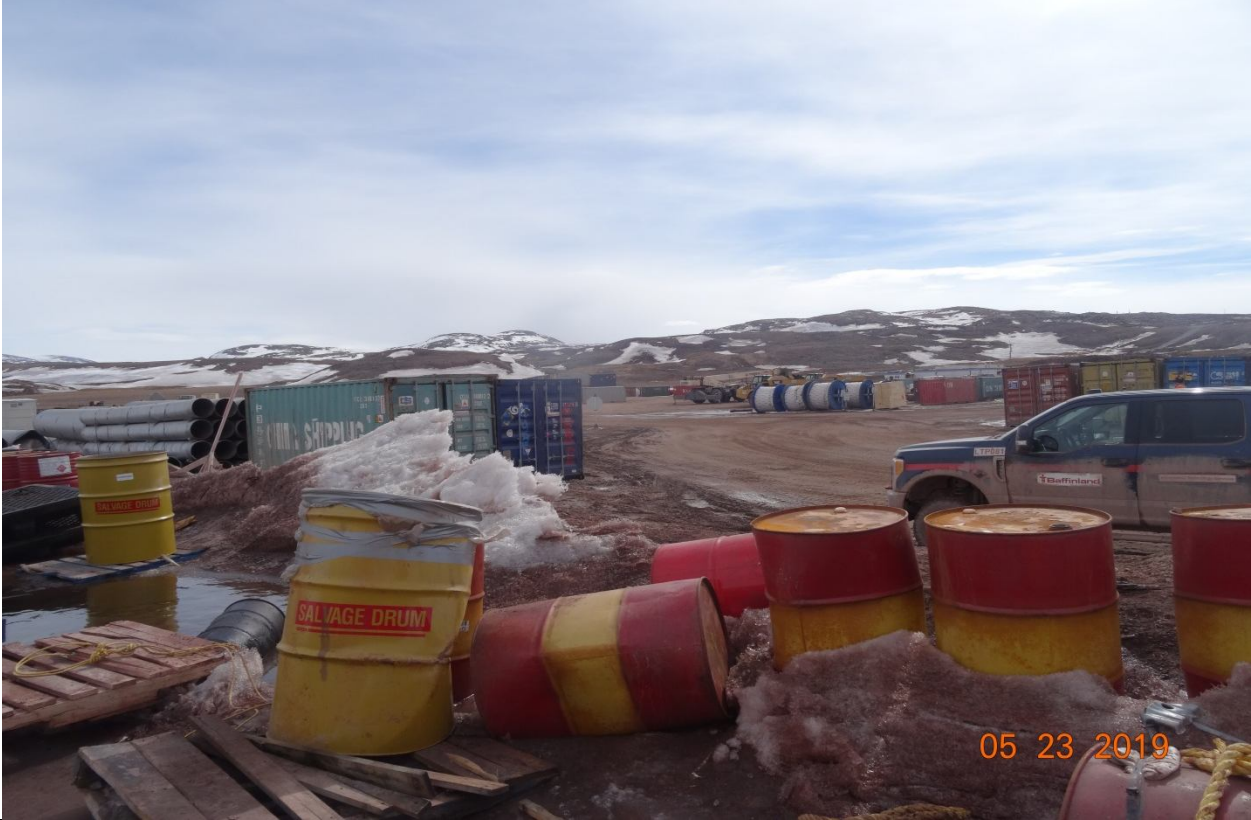
Photo 7

- c. The inspector noted damaged containers within the Hazardous Waste Berm, Section 4.4.2of the Hazardous Material and Hazardous waste Management Plan states that; "Regular inspections are performed and recorded. Containers are placed so that each container can be inspected for signs of leaks or deterioration. Leaking or deteriorated containers will be removed and their content transferred to a sound container." The Licensee is to remove all damaged containers and transfer the hazardous material to sound containers. (see Photo 7)

Description: Damaged Hazardous Waste containers.

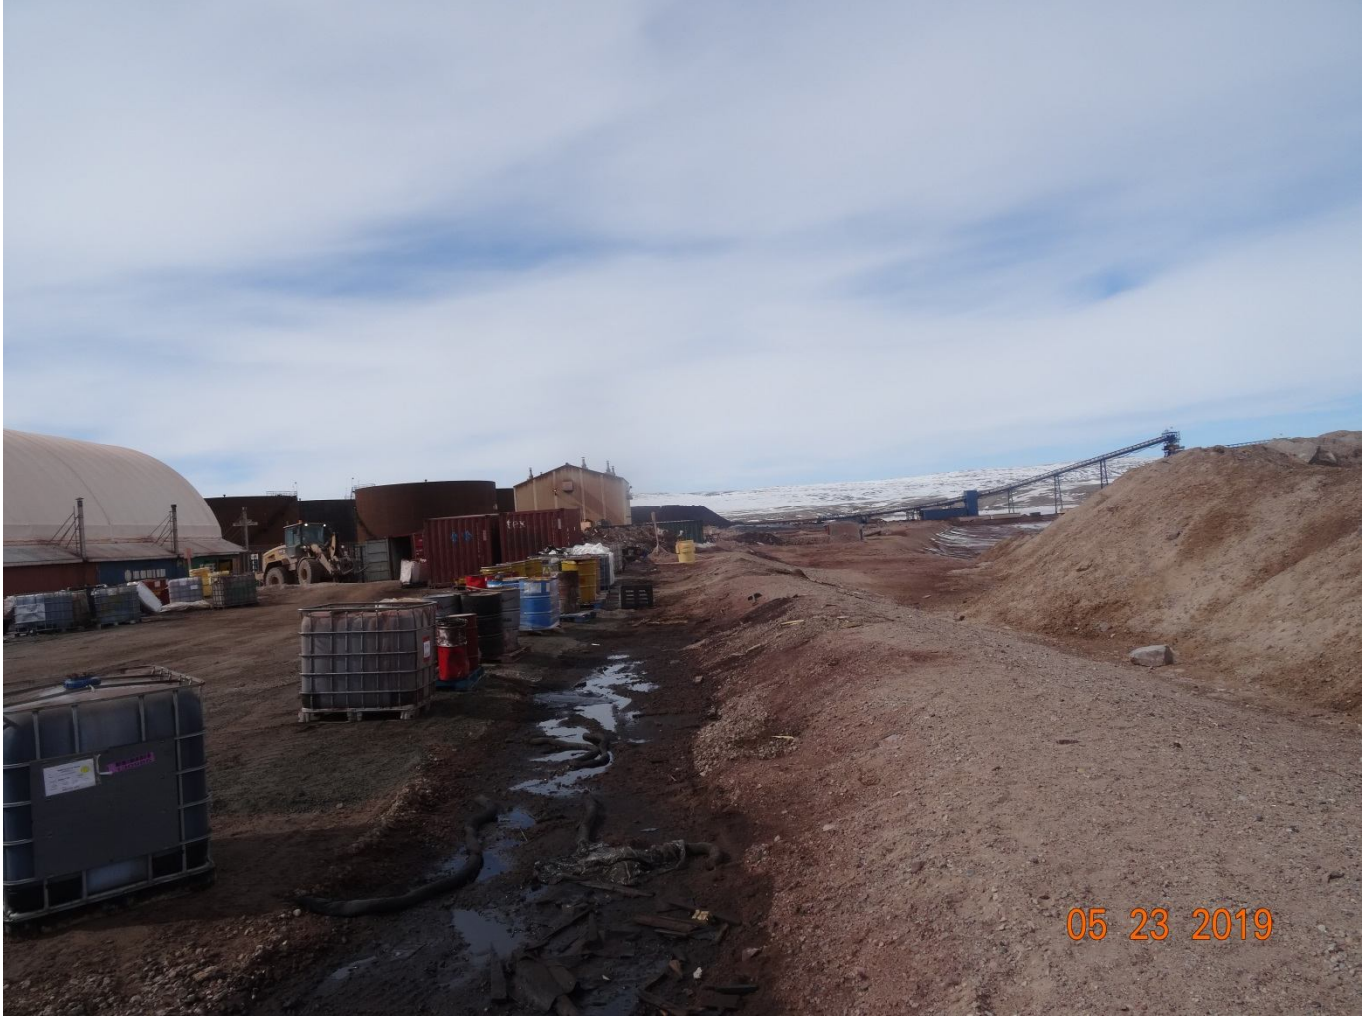
Photo 8

- a. During the inspection there was machinery operating in the hazardous waste berm and significant staining from spills in the facility, the machinery was freely driving in and out of this facility potentially spreading the spilled hazardous material and contaminating the surrounding area The inspector is requesting that the licensee remove the contaminated soil and appropriately dispose of it. (See Photo 8)

- b. The inspector noted that the licensee has recently placed new crushed rock in the facility over a portion of the spilled area and had absorbent material scattered over the affected area.(See Photo 8)

Description; Spill within Hazardous waste facility at Milne Inlet.

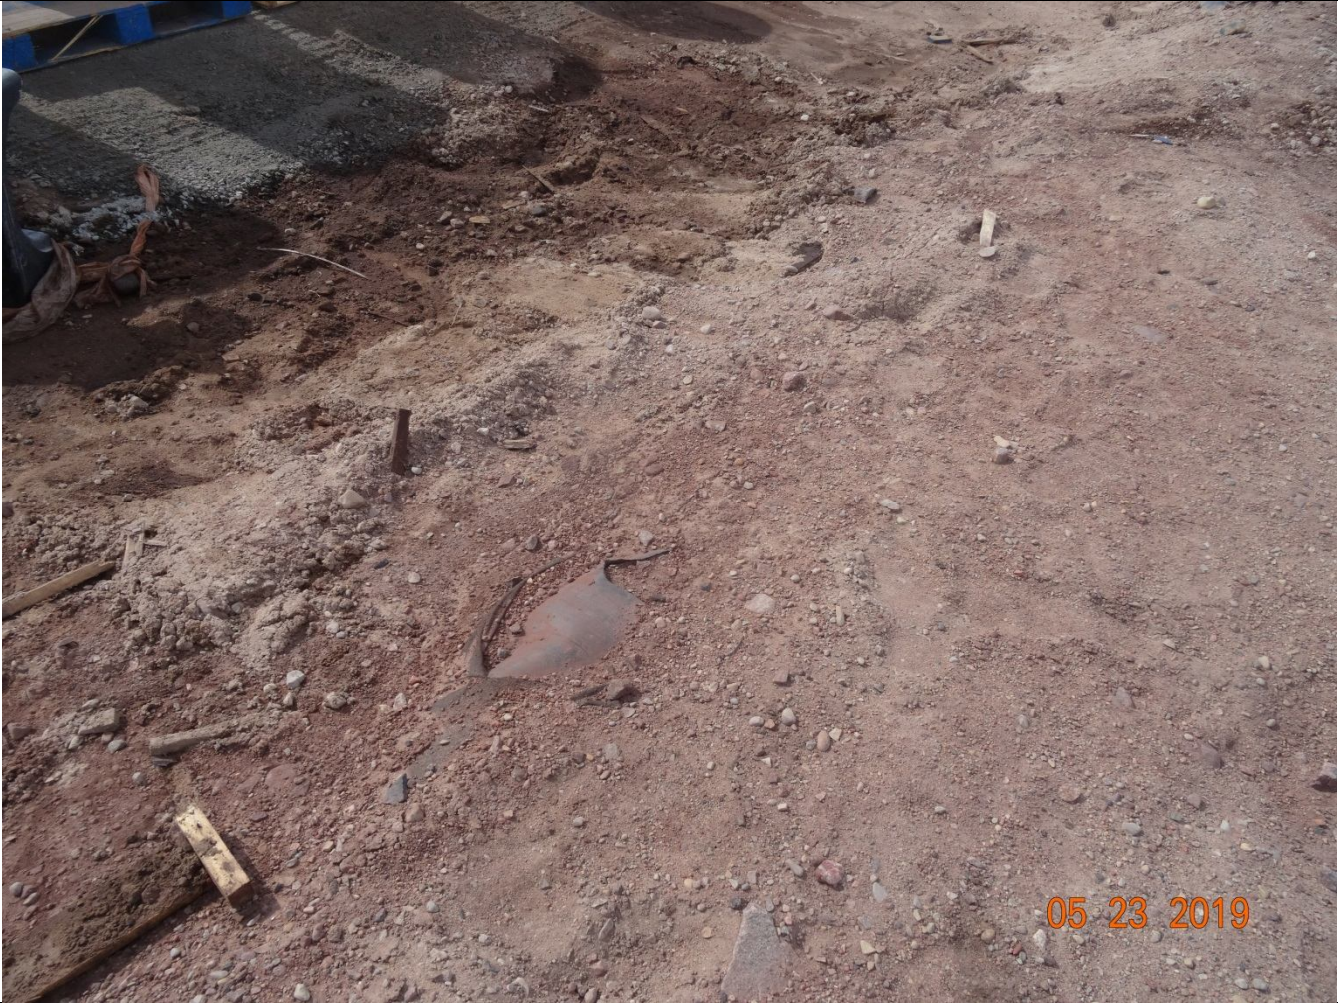
Photo 9

- d. The Inspector also noted rips in the liner of the facility that require repairs. (see Photo 9)

Description; Milne inlet Hazardous waste liner puncture.

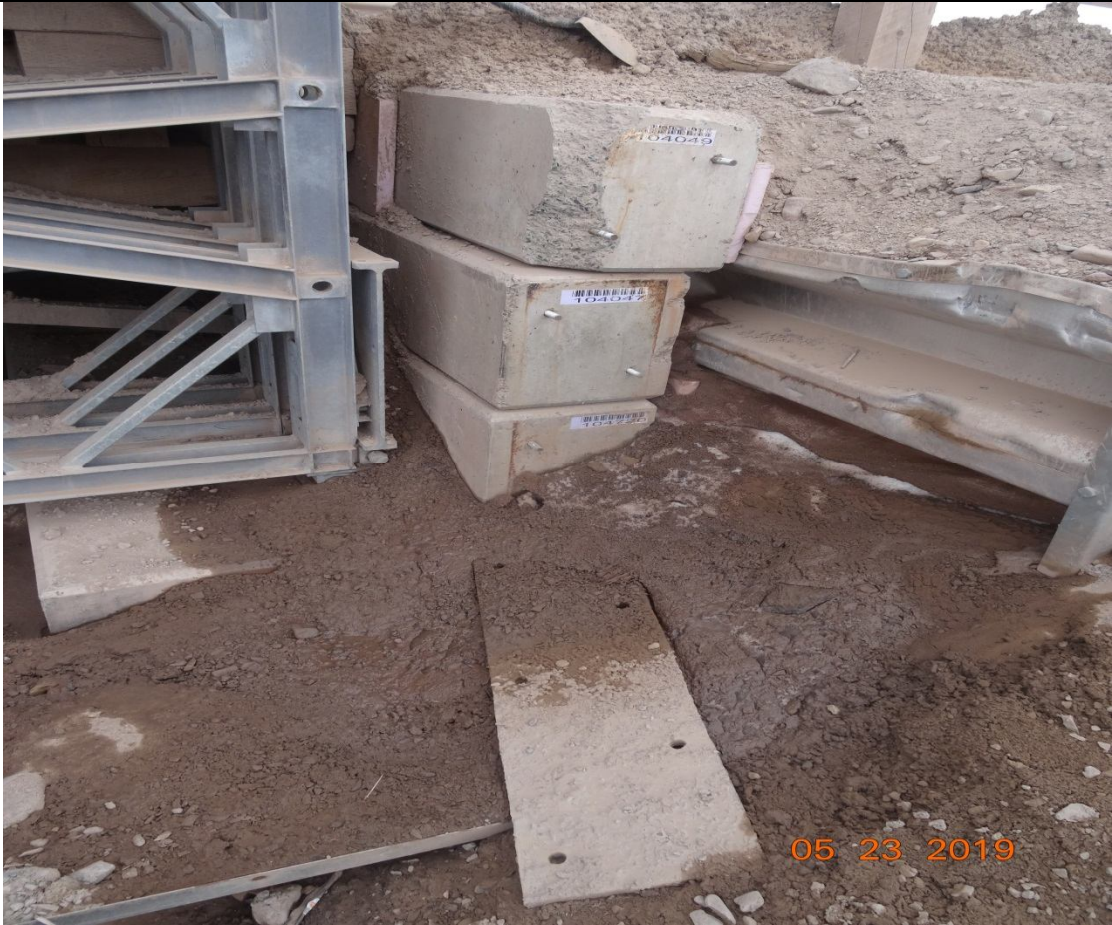
Photo 10

- I. Km 97 Bridge, Photo 10: The precast abutment wall appears moving out of place, the wall must be investigated by a qualified professional engineer and appropriate corrective actions are to be provided.

Description; Km 97 Bridge abutment concern

5. The licensee is to get a Professional Engineer to inspect the Bridges along the Tote road as stated by CIRNAC’s Civil Engineer and during the last Geotechnical inspection.

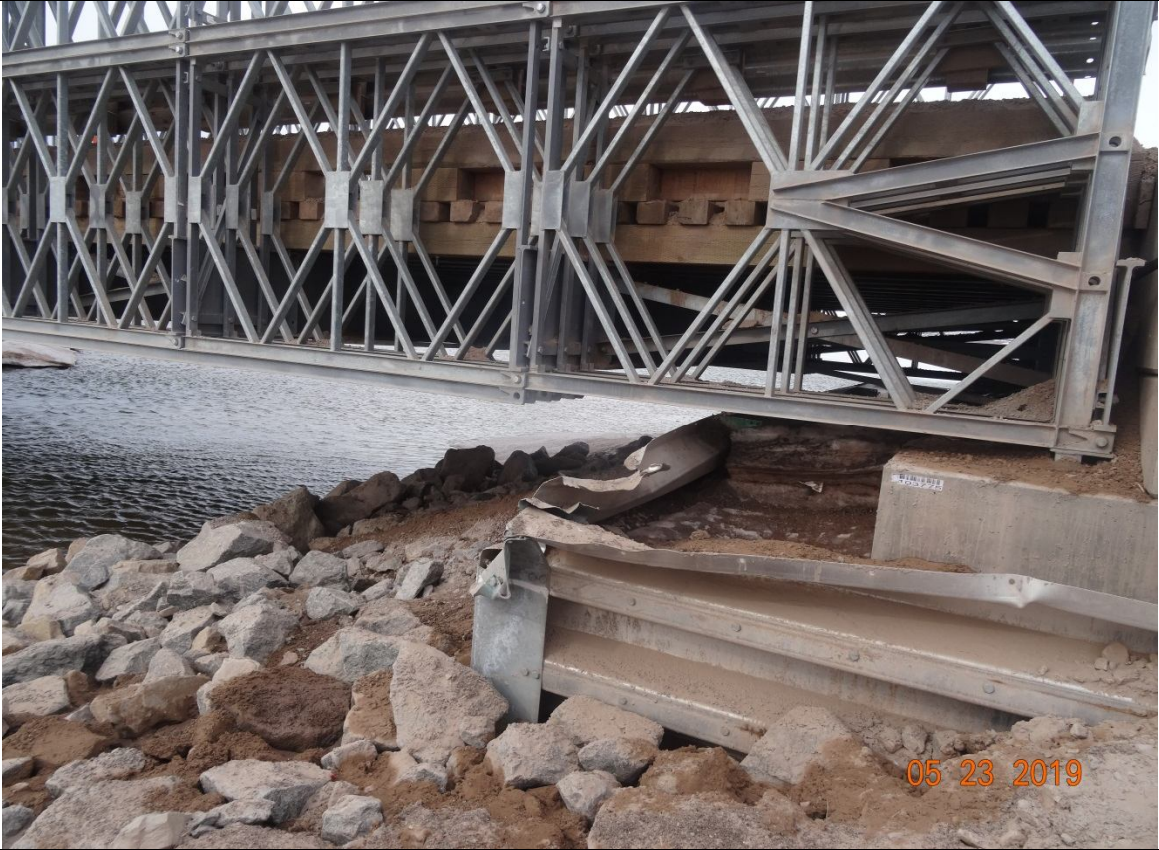
Photo 11

- II. Km 80 Bridge, Photo 11: Sizing and placing of the existing rip rap appear deficient and need to be reviewed. We would suggest having Baffinland look into a new design approach for the bridge abutment armoring features.

Description; Km 80 Bridge damage

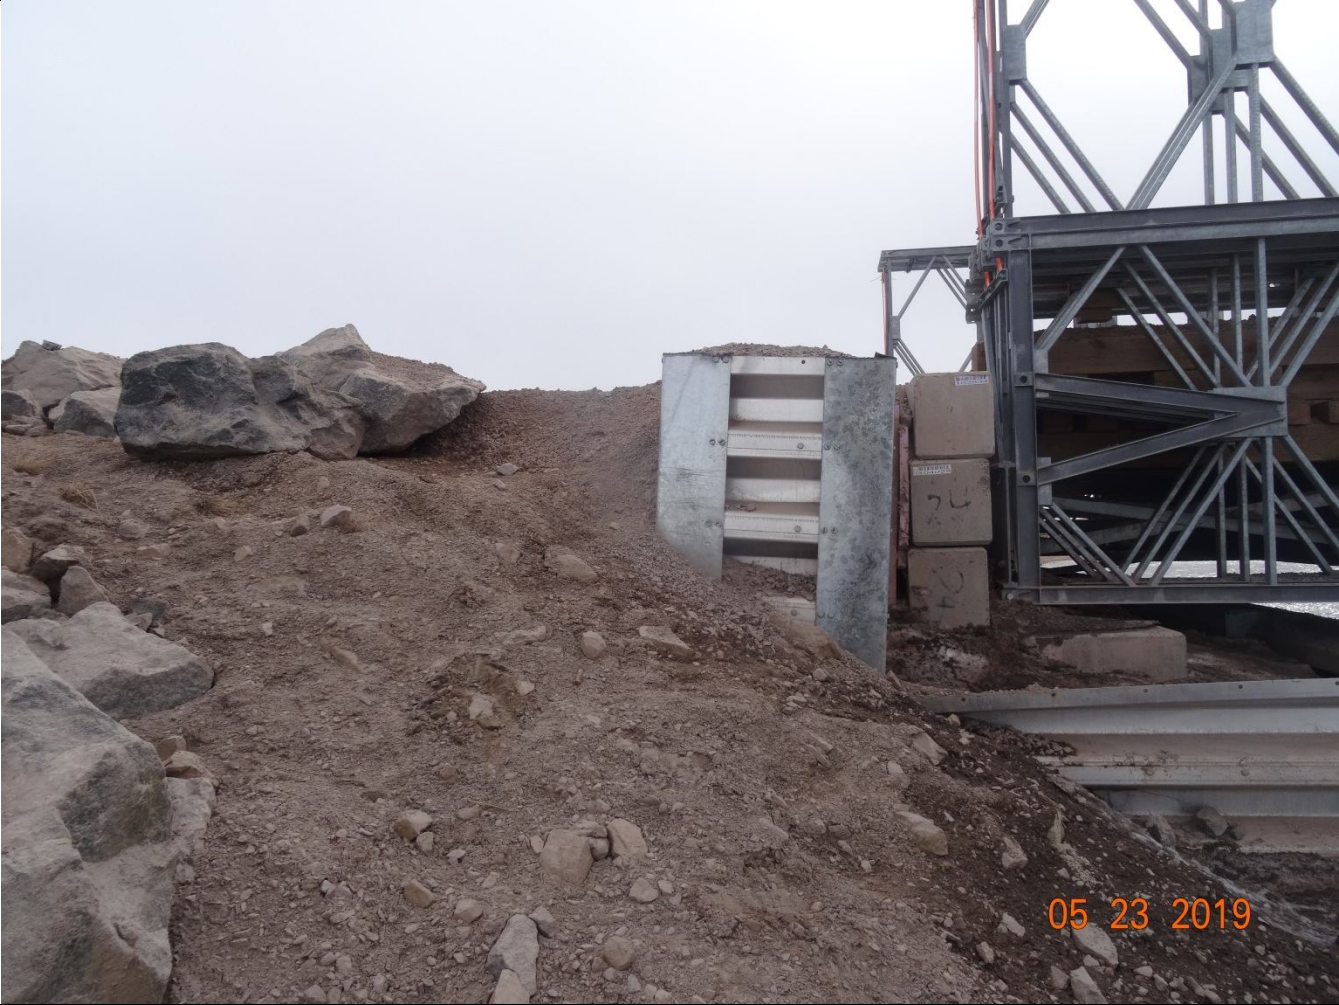
Photo 12

- III. Km 80 Bridge Photo 12: Armoring features are deficient. The existing abutment wall components do not appear stable. Baffinland is to investigate and provide adequate mitigation measures in place to ensure that the structural integrity of the bridge is not compromised.

Description; Km 80 Bridge abutment.

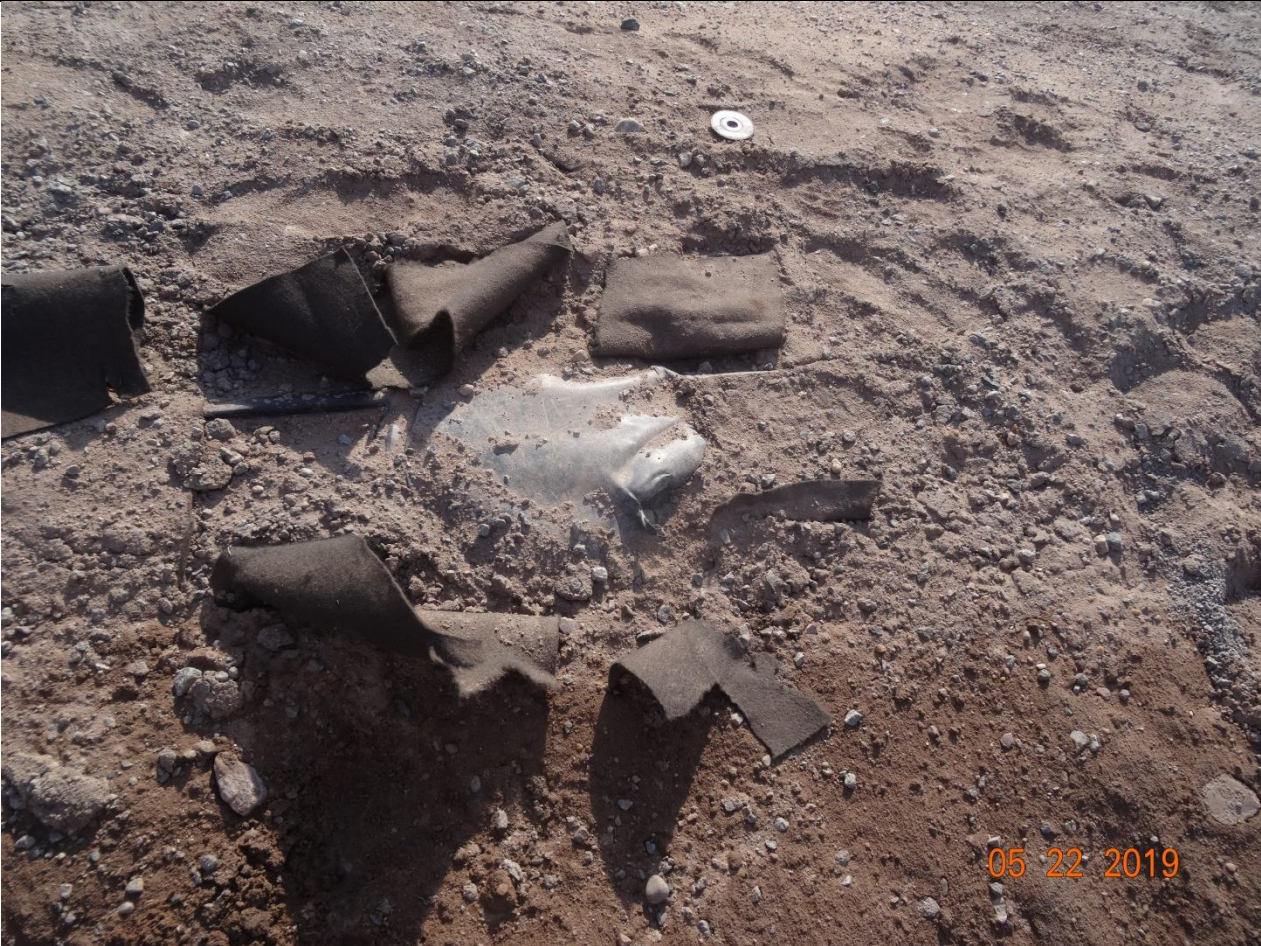
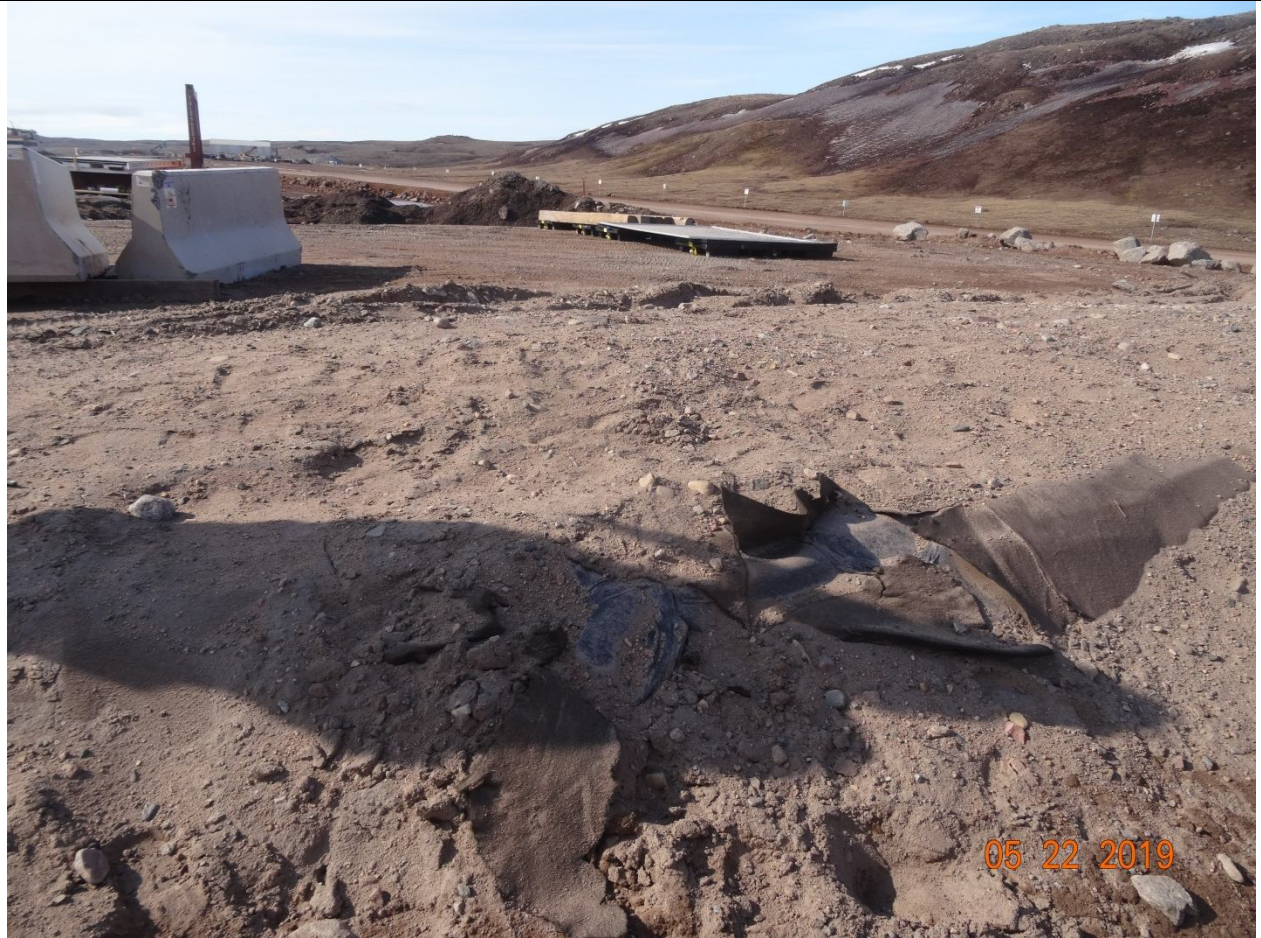
- a. While inspecting the Jet A storage it was noted that there was a high water mark significantly lower than the current water level. See Photos 13 and 14 for the noted concerns.
- b. There were rips in the Liner of this containment structure it appears to have hydrocarbons in the pooling water.

Description; Jet A storage liner rip.

6. The licensee is to repair the liner at the Jet “A” storage.
7. The licensee is to Install the appropriate water management structures or imply the appropriate snow management practices to limit machinery from driving through this surface water at Lay down #2.

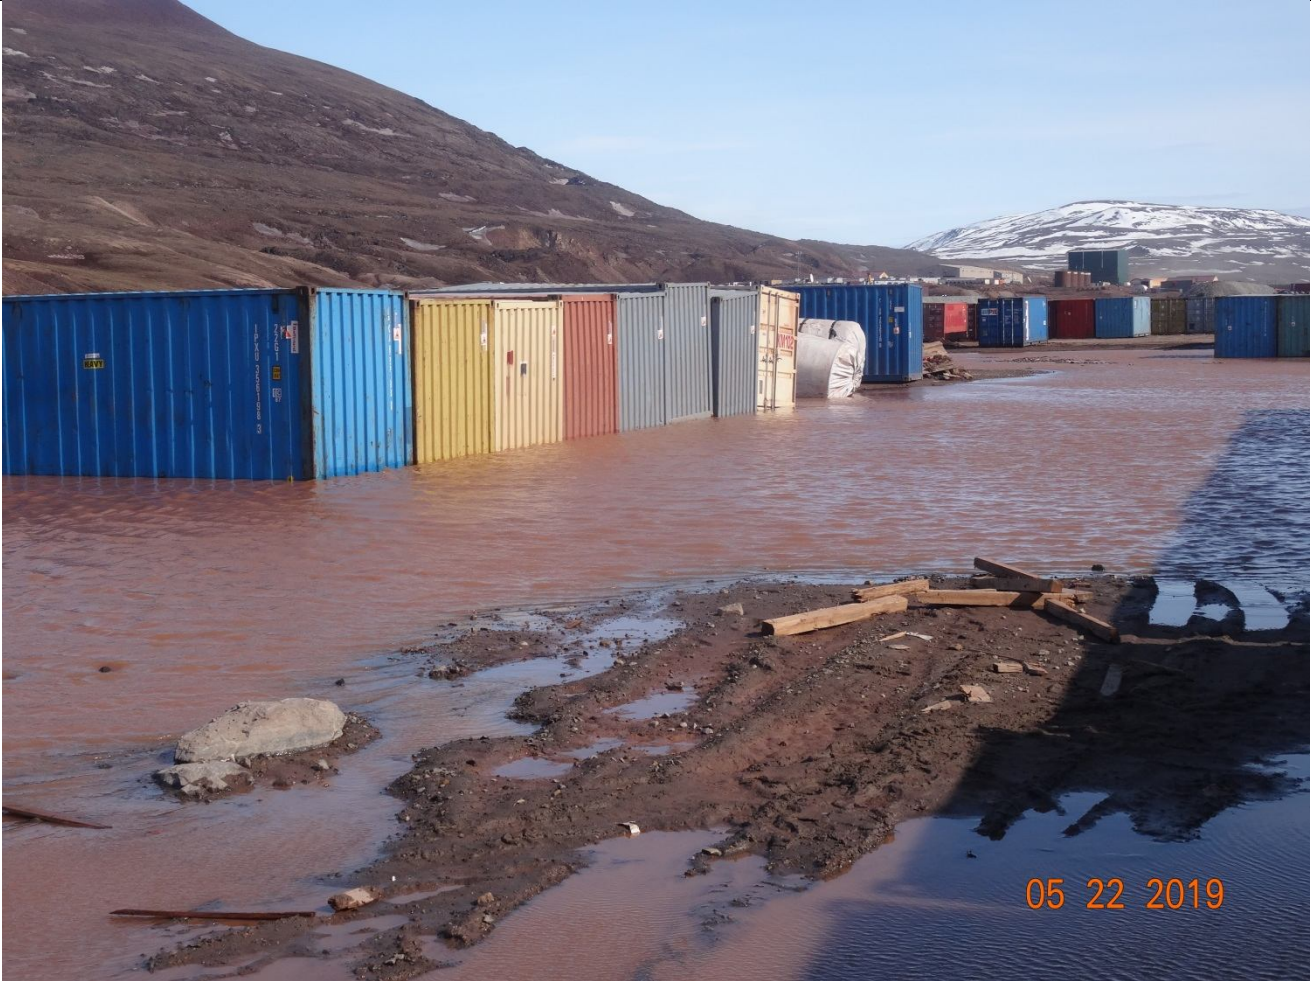
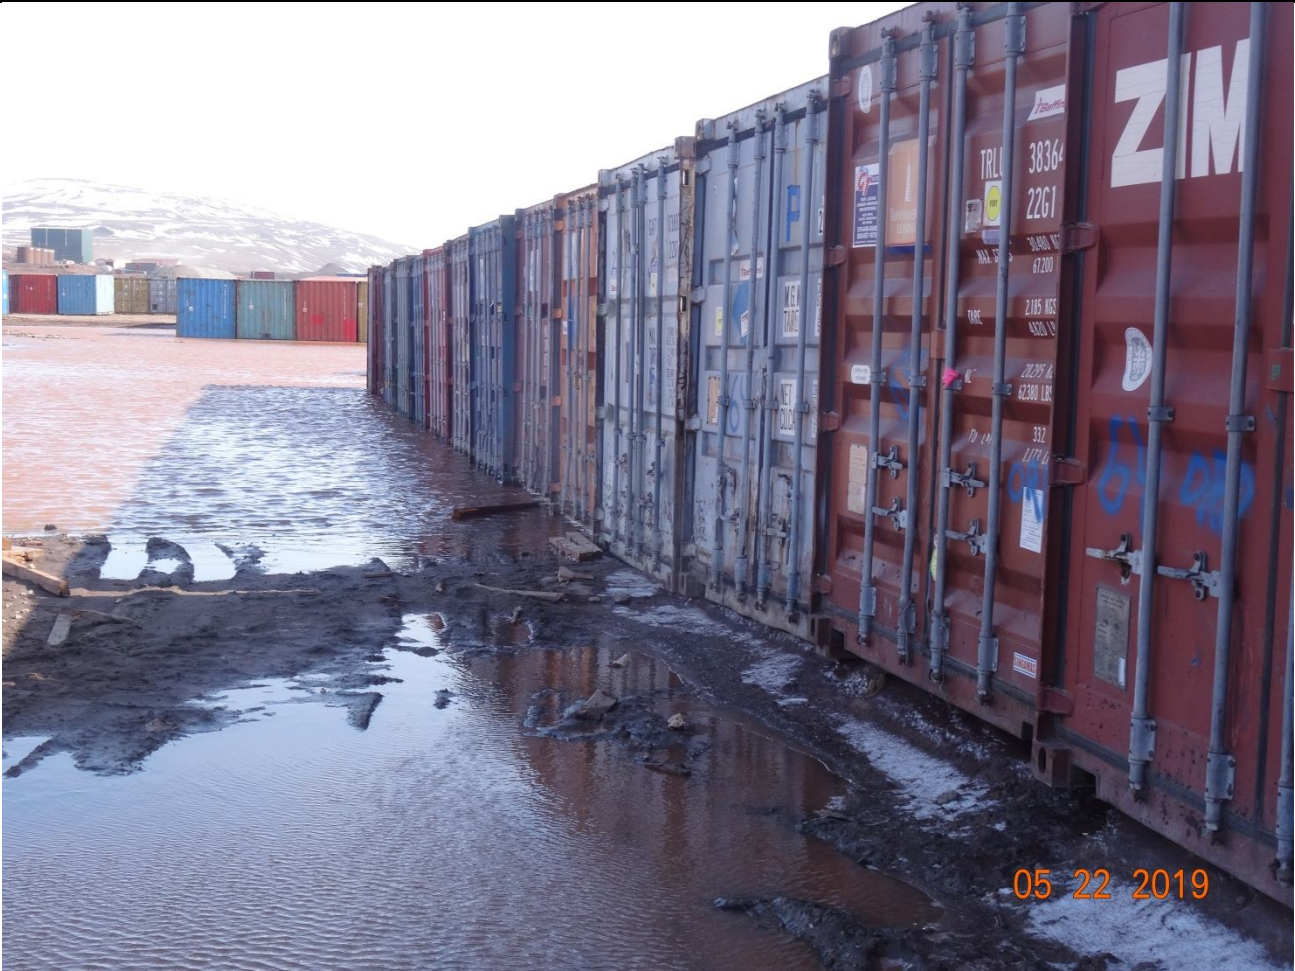
- a. At the time of the inspection there was significant flooding of this laydown, in the flooded area there was multiple storage containers sitting in the water.
- b. PART D item 22 states that; "The Licensee shall undertake necessary corrective measures to mitigate impacts on surface drainage resulting from the Licensee's activities." (see Photos 15 and 16 for photos of flooding)

Description; flooding of Laydown #2.

Description; flooding of Laydown #2

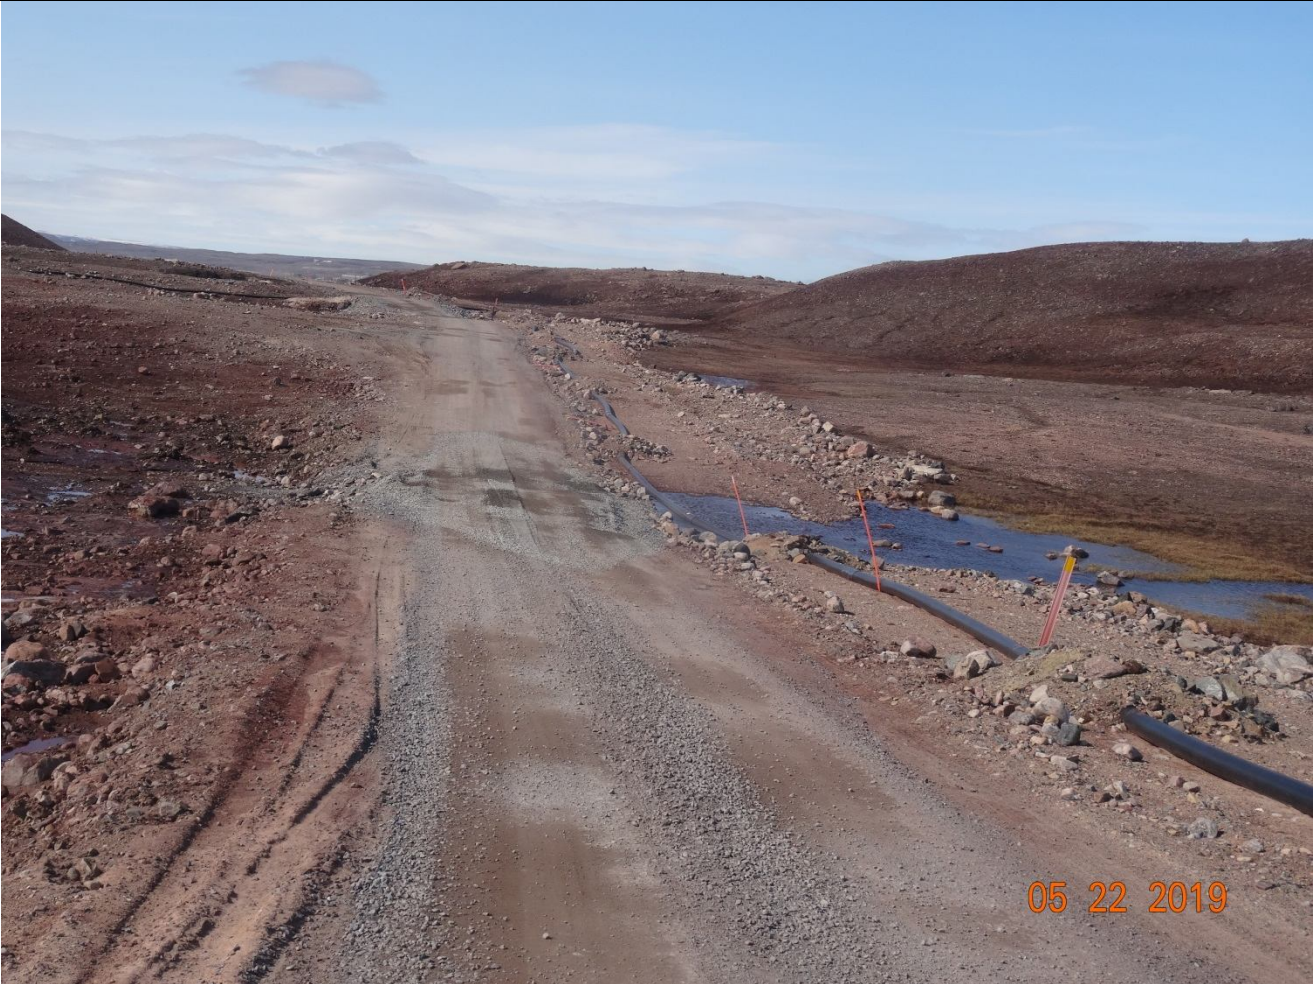
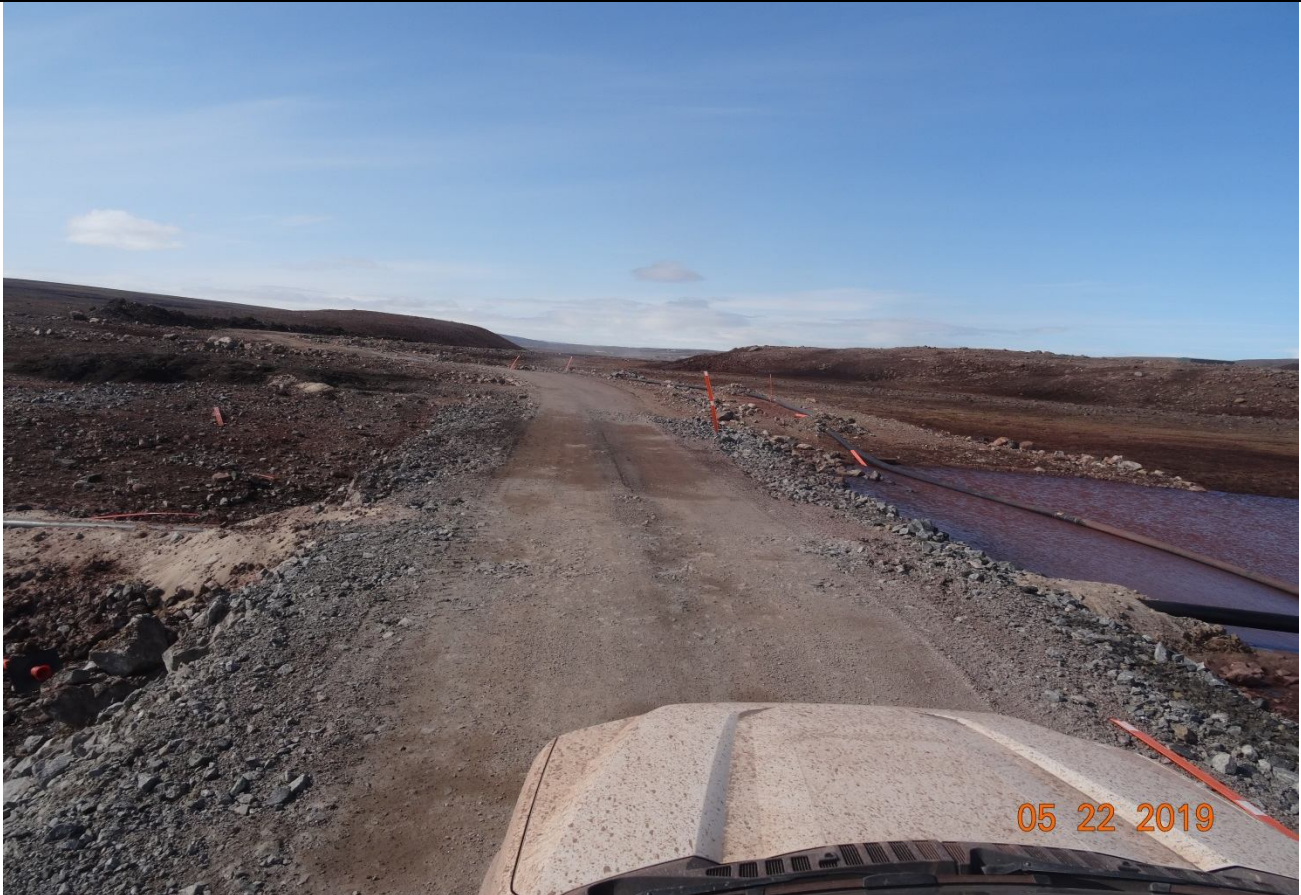
- a. During the inspection it was again noted that on this road there are area where the road blocks natural drainages which leads to flooding and washouts of the road.
- b. PART D item 22 states that; "The Licensee shall undertake necessary corrective measures to mitigate impacts on surface drainage resulting from the Licensee's activities." ( see photos 17 and 18 for the concerns noted above)

Description; Areas were natural drainage is blocked by the Mary River effluent access road

8. The licensee is to install the appropriate water management structures at areas along the Mary River Effluent discharge road where it disrupts the natural surface drainage.
