WATER LICENCE INSPECTION FORM

Licensee	Licensee Representative
BAFFINLAND IRON MINES CORPORATION	Connor Devereaux
Licence No. / Expiry	Representative's Title
2AM-MRY1325	Environmental Superintendent
Land / Other Authorizations	Land / Other Authorizations
8BC-MRY1416, 2BE-MRY1421	N2014X0012, N2014Q0016, N2014C0013
Date of Inspection	Inspector
May 22-23, 2019	Jonathan Mesher
Activities Inspected	
<input type="checkbox"/> Camp	<input type="checkbox"/> Drilling
<input type="checkbox"/> Roads/Hauling	<input checked="" type="checkbox"/> Mining
	<input type="checkbox"/> Construction
	<input type="checkbox"/> Reclamation
	<input type="checkbox"/> Fuel Storage
	<input type="checkbox"/> Other:

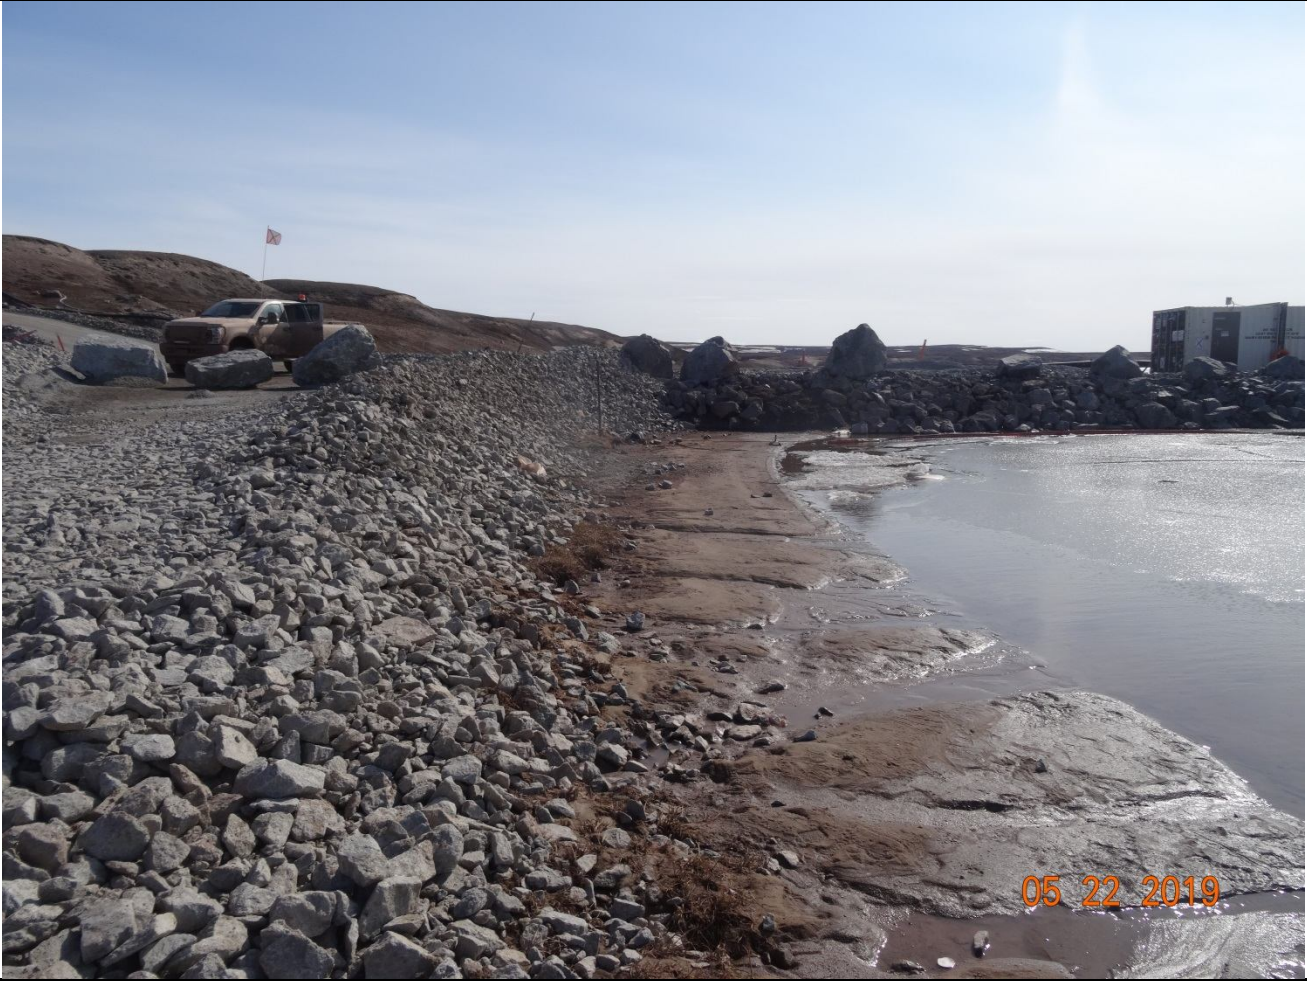
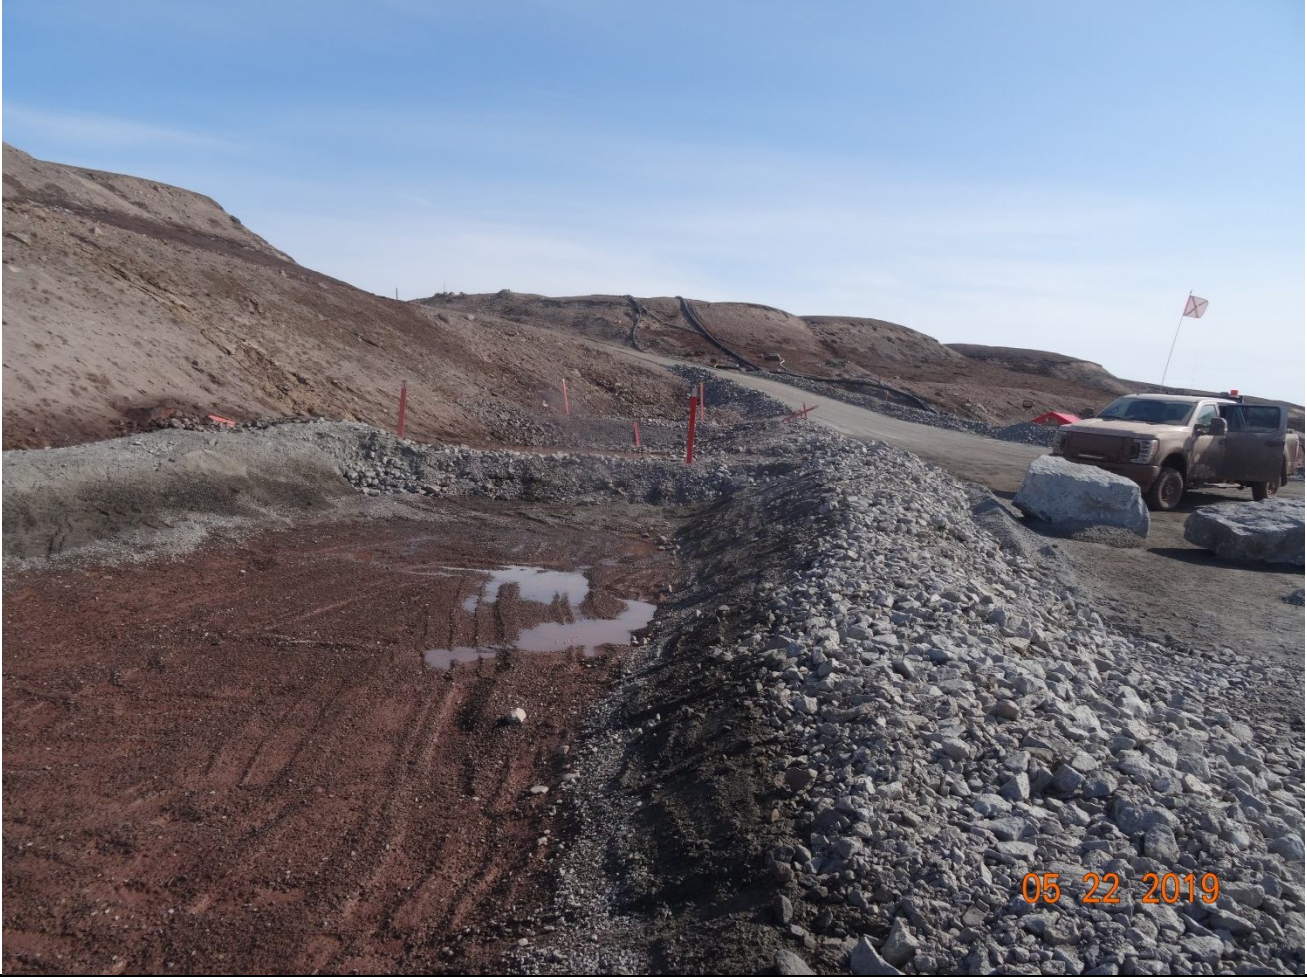
- a. In the last 2 years Baffinland has had continual problems with managing the runoff from the old Camp pad to Camp Lake during freshet, during the most recent inspection the licensee had constructed significant erosion structures such as, armoring along the drainage, armoring along the camp lake shore line and the installation of multiple settling ponds. When licensee was questioned about the approvals for the installation of these structures the licensee stated that the licence allows for construction of water management structures in emergency situations

- b. Due to the reoccurrence of this problem for multiple of years, the inspector does not believe that this is an emergency situation, The licensee is to submit the required documents in PART G of the licence 2AM-MRY1325 and seek approval for these water management structures. (see photos 19 and 20 for photos of the construction mentioned above).

Description; Construction within 31m of Camp Lake

Description; Water Management Structures constructed without approval.

9. The licensee is to submit the required documents in PART G of the licence 2AM-MRY1325 and seek approval for the water management structures constructed leading into Camp Lake.
