**RE: Water Licence 2AM-MRY1325 May 2019 Inspection Report**

Attachment 1: 2AM-MRY1325 May 2019 Inspection Report

WATER LICENCE INSPECTION FORM

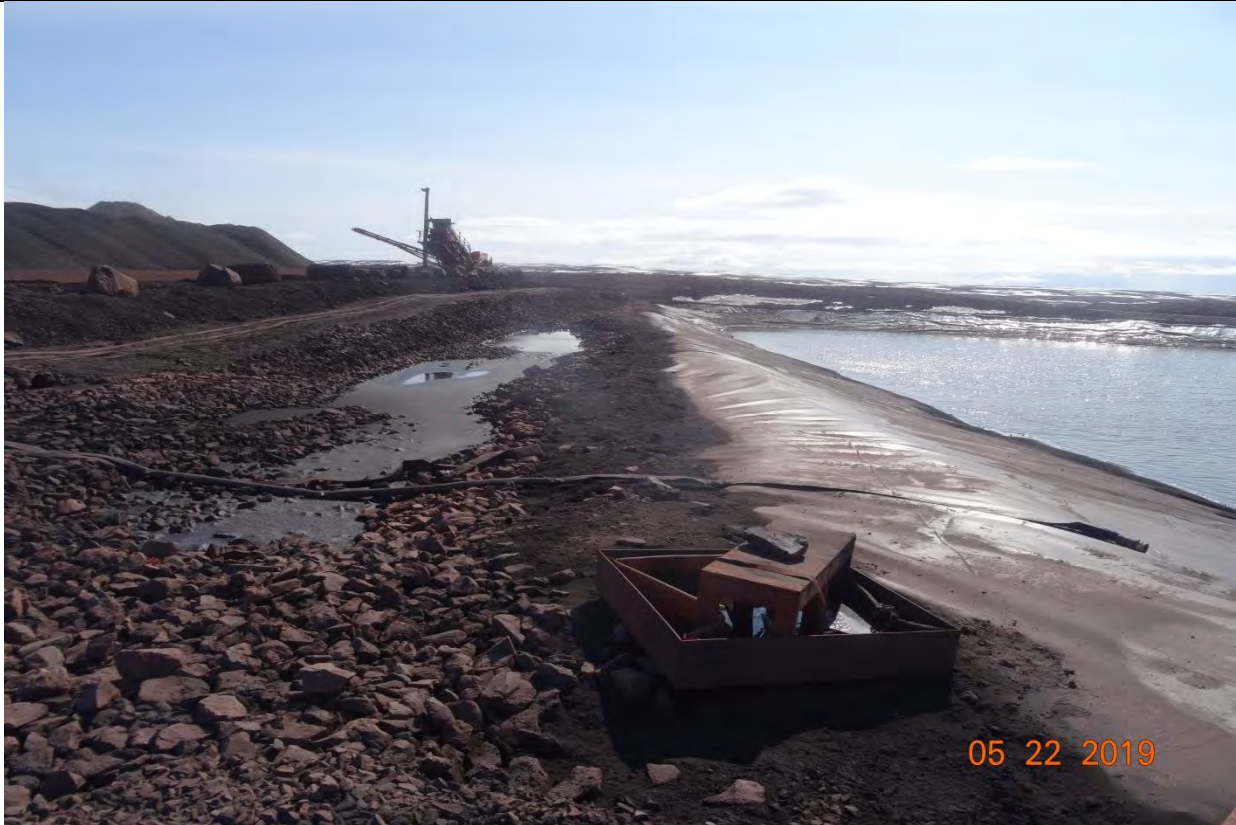
Date	Camera	Inspector	Authorization
August 22, 2018	Sony Cyber-shot	J.Mesher	2AM-MRY1325
<b>Photo Log</b>		<b>Location Baffinland</b>	
Photo 1

- c. As mentioned in previous inspection reports the slope of the ditches surrounding this facility do not appear to be consistent with the approved design and the construction material does not appear to be the approve size. (see Photo 1).

**Description:** Pooling in unlined ditches of the Crusher pad

surrounding Ore Crusher Pad are constructed with the approved materials in the approved design.

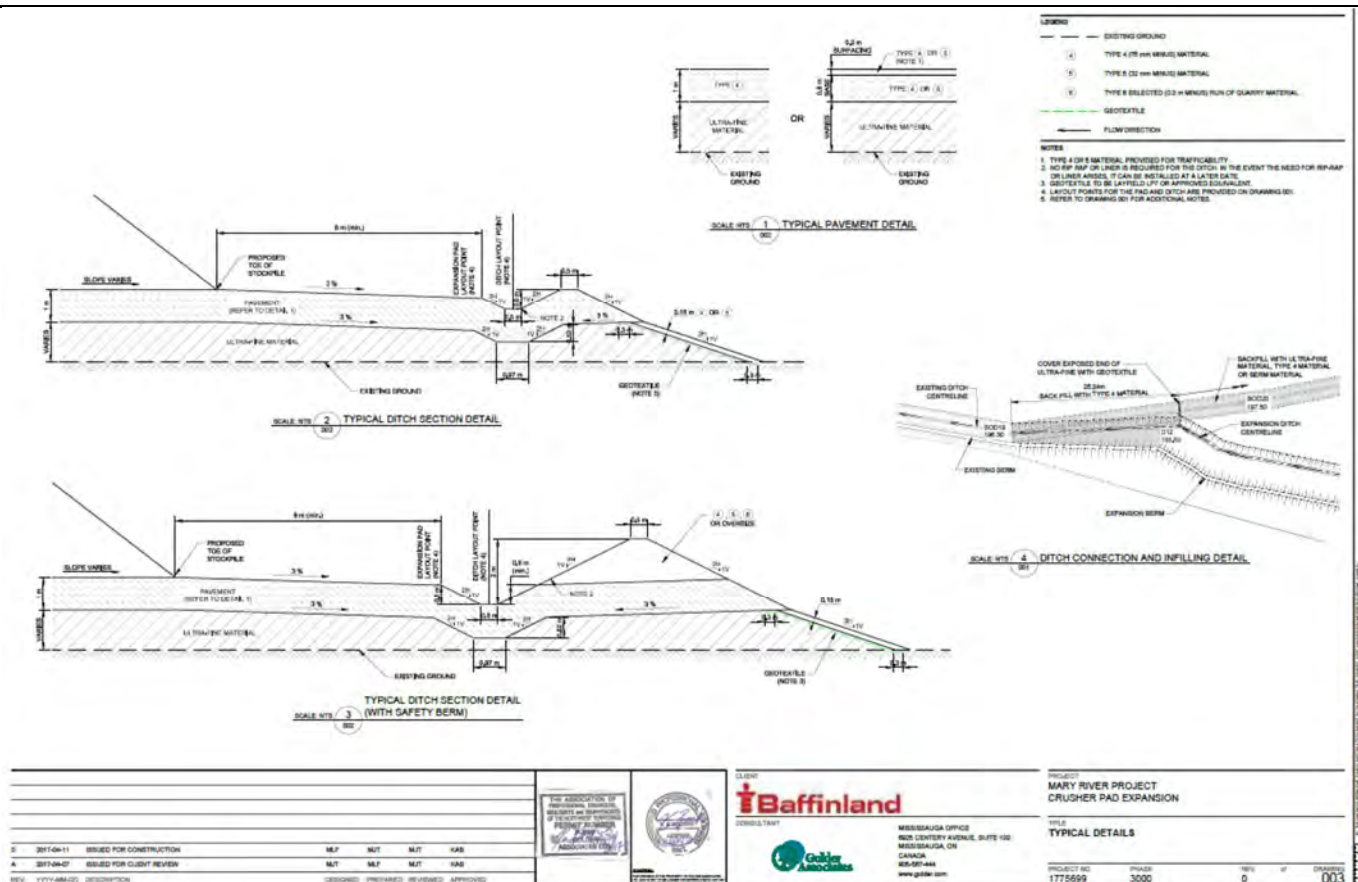
- b. The licensee continues to express to the Inspector that the perimeter road is designed to be 3m wide, in the "For Construction" drawing below produced by Golder Associates for BIMC it clearly shows there should be is 8m gap between the stockpile and the ditch. (See Photo 2 )While on site it was noted that the material used to construct the ditches are significantly larger than the approved material mentioned in the For Construction drawing.

**Description: Crusher Pad expansion For Construction**

- 1. The Licensee is to Install and maintain the required 8m gap between the Crusher Pad Stockpile and Water Management structures. If this not completed by August 15<sup>th</sup>, 2019 the inspector will proceed with further enforcement.
- 2. Due to the apparent discrepancy between the material in the For Construction drawings and what's actually on site, the Licensee is to provide a report ensuring that the Water Management structures

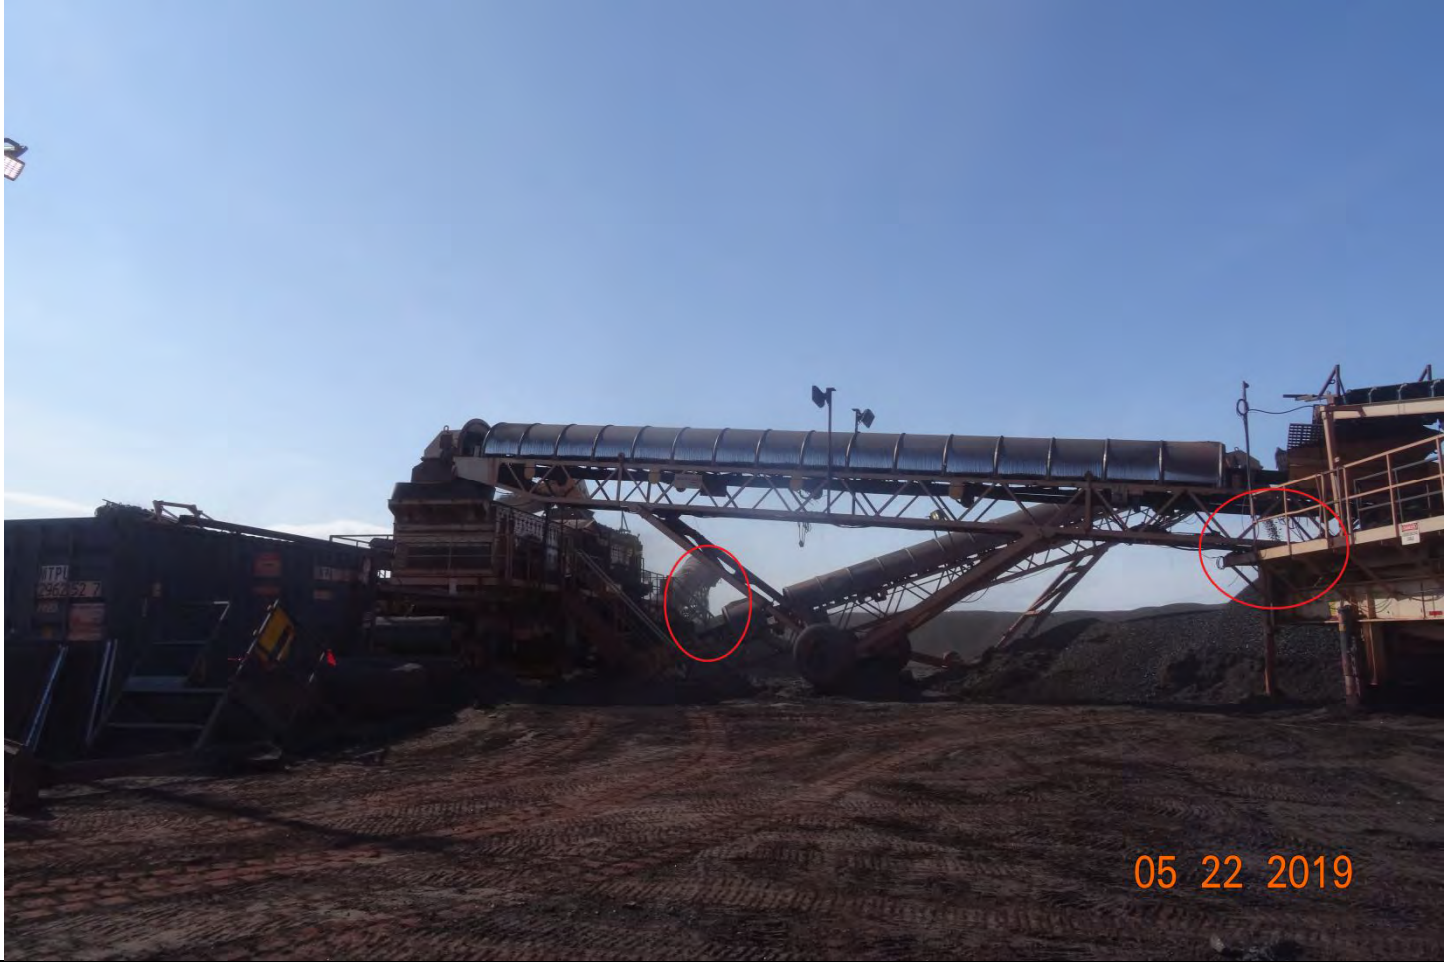
Photo 3

- d. It does not appear that the licensee is using the dust mitigation measures agreed upon, while on site the licensee was not using the shroud at the end of the conveyer belt that stacks the ore after crushing.( see Photo # 3)

Description: Lack of dust control

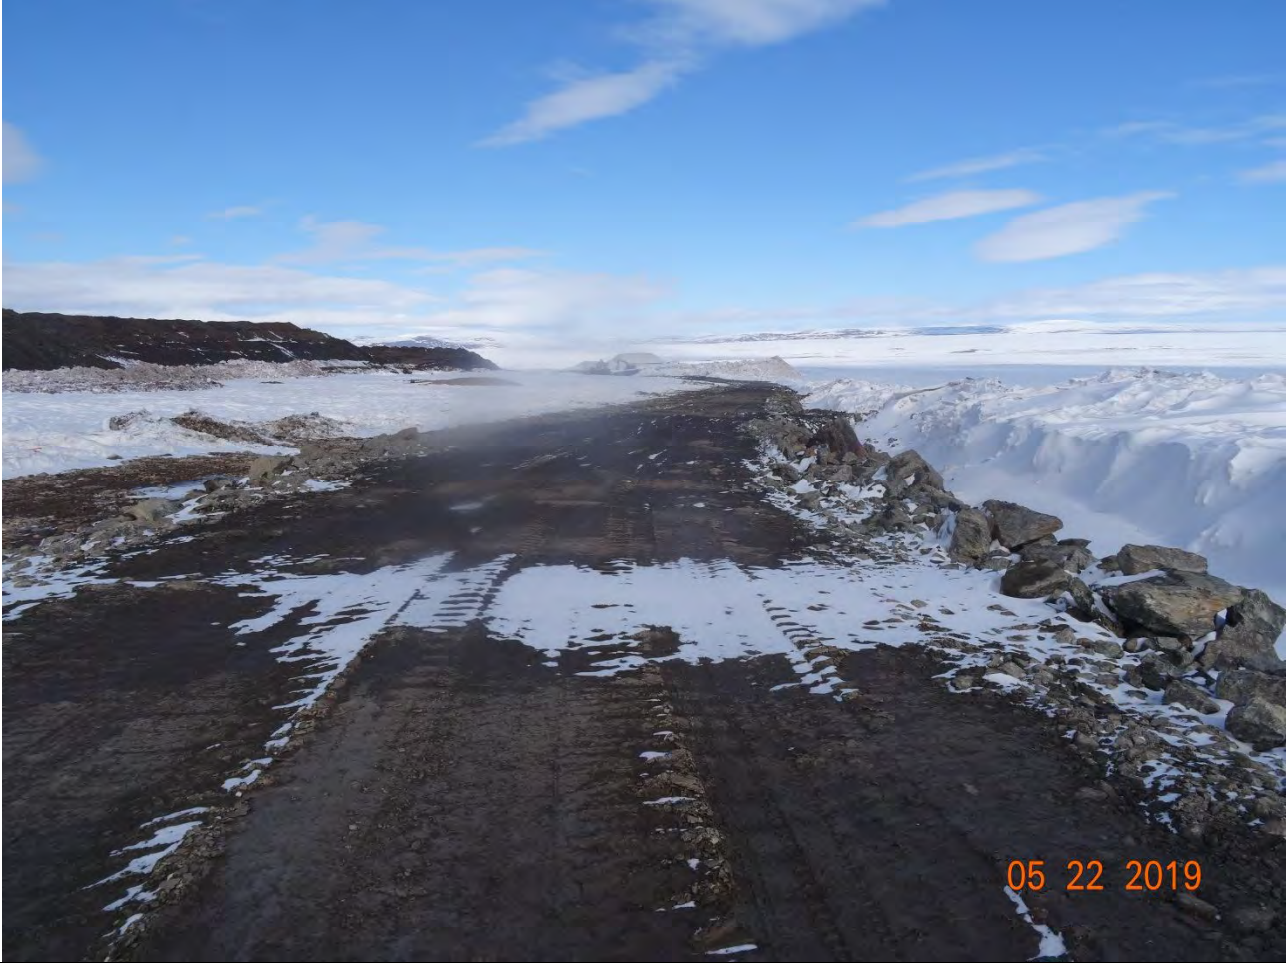
Photo 4

Description: Waste Rock Stockpile Ditches/ perimeter road construction

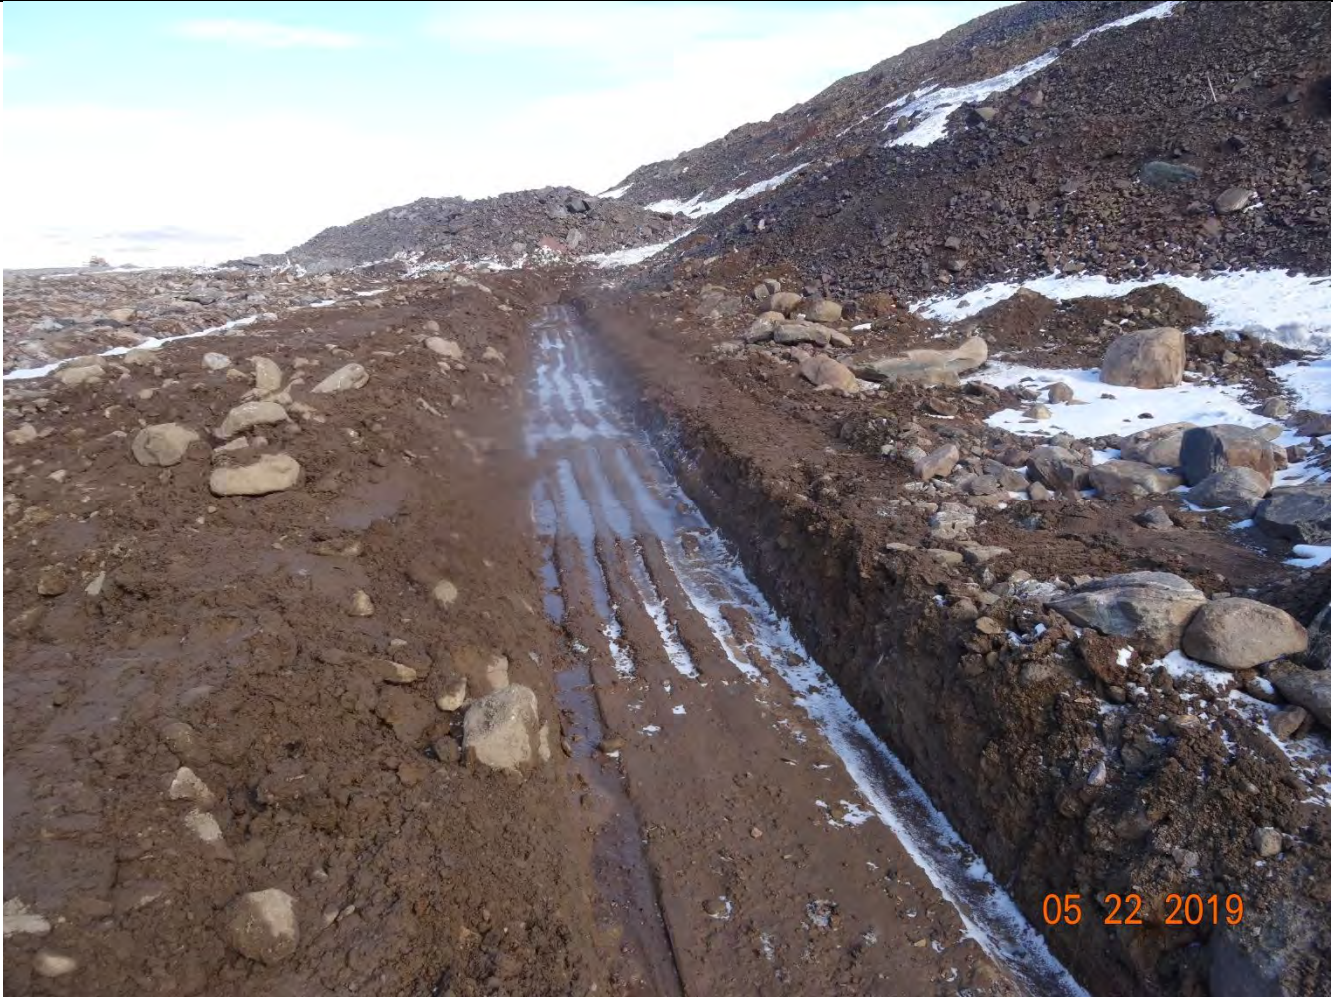
Photo 5

Description: Waste Rock Stockpile improperly constructed Ditches

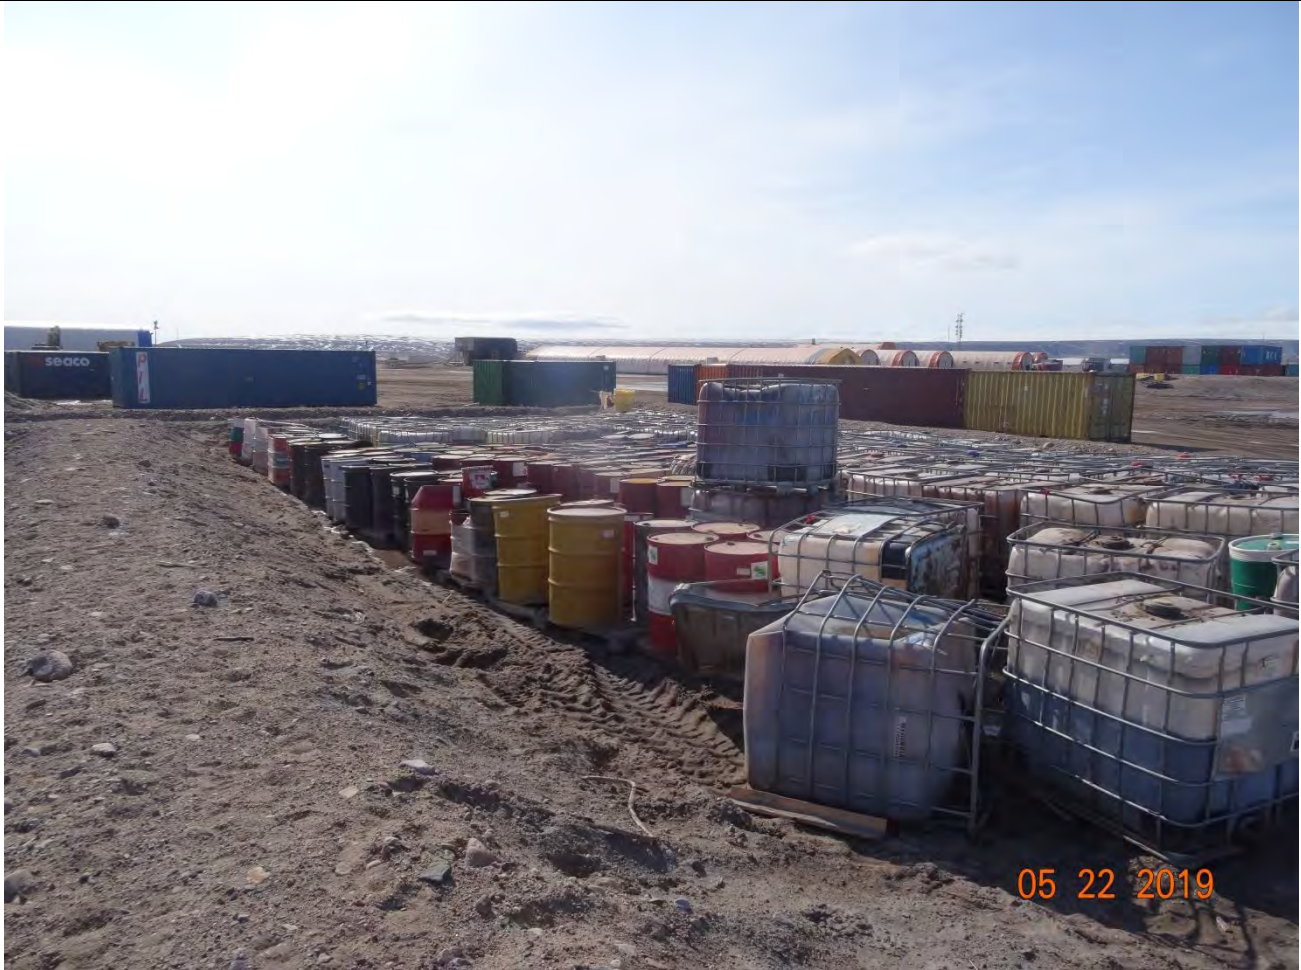
Photo 6

- a. The inspector noted that Hazardous waste berm #7 had limited capacity and the berm walls were inconsistent, the inspector is requesting that the licensee provide the for construction and As-built drawings for all Hazardous waste berms.
- b. The inspector noted damaged containers within the Hazardous Waste Berm, Section 4.4.2of the Hazardous Material and Hazardous waste Management Plan states that; "Regular inspections are performed and recorded. Containers are placed so that each container can be inspected for signs of leaks or deterioration. Leaking or deteriorated containers will be removed and their content transferred to a sound container." The Licensee is to remove all damaged containers and transfer the hazardous material to sound containers. ( see Photos #6 )

Description: Damaged Hazardous waste containers.

3. The licensee is to remove all Hazardous material from any damaged containers and place it in sound containers.
4. The licensee is to repair/ Key-in the liners at MP-05 and MP-06 to ensure all runoff is proper captured.

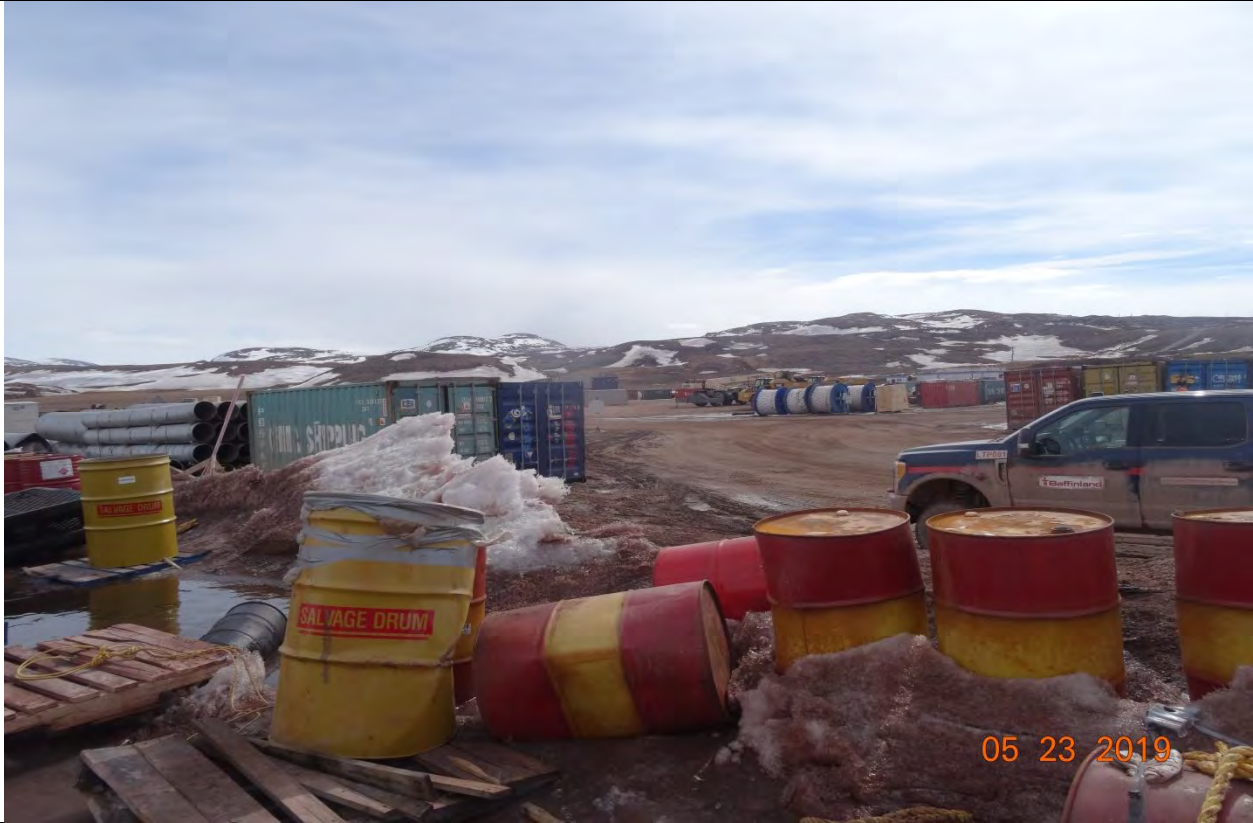
Photo 7

- c. The inspector noted damaged containers within the Hazardous Waste Berm, Section 4.4.2of the Hazardous Material and Hazardous waste Management Plan states that; "Regular inspections are performed and recorded. Containers are placed so that each container can be inspected for signs of leaks or deterioration. Leaking or deteriorated containers will be removed and their content transferred to a sound container." The Licensee is to remove all damaged containers and transfer the hazardous material to sound containers. (see Photo 7)

Description: Damaged Hazardous Waste containers.

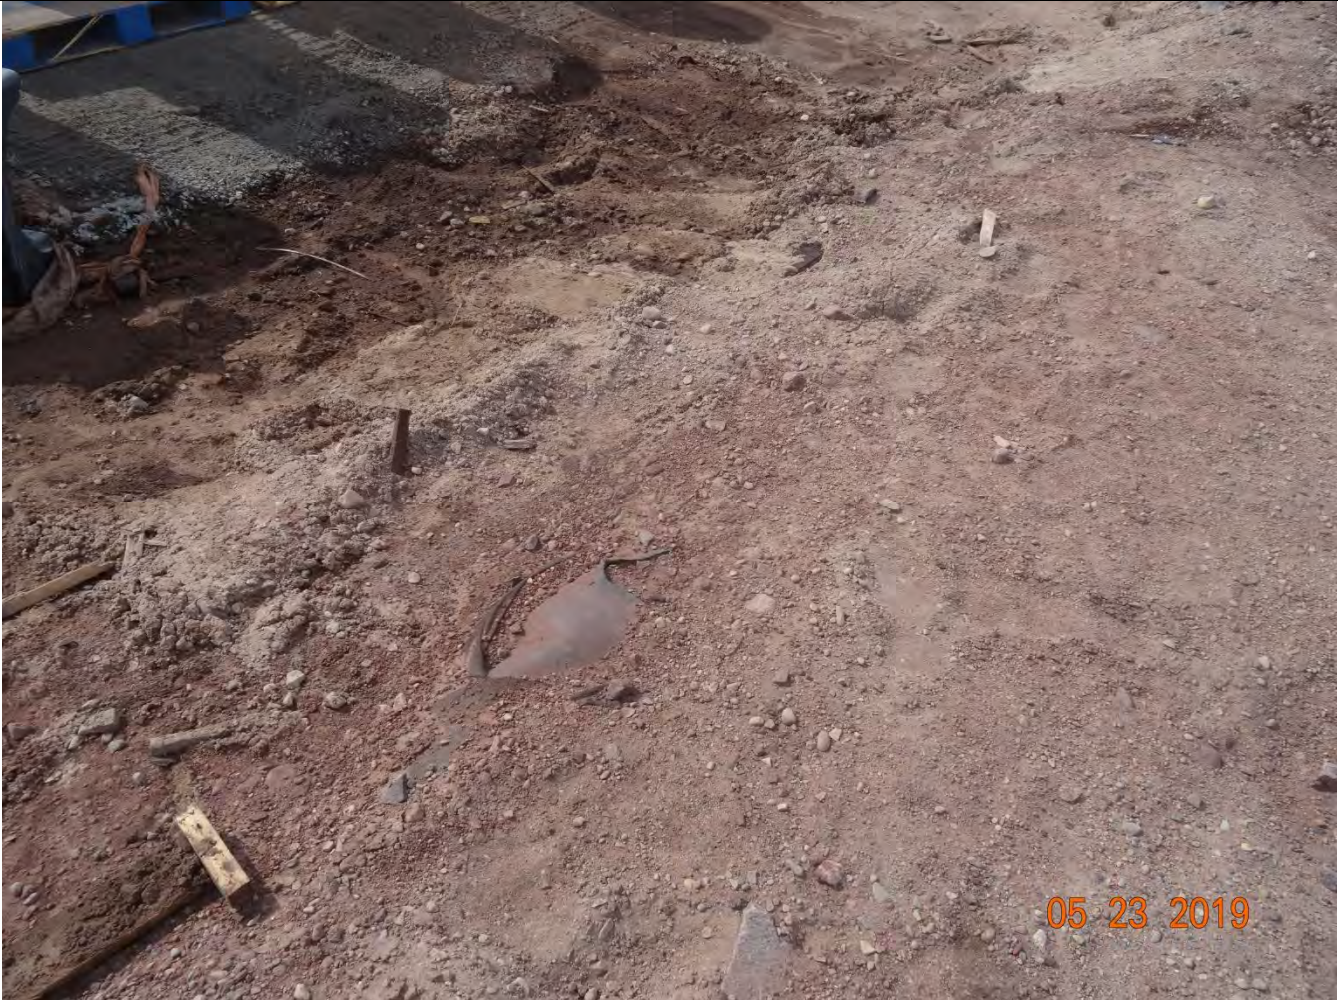
Photo 9

- d. The Inspector also noted rips in the liner of the facility that require repairs. (see Photo 9)

Description; Milne inlet Hazardous waste liner puncture.

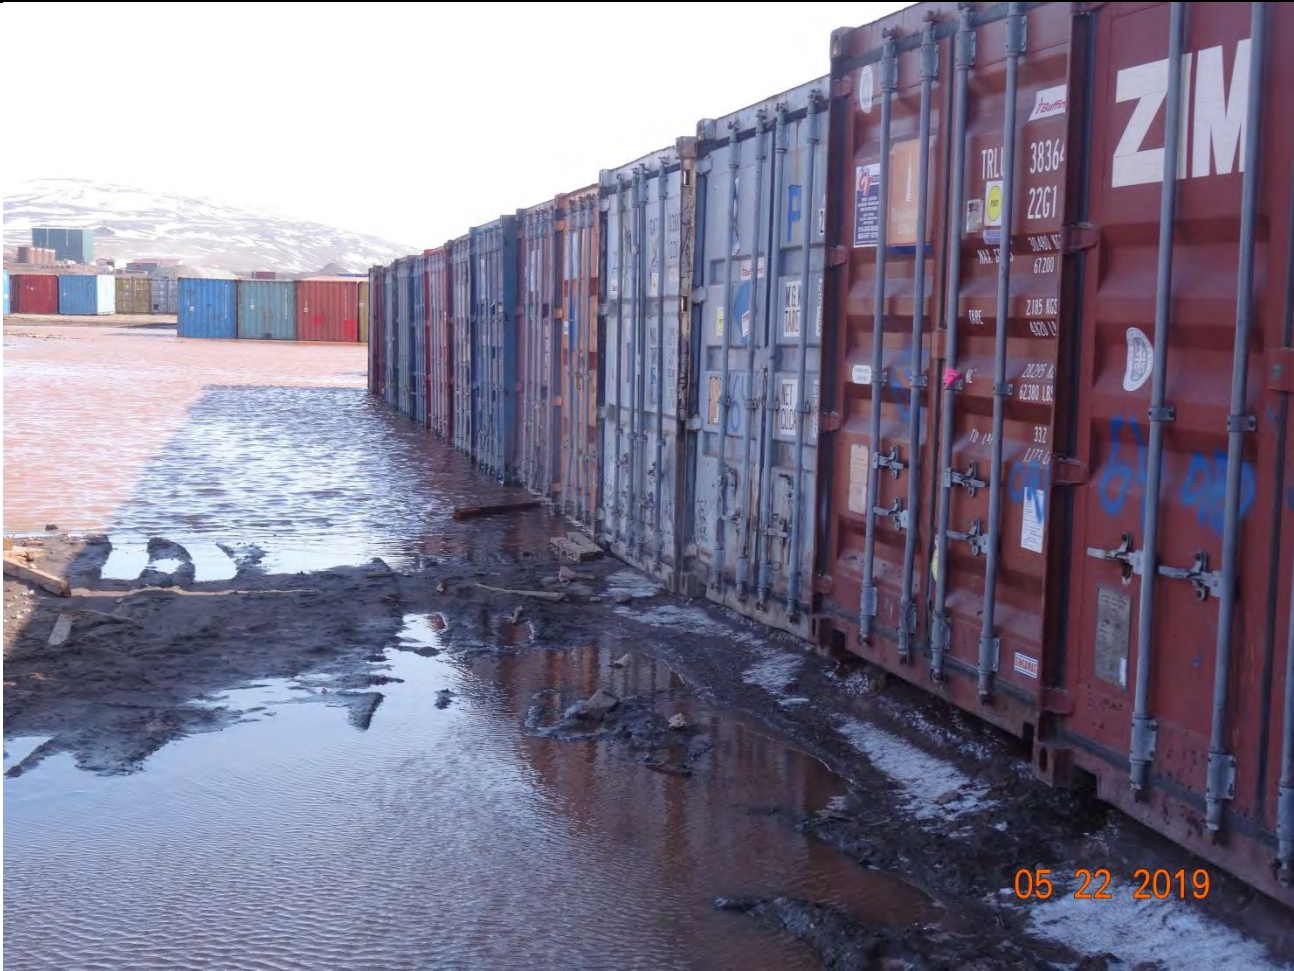
- a. At the time of the inspection there was significant flooding of this laydown, in the flooded area there was multiple storage containers sitting in the water.
- b. PART D item 22 states that; "The Licensee shall undertake necessary corrective measures to mitigate impacts on surface drainage resulting from the Licensee's activities." (see Photos 15 and 16 for photos of flooding)

Description; flooding of Laydown #2.

Description; flooding of Laydown #2

6. The licensee is to repair the liner at the Jet “A” storage.
7. The licensee is to Install the appropriate water management structures or imply the appropriate snow management practices to limit machinery from driving through this surface water at Lay down #2.

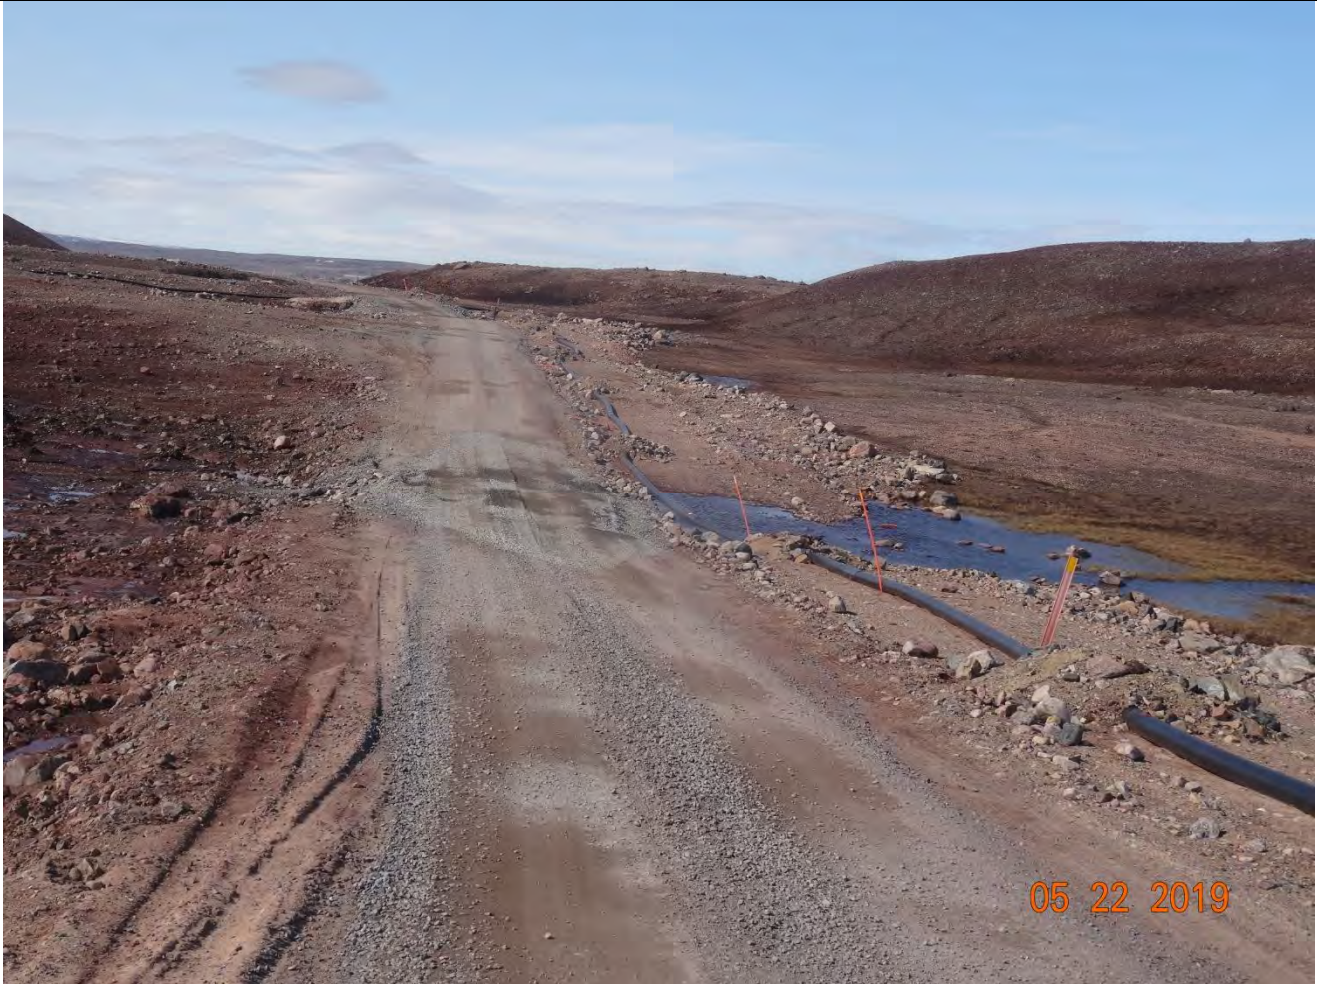
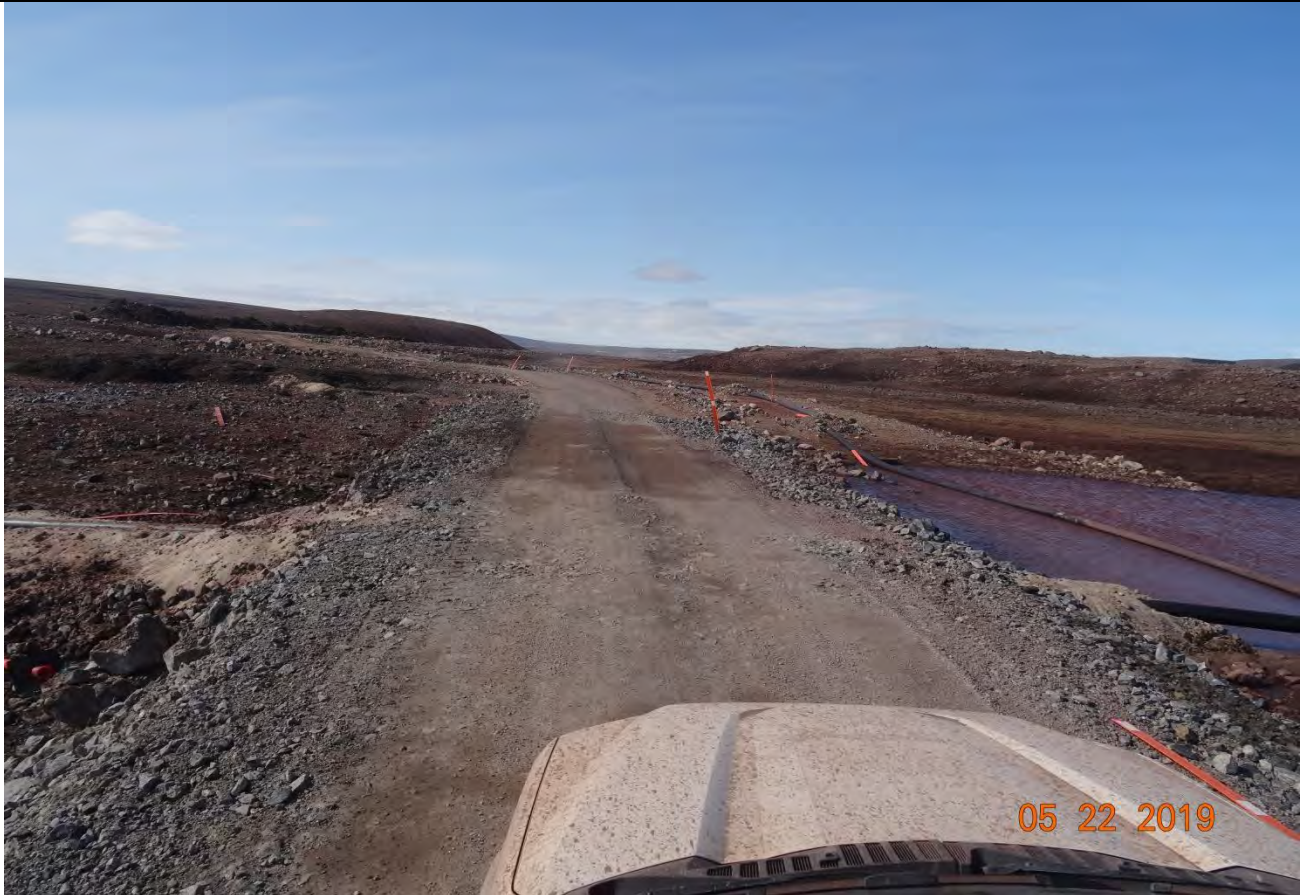
- a. During the inspection it was again noted that on this road there are area where the road blocks natural drainages which leads to flooding and washouts of the road.
- b. PART D item 22 states that; "The Licensee shall undertake necessary corrective measures to mitigate impacts on surface drainage resulting from the Licensee's activities." ( see photos 17 and 18 for the concerns noted above)

Description; Areas were natural drainage is blocked by the Mary River effluent access road

8. The licensee is to install the appropriate water management structures at areas along the Mary River Effluent discharge road where it disrupts the natural surface drainage.

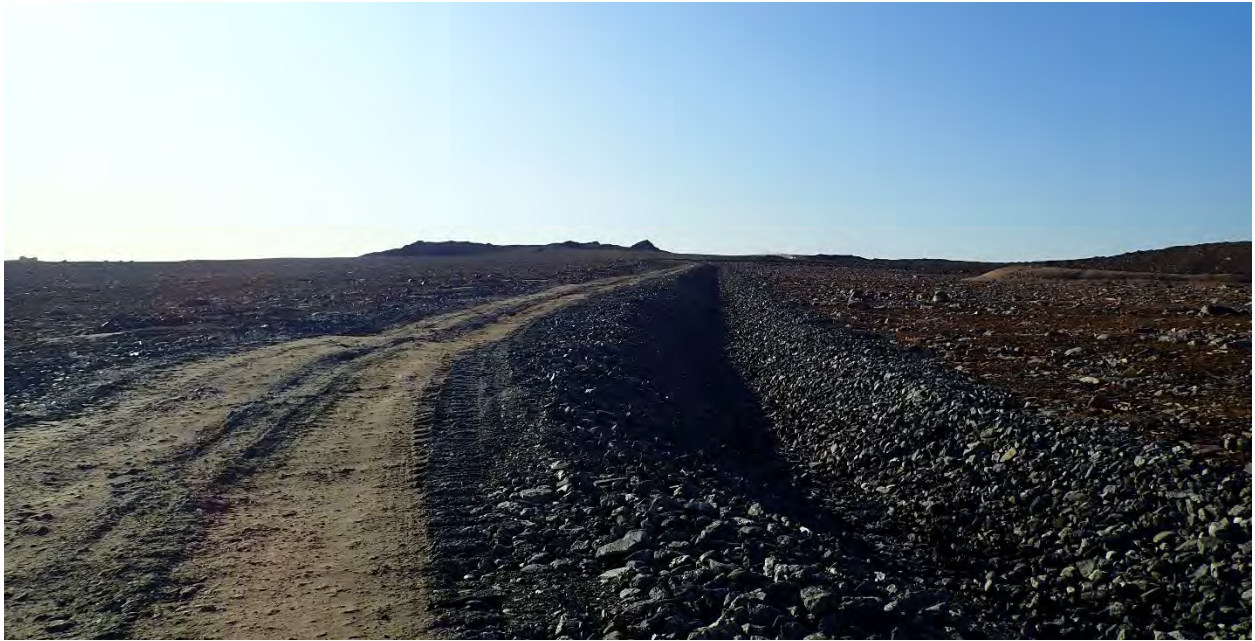
Photo 1: Ongoing Construction of WRF East Perimeter Road and Collection Ditch

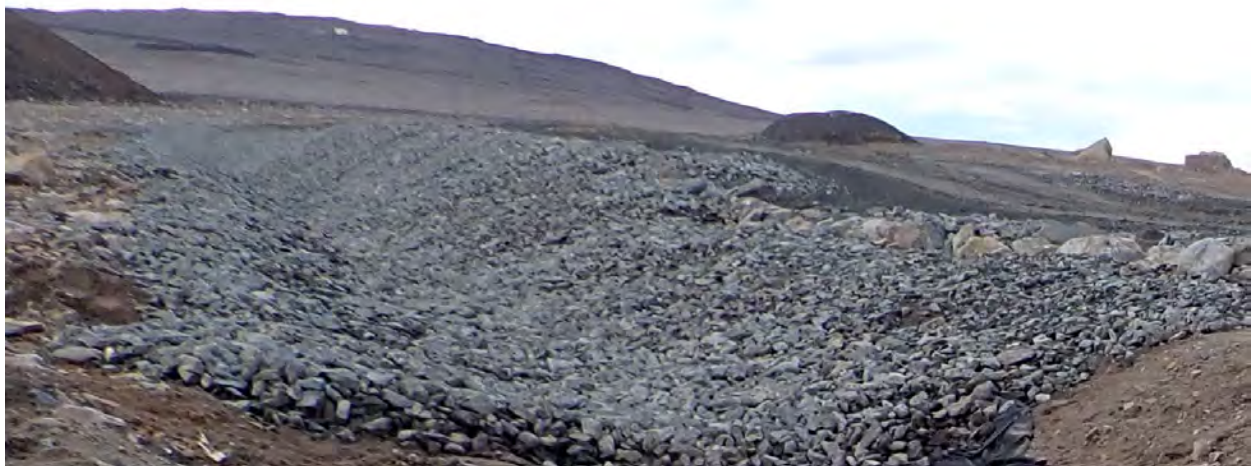
Photo 2: Ongoing Construction of WRF West Perimeter Road and Collection Ditch

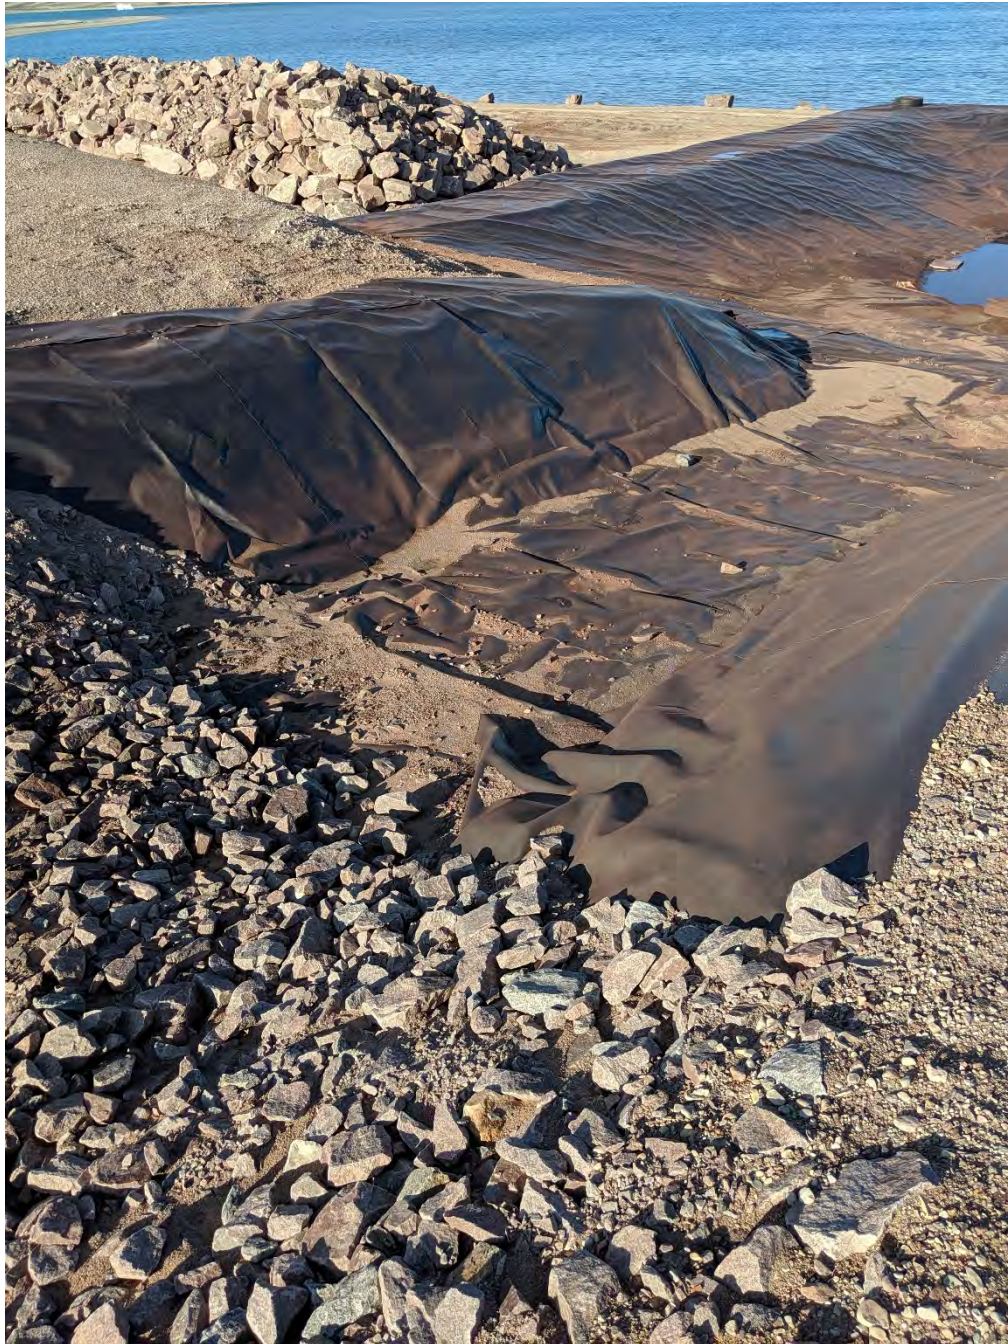
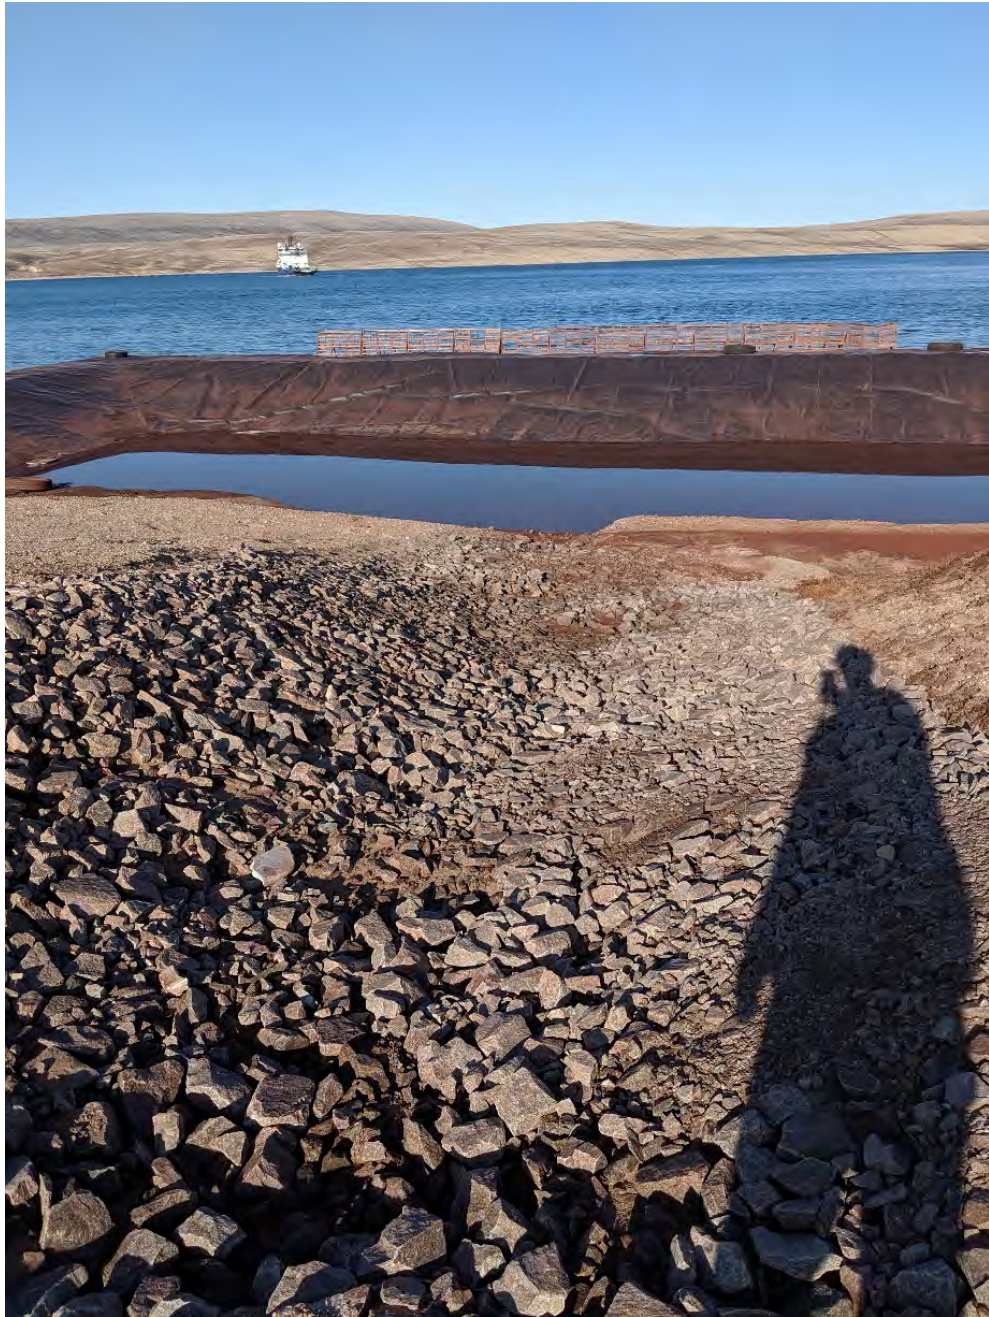
- b. The East ditch leading into MP-06 does not appear to be keyed in properly, there was evident of water flowing under the liner and material being washed under the liner. The inspector is requesting that the licensee properly key in the liner.

Photo 3: MP-06 Liner Key-In Repairs

Photo 4: MP-06 Liner Key-In Repairs

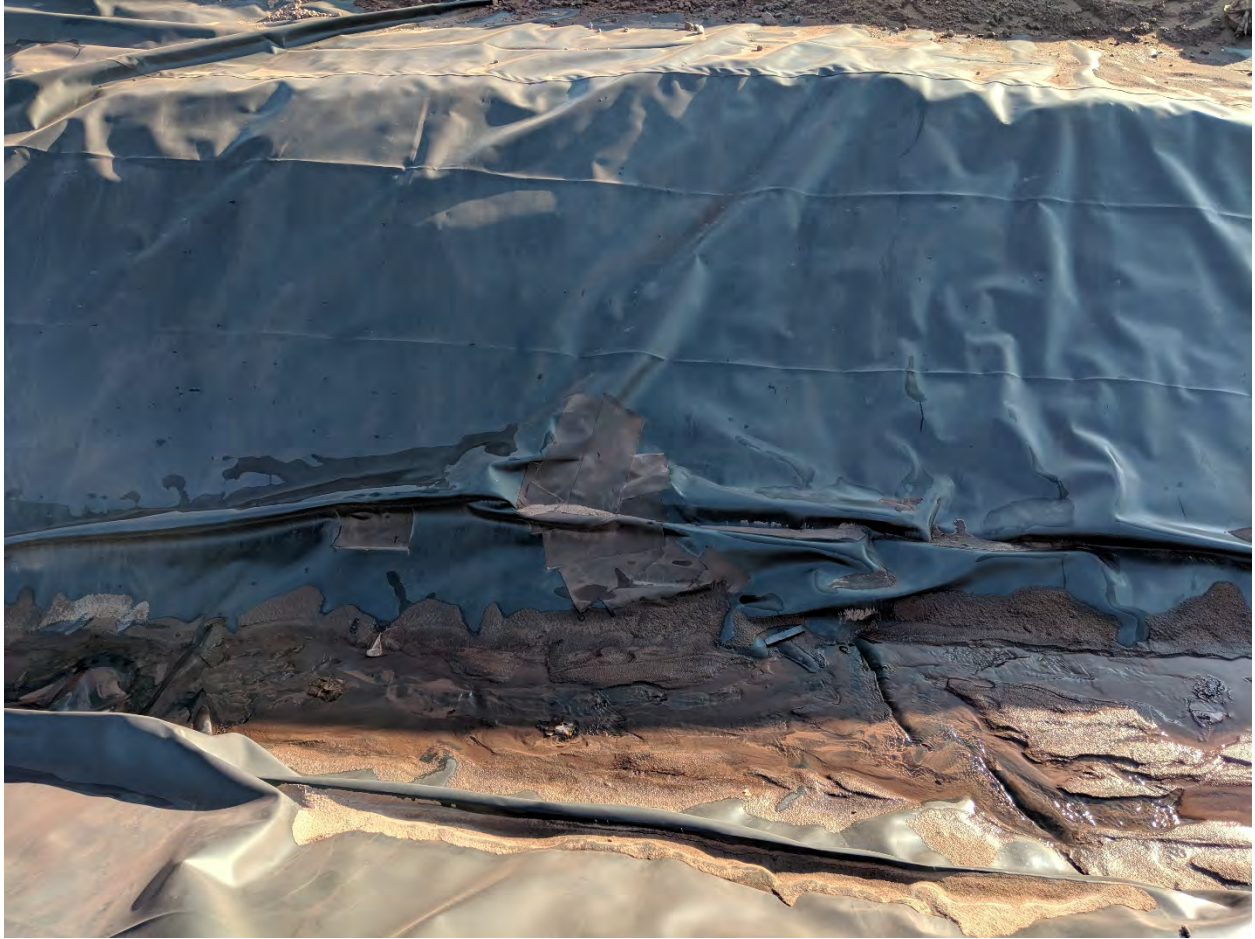
- d. The ditch leading into MP-05 has rips in the liner; the licensee is to repair the liner to ensure the runoff is properly treated.

Photo 5: MP-05 Ditch Liner Repairs

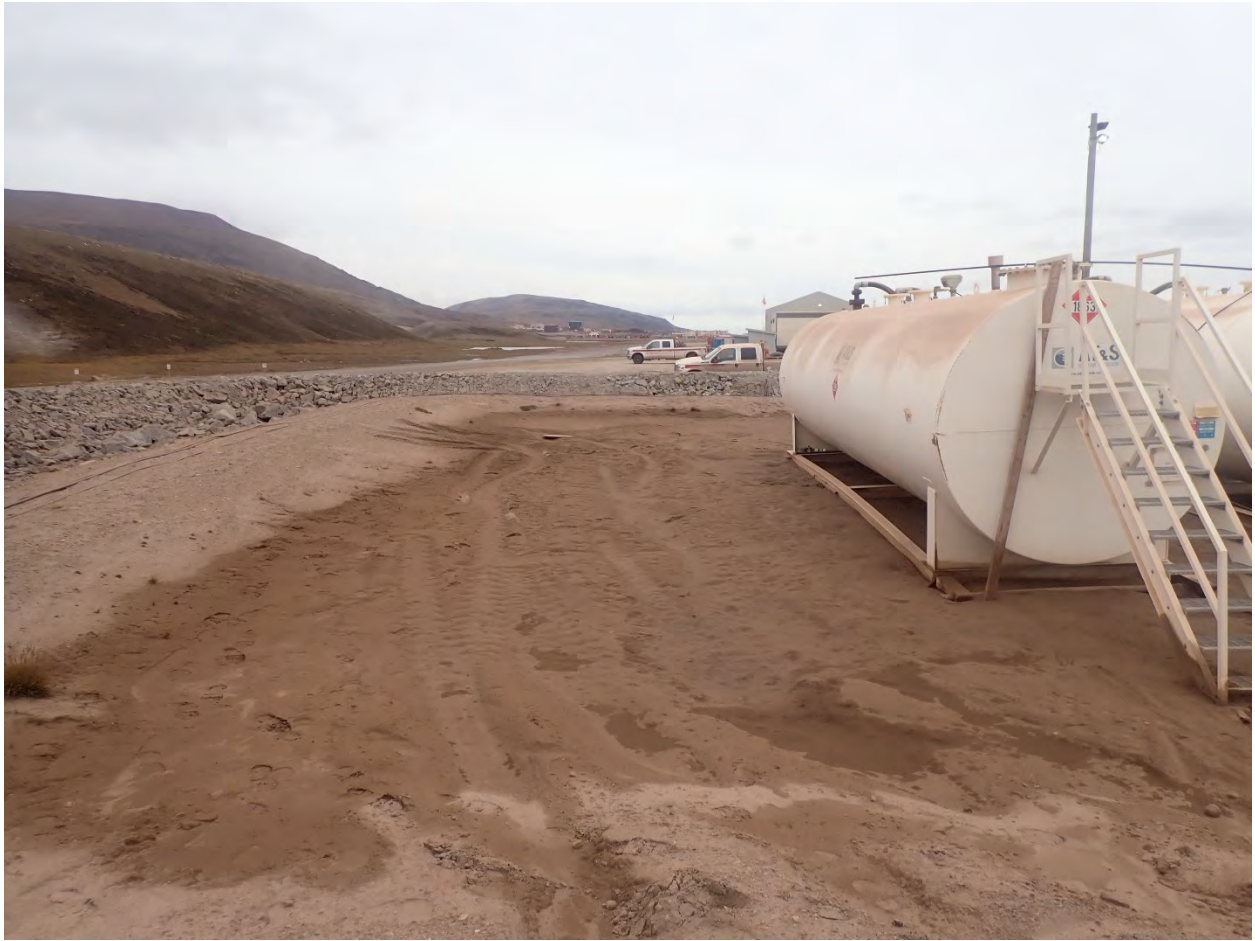
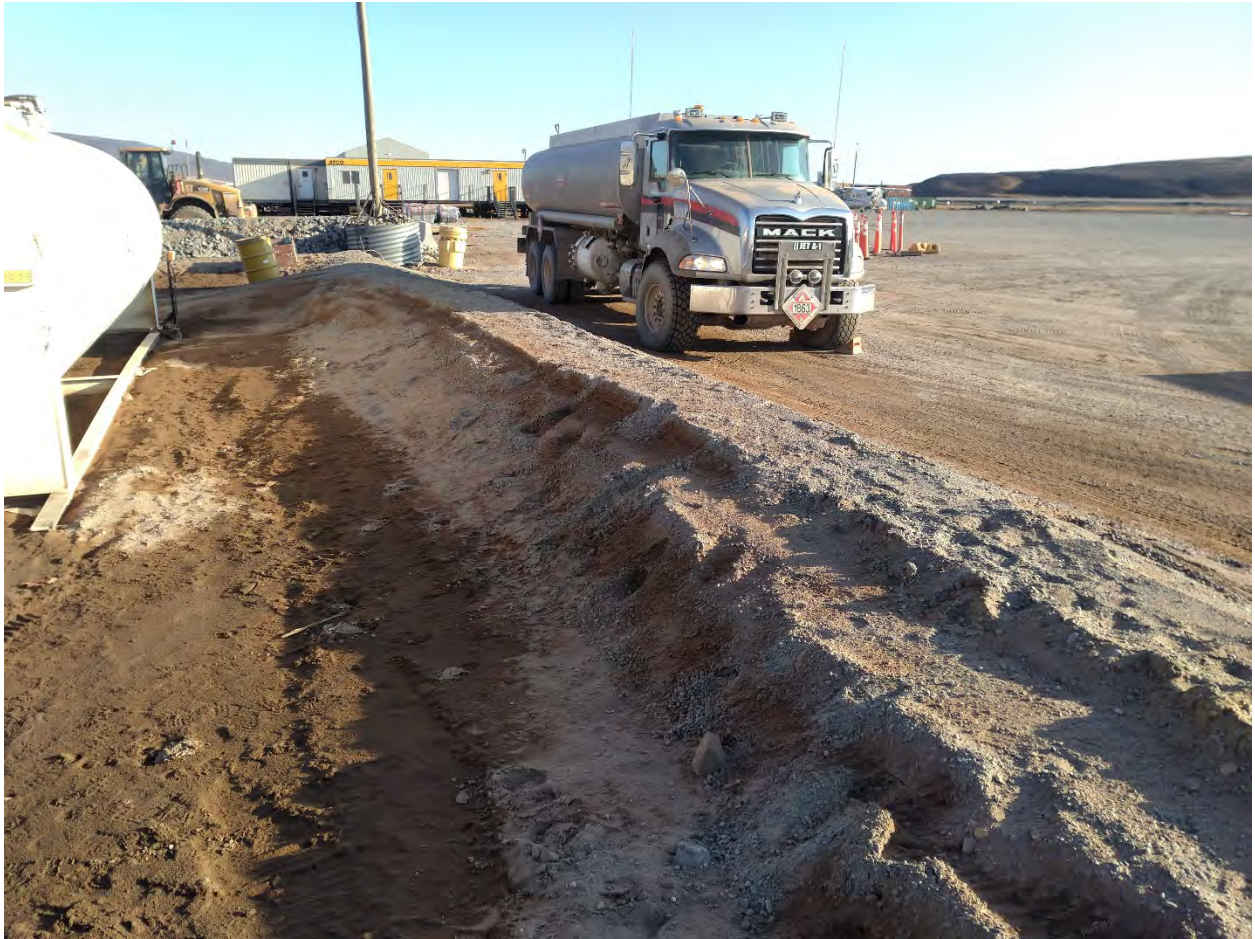
Photo 6: Jet A Storage

Photo 7: Jet A Storage
