**RE: Water Licence 2AM-MRY1325 September 2019 Inspection**

**Attachment 1:  
2AM-MRY1325 September 2019 Inspection Report**

**Table 1 – Baffinland Responses to CIRNAC Water Licence Inspection – September 2019**

## Mine Operations 2020 Freshet and Mine Haul Road Water Management Improvements

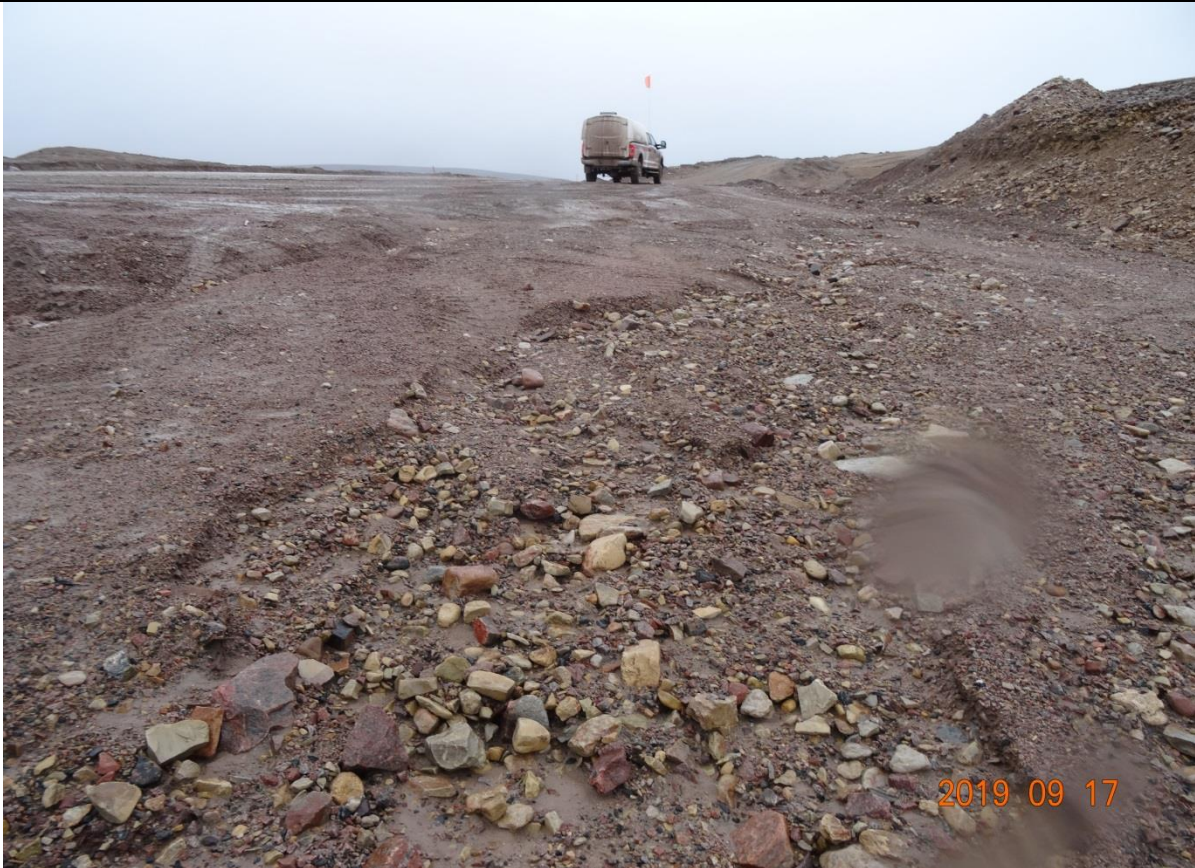
Date	Camera	Inspector	Authorization
	Sony Cyber-shot	J.Mesher	2AM-MRY
Photo Log		Location Iqaluit	
Photo 3

c) Km 63 Bridge had signs of erosion upstream on the port side of the bridge. The licensee is to install the appropriate erosion control measures in order to prevent further sediment from entering the surrounding waterways. See photos 3 and 4 for upstream and downstream images of the erosion.

Description: erosion near bridge

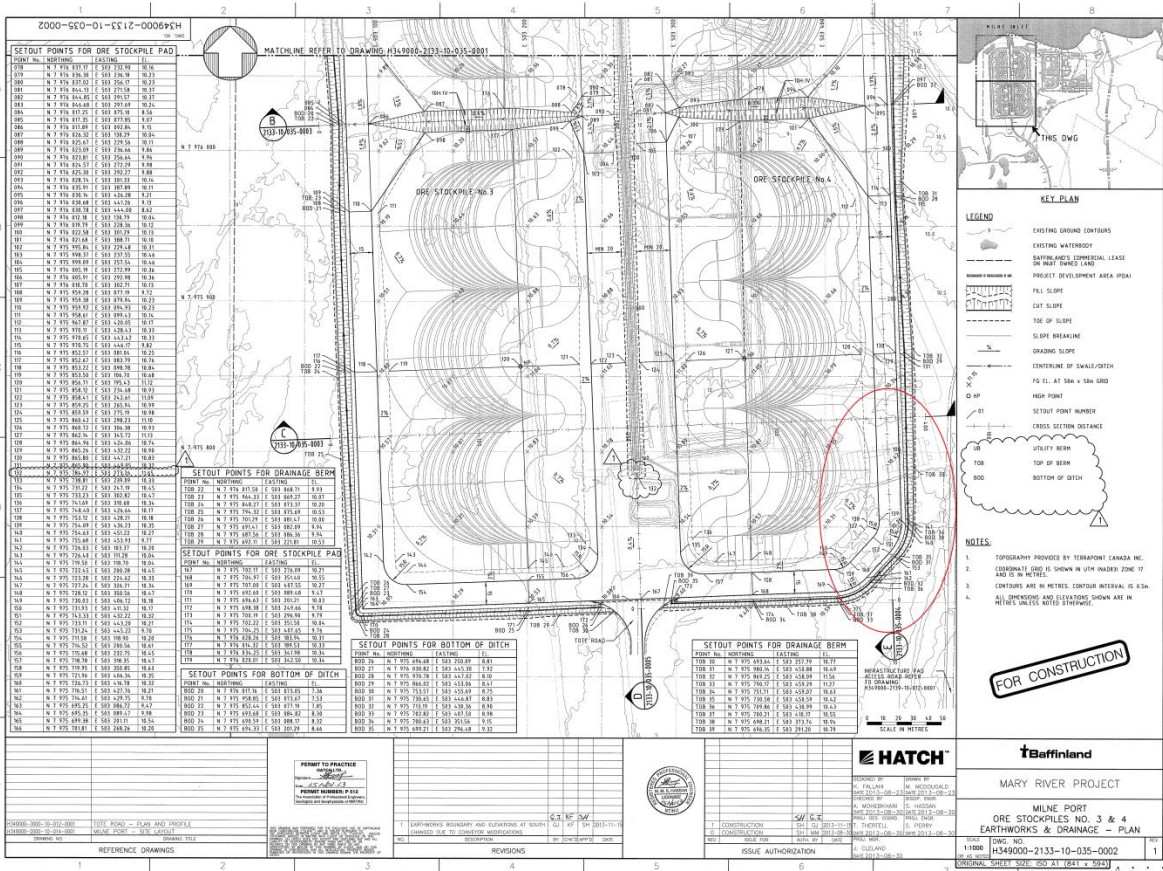
Photo 6

c) The Inspector identified discrepancies between the Ore Stockpile Pad and the provided AS-BUILT/ Issue for construction drawings (IFC) produced by HATCH (H349000-2133-10-035-0002). The Pad appears to be missing outer berms and the ditches on the SE side near the entrance. Once identified, the inspector requested the licensee to install the required ditches within 30 days as of September 17, 2019 and is to install all berms described in the engineered drawings. The missing ditches and berms are approximately within the red circle on Photo 6.

Description: missing ditched in red circle

HATCH For Construction drawings H349000-2133-10-035-0003.

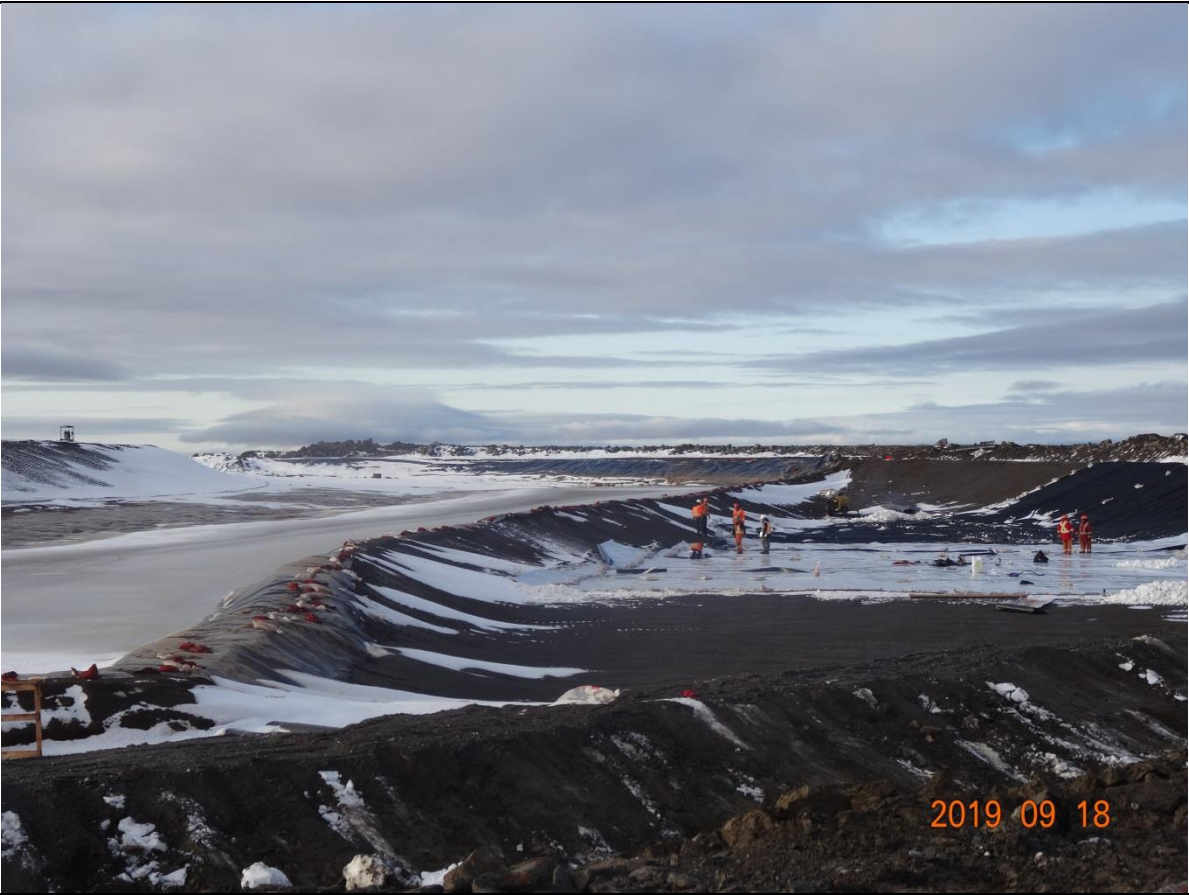
Photo 7

- a) At the time of the inspection, the upgrades on the sedimentation pond were approximately 75 % completed with the full upgrade expected on or about October 24<sup>th</sup>, 2019. No concerns were noted at time of the inspection. See photo 7 for work being done at the time of the inspection.
- b) At the time of the inspection the licensee had completed the installation and required upgrades to the ditches. During the inspection the ditches were snow covered. A more in-depth inspection will be conducted during open water season.
- c) The licensee is still investigating what the potential causes of the leak from the Waste Rock Stockpile Pond were; one potential cause is the lack of granular fill placed upon the existing tundra. The inspector is requesting that the licensee provides the reason for this leak once determined.

Description: waste rock stockpile pond upgrades

- IV. To ensure that all ditches on site are constructed, as described, in the engineered drawings and are operating as intended.
- V. To provide the findings of the internal investigation on why the waste rock stockpile pond was leaking.

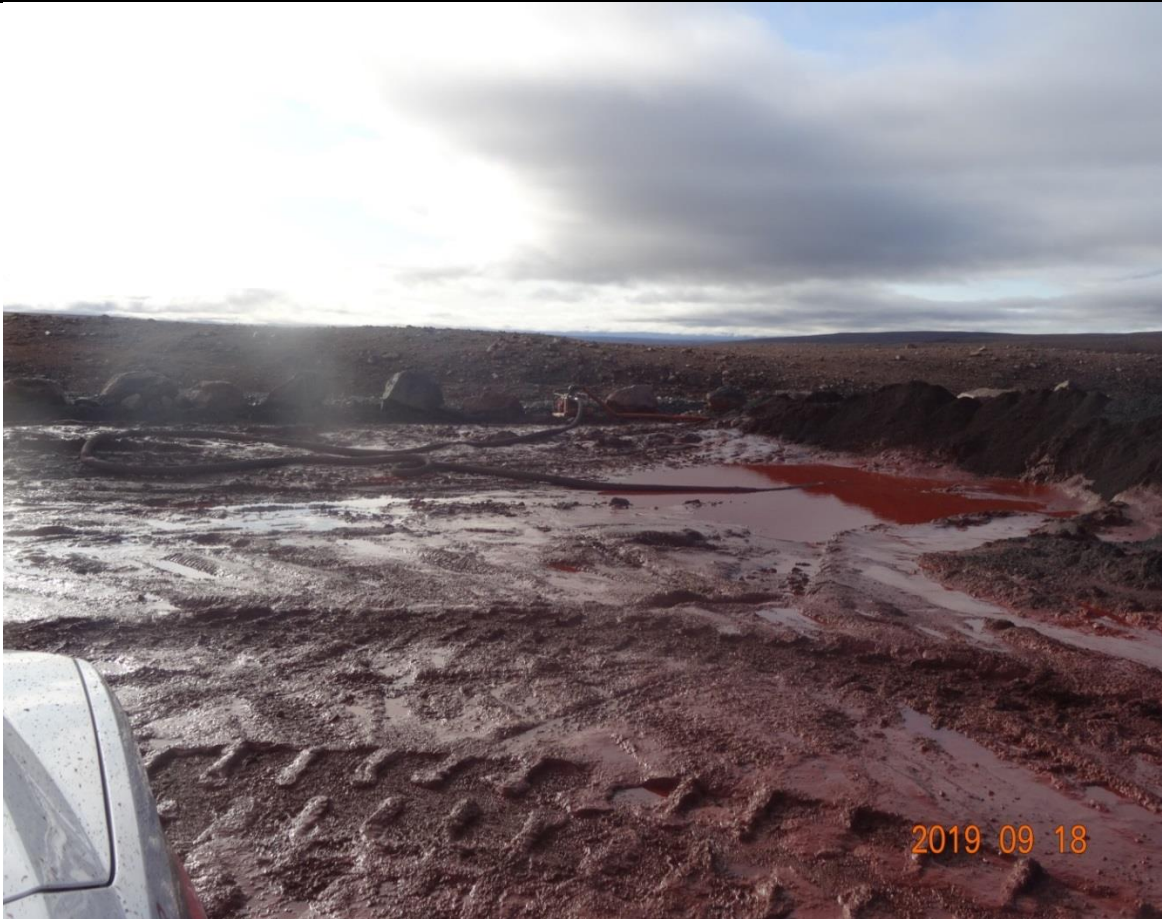
- a) At the time of the inspection the ditch system around the stockpile was not functioning as intended. The licensee is currently pumping water into the ponds from the pooling water on the Pad. The licensee is to ensure this water management structure is functional prior to freshet 2020. See photo 9 for the pumping occurring.

Description: Crusher pad water pumping

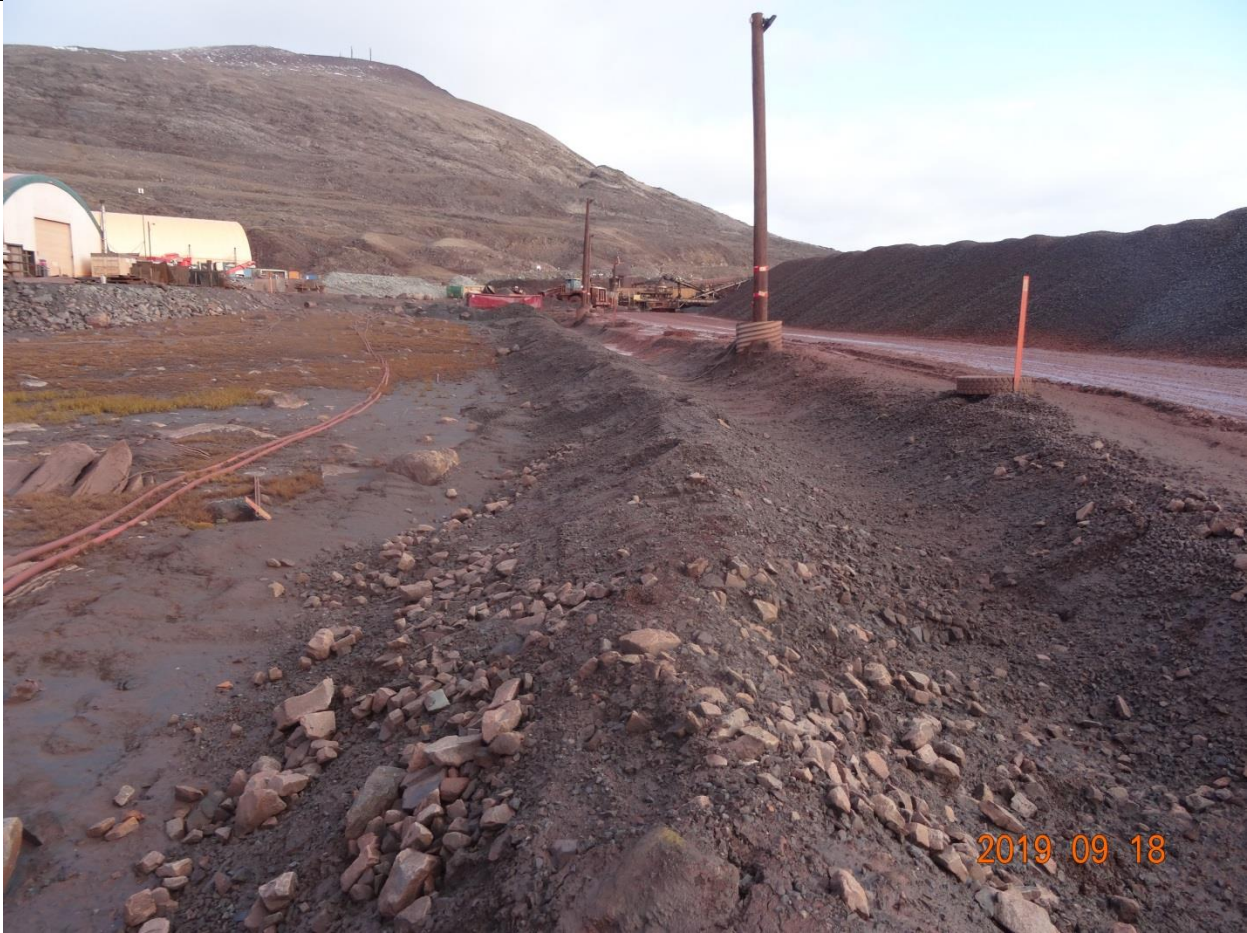
Date	Camera	Inspector	Authorization
	Sony Cyber-shot	J.Mesher	2AM-MRY
Photo Log	Location Iqaluit		
Photo 10

- c) The ditches on the North West side of the Crusher pad are covered with or possibly constructed of Ore. In this same area there is visible Ore outside the containment area. The inspector is requesting this Ore to be removed or for the licensee to provide approval for the usage of Ore as construction material. See Photo 10 for the ditch and berm that is laden with Ore.

- d) The licensee does not appear to be able to deal with surface water on and adjacent to the Ore Crusher pad. The inspector is requesting that the licensee develop a plan to deal with the constantly pooling water to the North West side of the pad ( on the left of Photo 10) and the pad its self.

Description: ore in ditch and outside containment. On the left there is a area where water regularly pools

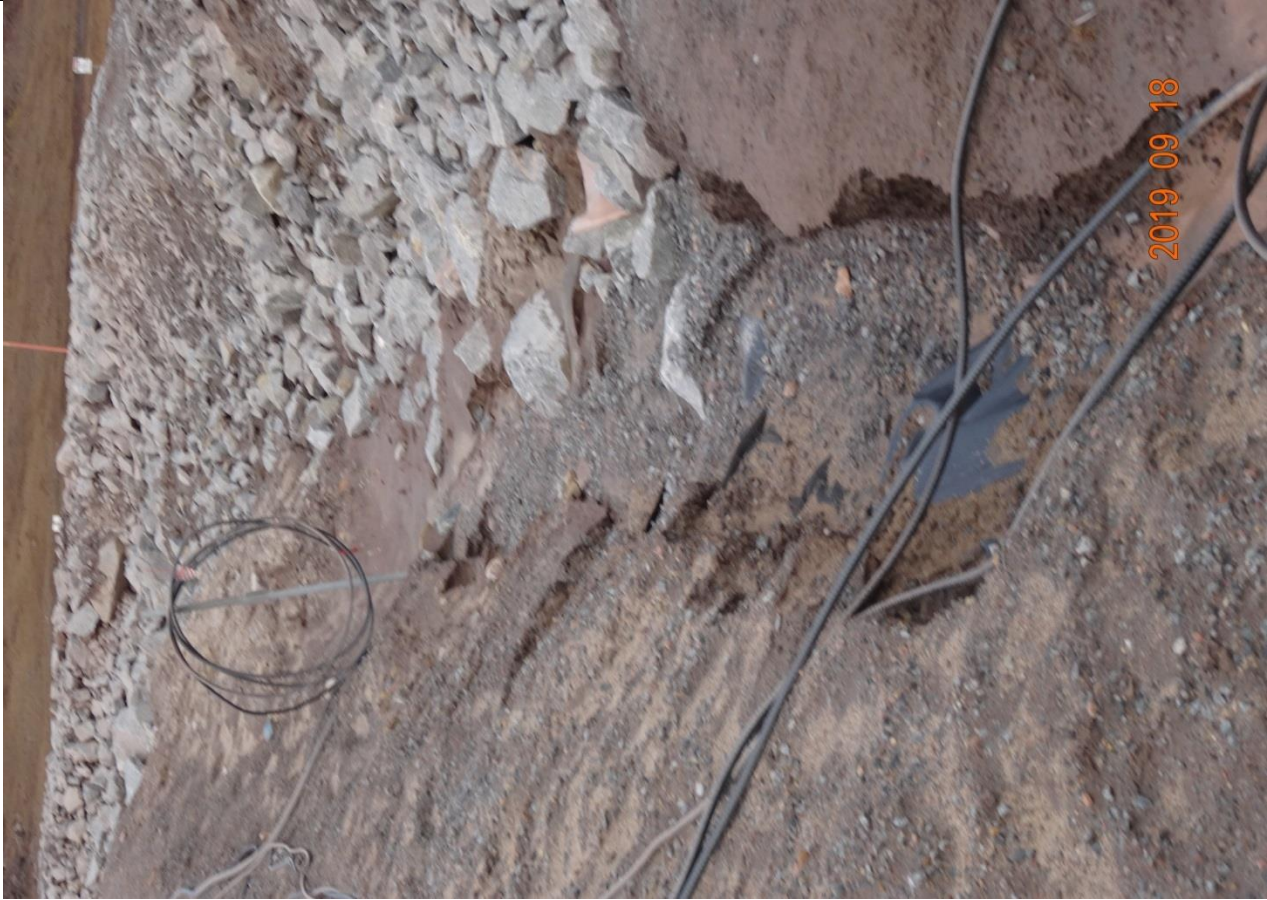
Date	Camera	Inspector	Authorization
	Sony Cyber-shot	J.Mesher	2AM-MRY
Photo Log	Location Iqaluit		
Photo 11

- a) During the inspection there were signs of erosion on the south berm wall. This erosion appears to be occurring due to water flowing off the runway towards the outer road. The licensee is to employ the appropriate erosion control measures to prevent this from occurring in the future. See photo 11 for the area of erosion.

Description: erosion on Jet A fuel berm.
