WATER LICENCE INSPECTION FORM

Licensee	Licensee Representative
Baffinland Iron Mines Ltd.	Connor Deveraux
Licence No. / Expiry	Representative's Title
2AM-MRY1325	General Supervisor Environment
Land / Other Authorizations	Land / Other Authorizations
--	--
Date of Inspection	Inspector
October 14th, 2020	Omer Pasalic
Activities Inspected	
<input type="checkbox"/> Camp	<input type="checkbox"/> Drilling
<input checked="" type="checkbox"/> Roads/Hauling	<input checked="" type="checkbox"/> Mining
	<input type="checkbox"/> Construction
	<input type="checkbox"/> Other:
	<input type="checkbox"/> Reclamation
	<input type="checkbox"/> Fuel Storage

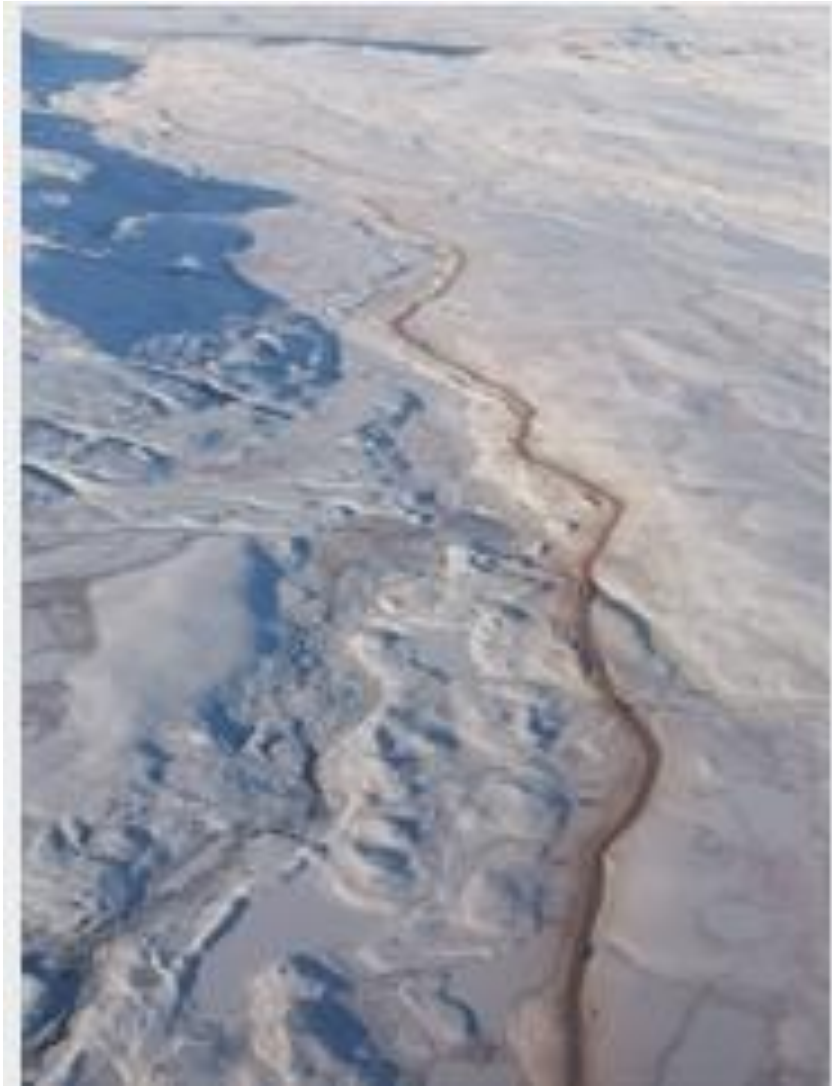
PHOTO LOG			
Date:	Authorization Number:	Camera/Model:	Inspector
October 14 <sup>th</sup> , 2020	2AM-MRY1325	HUAWEI P30 PRO	Pasalic
Photo No.			
Photo 1		Road connecting two sites.

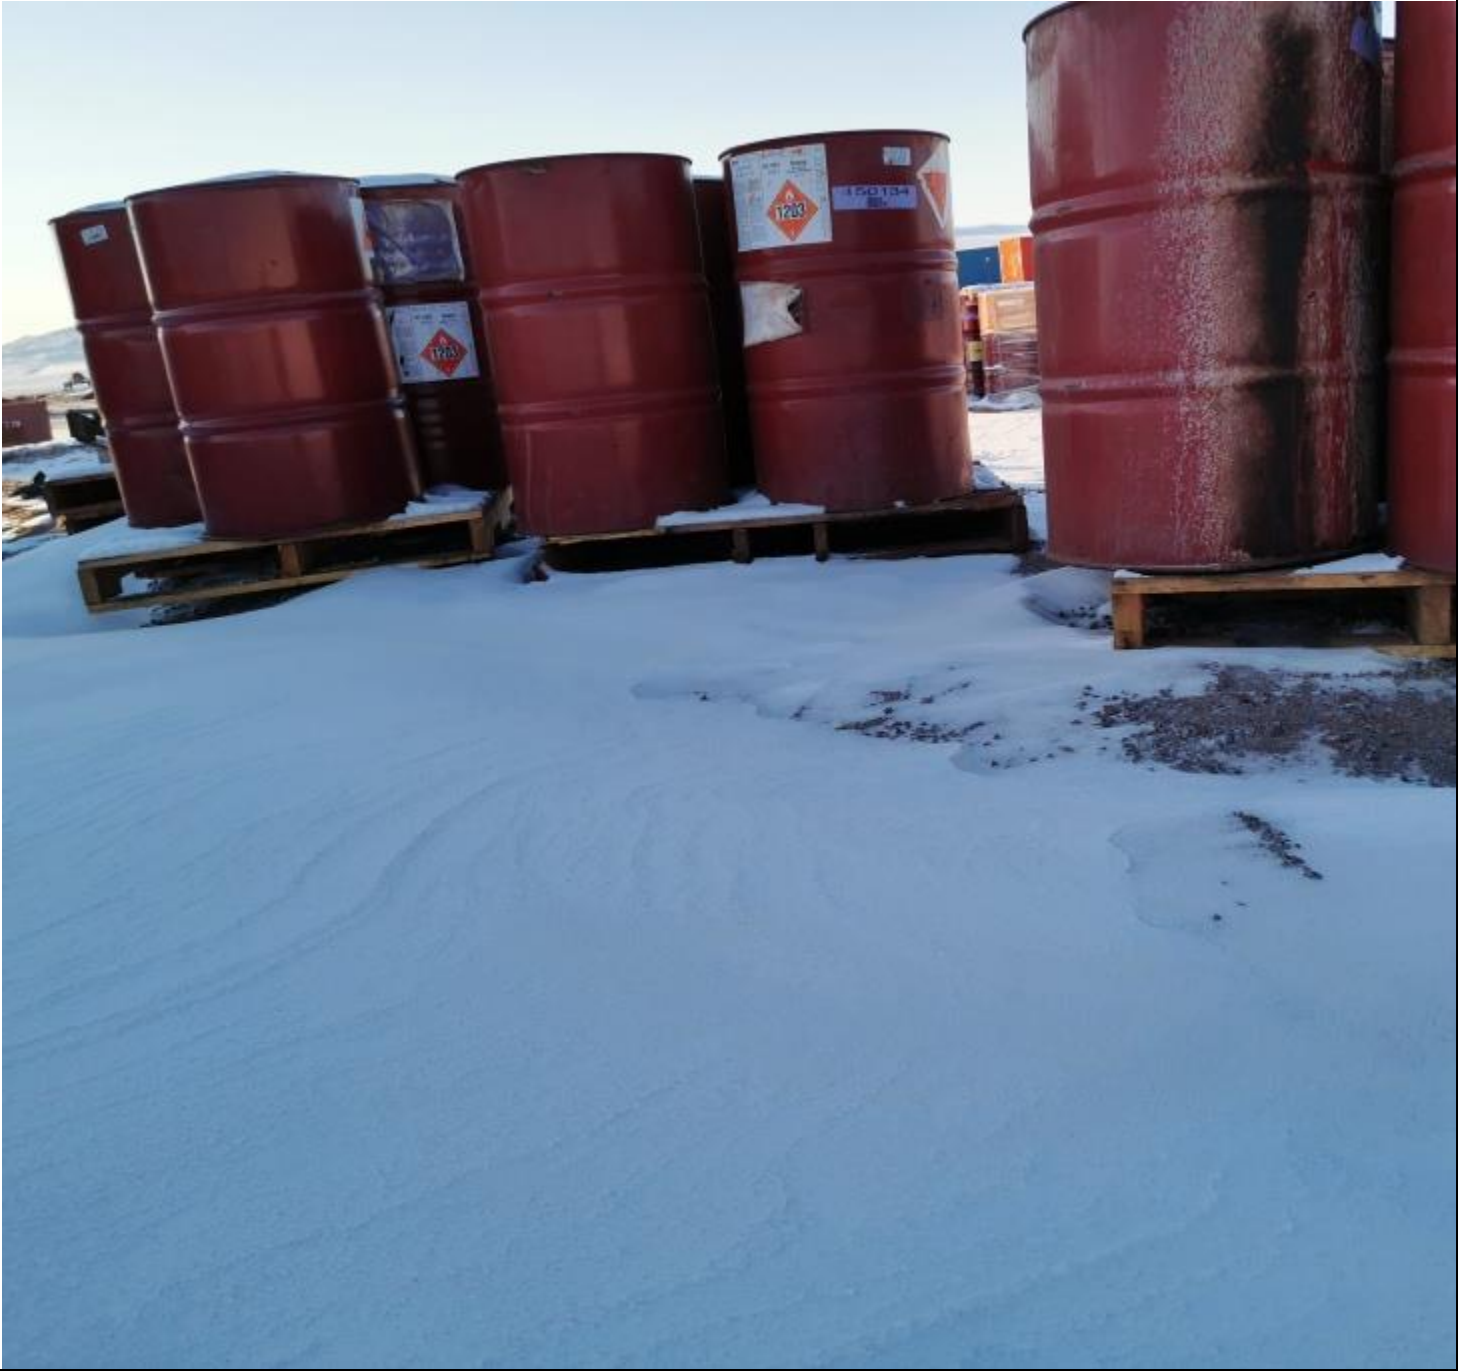
Photo No.
Photo 2

a) At the time of the inspection, the licensee ensured that the spill kits are readily available and are located within the site itself. The berms were well maintained around the storage facilities. No signs of any fuel spills were detected. No signs of water pooling were detected. No signs of debris were detected.

Fuel cache stored on site.

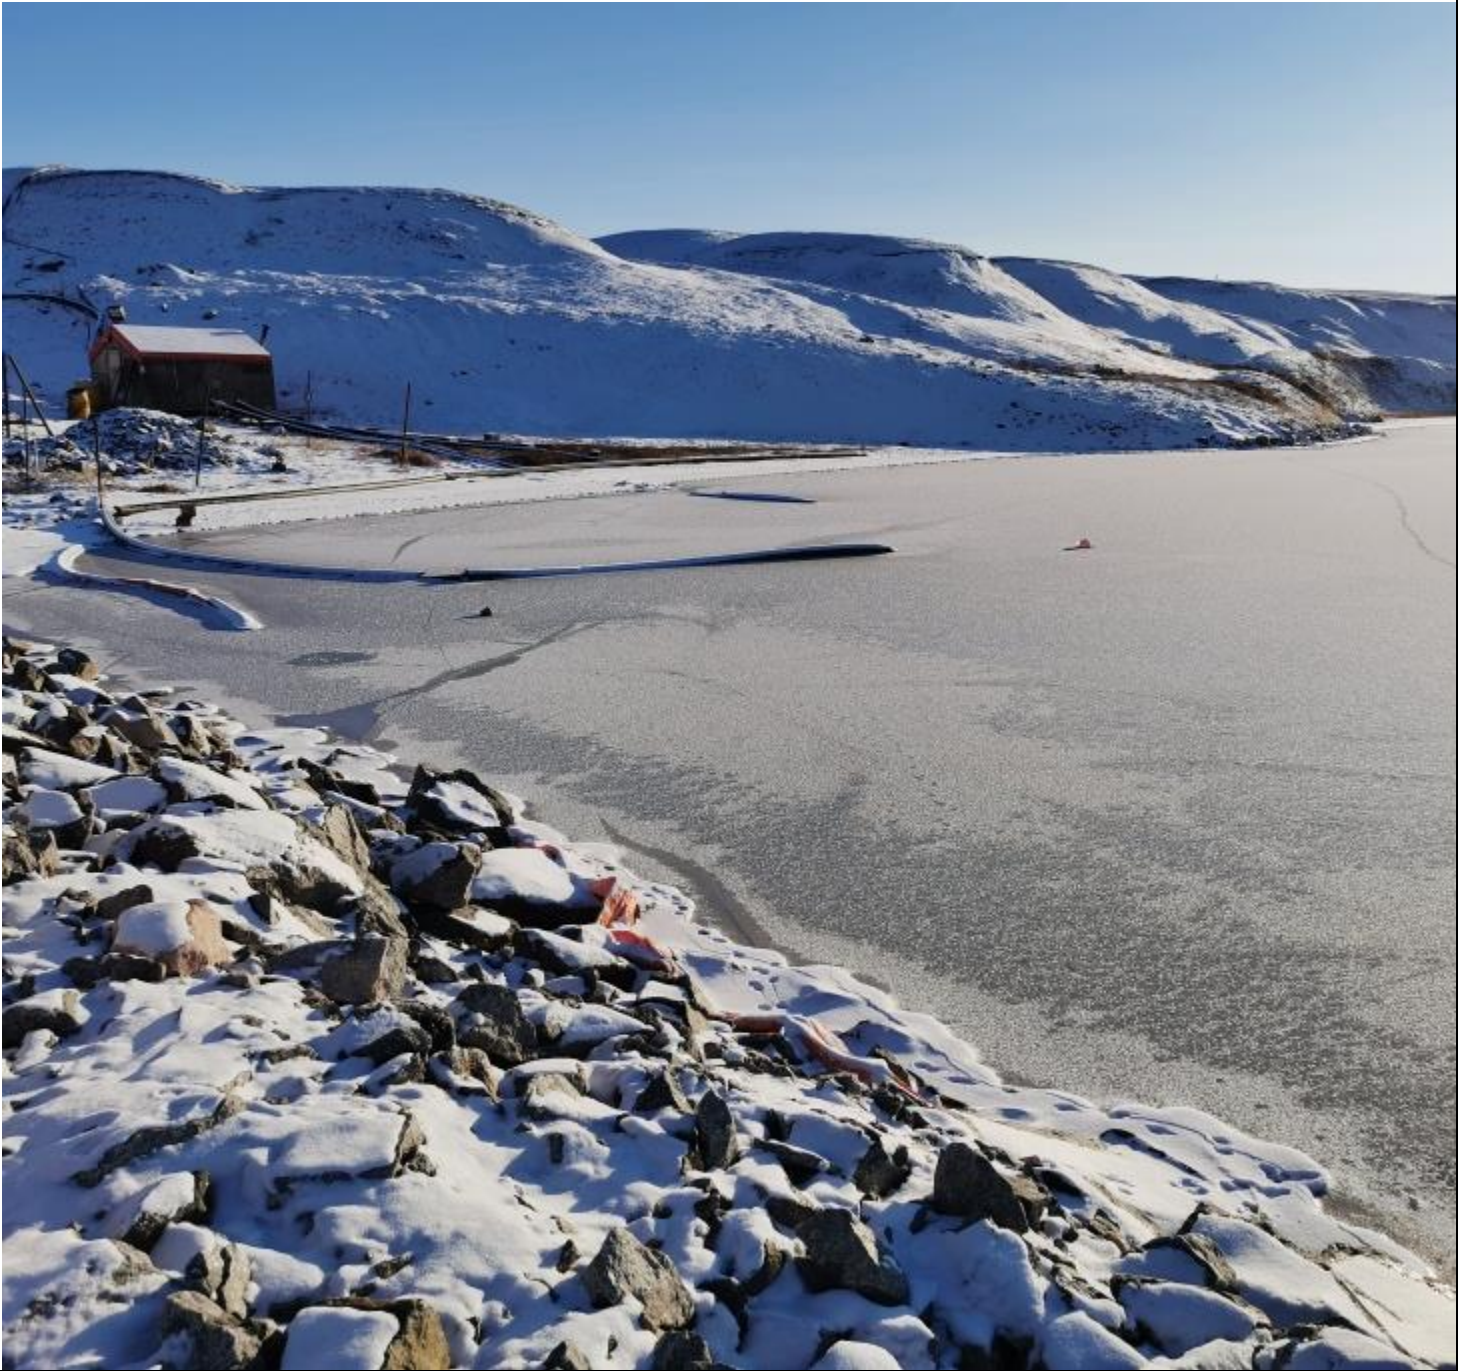
a) Area of the jetty was inspected. No signs of any violations were noted. The area of the intake was cleared of any obstacles. No hazardous material present or stored in the immediate vicinity. Red dust was not present or observed in the area at the time of the inspection. The inspector had no concerns.

Photo No.
Photo 3
Jetty

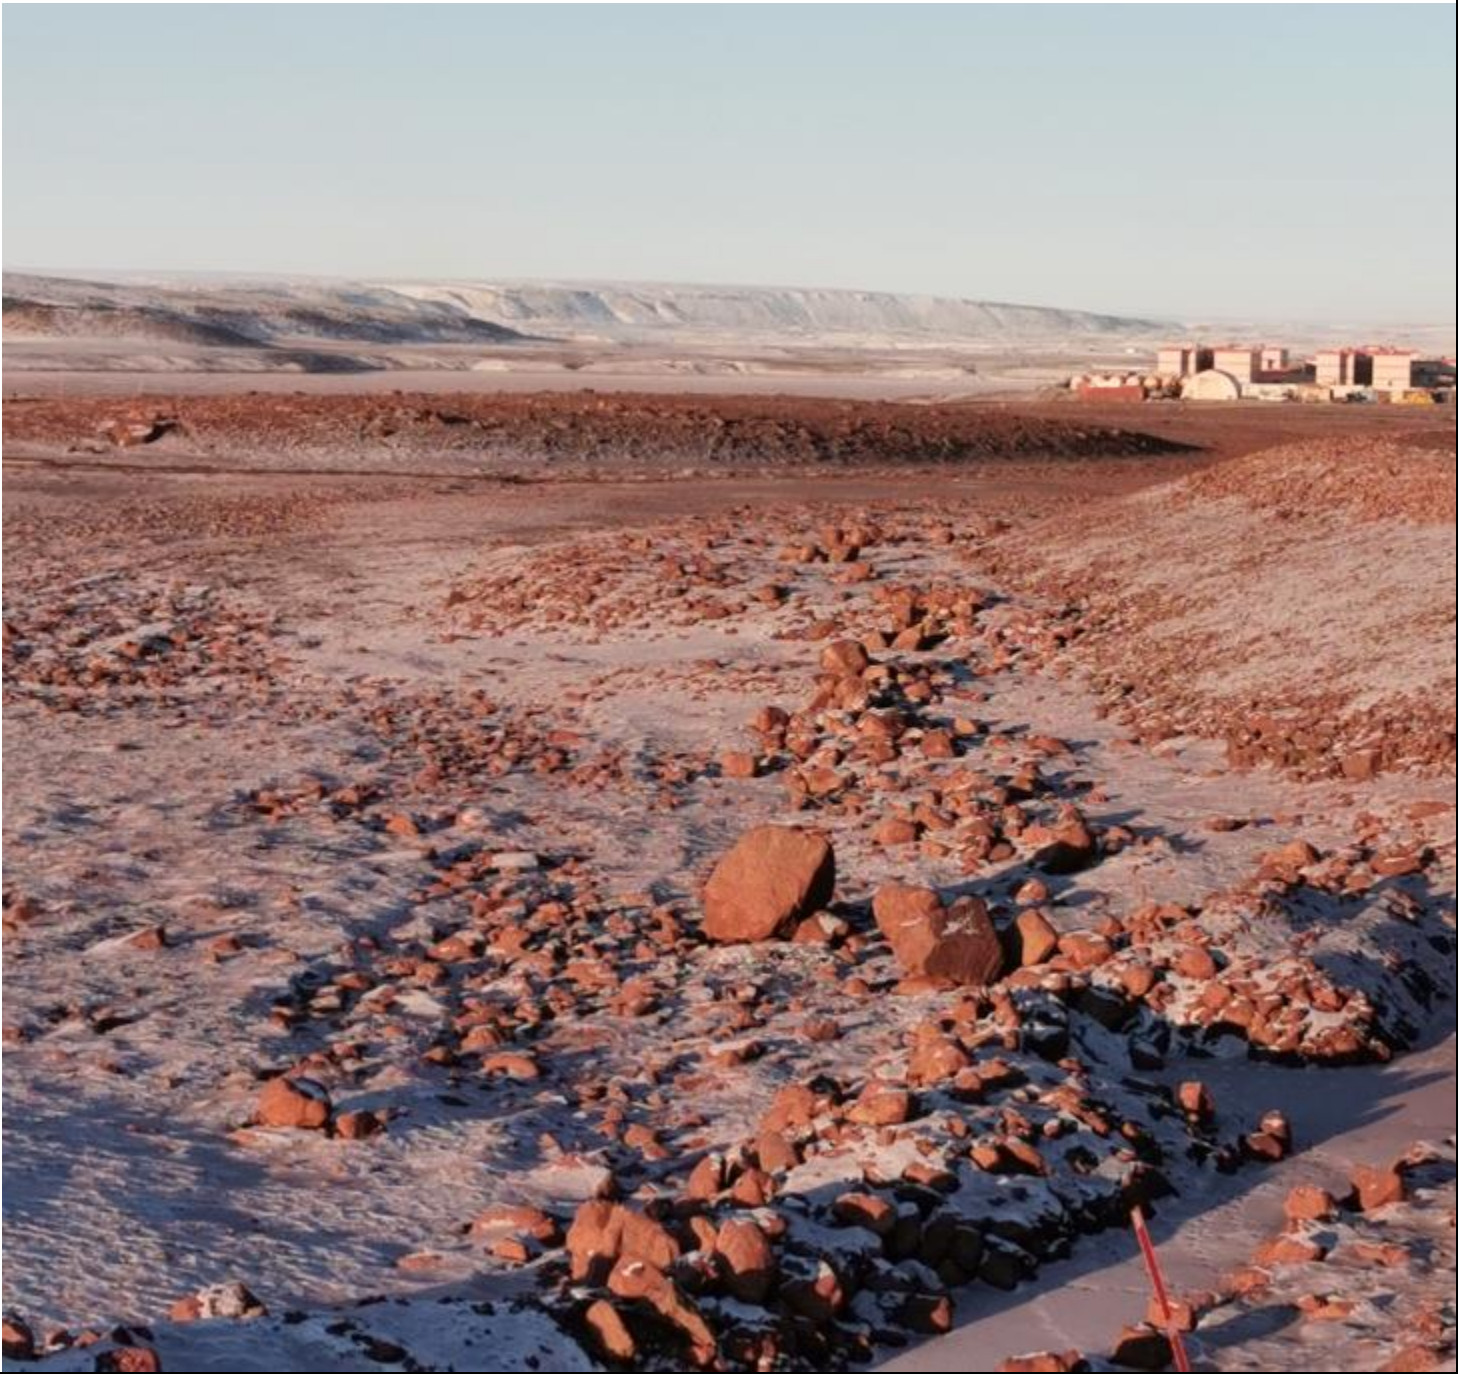
No concerns, except the snow covered red dust , were noted during this inspection.

Date:	Authorization Number:	Camera/Model:	Inspector
October 14 <sup>th</sup> , 2020	2AM-MRY1325	HUAWEI P30 PRO	Pasalic
Photo No.			
Photo 4		Red dust covering the ground at Mary River site

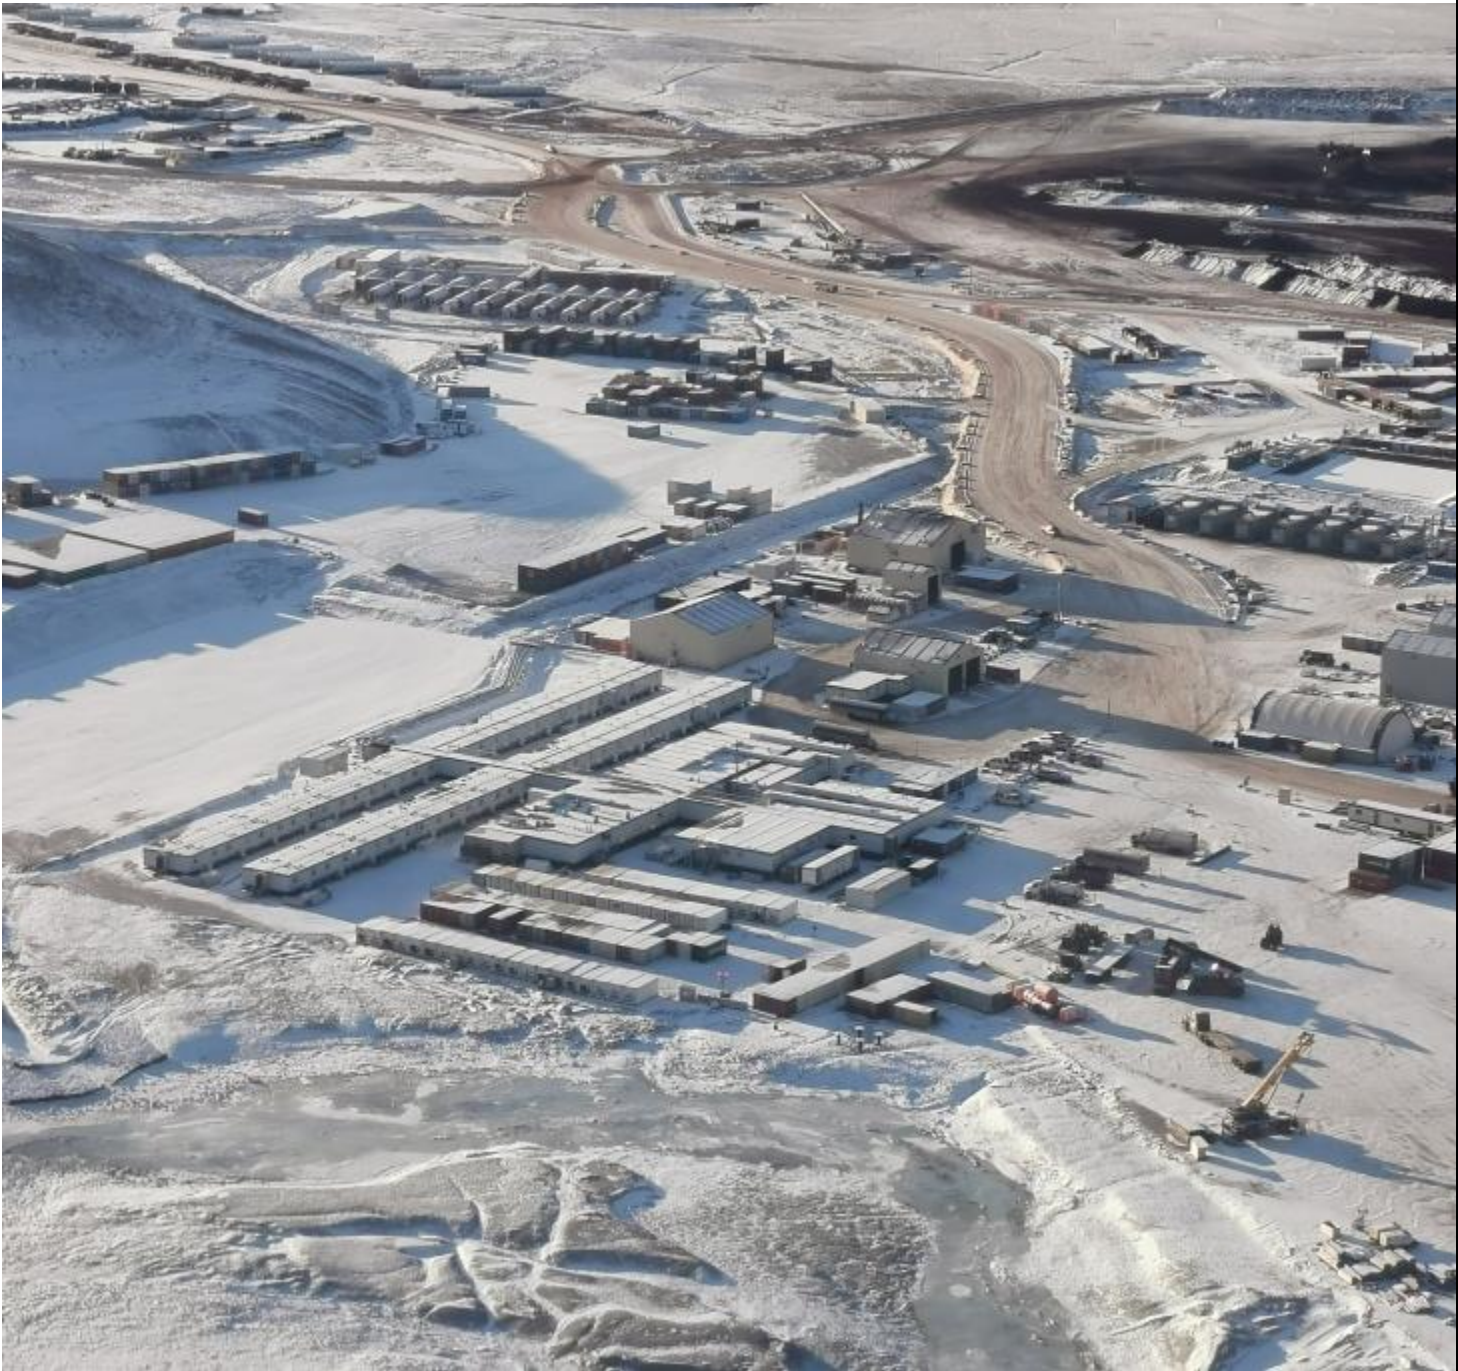
Date:	Authorization Number:	Camera/Model:	Inspector
October 14 <sup>th</sup> , 2020	2AM-MRY1325	HUAWEI P30 PRO	Pasalic
Photo No.			
Photo 5		Aerial photo of Mary River site

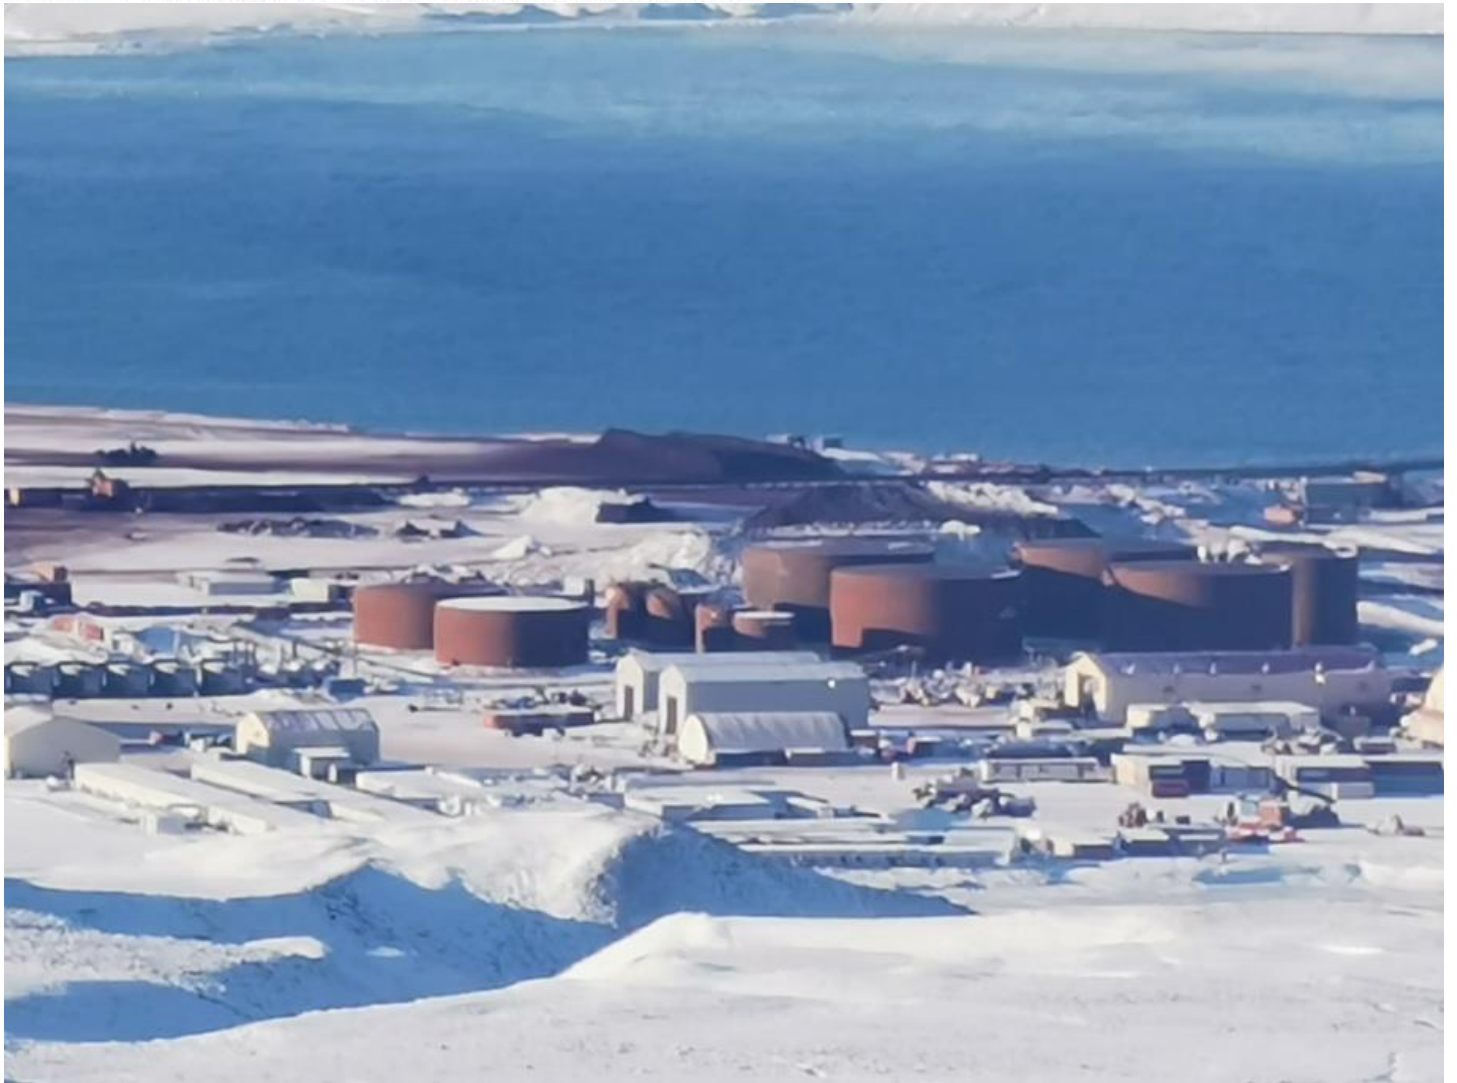
PHOTO LOG			
Date:	Authorization Number:	Camera/Model:	Inspector
October 14 <sup>th</sup> , 2020	2AM-MRY1325	HUAWEI P30 PRO	Pasalic
Photo No.			
Photo 6		Aerial photo of Milne Inlet site
