WATER LICENCE INSPECTION FORM

| Baffinland Iron Mines | Connor Devereaux |
| September 16-17, 2021 | Jonathan MESHER |

On September 16-17, 2021 I Jonathan Mesher Resource Management Officer of CIRNAC conducted a Water licence inspection at the Mary River Project, Tote Road and Milne port site.

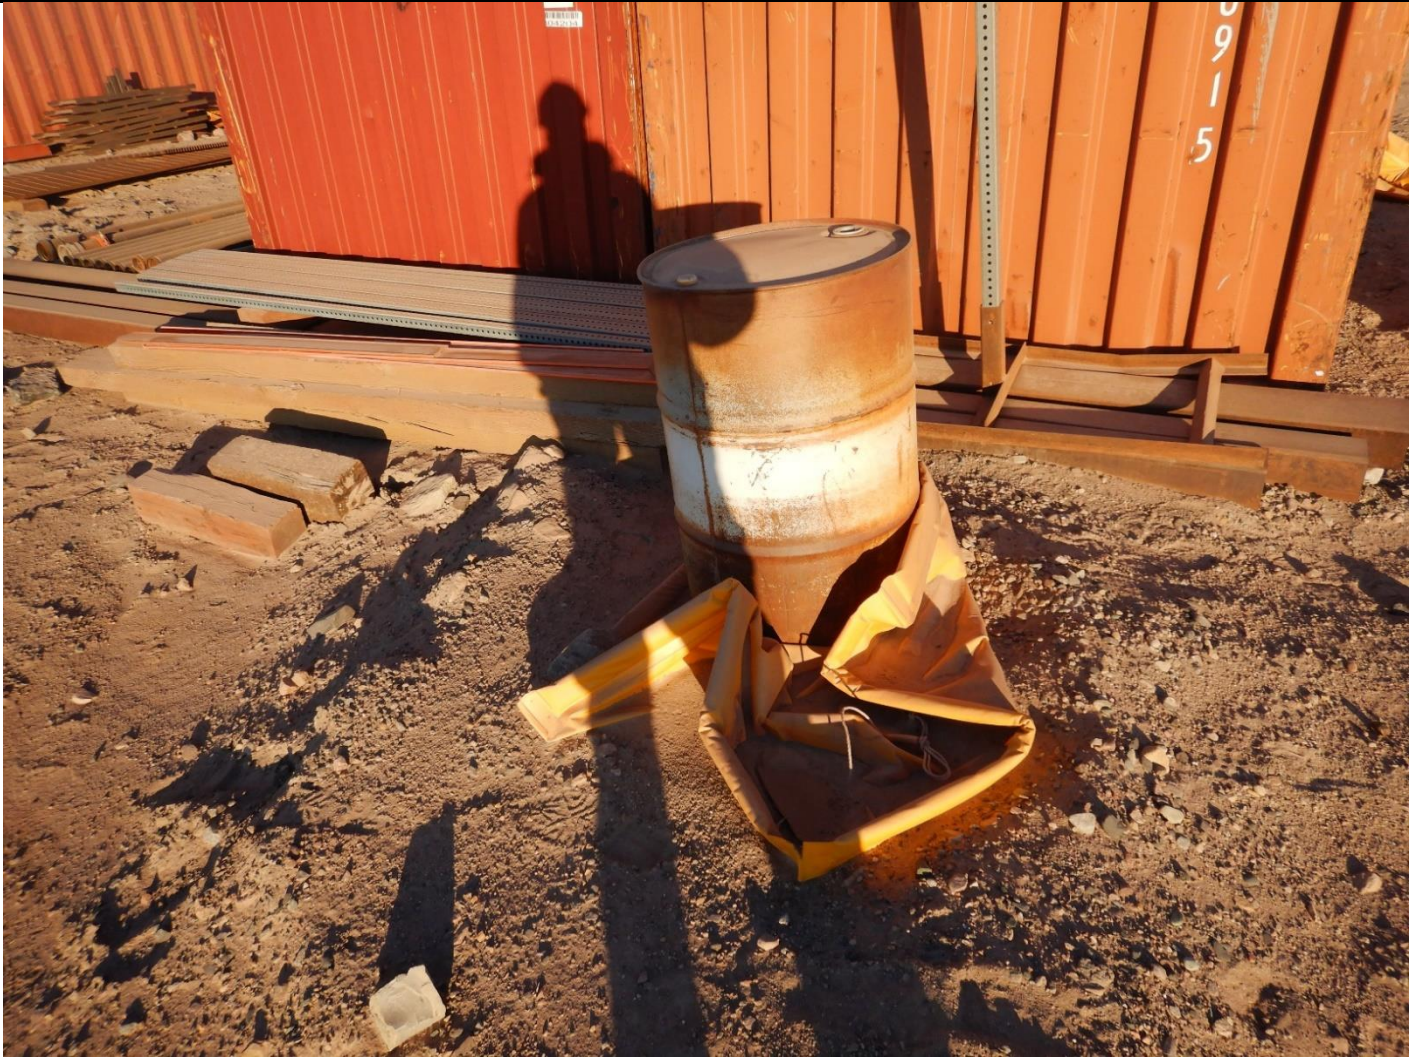
Photo 1

Description: damaged drip tray at km 97

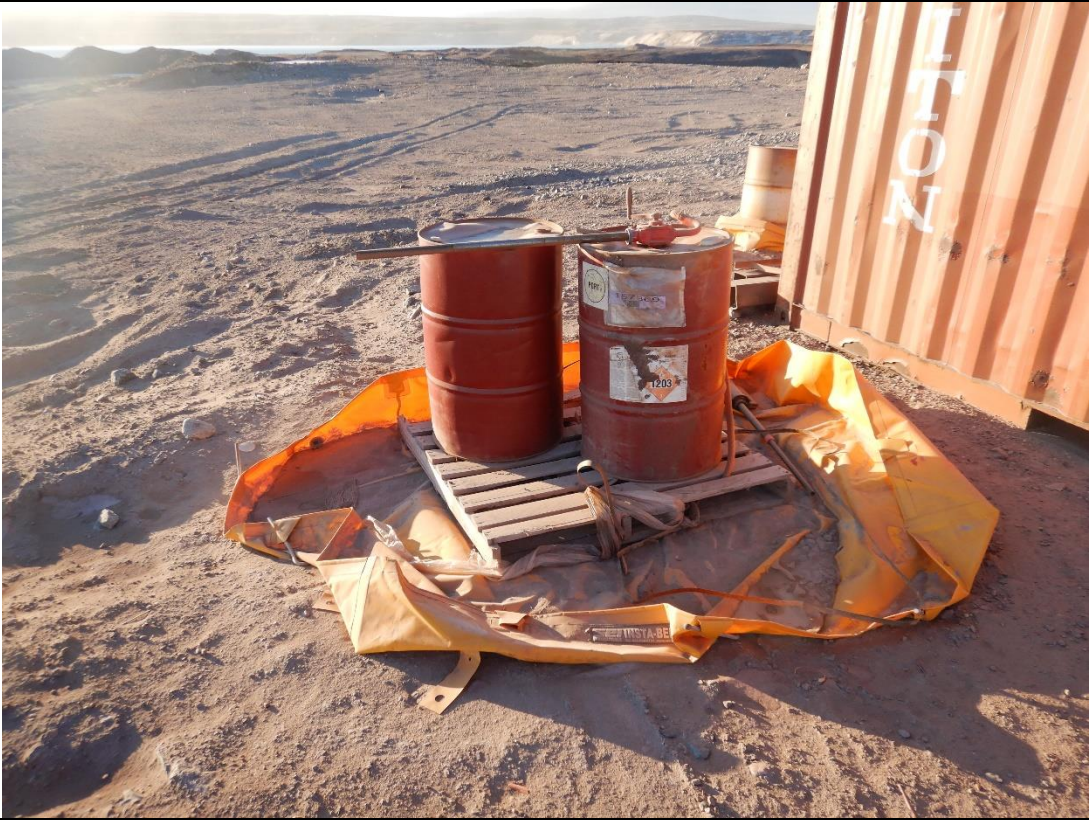
| Date | Camera | Inspector | Authorization |
|---|---|---|---|
| Photo 2 | | | |

| Date | Camera | Inspector | Authorization |
|---|---|---|---|
| Description: damaged drip tray at km 97 | | | |

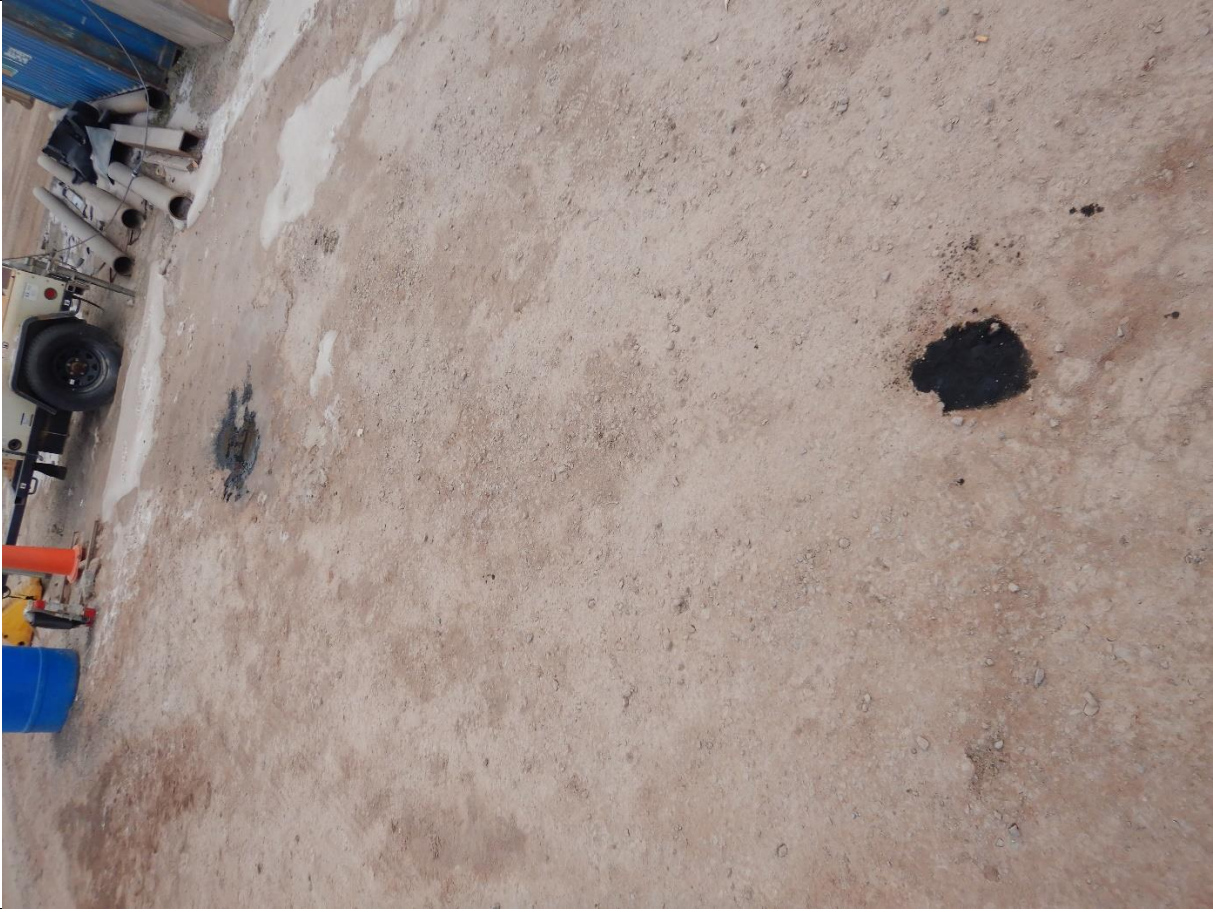
| Date | Camera | Inspector | Authorization |
|--|---|---|---|
| Photo 3 | | | |

1-60 Crown Land- multiple spills of unknown substance(potentially motor oil) on the ground near the parking area. See photo 3 for the spills.

| Date | Camera | Inspector | Authorization |
|--|---|---|---|
| Description: km 60 spill. | | | |

8. The Licensee shall implement sediment and erosion control measures prior to and maintain such measures during the undertaking to prevent entry of sediment into Water.
- 2) The licensee is to ensure the following waste/water management structures are operating as intended and consistent with the design in the plans approved by the Nunavut Water Board ; Ore stockpile ditches and gradient, Crusher pad ditches, MP-07 ditches, Western Globe Fuel Module, HWB 03, HWB 04.
- 3) The licensee is to remove all waste from the snow dumps and provide a monitoring schedule to ensure the snow dumps are not contaminating the surrounding water bodies.
- 4) The licensee is to remediate all spills noted in this report.

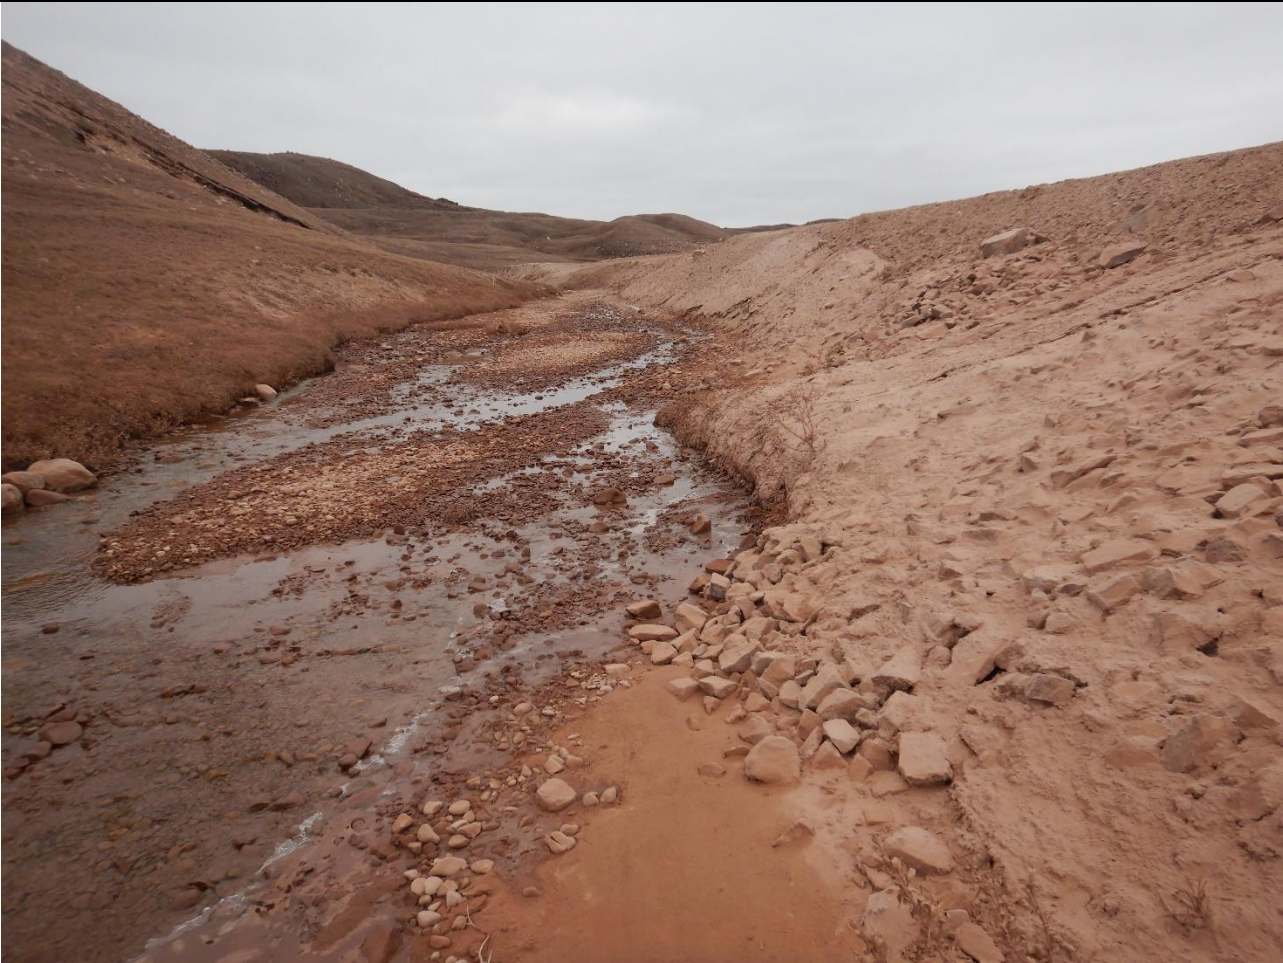
| Date | Camera | Inspector | Authorization |
|---|---|---|---|
| Photo 4 | | | |

1-154A/ Spill 21247- there was visible erosion on the road near the culvert, upstream of the culvert and down stream of the culvert. See photos 4 &5 for erosion.

| Date | Camera | Inspector | Authorization |
|---|---|---|---|
| Description: Cv-154 erosion upstream | | | |

| Section 2 | <input type="checkbox"/> Comments | <input type="checkbox"/> Non-Compliance with Act or Licence | <input checked="" type="checkbox"/> Action Required |
|--|---|---|---|
| 1) The licensee is to install the appropriate erosion control measures to prevent continued erosion identified in comments A1-A7, C1 and C2. The following items in Part C of the license 2AM-MRY1325 require the licensee to prevent erosion and maintain erosion control measures; | | | |

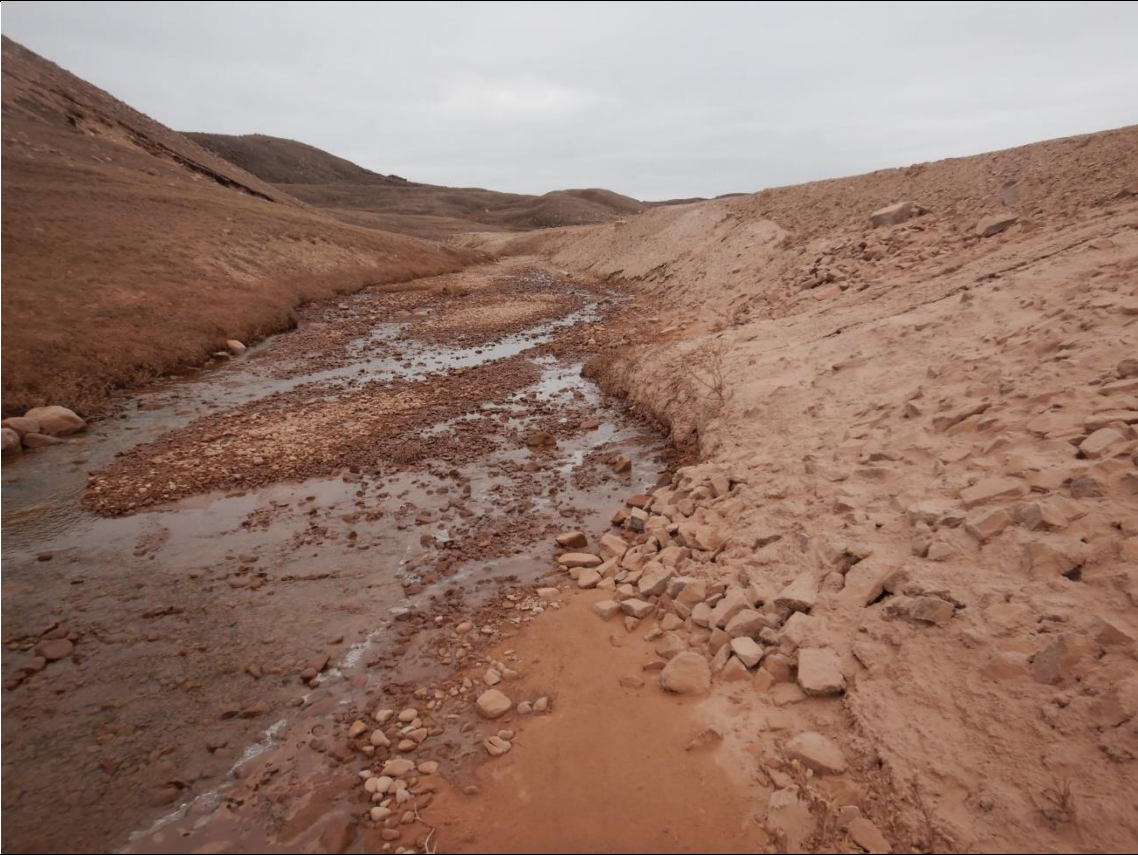
| Date | Camera | Inspector | Authorization |
|--|---|---|---|
| Photo 5 | | | |

| Date | Camera | Inspector | Authorization |
|--|---|---|---|
| Description: Cv-154 erosion down stream. | | | |

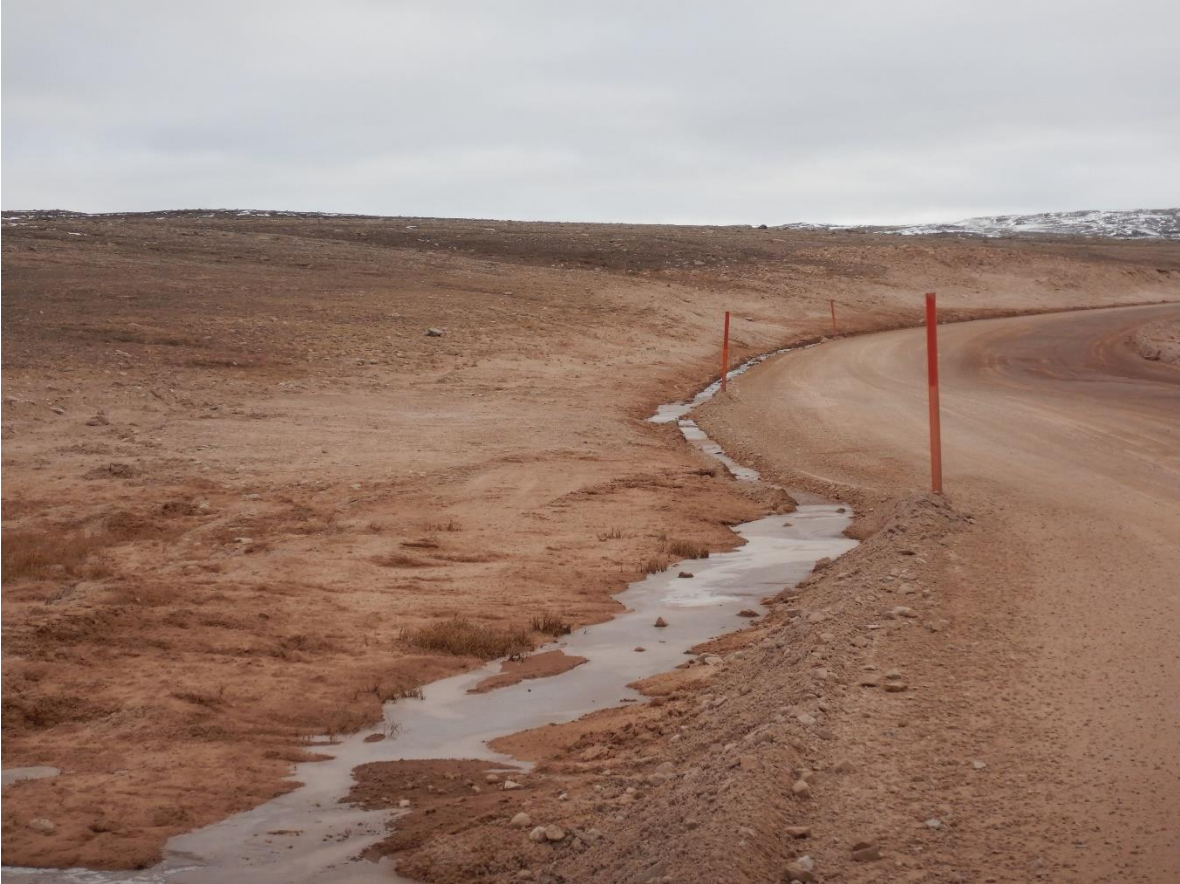
| Date | Camera | Inspector | Authorization |
|---|---|---|---|
| Photo 6 | | | |

1-093/spill 21247- potentially non-engineered ditches upstream of the culvert could be causing increased TSS. See photo 6 for the potentially non-engineered ditches. See photo 7 for the potentially, non-engineered ditches.

| Date | Camera | Inspector | Authorization |
|---|---|---|---|
| Description: Cv-112, potential cause of TSS. | | | |

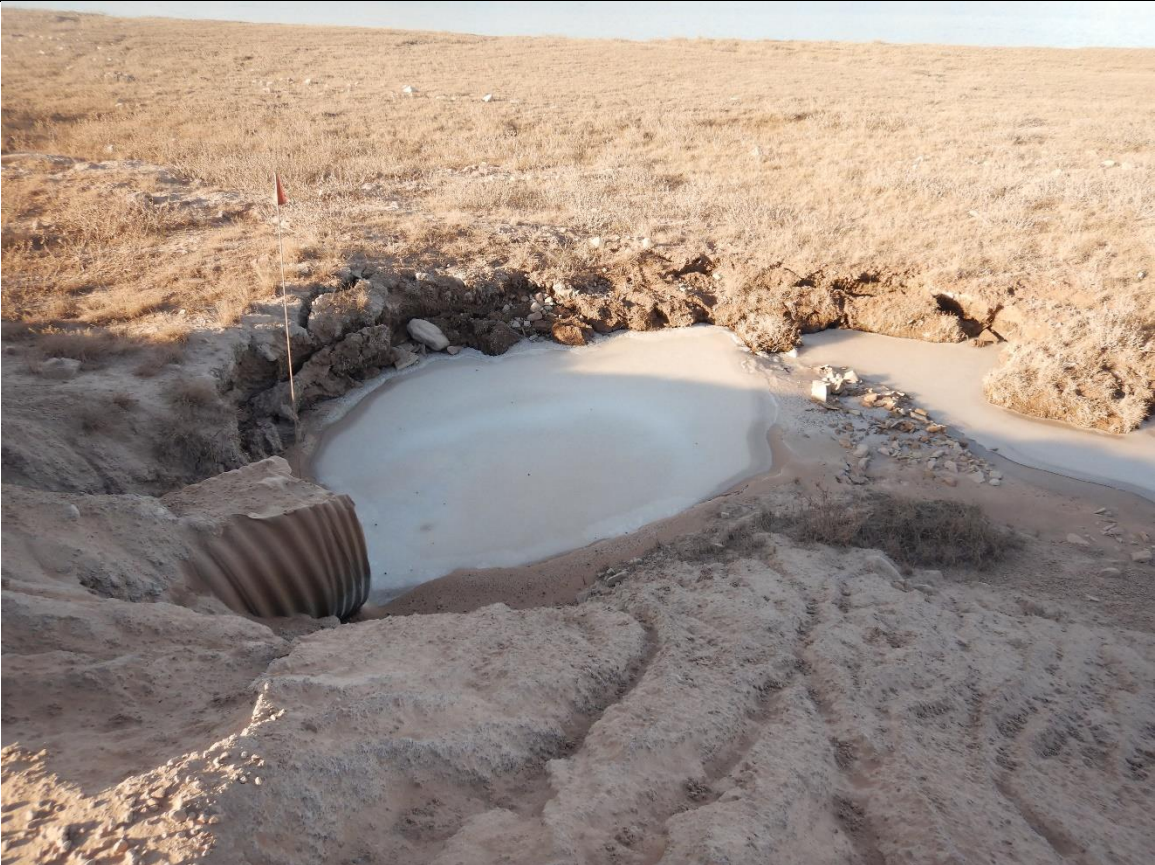
1-24/spill 21247- significant erosion on both sides of culvert. See photos 8-9 for the erosion.

Description: BG-24, erosion on down stream side of culvert/ damaged culvert.

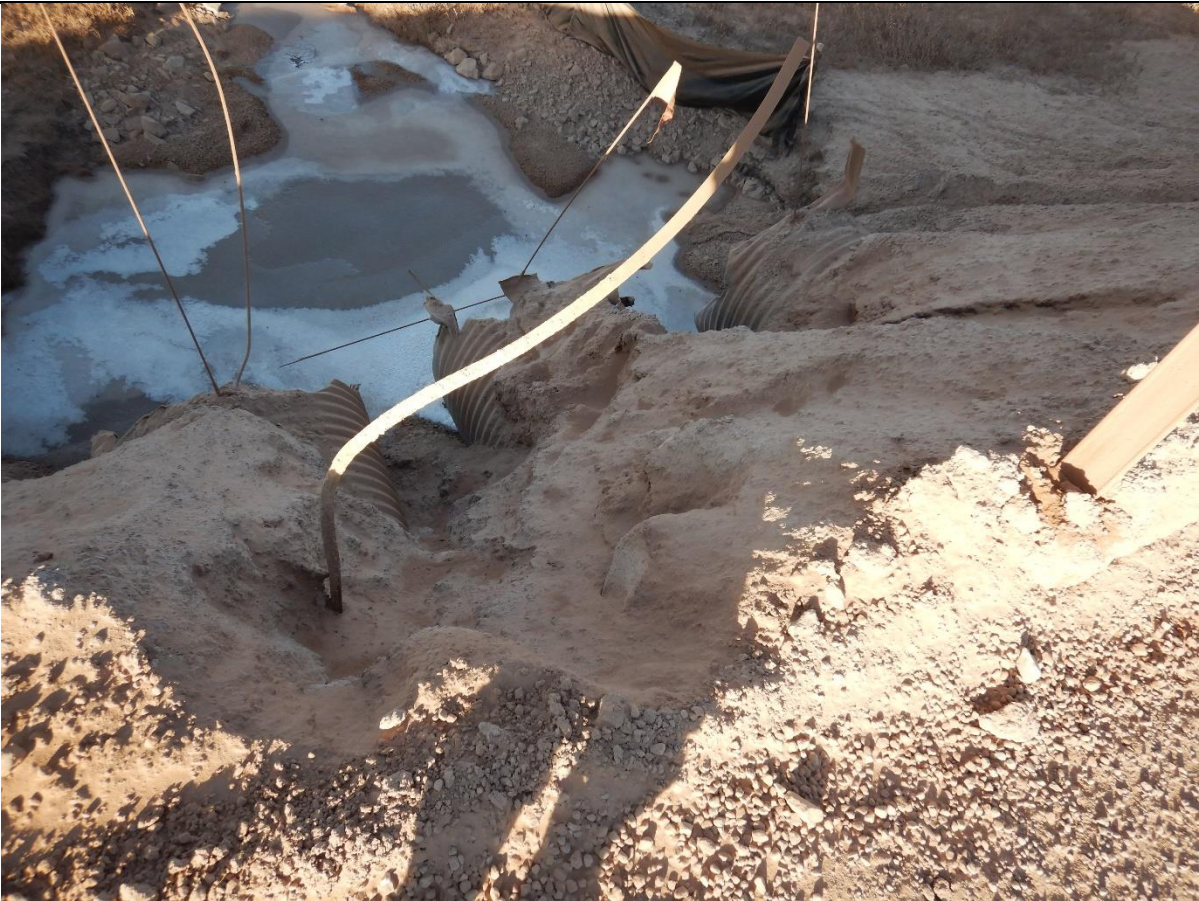
Description: BG-24, erosion on down stream side of culvert/ damaged culvert.

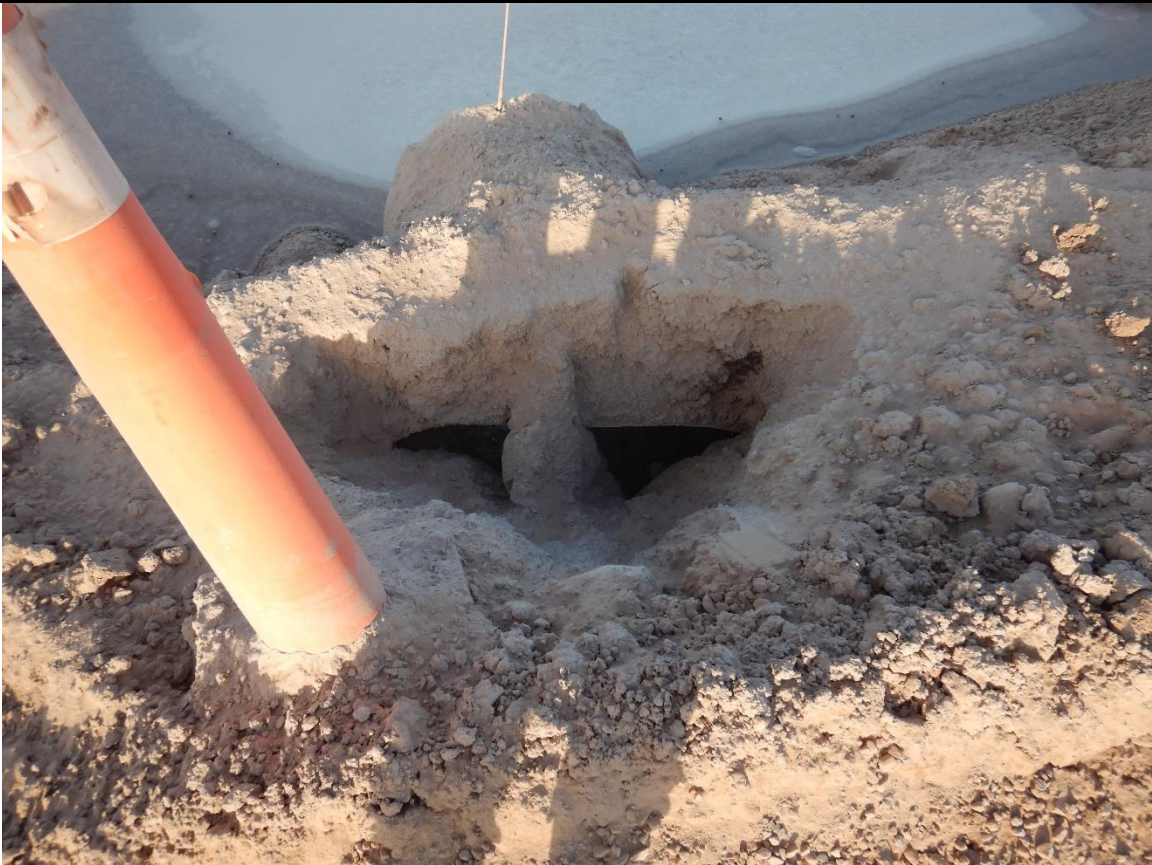
Photo 10

1-001/spill 21247- damaged culvert and erosion on down stream side of culvert. See photo 10 for the photos of the

Description: Cv-001 damaged culvert.

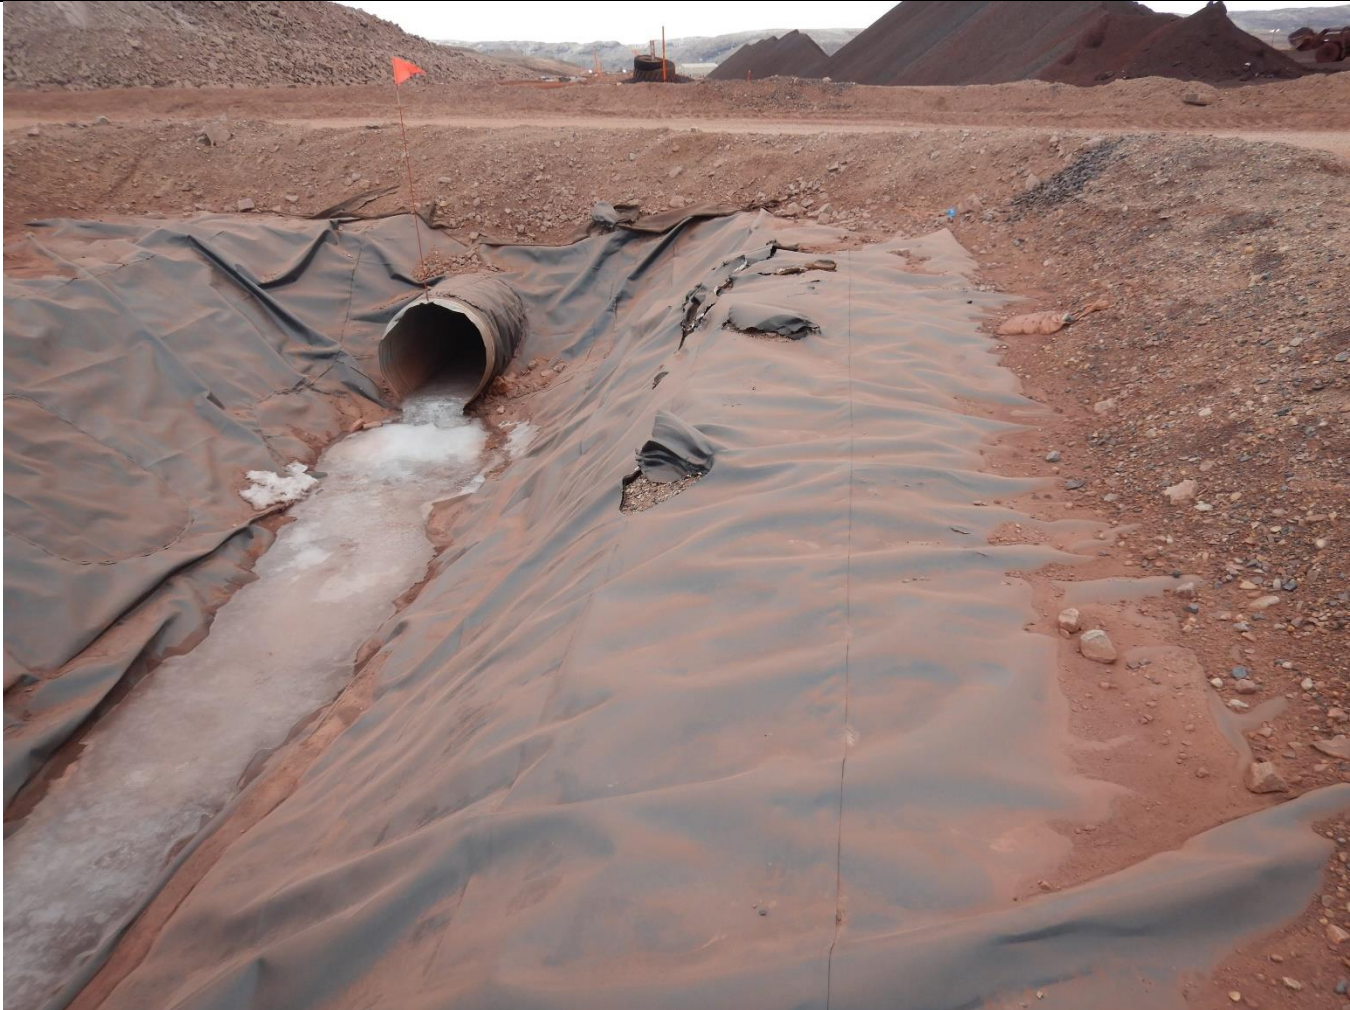
Photo 11

- 1)MP-05- The inspector noted rips on the liner at the inflow after the culvert, the pond appeared to be appropriately pumped down. See photo 11 for pictures of the rips.

Description: damaged liner at MP-05

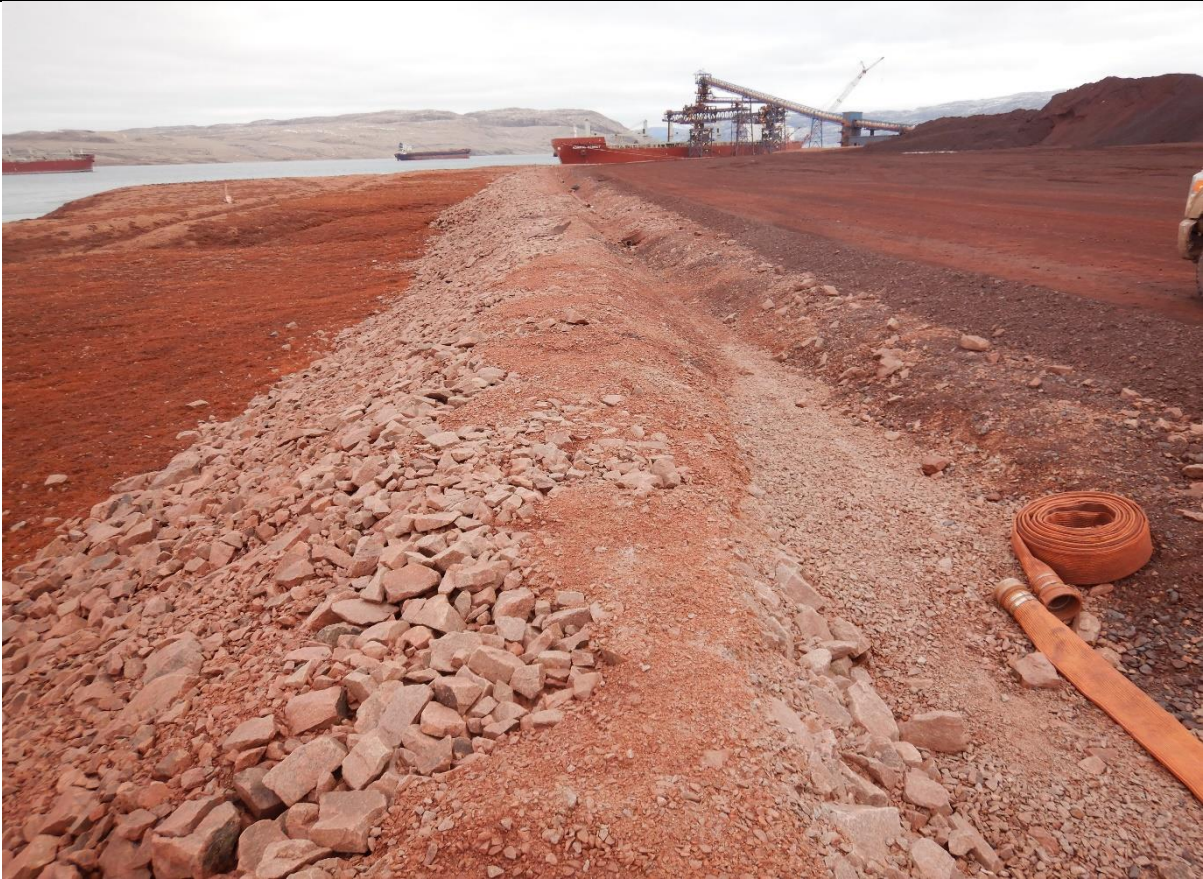
| Date | Camera | Inspector | Authorization |
|--|---|---|---|
| Photo 13 | | | |

- 2)MP-06- There was erosion noted on the East inflow of the pond, the pond appeared appropriately pumped down. See photo 12 for the erosion noted.
- 3)Pond 3- Pond 3 is unable to passively drain into MP-06 and the ditch connecting the two ponds is leaking. The surface water on the South West side of the ore pad is unable to drain into Pond 3. See photo 13 for a picture of the hoses used to pump the water from pond 3 into mp-06 and the area leaking.

| Date | Camera | Inspector | Authorization |
|--|---|---|---|
| Description: hoses required for pumping and leaking area of the ditch. | | | |

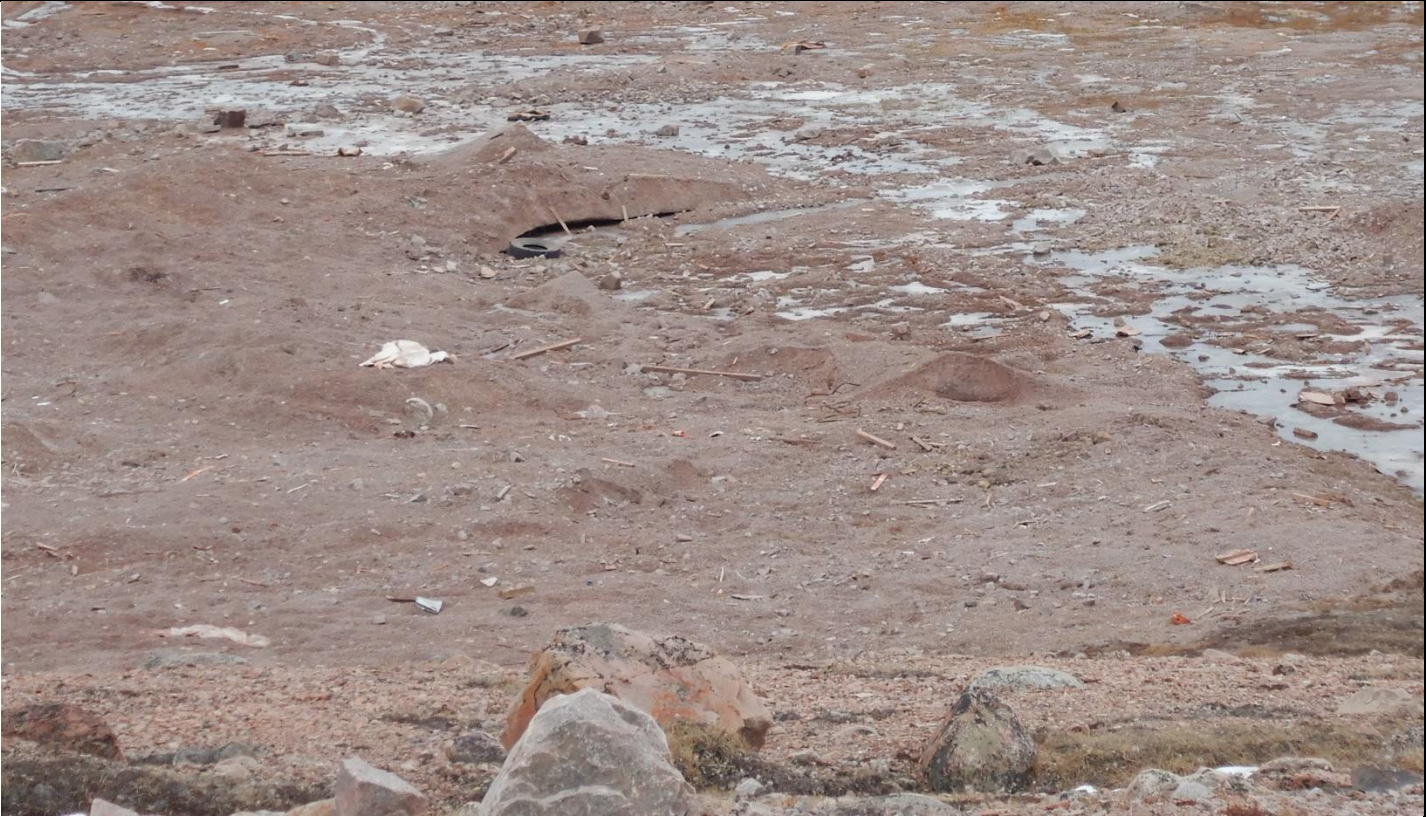
- 4)Snow dumps- The snow dumps appear to be contaminated with litter scooped up during the winter season. see photos 14 and 15 for waste in the snow dumps.

Description: current snow dump containing waste.

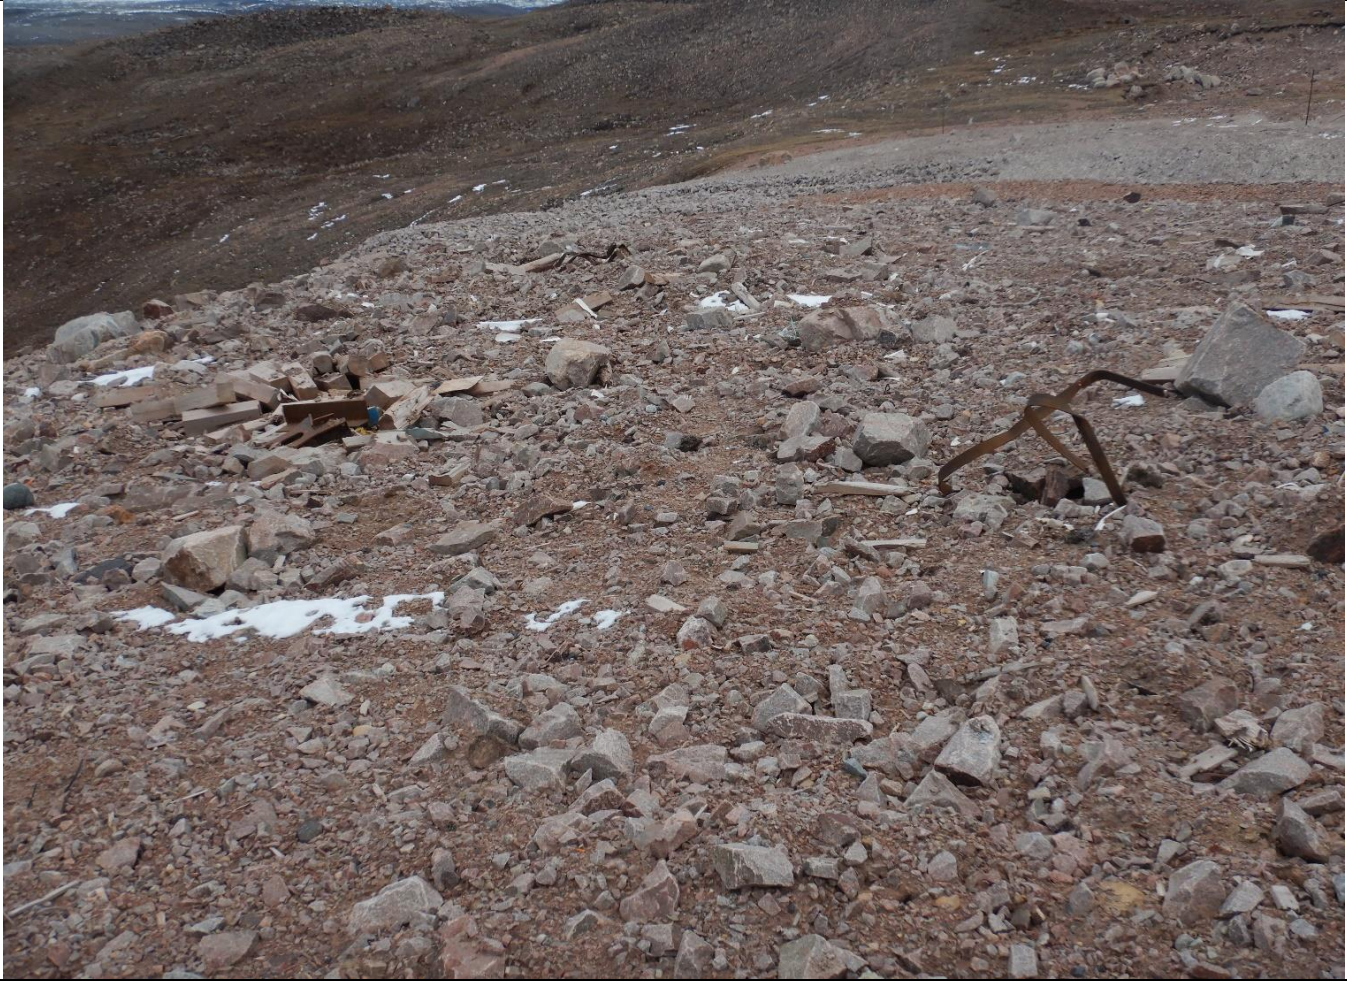
Description: previous snow dump still containing plastic, metal and wood waste

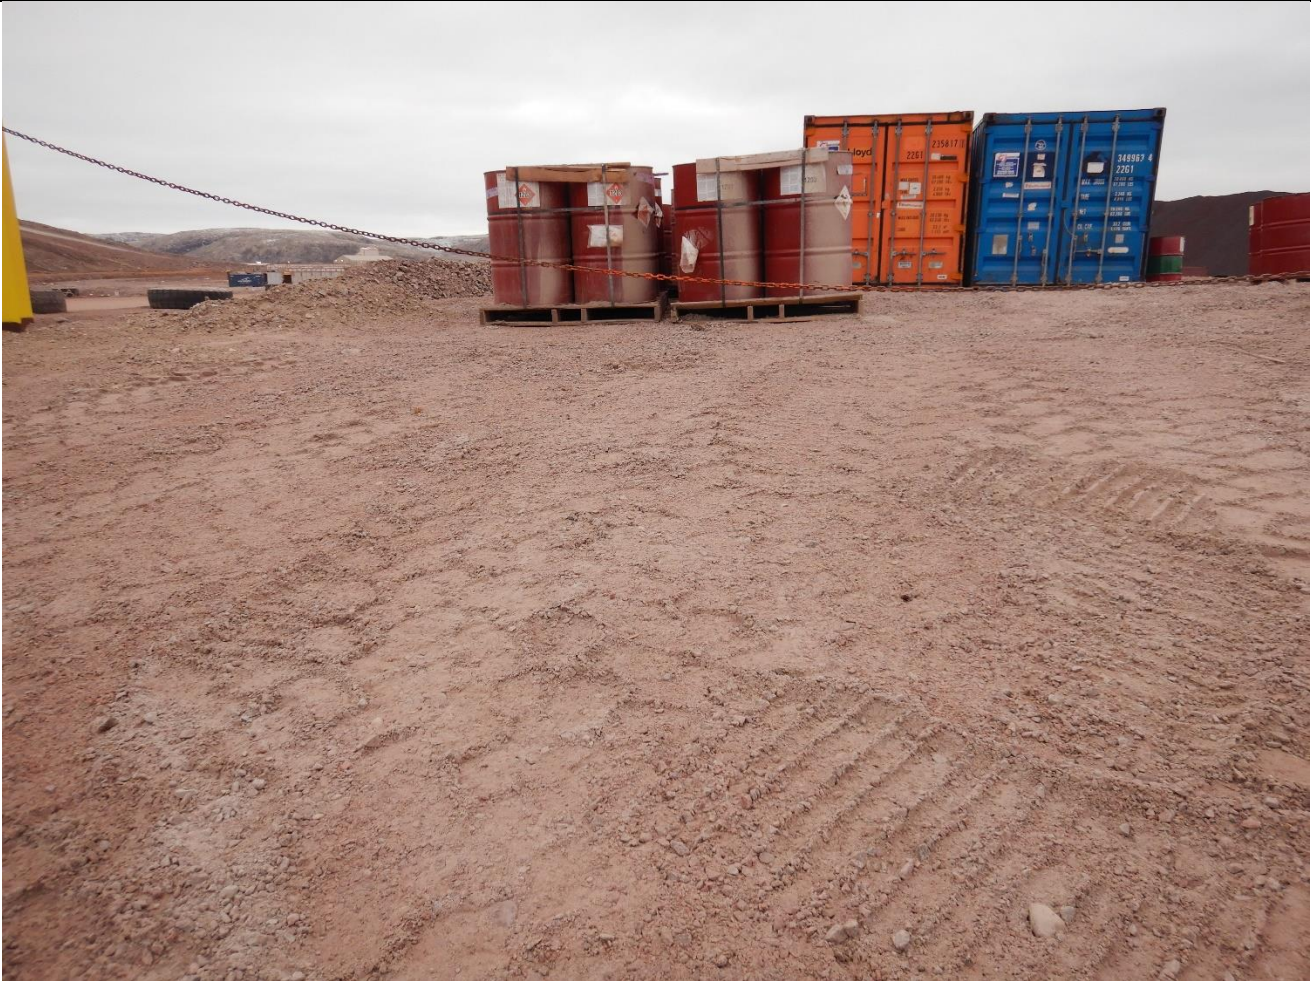
- 5) HWB 03 and 04- the is no defined berm where waste is being stored it appears if a spill did occur the waste would flow outside of this facility. See photo 16 for a picture of this facility.

Description: standing outside the HWB’s looking in, you can clearly see there is no defined berm.

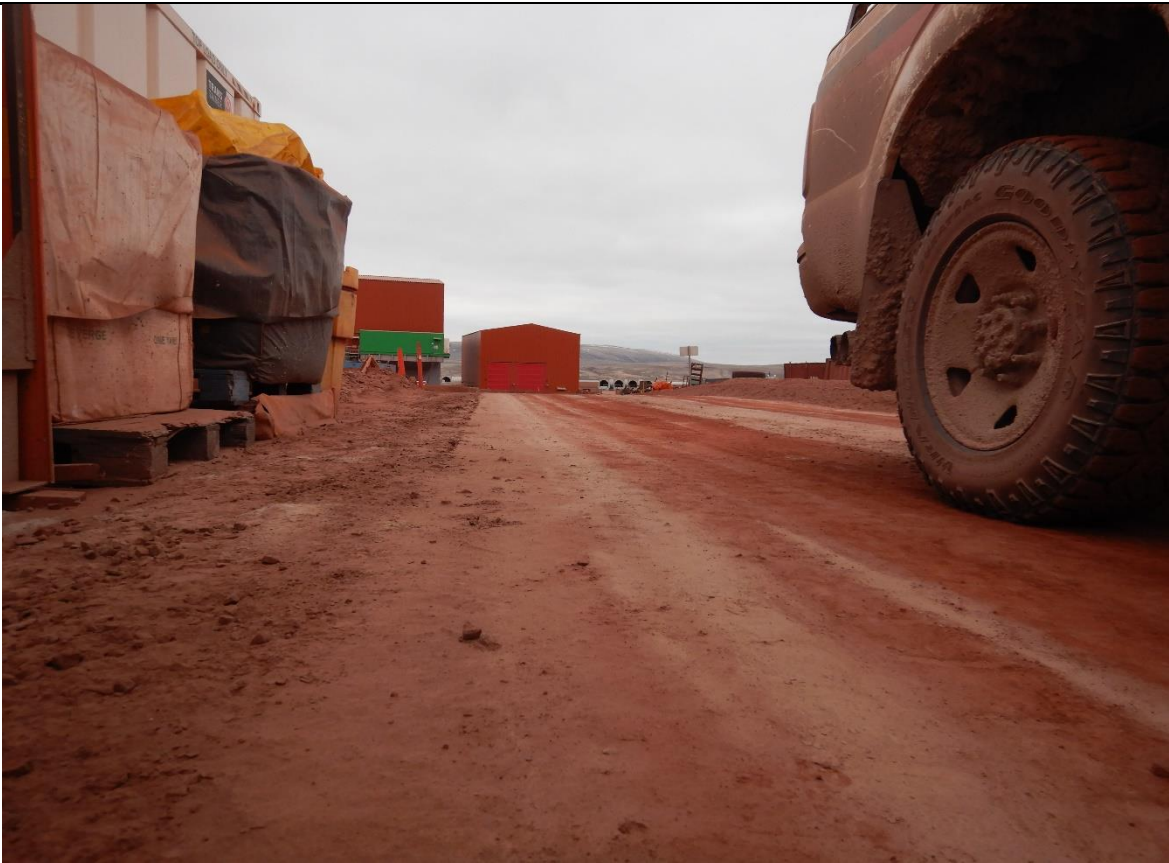
- 6)western globe fuel module- there is no visible berm, this pumping station does not appear to be properly contained, if a spill was or occur or if rain was to pool and become contaminated it appears to be able to flow outside of containment. See photo 17 for the lack of defined berms.

Description: lack of defined berms at fuel module.

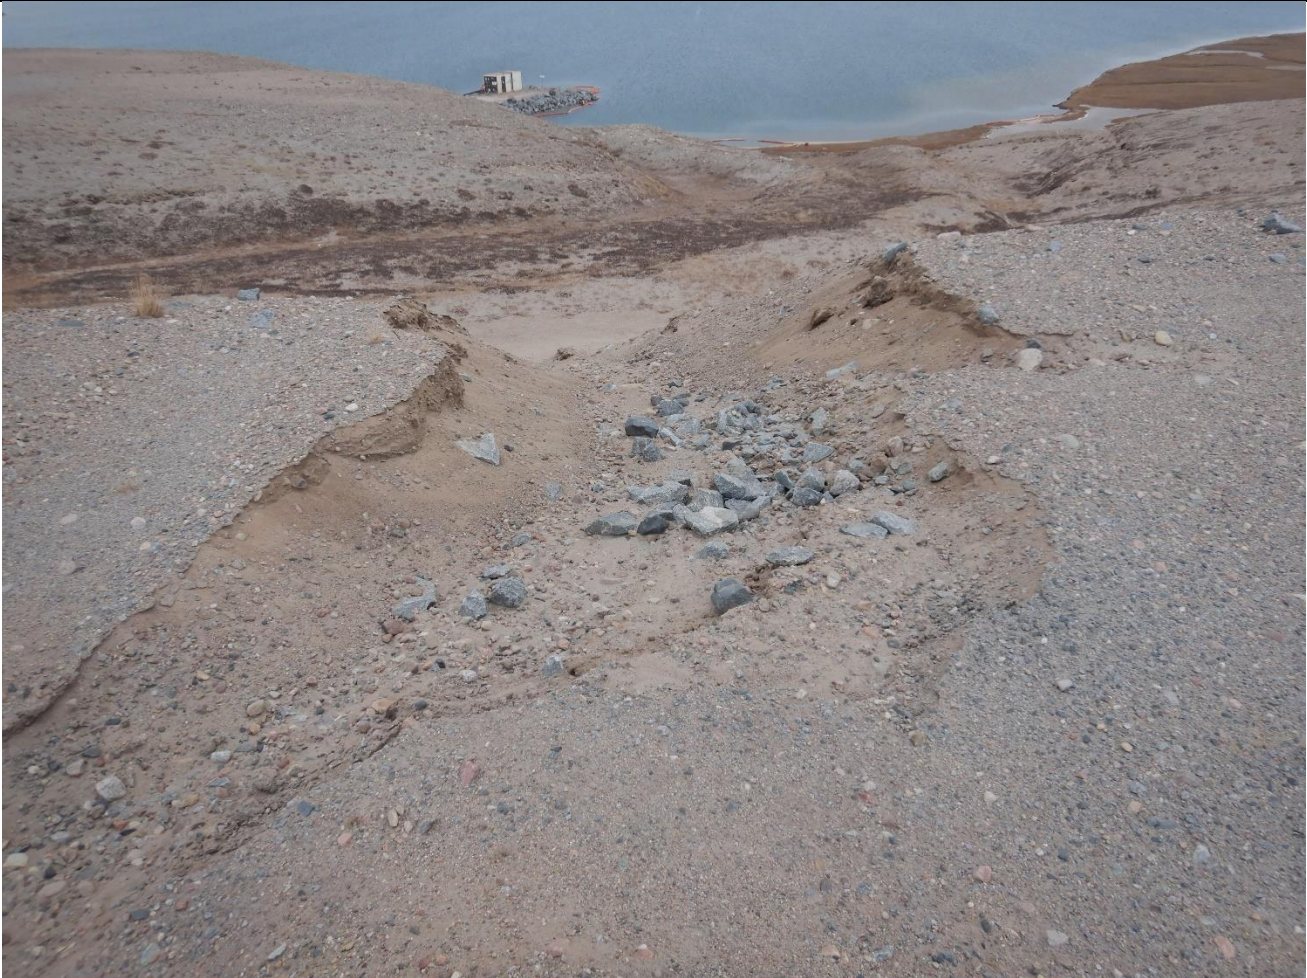
- 1) The inspector noted erosion North of the camp lake intake, is appears surface water from the runway and surrounding area has no water management structure to manage it. This surface water has previously caused erosion near the camp lake tributary and now is eroding the sandy hills north of the water intake. See photo 18 and 19 for pictures of this erosion.

Description: Erosion near water intake, standing on runway perimeter road looking towards camp lake.

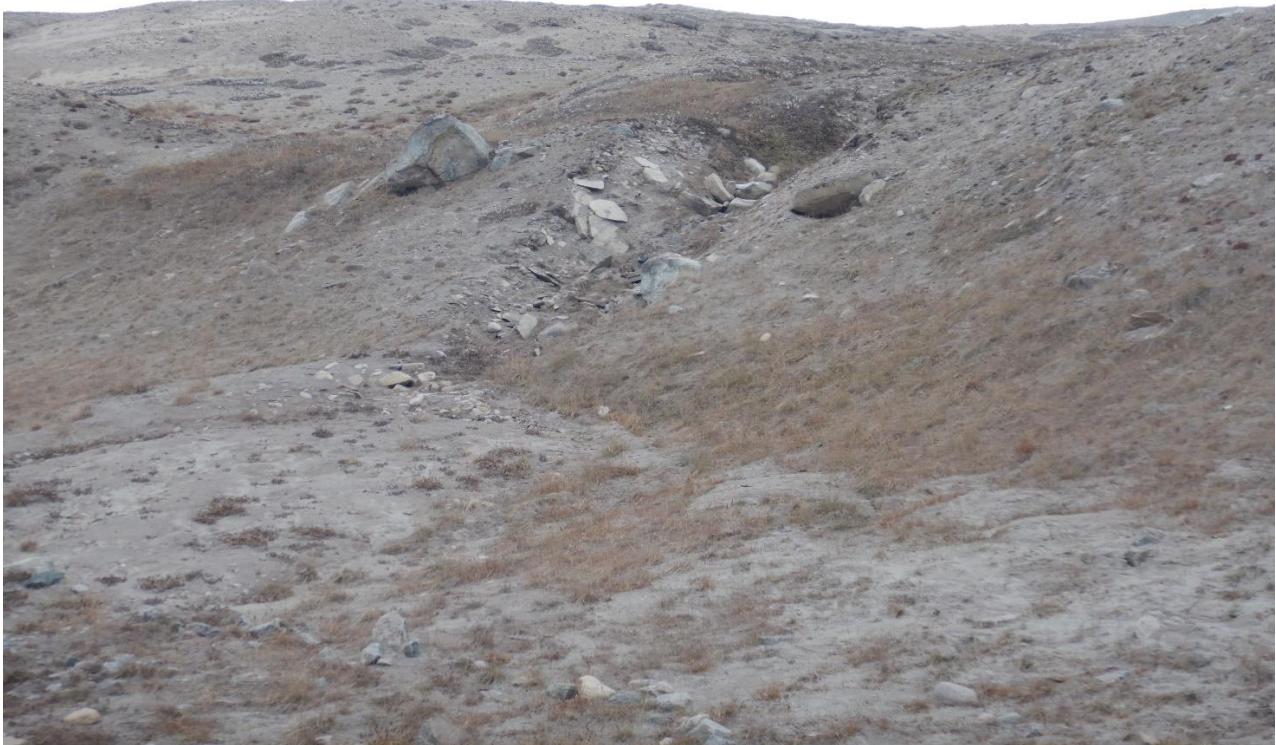
Description: Erosion near water intake, standing near intake looing at the hillside.

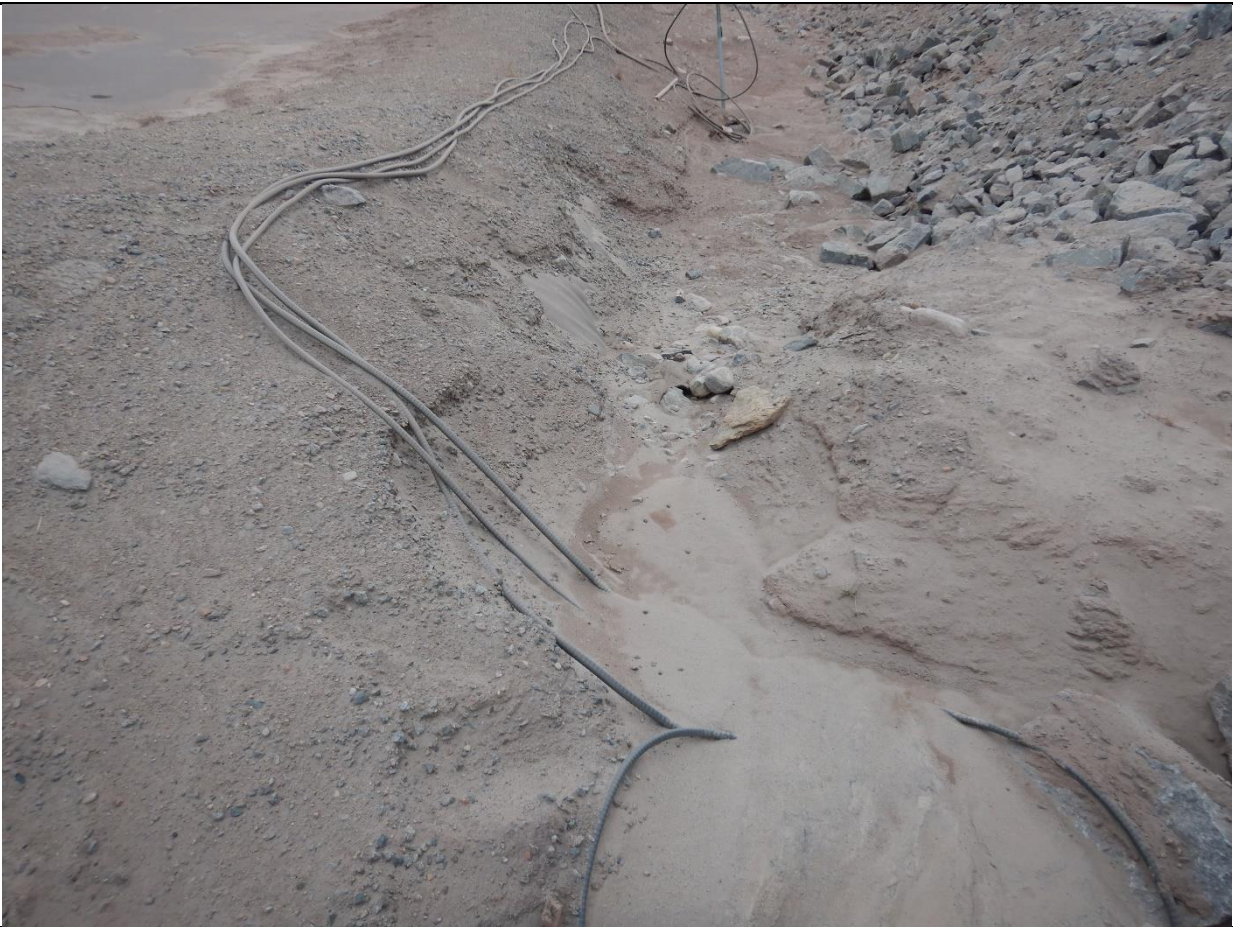
- 2) Aircraft Fuel berm- The inspector noted erosion on the outside of this berm. See photo 20 for the erosion noted.
- 3) Landfill- While inspecting the landfill the following items were noted; food waste, fuel filters two generators, break fluid and a automotive fuel tank. See photo 21 for a photo of some of the items mentioned.

Description: Erosion on outside of aircraft fuel berm.

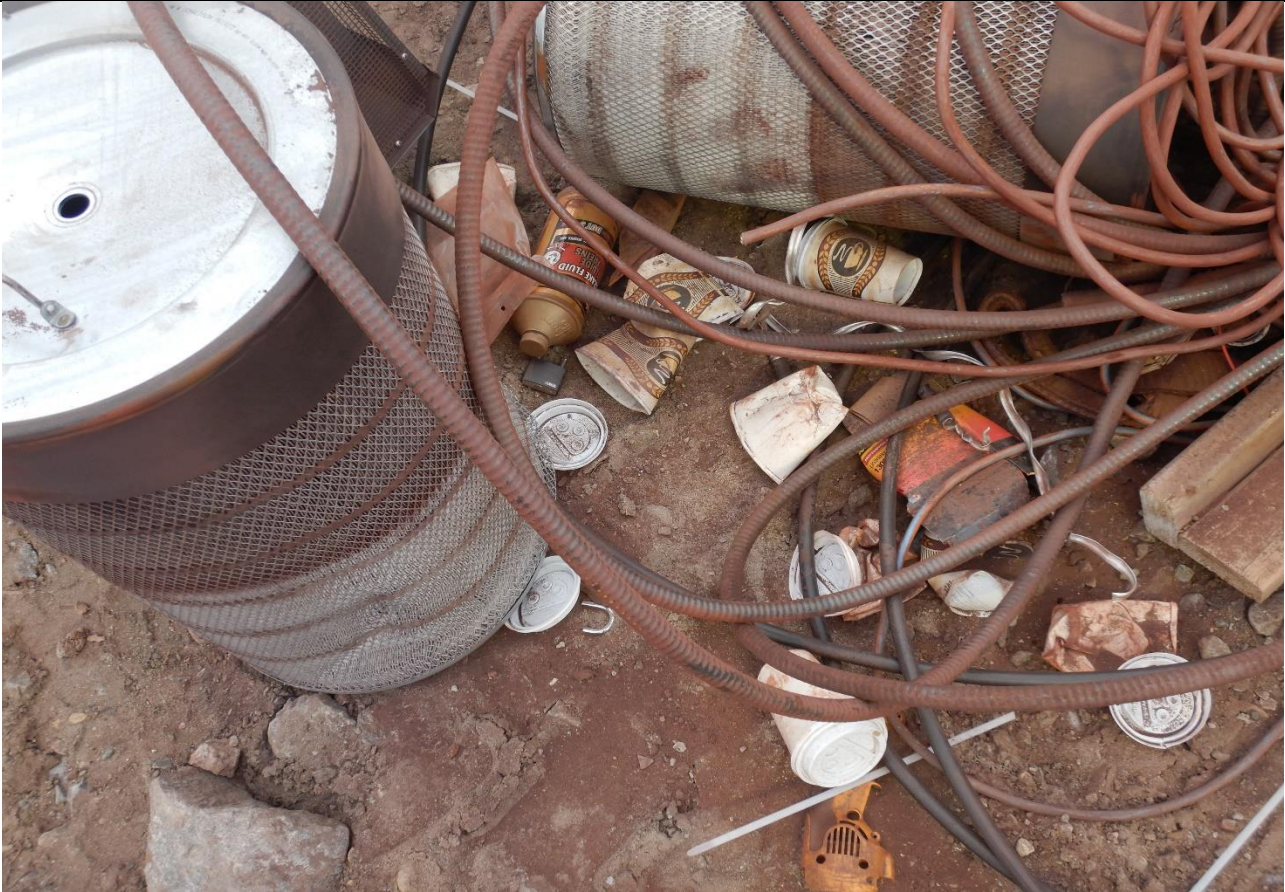
Description: Erosion near water intake, standing on runway perimeter road looking towards camp lake.
