WATER LICENCE INSPECTION FORM

| Baffinland Iron Mines | Connor Devereaux |
| September 16-17, 2021 | Jonathan MESHER |

On September 16-17, 2021 I Jonathan Mesher Resource Management Officer of CIRNAC conducted a Water licence inspection at the Mary River Project, Tote Road and Milne port site.

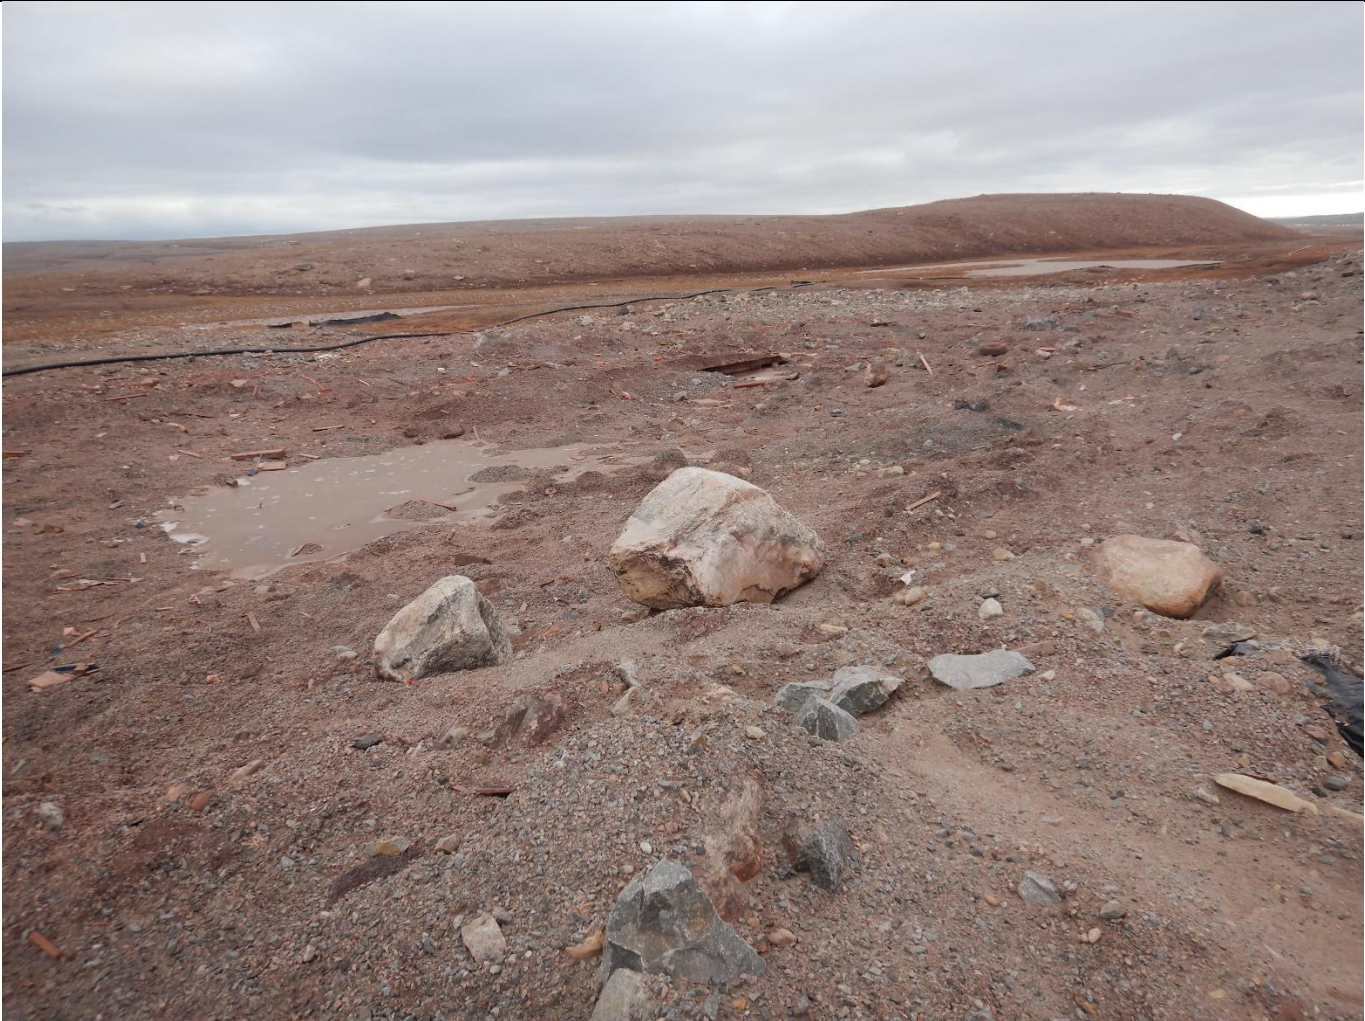
- 4) Mine site snow dump- the mine site snow dump also has significant waste. See photo 22 for the waste in the snow dump
- 5) Waste Rock Stockpile pond- this waste rock stockpile and the surrounding area was snow covered at the time of the inspection making it difficult to identify any concerns, no concerns were noted.

Description: Mine site snow dump.

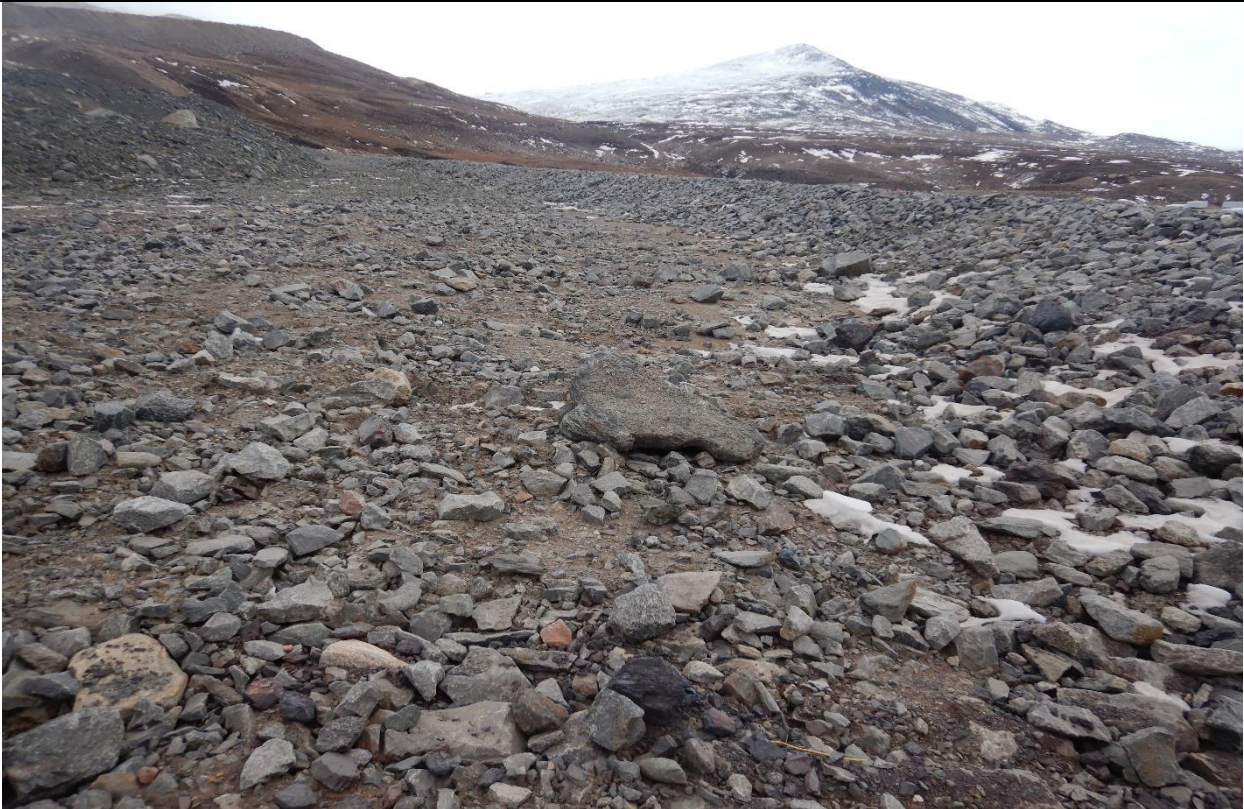
- 6) MS-07/spill 21268- This facility is currently dealing with a seepage issue potentially due to gradient of the ditch and the type of fill used. See Photo 23 for the ditch with the unresolved seepage.

Description: MS-07 ditch with ongoing seepage issue.

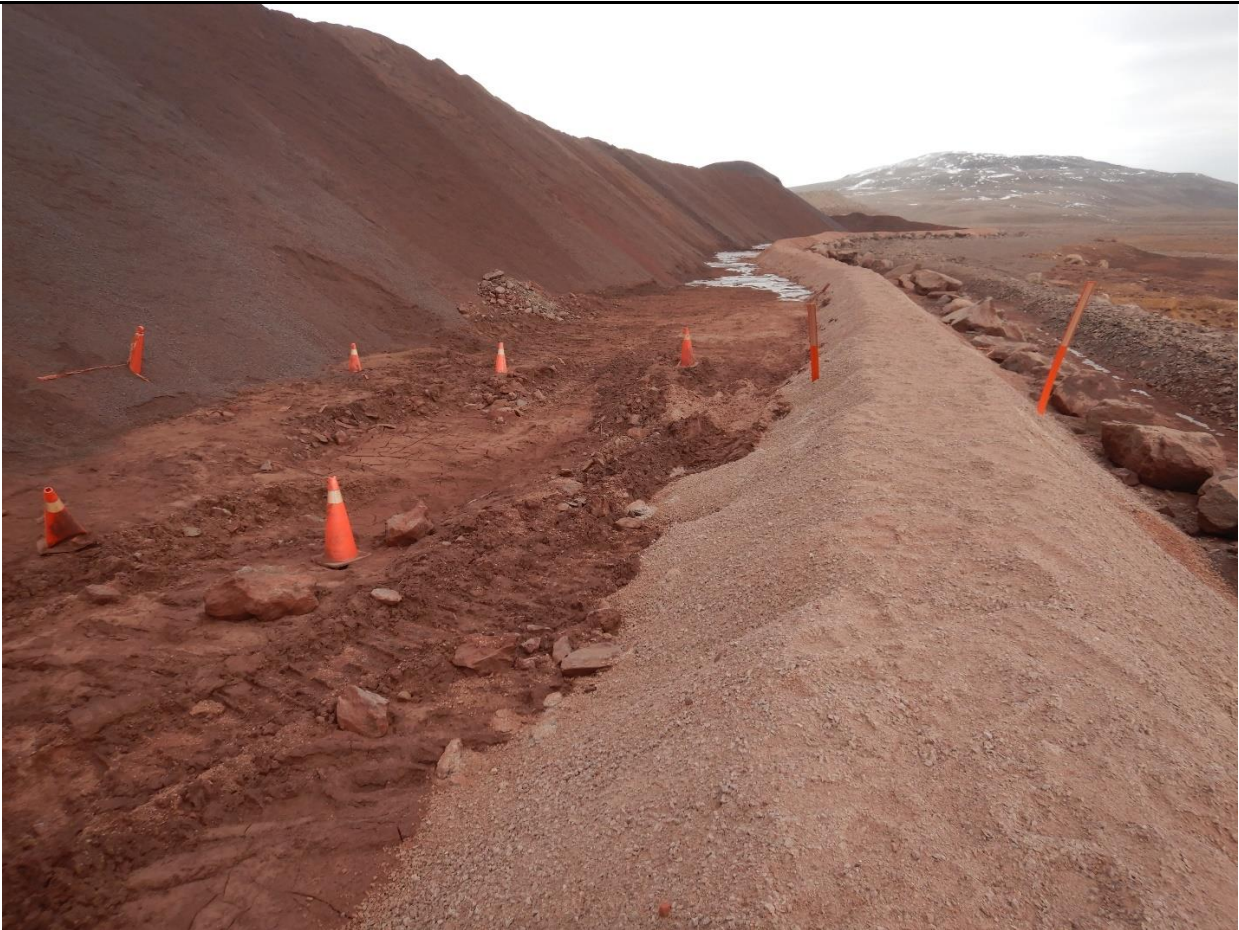
Photo 24

- 7) Crusher Pad and pond- The Crusher pad is currently dealing with a unresolved seepage as well, the ditch that is designed to divert surface water to the containment pond is not operational due to a leak. The licensee currently has a sump installed and is pumping water from the sump into the containment pond. See photo 24 for a photo of the sump and berms installed to keep the surface water out o the ditches.

Description: Berm and sump installed.

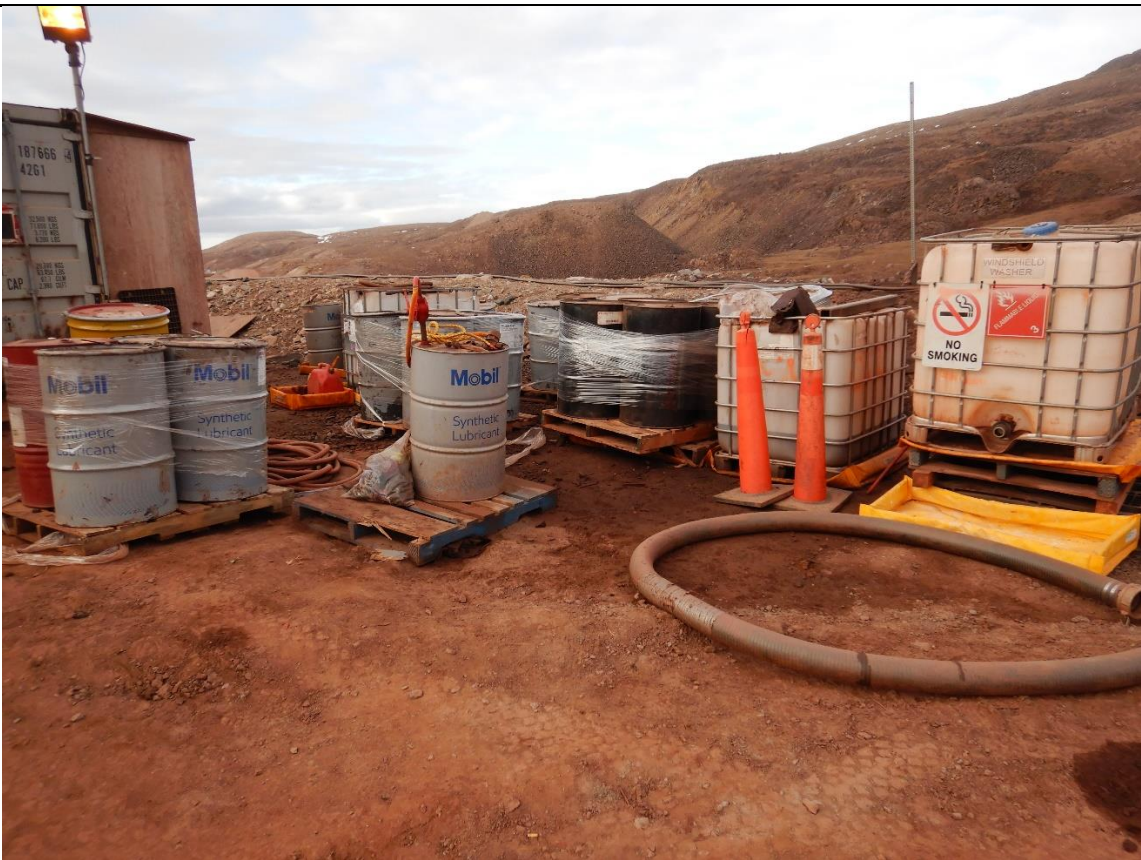
Photo 25

- 8) Km 104 laydown- during the inspection the inspector noted the following concerns at the 104 laydown;
 - Lubricants and hazardous material outside of containment, in damaged containment and staining which smelled strongly of fuel. See photo 25 for the area with staining and hazardous material outside of containment.

Description: hazardous material outside of containment, in damaged containment and staining in the area.

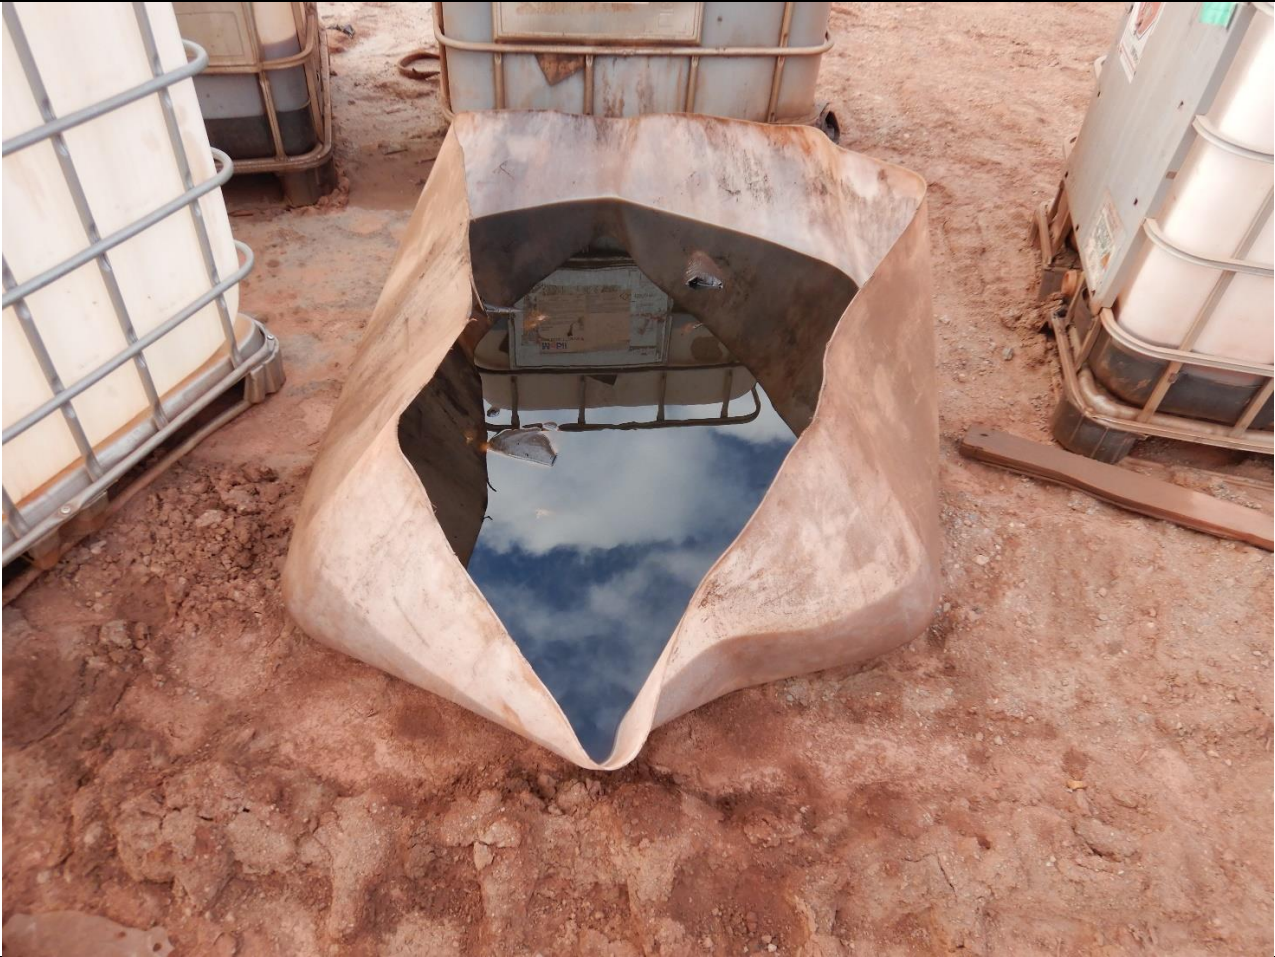
Photo 26

- Open containers with dirty absorbent rags nearing capacity, see photo 26 and 27 for the containers.
 - Heavy equipment actively leaking on the ground with no drip tray, see photos 28 and 29 for photos of fluid under heavy equipment at laydown 104.

Description: dirty spill rags and unknown waste in open container outside of containment

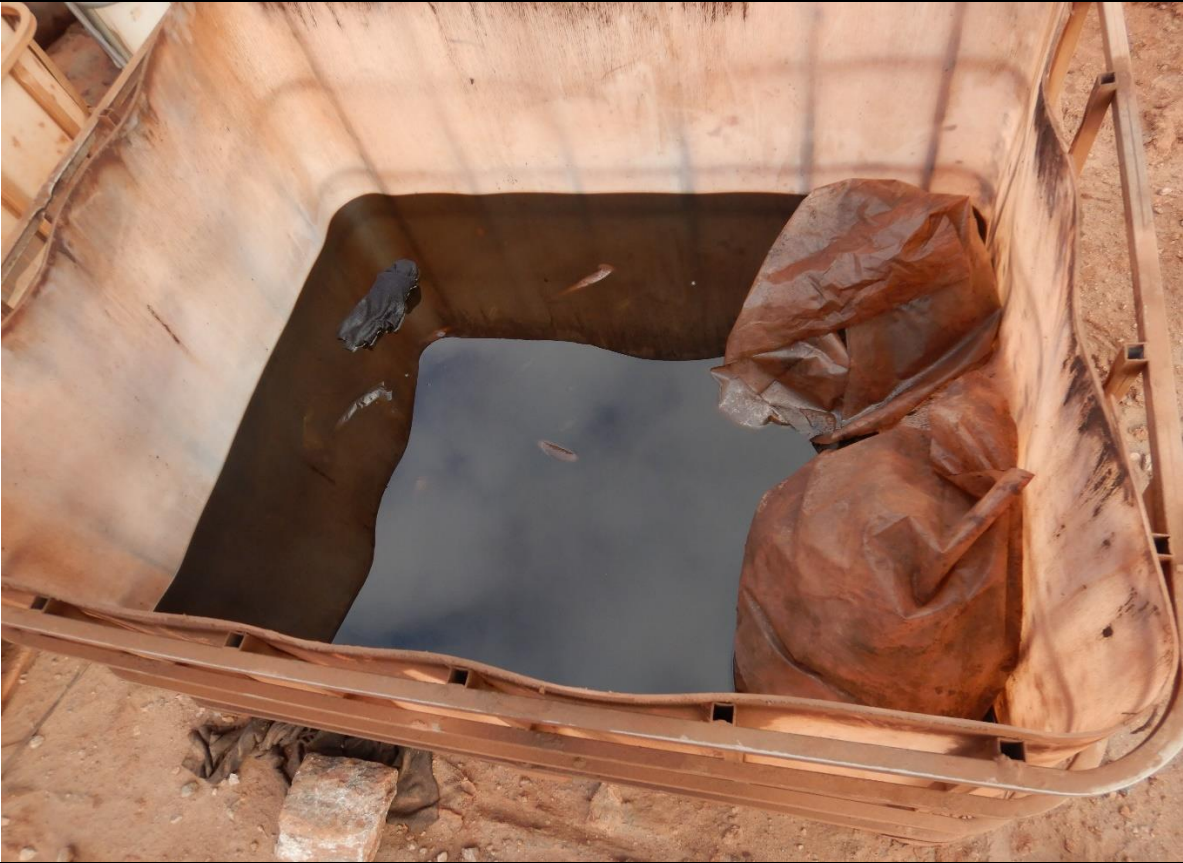
Photo 27

Description: dirty spill rags and unknown waste in open container outside of containment

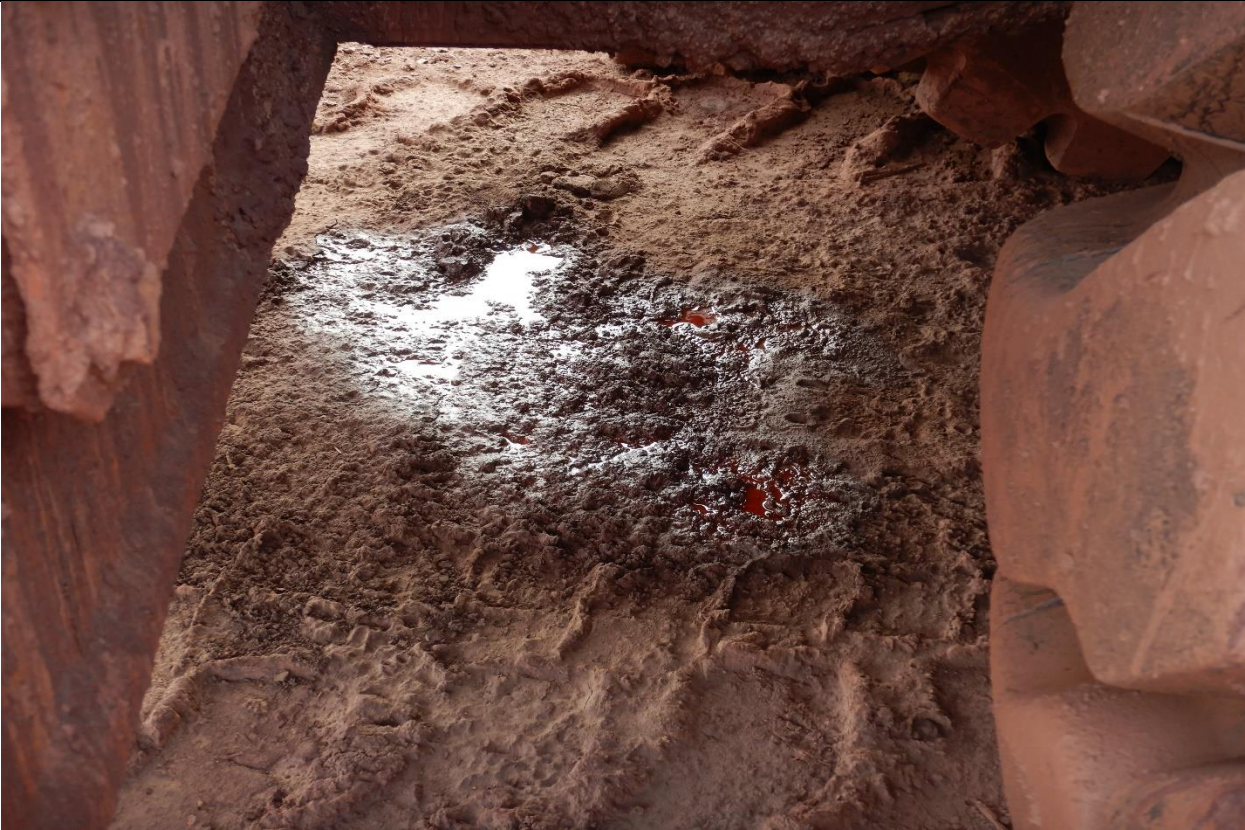
Description: fluid leaking from heavy equipment.

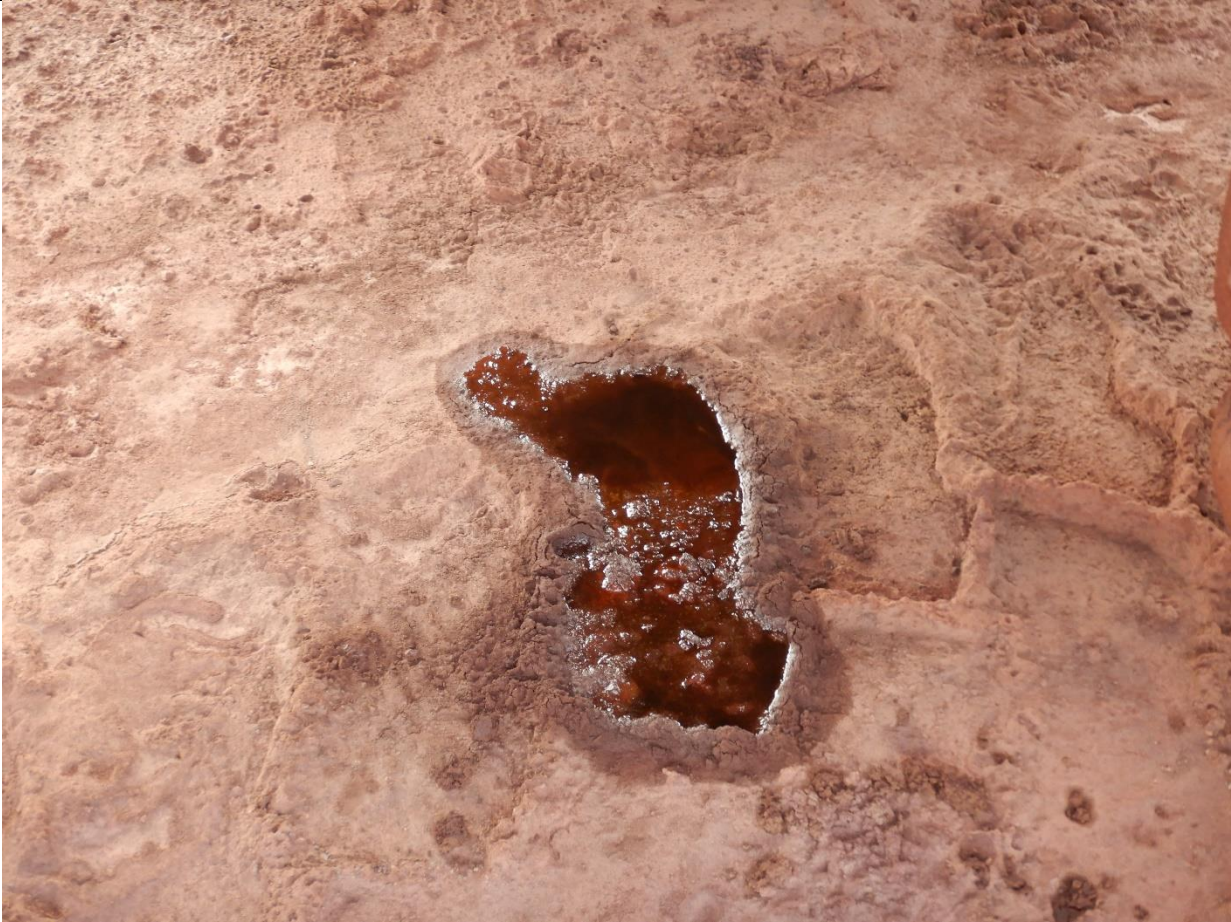
Description: fluid leaking from heavy equipment.
