RE: Water Licence 2AM-MRY1325 September 2021 Inspection – Follow Up

2021-QIK-JKM012 2AM-MRY1325 Inspection Report

WATER LICENCE INSPECTION FORM

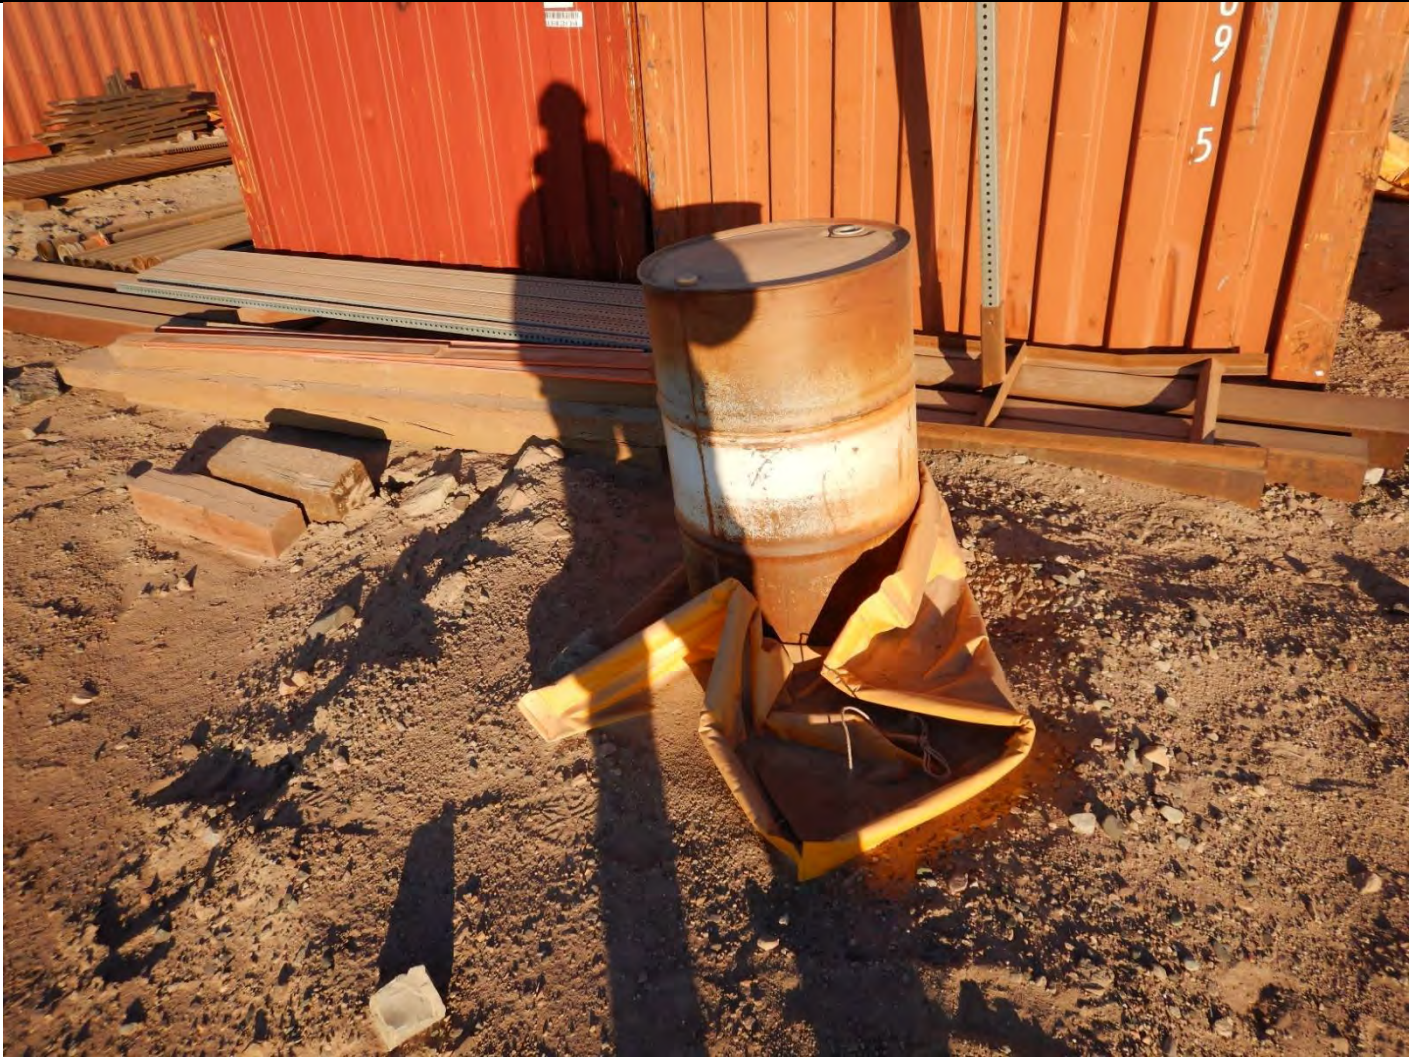
Photo 1

Description: damaged drip tray at km 97

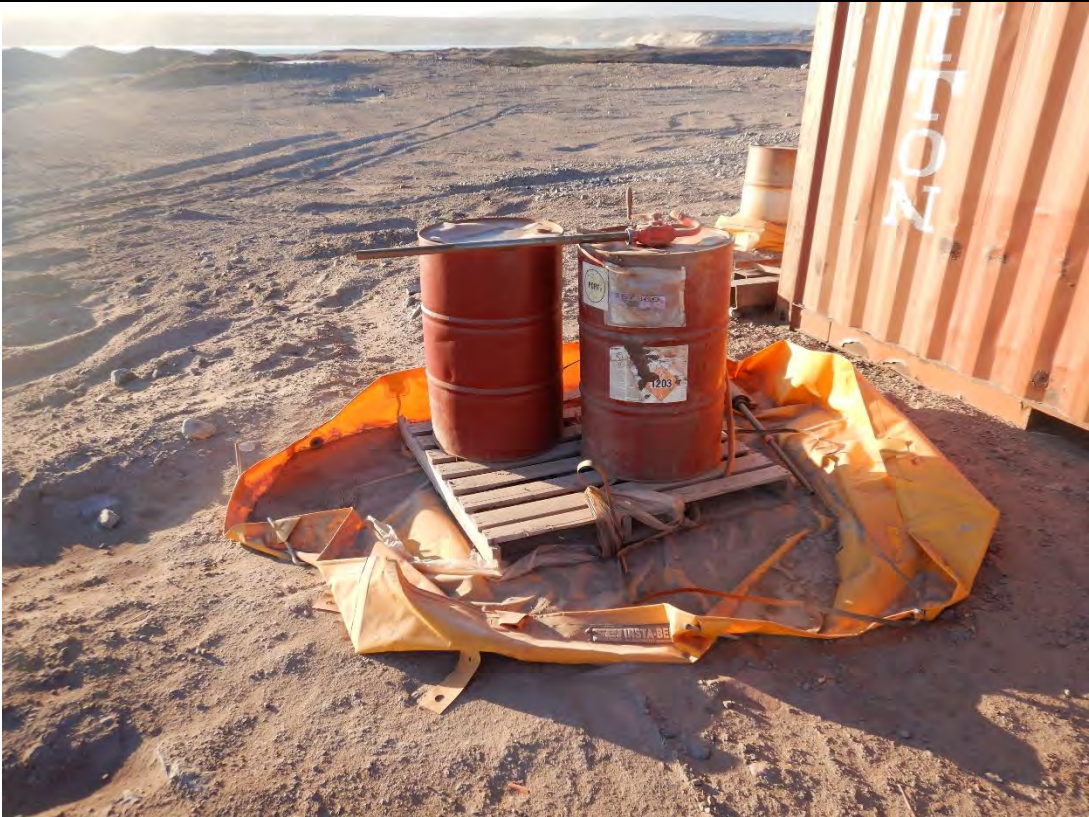
Description: damaged drip tray at km 97

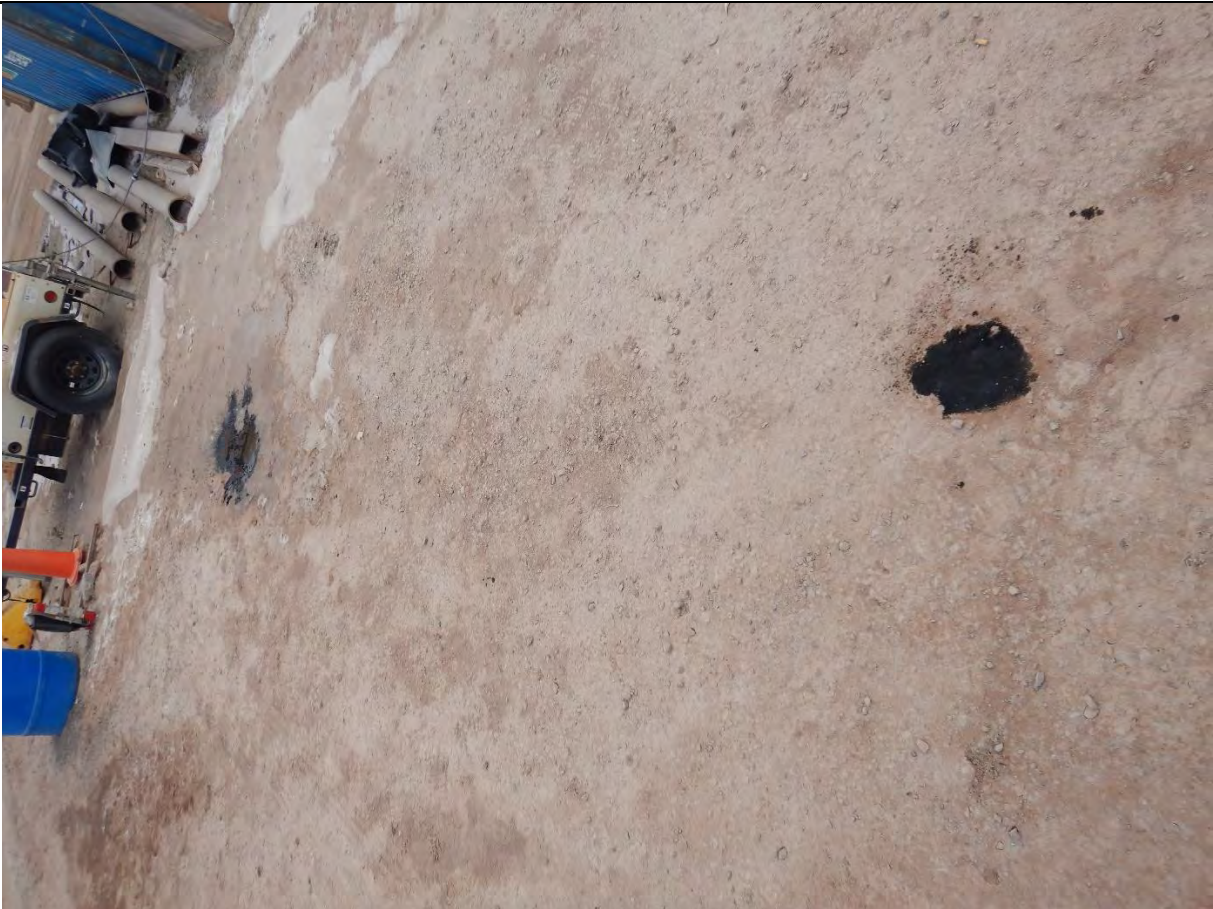
1-60 Crown Land- multiple spills of unknown substance(potentially motor oil) on the ground near the parking area. See photo 3 for the spills.

Description: km 60 spill.

Number	Project Location	Description of Concern or Finding	Response
A) Tote Road			
1)	KM-60 Crown Land	Multiple spills of unknown substance (potentially motor oil) on the ground near the parking area. See photo 3 for the spills. The licensee is to install the appropriate erosion control measures to prevent continued erosion identified in comments A1-A7, C1 and C2. The licensee is to remediate all spills noted in this report.	The KM60 Laydown is regularly inspected for surficial staining, and follow-up inspections since the September Water License inspection have confirmed no further staining has been present and no vehicles or stationary equipment were found to be leaking. Surficial staining that is observed on the laydown is cleaned up and placed in appropriate secondary containment. Photo 1 in Attachment 2 show the current status of the KM60 Laydown.

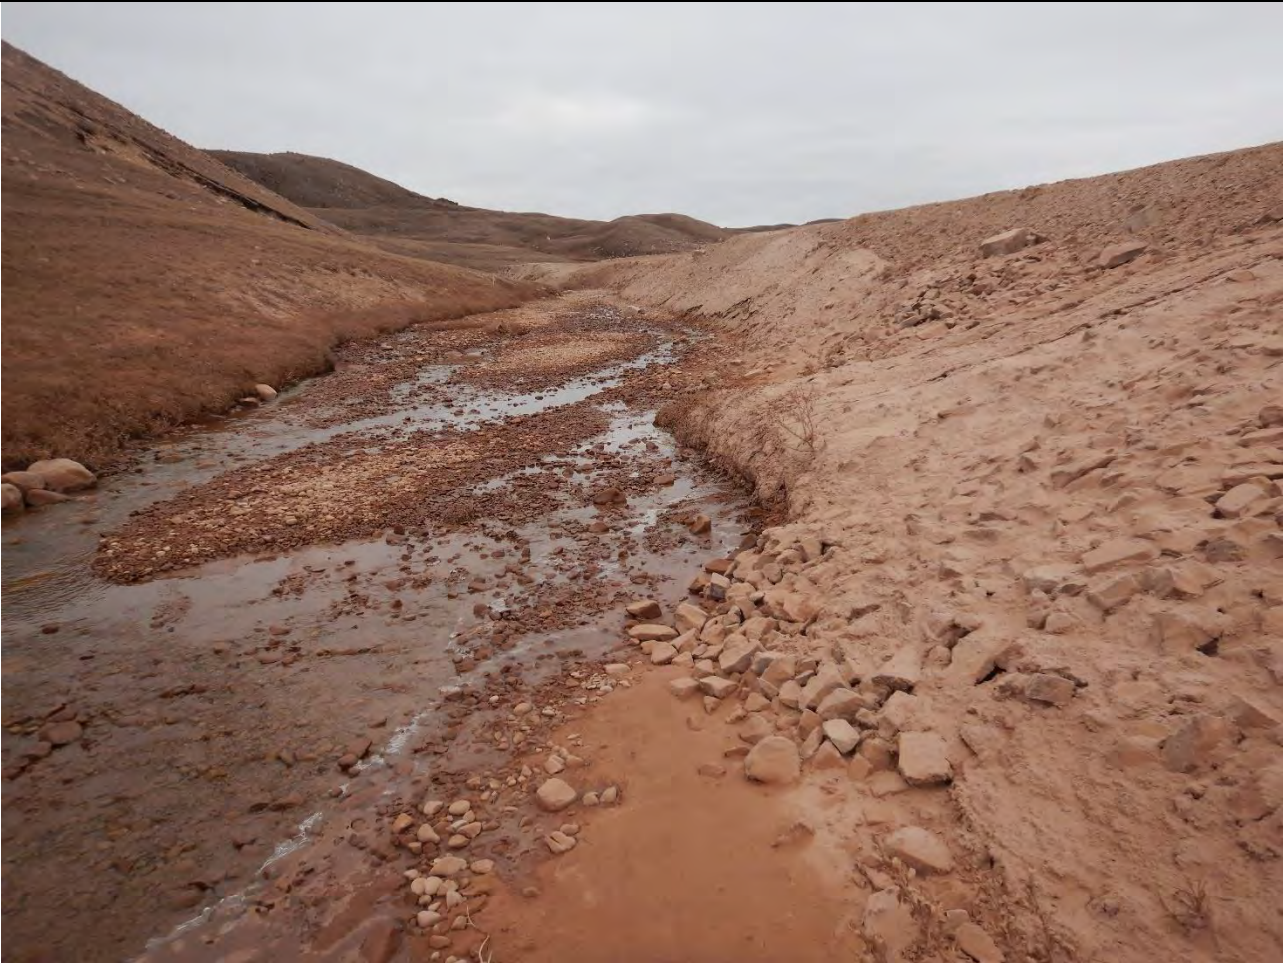
1-154A/ Spill 21247- there was visible erosion on the road near the culvert, upstream of the culvert and down stream of the culvert. See photos 4 &5 for erosion.

Description: Cv-154 erosion upstream

2)	CV-154A	Spill 21247 - There was visible erosion on the road near the culvert, upstream of the culvert and down stream of the culvert. See photos 4 & 5 for erosion. The licensee is to install the appropriate erosion control measures to prevent continued erosion identified in comments A1-A7, C1 and C2. The licensee is to remediate all spills noted in this report.	Following the elevated TSS conditions at CV-154A on June 1, 2021, an assessment was completed to identify potential erosion and sediment control measures around the culvert crossing. During July 2021, check dams were constructed within the ditch and armouring of the ditch upstream of the culvert inlet was completed. Photo 2 in Attachment 2 shows the completed check dams. Additional work will be completed at this culvert crossing prior to freshet 2022, including removing excess sediment from the culvert inlet and outlet banks, reshaping and re-armouring of the embankment slopes, and routine maintenance of the check dams.

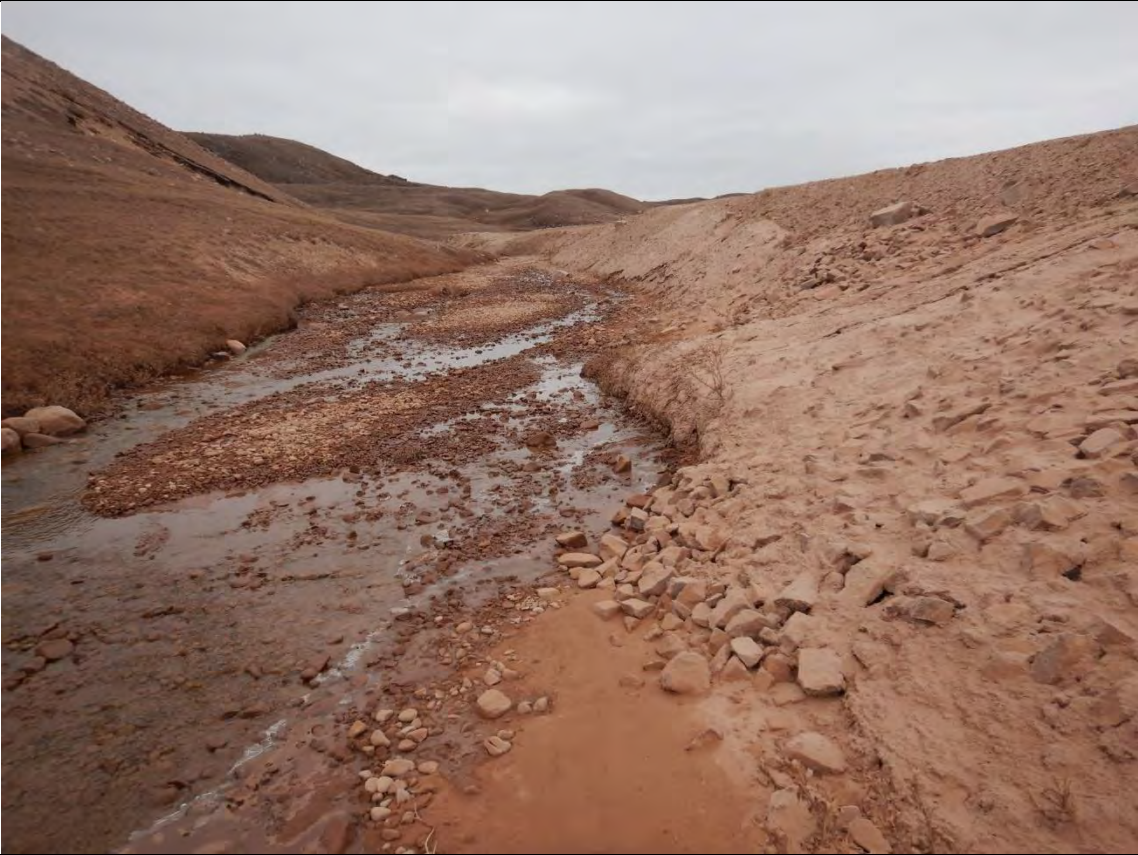
Description: Cv-154 erosion down stream.

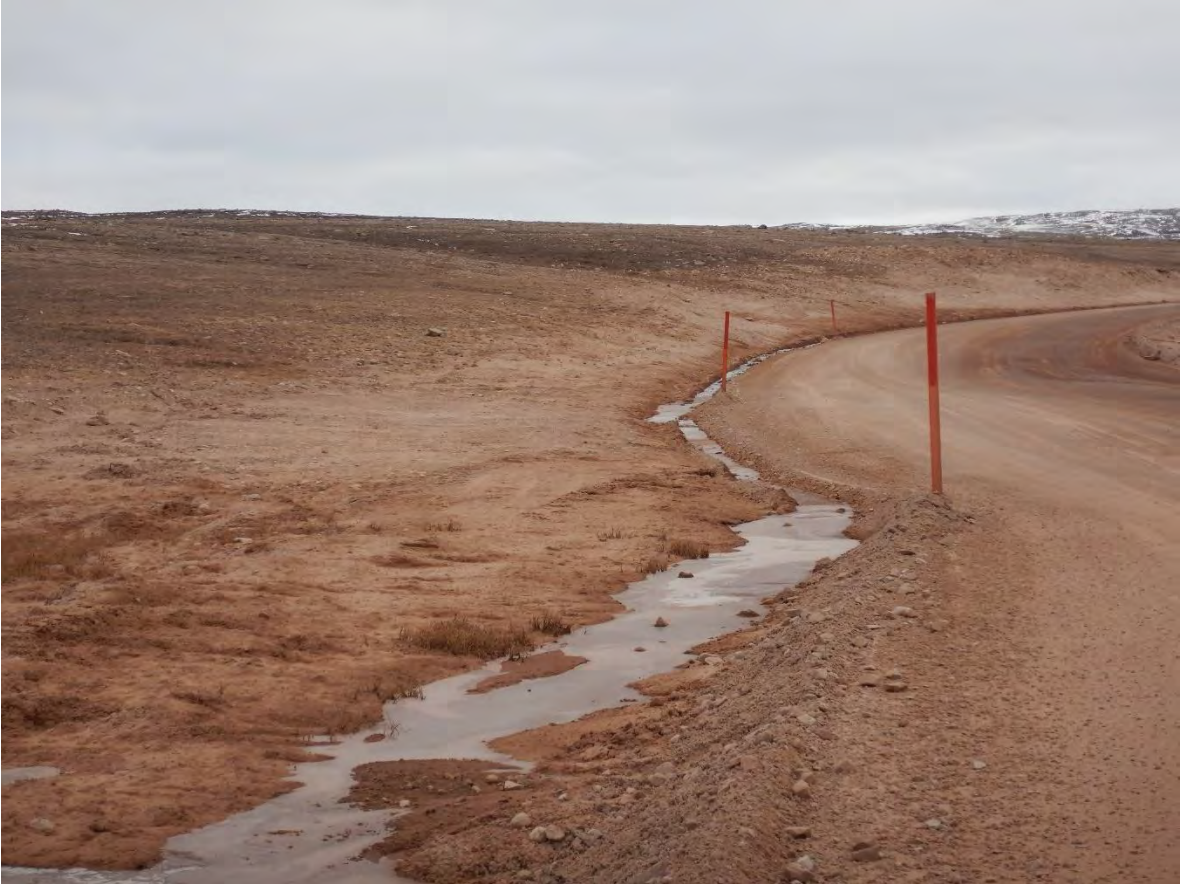
1-112/spill 21247- potentially non-engineered ditches upstream of the culvert could be causing increased TSS. See Photo # 1 for the mentioned ditches.

Description: Cv-112, potential cause of TSS.

4)	CV-112	Spill 21247- Potentially non-engineered ditches upstream of the culvert could be causing increased TSS. See Photo # 6 for the mentioned ditches. The licensee is to install the appropriate erosion control measures to prevent continued erosion identified in comments A1-A7, C1 and C2. The licensee is to remediate all spills noted in this report.	Following the elevated TSS conditions at CV-112 on June 1, 2021, temporary ESC measures were installed and an assessment was completed to identify erosion and sediment control measures around the culvert crossing. Prior to freshet 2022, excess sediment will be removed from the culvert inlet and outlet banks, embankments will be reshaped and re-armoured, and the ditch on the inlet side will be cleaned out of sediment and armoured as per the approved Civil Design Criteria for the Project.

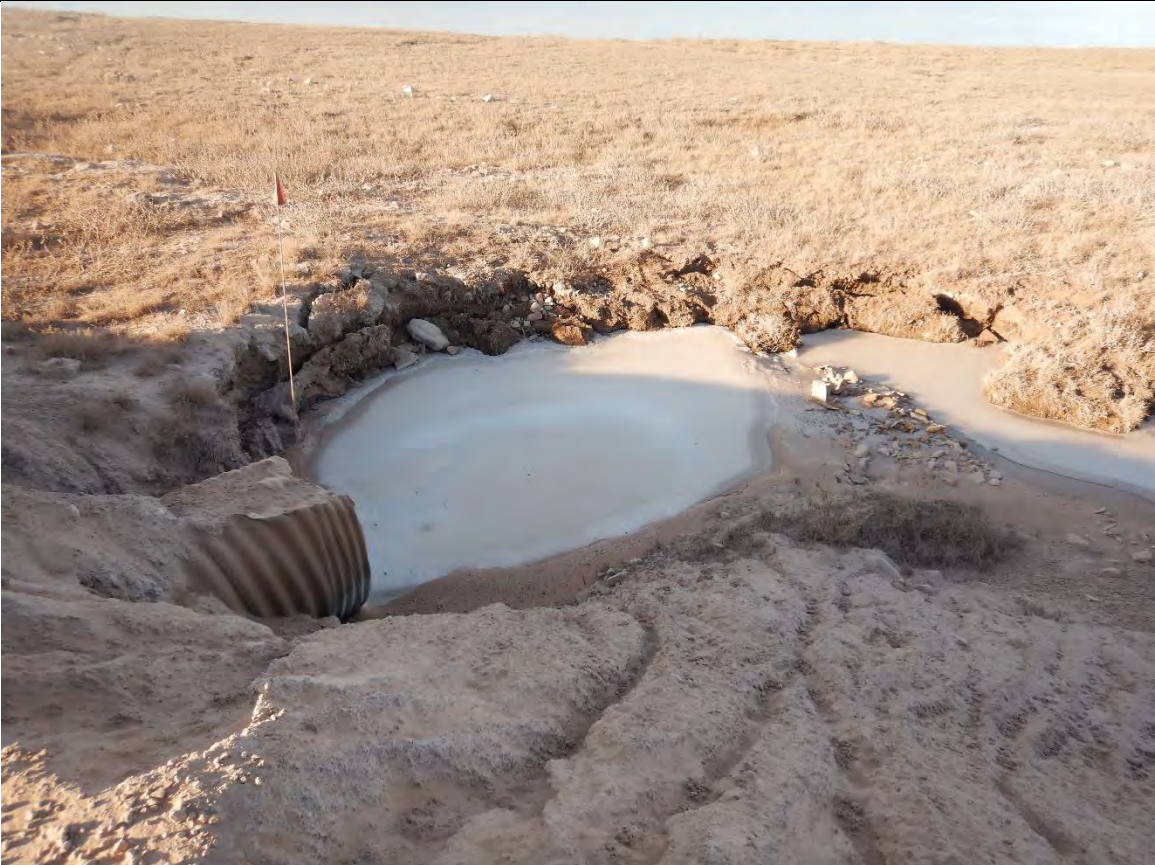
Photo Log
Photo 8

1-24/spill 21247- significant erosion on both sides of culvert. See photos 8-9 for the erosion.

Description: BG-24, erosion on down stream side of culvert/ damaged culvert.

6)	BG-24	Spill 21247- Significant erosion on both sides of culvert. See photos 8-9 for the erosion. The licensee is to install the appropriate erosion control measures to prevent continued erosion identified in comments A1-A7, C1 and C2. The licensee is to remediate all spills noted in this report.	Following the elevated TSS conditions at BG-24 on June 8, 2021, an assessment was completed to identify erosion and sediment control measures around the culvert crossing. Prior to freshet 2022, excess sediment will be removed from the culvert inlet and outlet banks, culvert extensions will be installed and road embankments will be re-armoured.

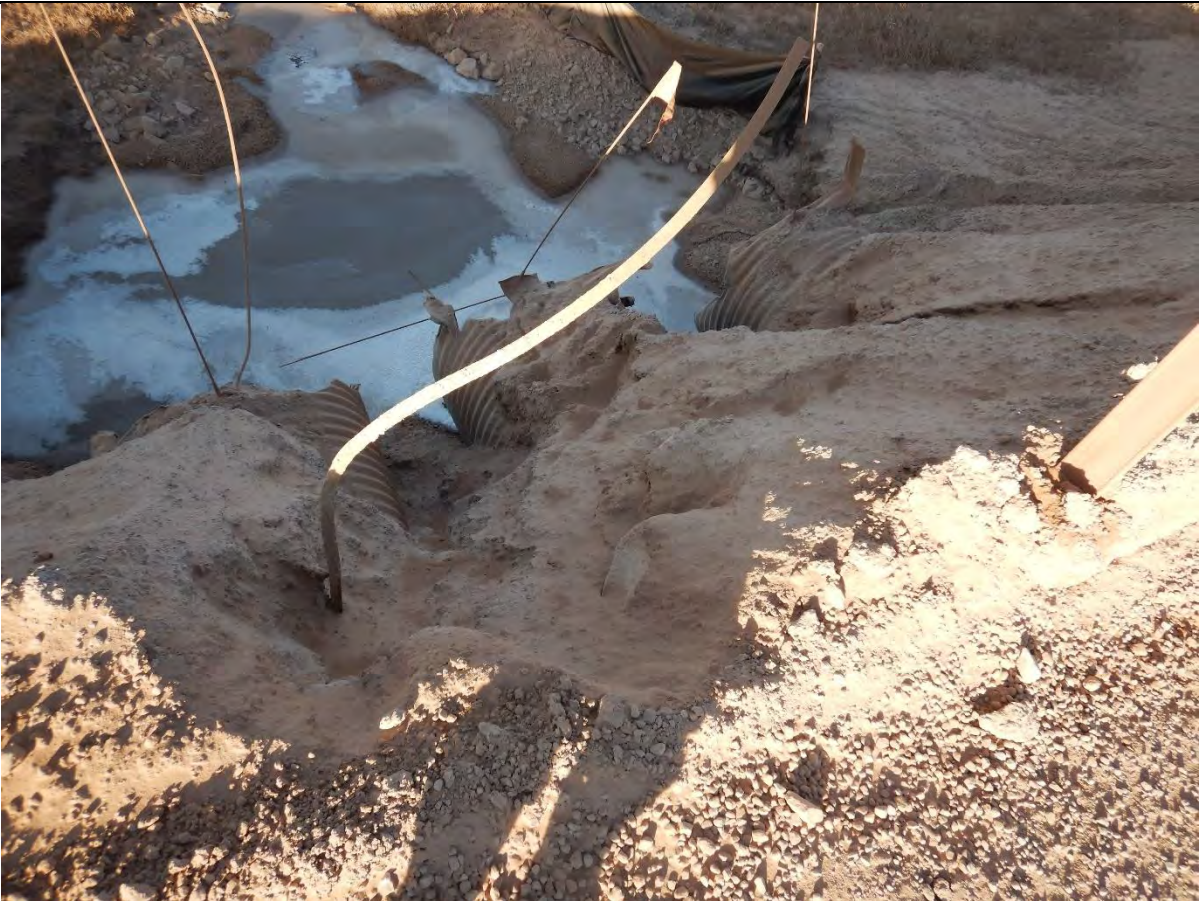
Photo Log
Photo 9

Description: BG-24, erosion on down stream side of culvert/ damaged culvert.

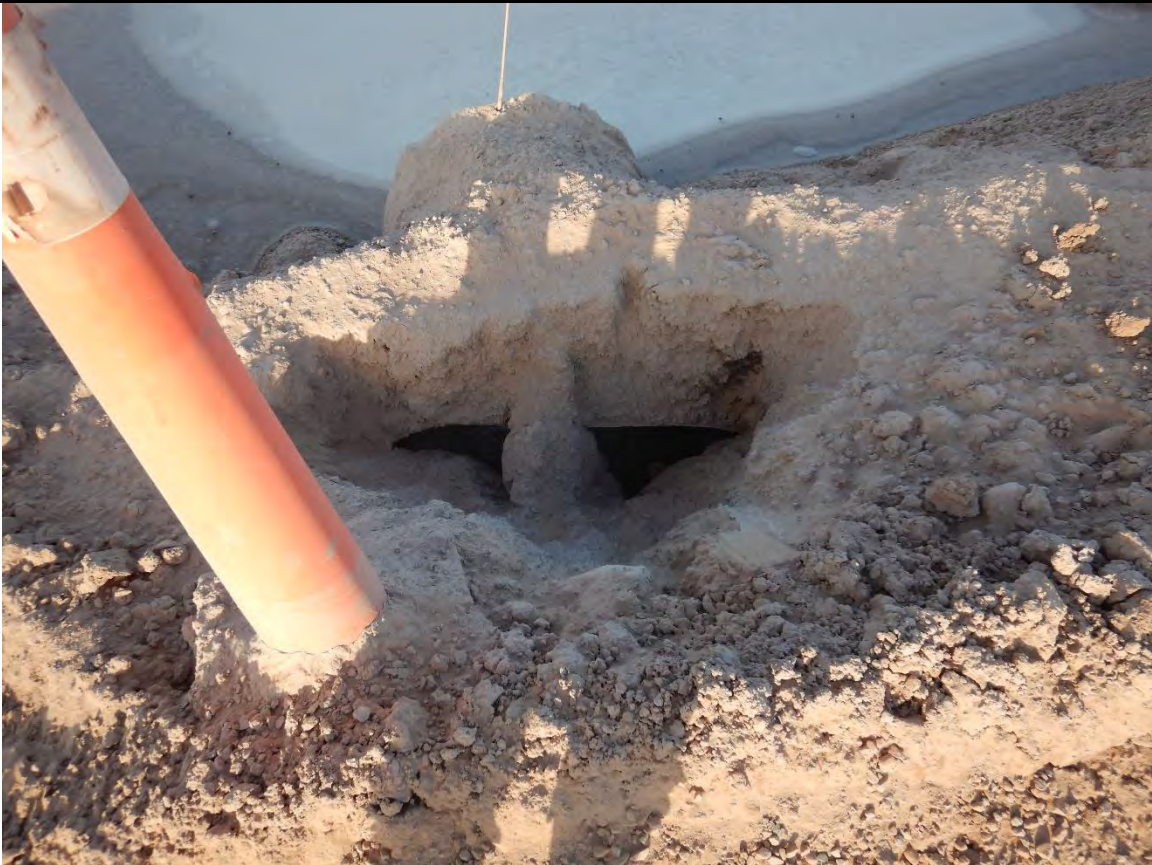
Photo 10

1-001/spill 21247- damaged culvert and erosion on down stream side of culvert. See photo 10 for the photos of the

Description: Cv-001 damaged culvert.

7)	CV-001	Spill 21247- Damaged culvert and erosion on down stream side of culvert. See photo 10 for the photos of the damaged culvert. The licensee is to install the appropriate erosion control measures to prevent continued erosion identified in comments A1-A7, C1 and C2. The licensee is to remediate all spills noted in this report.	Following the elevated TSS conditions at CV-112 on June 1, 2021, an assessment was completed to identify erosion and sediment control measures around the culvert crossing. Prior to freshet 2022, excess sediment will be removed from the culvert inlet and outlet banks, culvert extensions installed to repair the damaged end, and road embankments will be re-armoured.
	KM97	Damaged drip trays were identified in CIRNAC inspection report supporting Photo 1 and Photo 2 beneath fuel drums at KM97.	The fuel drums at KM97 were removed from the area and placed in appropriate secondary containment. Photo 5 in Attachment 2 shows the area at KM97 with the fuel drums and damaged spill trays removed.

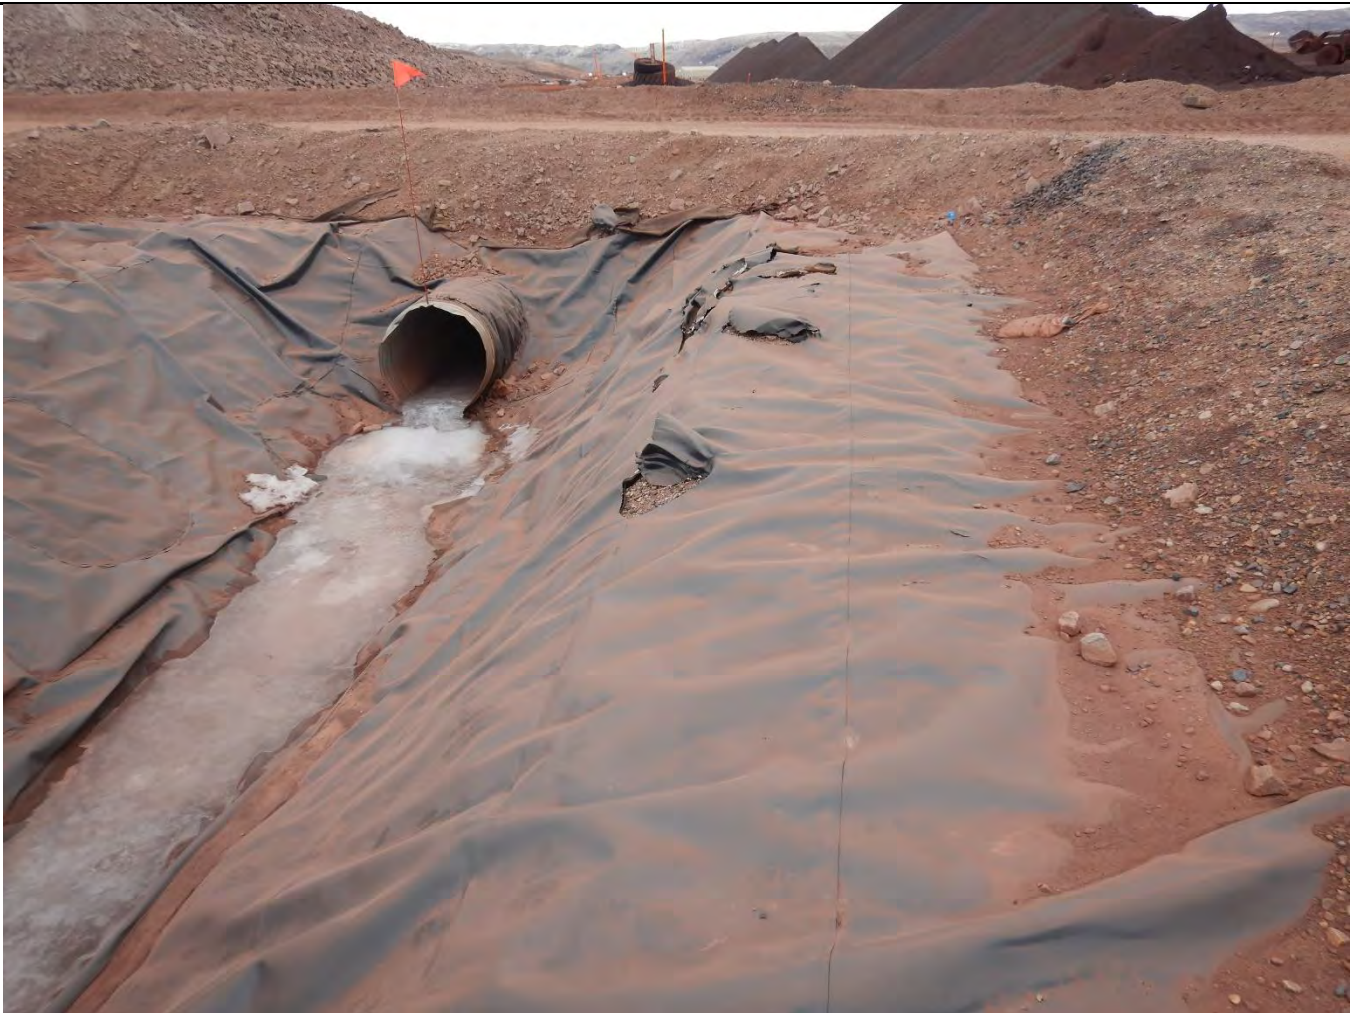
Photo 11

- 1)MP-05- The inspector noted rips on the liner at the inflow after the culvert, the pond appeared to be appropriately pumped down. See photo 11 for pictures of the rips.

Description: damaged liner at MP-05

B) Milne Port			
1)	MP-05	The inspector noted rips on the liner at the inflow after the culvert, the pond appeared to be appropriately pumped down. See photo 11 for pictures of the rips.	Surface Water Management Pond MP-05 and associated ditches are routinely inspected as per Baffinland's Type A Water License. A geotechnical inspection of MP-05 was completed in September 2021, and the 2021 Geotechnical Report No. 2 noted that the pond was in excellent condition with stable, well-maintained berms and intact liner. The minor liner damage observed by CIRNAC near the crest of the southern inlet channel to the pond was also identified during the September geotechnical inspection. Baffinland is assessing suitable controls to prevent this liner damage, and will repair the minor rips identified above the water line during Q2 2022.

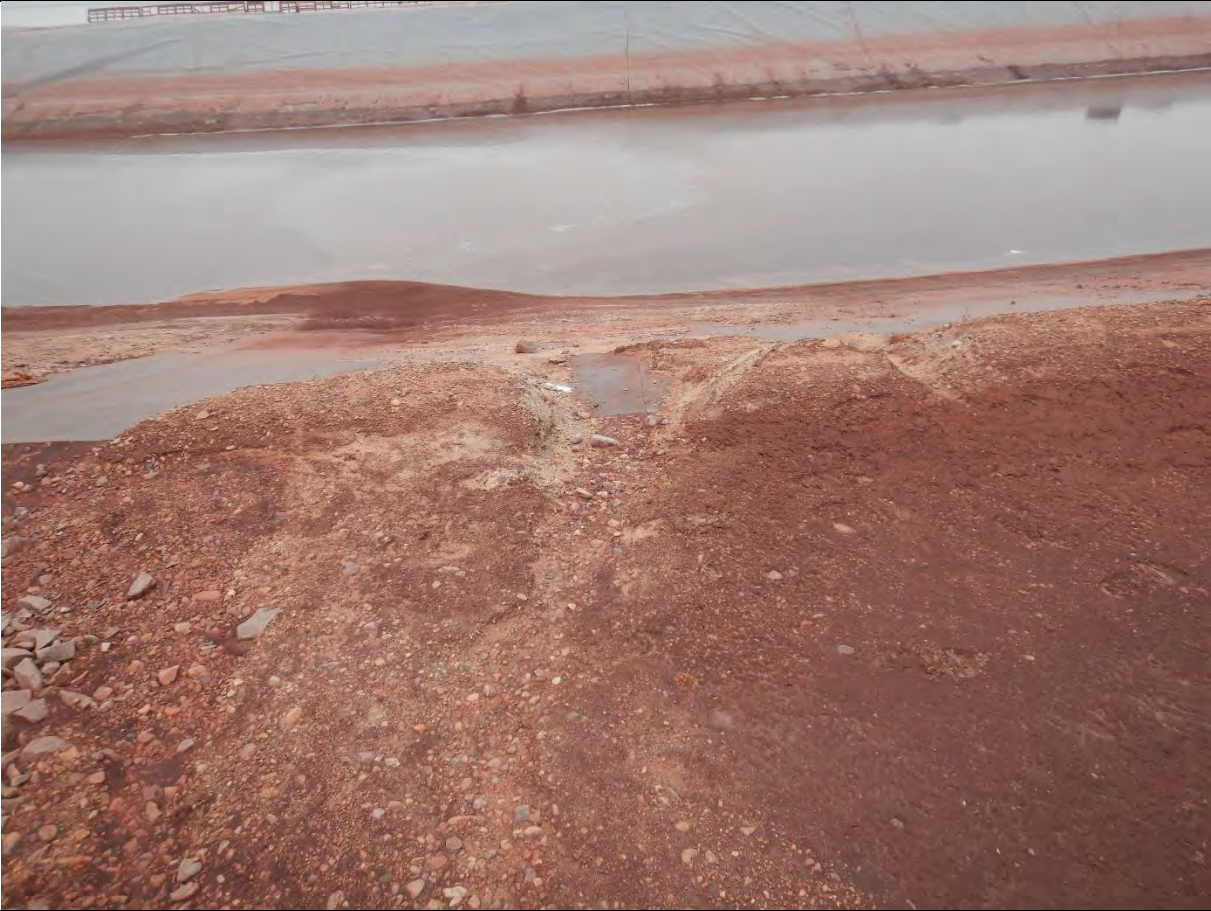
Description: erosion on the East inflow of MP-06

2)	MP-06	There was erosion noted on the East inflow of the pond, the pond appeared appropriately pumped down. See photo 12 for the erosion noted.	Surface Water Management Pond MP-06 and associated ditches are routinely inspected as per Baffinland's Type A Water License. A geotechnical inspection of MP-06 was completed in September 2021, and the 2021 Geotechnical Report No. 2 noted that the pond was in excellent condition with stable, well-maintained berms and intact liner. To prevent the erosion observed during the September Water Licence inspection, a berm will be constructed to ensure runoff from the Ore pad enters the appropriate ditches for conveyance to MP-06. Baffinland will conduct routine monitoring and maintenance activities prior to Freshet 2022, which includes the regrading and stabilization of berm slopes and crests, and ensuring runoff from the ore pad enters the appropriate ditches.

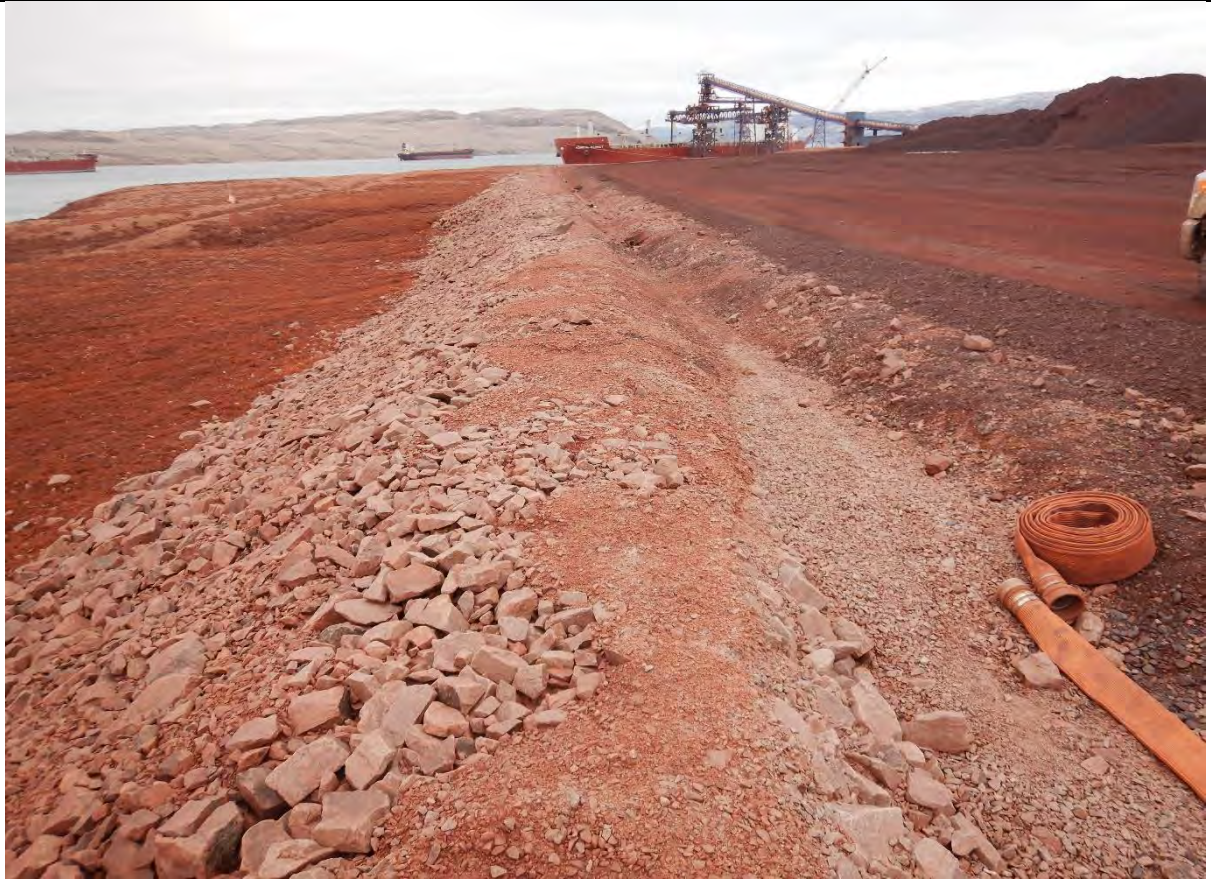
Description: hoses required for pumping and leaking area of the ditch.

3)	Pond 3	Pond 3 is unable to passively drain into MP-06 and the ditch connecting the two ponds is leaking. The surface water on the South West side of the ore pad is unable to drain into Pond 3. See photo 13 for a picture of the hoses used to pump the water from pond 3 into mp-06 and the area leaking. The licensee is to ensure the following waste/water management structures are operating as intended and consistent with the design in the plans approved by the Nunavut Water Board; Ore stockpile ditches and gradient, Crusher pad ditches, MP-07 ditches, Western Globe Fuel Module, HWB 03, HWB 04.	The west ore pad ditch normally collected a low volume of runoff water from the ore pad intermittently, however, a temporary diversion berm was constructed to prevent this runoff from reporting to the ditch until the ditch is repaired. In the interim, ore pad runoff water is being redirected to the surface water management ponds. The temporary diversion berm is inspected on a regular basis and is functioning as intended and diverting water away from the affected ditch and to the surface water management ponds. Pond 3 water is pumped directly into MP-06 whenever necessary. Corrective actions to address the seepage are under investigation and runoff water from the ore pad will continue to be diverted to the surface water management ponds via the interim measures until permanent corrective actions are identified and implemented.

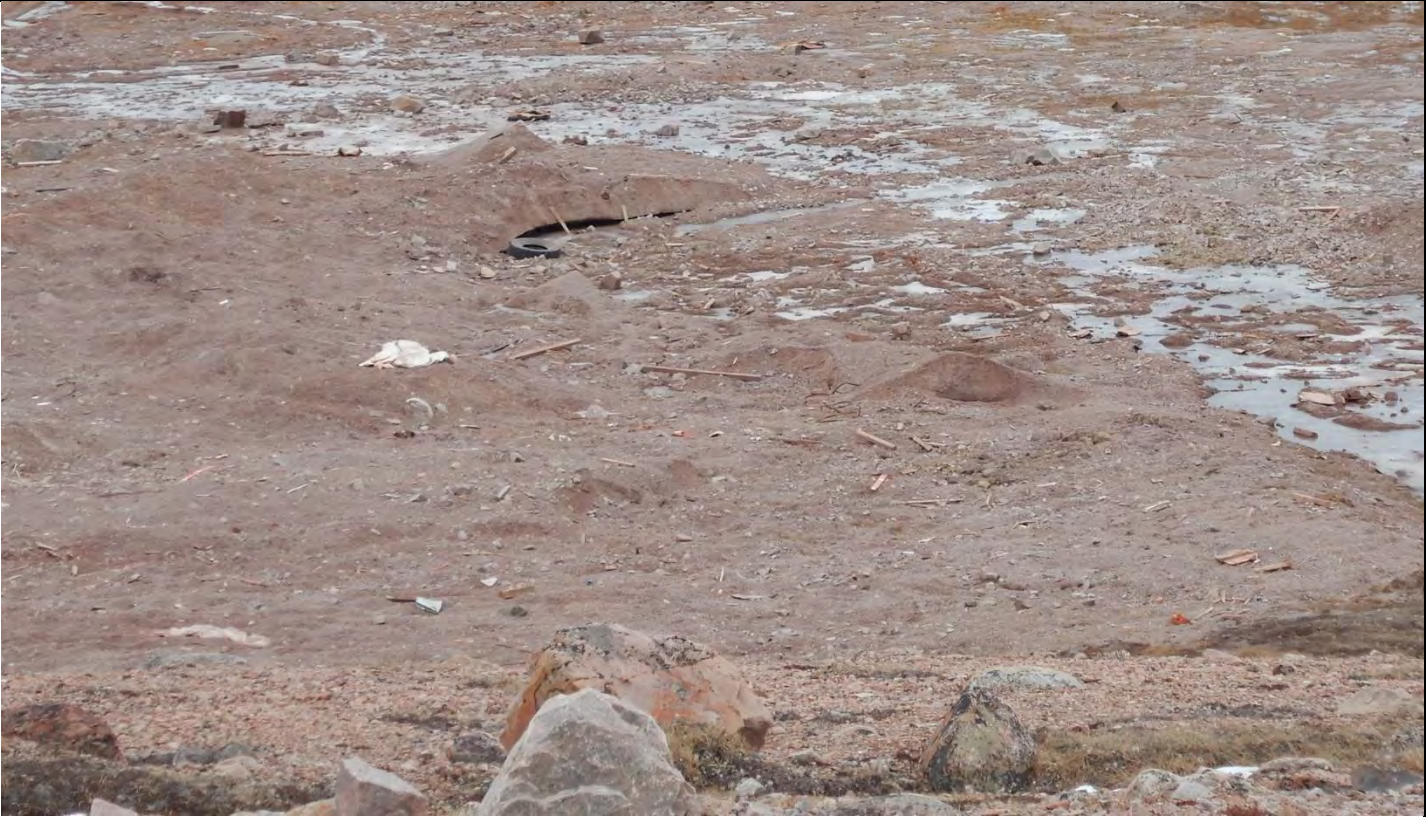
- 4)Snow dumps- The snow dumps appear to be contaminated with litter scooped up during the winter season. see photos 14 and 15 for waste in the snow dumps.

Description: current snow dump containing waste.

4)	Snow Dumps	<p>The snow dumps appear to be contaminated with litter scooped up during the winter season. See photos 14 and 15 for waste in the snow dumps.</p> <p>The licensee is to remove all waste from the snow dumps and provide a monitoring schedule to ensure the snow dumps are not contaminating the surrounding water bodies.</p>	<p>As per Baffinland's Snow Management Plan (SMP), clean up and removal of debris is an ongoing task as snow melts throughout the year and debris surfaces (see Photo 6 in Attachment 2). This remains a priority for Baffinland on an annual basis. Water quality monitoring of snowmelt and surface water runoff is monitored via the Surveillance Network Program (SNP), the Tote Road Monitoring Program (TRMP), and additional monitoring locations to support the SNP and TRMP for areas down gradient of snow stockpile locations. Monitoring results of the SNP, TRMP and temporary freshet monitoring stations are reported annually in the QIA & NWB Annual Report for Operations. Results of the SNP are also reported monthly as required by the Project's Type 'A' Water Licence. Regular inspections of the snow stockpiles are completed as per Baffinland's Snow Management Plan (SMP) and include stockpile assessment for the presence of debris.</p>

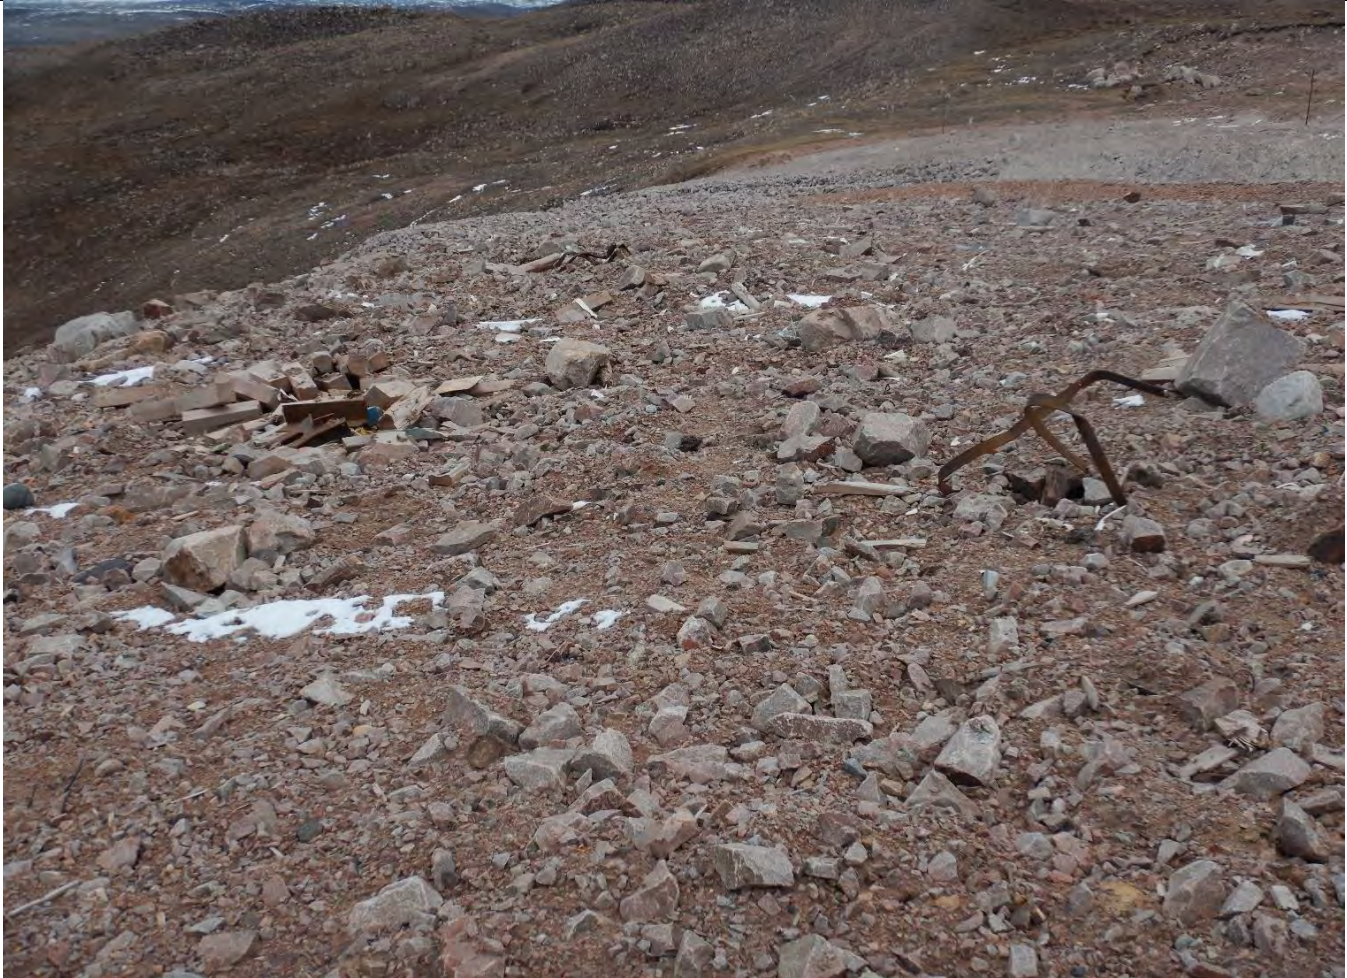
Description: previous snow dump still containing plastic, metal and wood waste

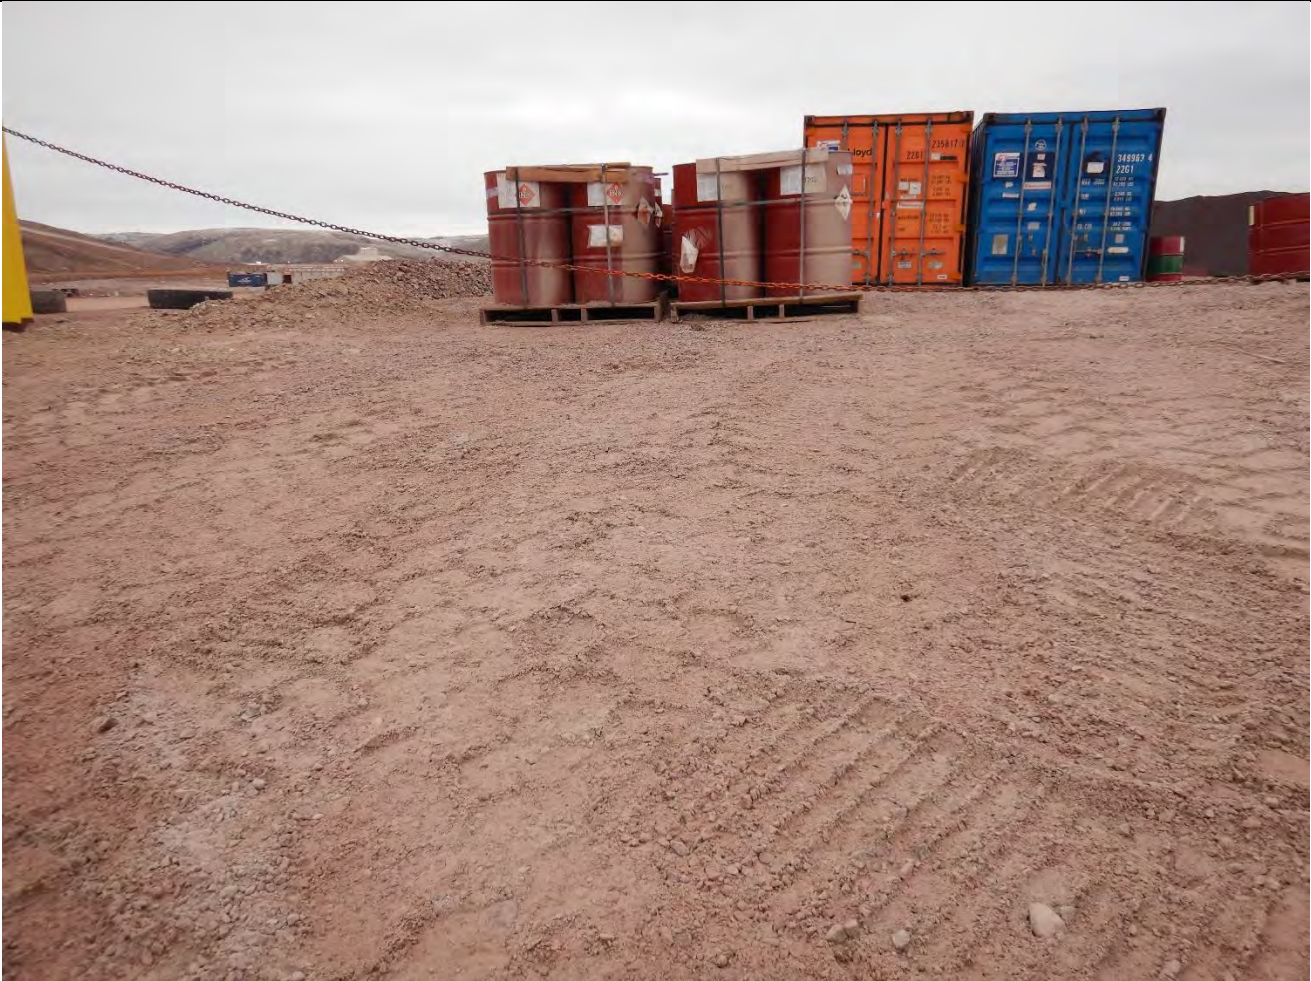
- 5) HWB 03 and 04- the is no defined berm where waste is being stored it appears if a spill did occur the waste would flow outside of this facility. See photo 16 for a picture of this facility.

Description: standing outside the HWB’s looking in, you can clearly see there is no defined berm.

5)	HWB 03 and 04	<p>There is no defined berm where waste is being stored it appears as if a spill did occur the waste would flow outside of this facility. See photo 16 for a picture of this facility.</p> <p>The licensee is to ensure the following waste/water management structures are operating as intended and consistent with the design in the plans approved by the Nunavut Water Board; Ore stockpile ditches and gradient, Crusher pad ditches, MP-07 ditches, Western Globe Fuel Module, HWB 03, HWB 04.</p>	<p>Baffinland will regrade the area at the entrance of twin-cell HWB-3/HWB-4 prior to freshet 2022 to re-establish the gradient normally present within the cells. Routine inspections of HWB-3/ HWB-4 are completed regularly as part of the inspections of structures designed to contain, withhold, divert or retain waters or wastes during periods of flow; conducted in accordance with Part E Item 11 of the Water Licence.</p>

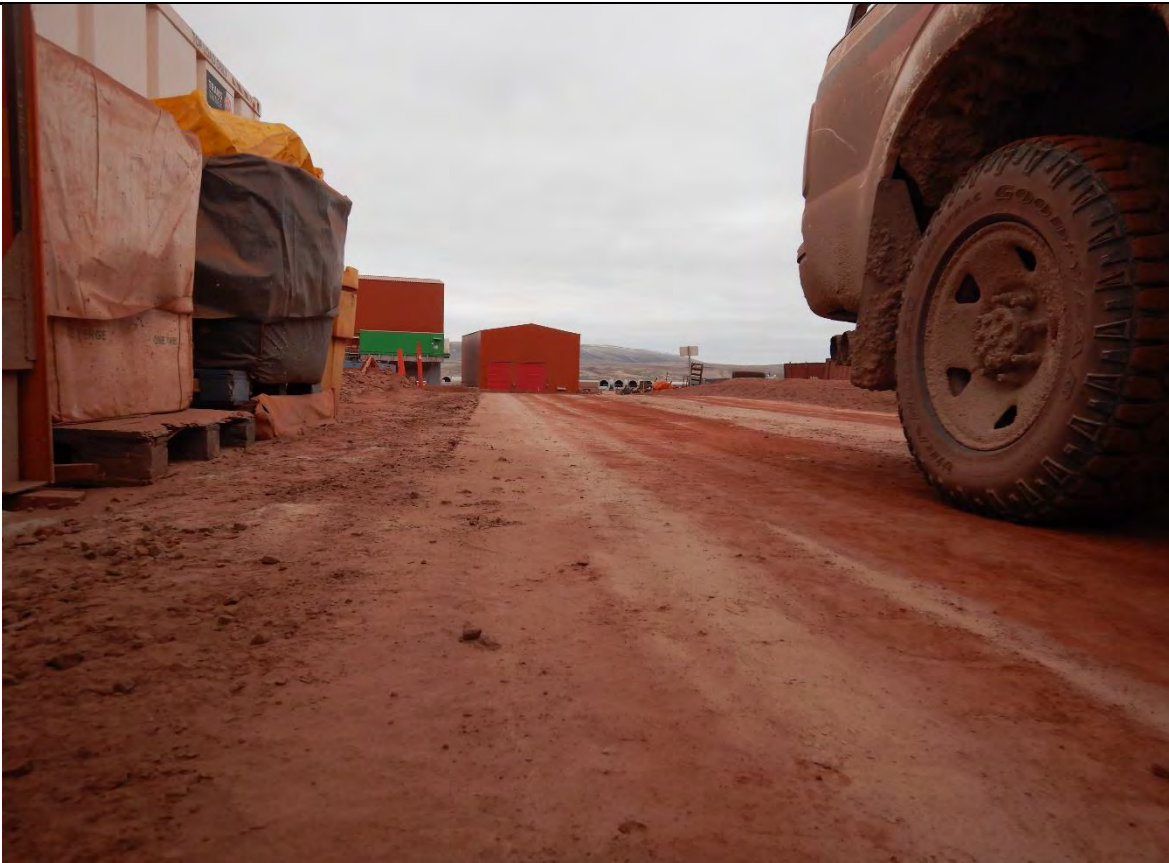
- 6)western globe fuel module- there is no visible berm, this pumping station does not appear to be properly contained, if a spill was or occur or if rain was to pool and become contaminated it appears to be able to flow outside of containment. See photo 17 for the lack of defined berms.

Description: lack of defined berms at fuel module.

6)	Western Globe Fuel Module	<p>There is no visible berm, this pumping station does not appear to be properly contained, if a spill was or occur or if rain was to pool and become contaminated it appears to be able to flow outside of containment. See photo 17 for the lack of defined berms.</p> <p>The licensee is to ensure the following waste/water management structures are operating as intended and consistent with the design in the plans approved by the Nunavut Water Board; Ore stockpile ditches and gradient, Crusher pad ditches, MP-07 ditches, Western Globe Fuel Module, HWB 03, HWB 04.</p>	<p>The Western Global Fuel Module is a lined facility equipped with spill response supplies. There should be a small gravel berm around the fuel module to contain any possible spills, and Baffinland will re-construct this berm by December 31, 2021. Baffinland's Environmental Protection Plan (EPP) outlines additional protection measures for fuel dispensing activities to prevent fuel releases during refueling. These measures include supervision of fuel transfer points at all times during refueling and daily inspections of permanent fuel dispensing facilities. Photo 8 and Photo 9 in Attachment 2 show the condition of the OHT refuelling facility and spill kit.</p>
