RE: Water Licence 2AM-MRY1325 September 2021 Inspection – Follow Up

2021-QIK-JKM012 2AM-MRY1325 Inspection Report

WATER LICENCE INSPECTION FORM

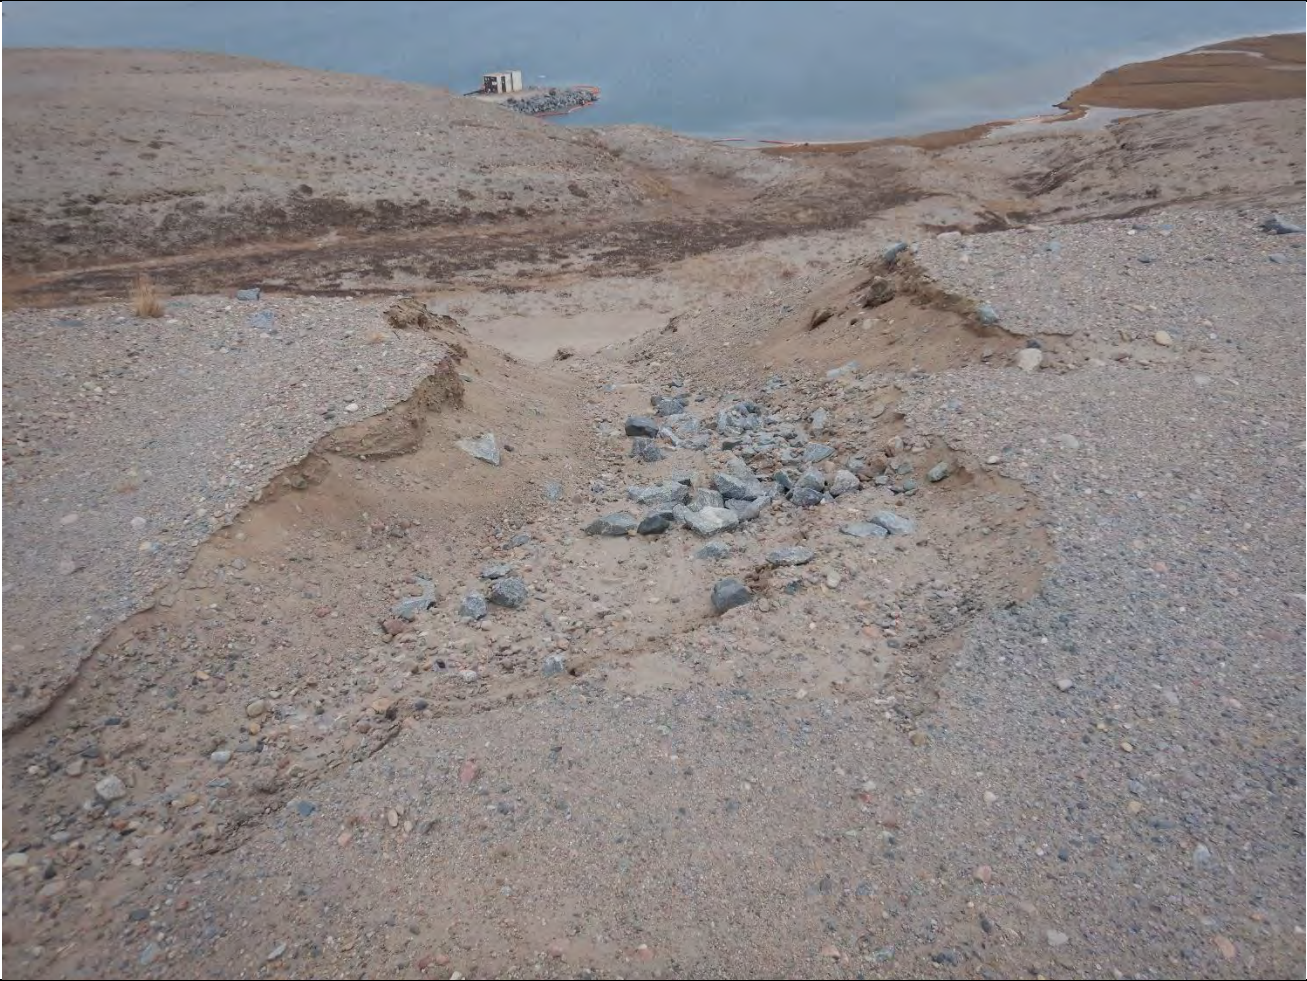
- 1) The inspector noted erosion North of the camp lake intake, is appears surface water from the runway and surrounding area has no water management structure to manage it. This surface water has previously caused erosion near the camp lake tributary and now is eroding the sandy hills north of the water intake. See photo 18 and 19 for pictures of this erosion.

Description: Erosion near water intake, standing on runway perimeter road looking towards camp lake.

C) Mine Site			
1)	North of Camp Lake Intake	<p>The inspector noted erosion North of the camp lake intake, it appears surface water from the runway and surrounding area has no water management structure to manage it. This surface water has previously caused erosion near the camp lake tributary and now is eroding the sandy hills north of the water intake. See photo 18 and 19 for pictures of this erosion.</p> <p>The licensee is to install the appropriate erosion control measures to prevent continued erosion identified in comments A1-A7, C1 and C2.</p>	<p>Baffinland will implement additional erosion and sediment control measures in accordance with the SWAEMP to address the erosion north of the Camp Lake Intake prior to Freshet 2022, which was identified during the September Water Licence inspection. Water management measures for runoff in this area is being addressed as part of the ongoing implementation of Baffinland's Long Term Water Management Plan (LTWMP).</p>

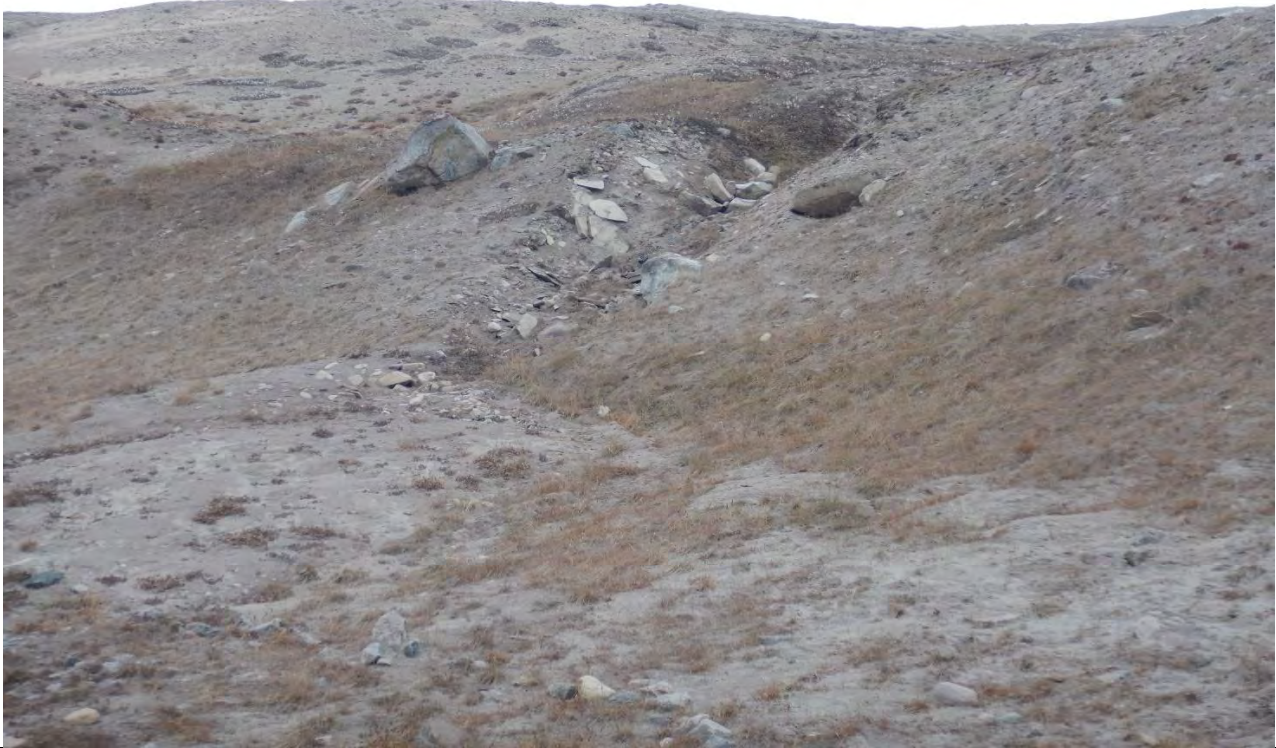
Description: Erosion near water intake, standing near intake looing at the hillside.

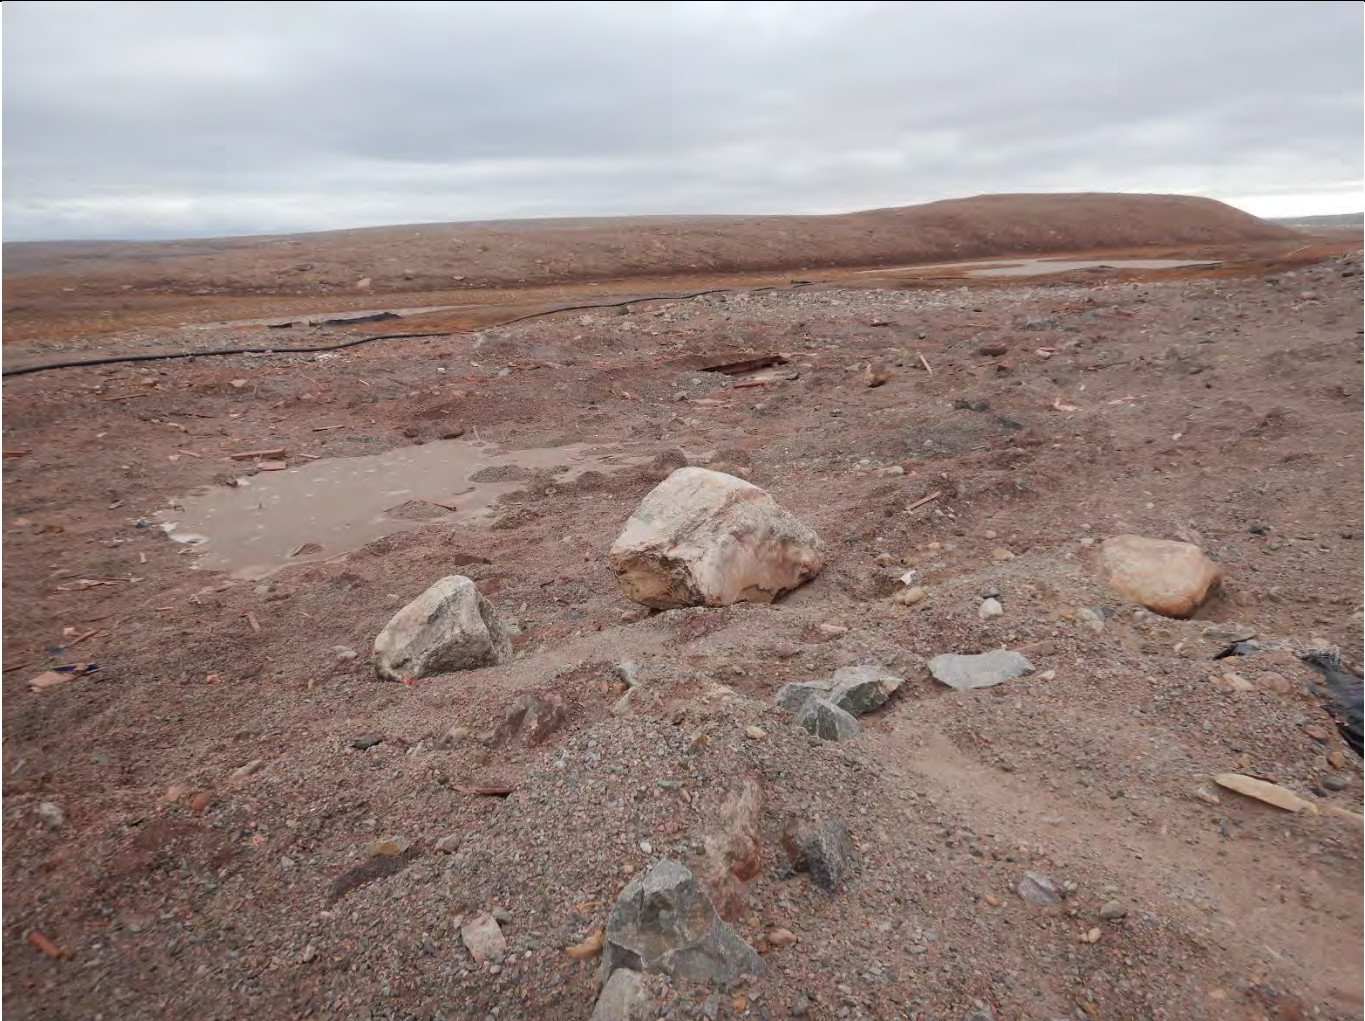
- 4) Mine site snow dump- the mine site snow dump also has significant waste. See photo 22 for the waste in the snow dump
- 5) Waste Rock Stockpile pond- this waste rock stockpile and the surrounding area was snow covered at the time of the inspection making it difficult to identify any concerns, no concerns were noted.

Description: Mine site snow dump.

4)	Mine Site Snow Dump	The mine site snow dump also has significant waste. See photo 22 for the waste in the snow dump. The licensee is to remove all waste from the snow dumps and provide a monitoring schedule to ensure the snow dumps are not contaminating the surrounding water bodies.	As per Baffinland's Snow Management Plan (SMP), clean up and removal of debris is an ongoing task as snow melts throughout the year and debris surfaces (see Photo 6 in Attachment 2). Water quality monitoring of snowmelt and surface water runoff is monitored via the Surveillance Network Program (SNP), the Tote Road Monitoring Program (TRMP), and additional monitoring locations to support the SNP and TRMP for areas down gradient of snow stockpile locations. Monitoring results of the SNP, TRMP and temporary freshet monitoring stations are reported annually in the QIA & NWB Annual Report for Operations. Results of the SNP are also reported monthly as required by the Project's Type 'A' Water Licence. Regular inspections of the snow stockpiles are completed as per Baffinland's SMP and include stockpile assessment for the presence of debris.

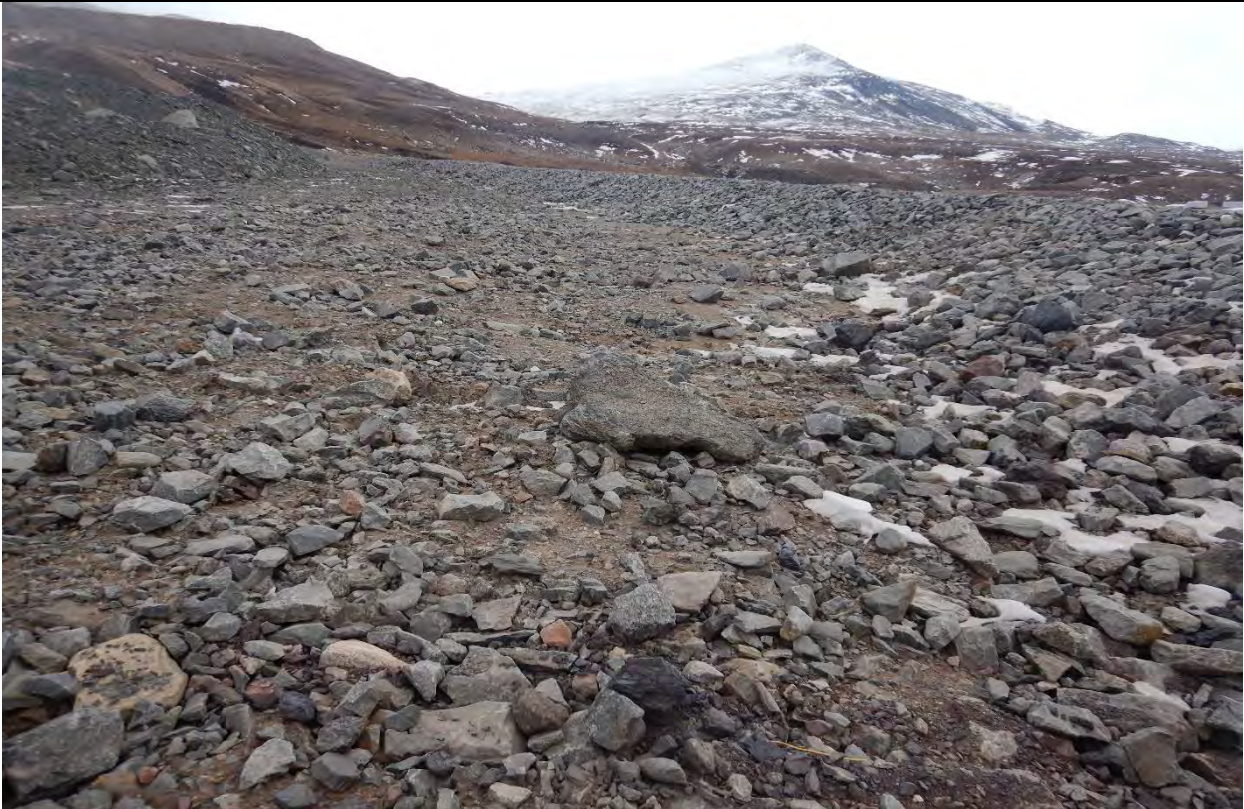
- 6) MS-07/spill 21268- This facility is currently dealing with a seepage issue potentially due to gradient of the ditch and the type of fill used. See Photo 23 for the ditch with the unresolved seepage.

Description: MS-07 ditch with ongoing seepage issue.

5)	MS-07	Spill 21268- This facility is currently dealing with a seepage issue potentially due to gradient of the ditch and the type of fill used. See Photo 23 for the ditch with the unresolved seepage. The licensee is to remediate all spills noted in this report.	Interim ground work measures including temporary diversion swales and a sump, constructed in accordance with Baffinland's MDMER Emergency Response Plan, continue to be inspected on a regular basis and are functioning as intended to convey all seepage water into the KM106 Ore Stockpile Facility Pond (MS-07). Baffinland has retained a third party consulting firm to investigate the KM106 diversion berm to determine appropriate corrective actions to ensure the berm functions as per design criteria. All contact water will continue to be captured and conveyed to the surface water management pond via the interim measures until permanent corrective actions are identified and implemented.

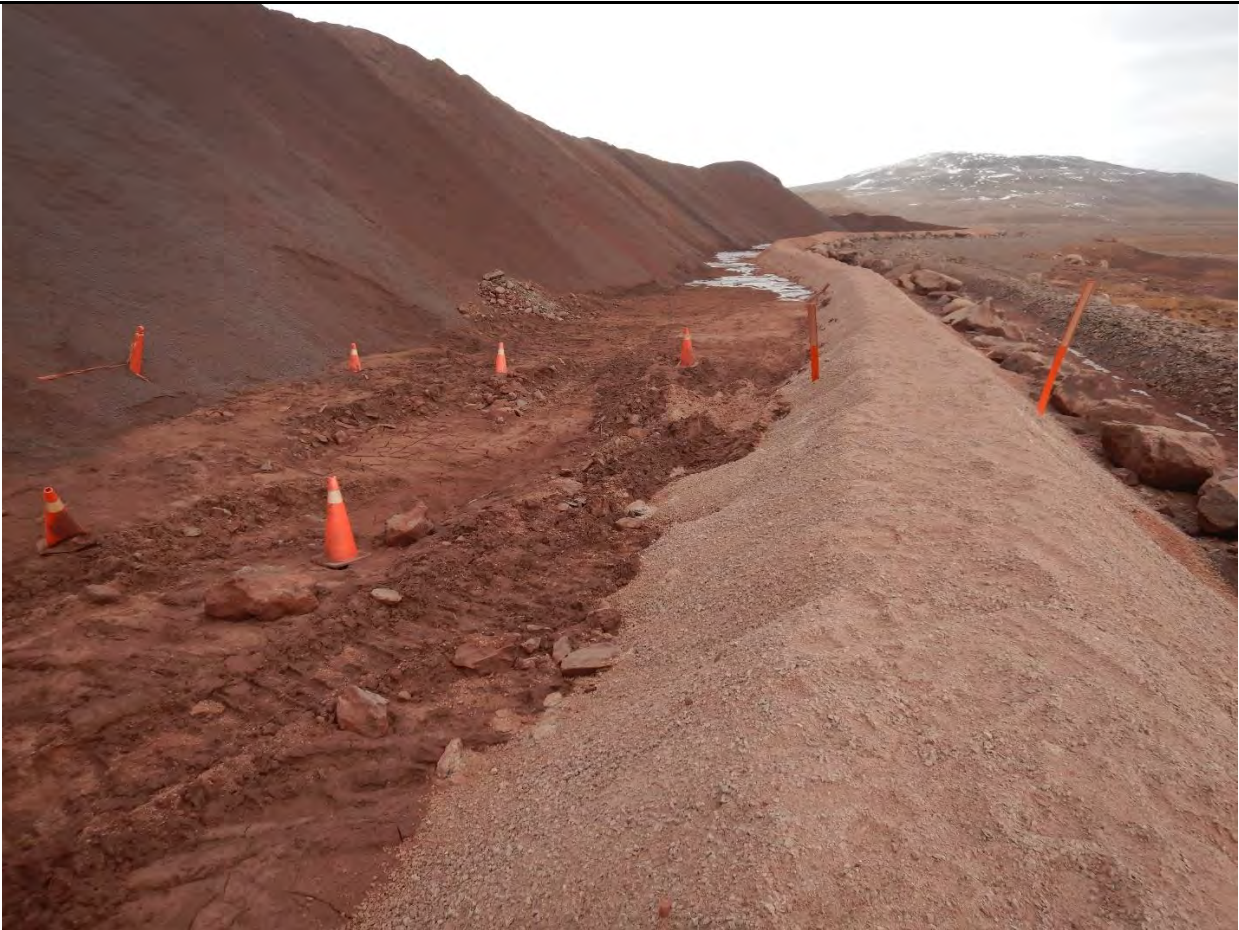
Photo 24

- 7) Crusher Pad and pond- The Crusher pad is currently dealing with a unresolved seepage as well, the ditch that is designed to divert surface water to the containment pond is not operational due to a leak. The licensee currently has a sump installed and is pumping water from the sump into the containment pond. See photo 24 for a photo of the sump and berms installed to keep the surface water out o the ditches.

Description: Berm and sump installed.

6)	Crusher Pad and Pond	The Crusher pad is currently dealing with an unresolved seepage as well, the ditch that is designed to divert surface water to the containment pond is not operational due to a leak. The licensee currently has a sump installed and is pumping water from the sump into the containment pond. See photo 24 for a photo of the sump and berms installed to keep the surface water out of the ditches. The licensee is to ensure the following waste/water management structures are operating as intended and consistent with the design in the plans approved by the Nunavut Water Board; Ore stockpile ditches and gradient, Crusher pad ditches, MP-07 ditches, Western Globe Fuel Module, HWB 03, HWB 04.	Interim contingency measures to manage water at the Crusher Facility which includes a diversion berm and sumps, constructed in accordance with Baffinland's MDMER Emergency Response Plan, continue to be inspected on a regular basis and are functioning as intended to convey all seepage water into Crusher Facility surface water management pond MS-06. MS-06 is routinely inspected as per Baffinland's Type A Water License. A geotechnical inspection of MS-06 was completed in September 2021, and the 2021 Geotechnical Report No. 2 indicated that the liner within the pond and on the upstream slopes of the berm appears to be intact. There was no evidence of seepage from the pond at the time of the inspection. Baffinland continues to implement the Ore Crusher pad Regrading Strategy to prevent the pooling of water on and around the Crusher Facility pad. All contact water will continue to be captured and conveyed to the surface water management pond via the interim measures until permanent corrective actions are identified and implemented. Water management measures for the Crusher Facility are being addressed as part of the ongoing implementation of Baffinland's LTWMP.

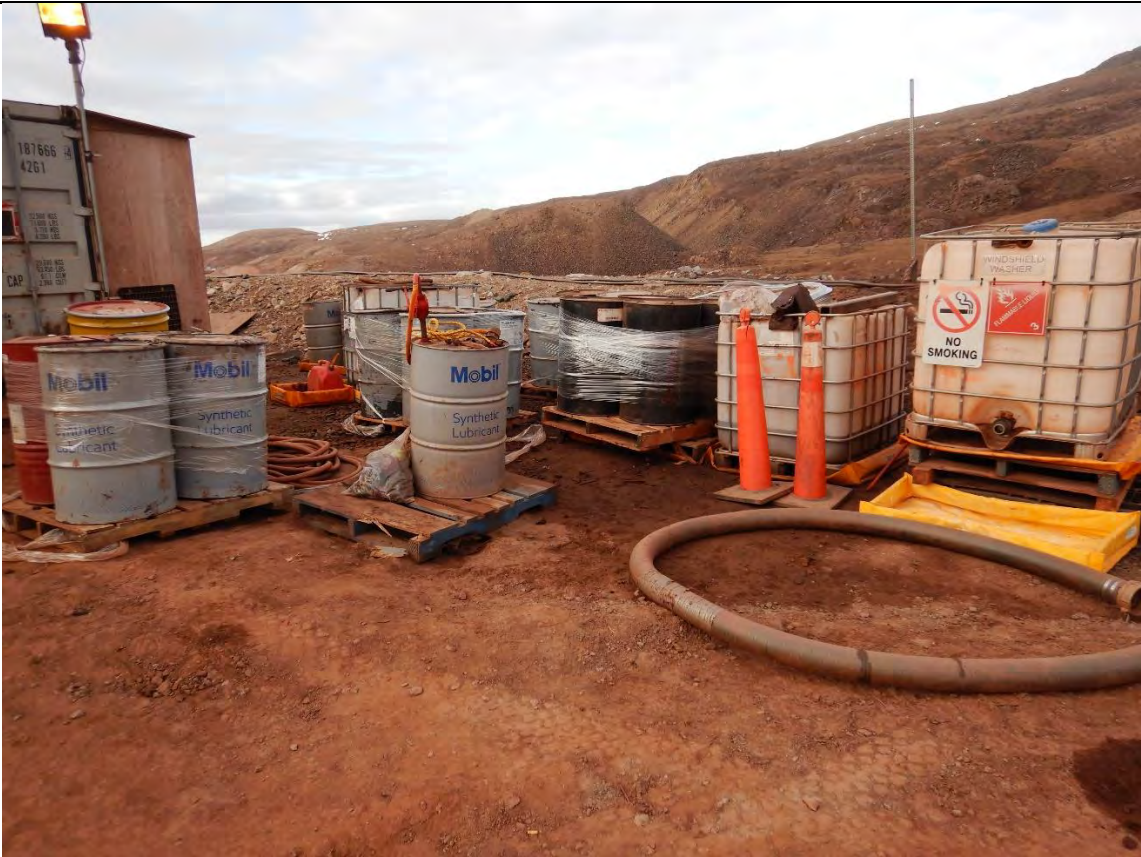
Photo 25

- 8) Km 104 laydown- during the inspection the inspector noted the following concerns at the 104 laydown;
 - Lubricants and hazardous material outside of containment, in damaged containment and staining which smelled strongly of fuel. See photo 25 for the area with staining and hazardous material outside of containment.

Description: hazardous material outside of containment, in damaged containment and staining in the area.

7)	KM 104 Laydown	<p>During the inspection the inspector noted the following concerns at the 104 laydown:</p> <ul style="list-style-type: none">• Lubricants and hazardous material outside of containment, in damaged containment and staining which smelled strongly of fuel. See photo 25 for the area with staining and hazardous material outside of containment.• Open containers with dirty absorbent rags nearing capacity, see photo 26 and 27 for the containers.• Heavy equipment actively leaking on the ground with no drip tray, see photos 28 and 29 for photos of fluid under heavy equipment at laydown 104.	<p>Containers that were observed to be located outside of secondary containment are in progress of being removed from the area and placed within appropriate secondary containment. Surficial staining observed beneath heavy equipment at the KM104 Laydown was cleaned up and placed in appropriate secondary containment. Spill trays were subsequently placed underneath dripping equipment and equipment in mid-term and long-term storage, in accordance with the EPP, to provide secondary containment to prevent spills due to product leaks. Photo 11 and Photo 12 in Attachment 2 show examples of these corrective actions. Baffinland is committed to ensuring that spill trays are placed beneath dripping equipment and equipment that is not being used for more than five (5) days, and beneath all stationary equipment that is regularly refueled. Operational areas are inspected for proper use of secondary containment during routine compliance inspections and any issues are addressed as they are identified.</p>

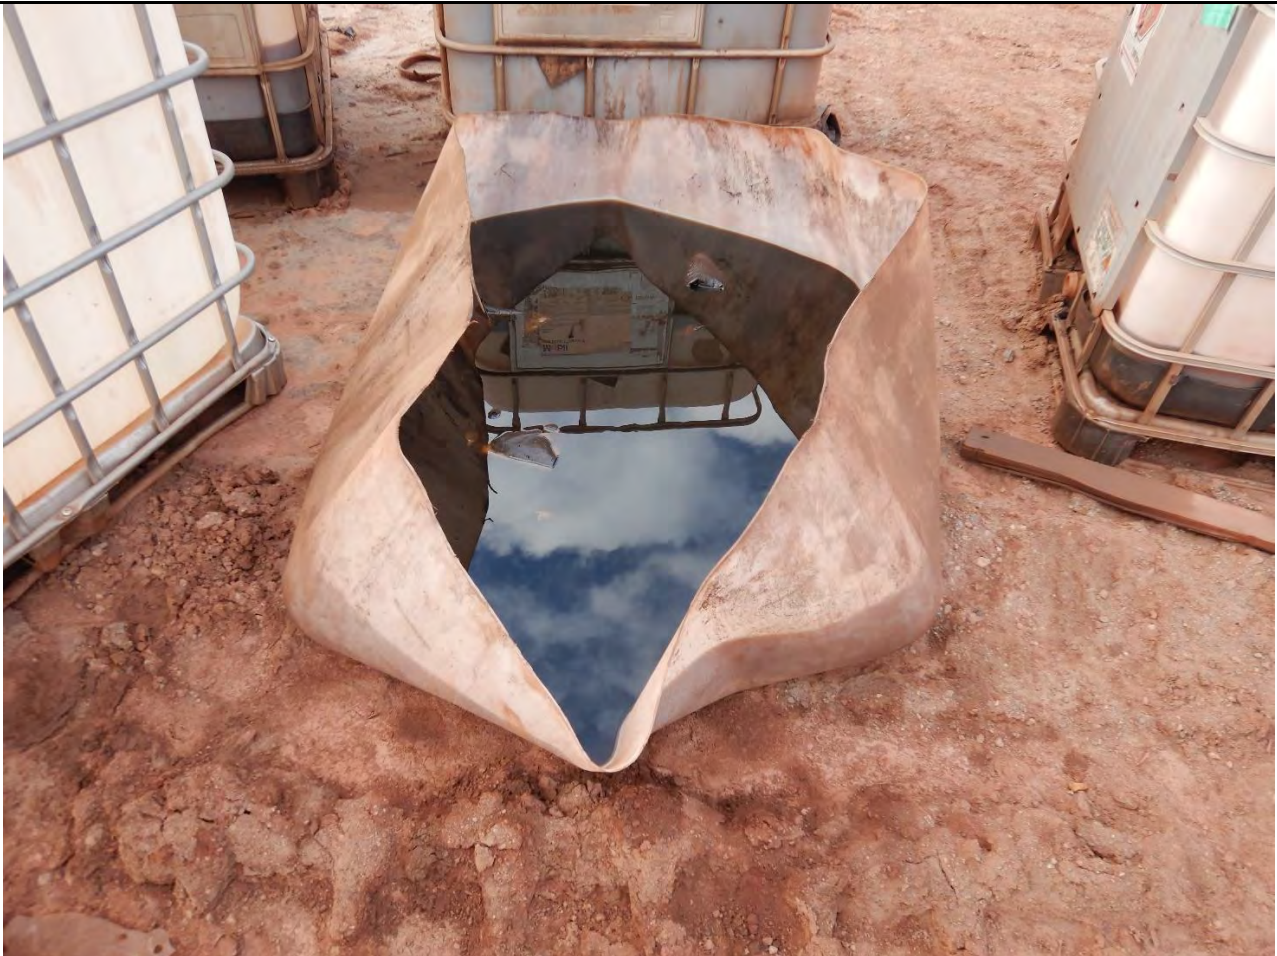
Photo 26

Description: dirty spill rags and unknown waste in open container outside of containment

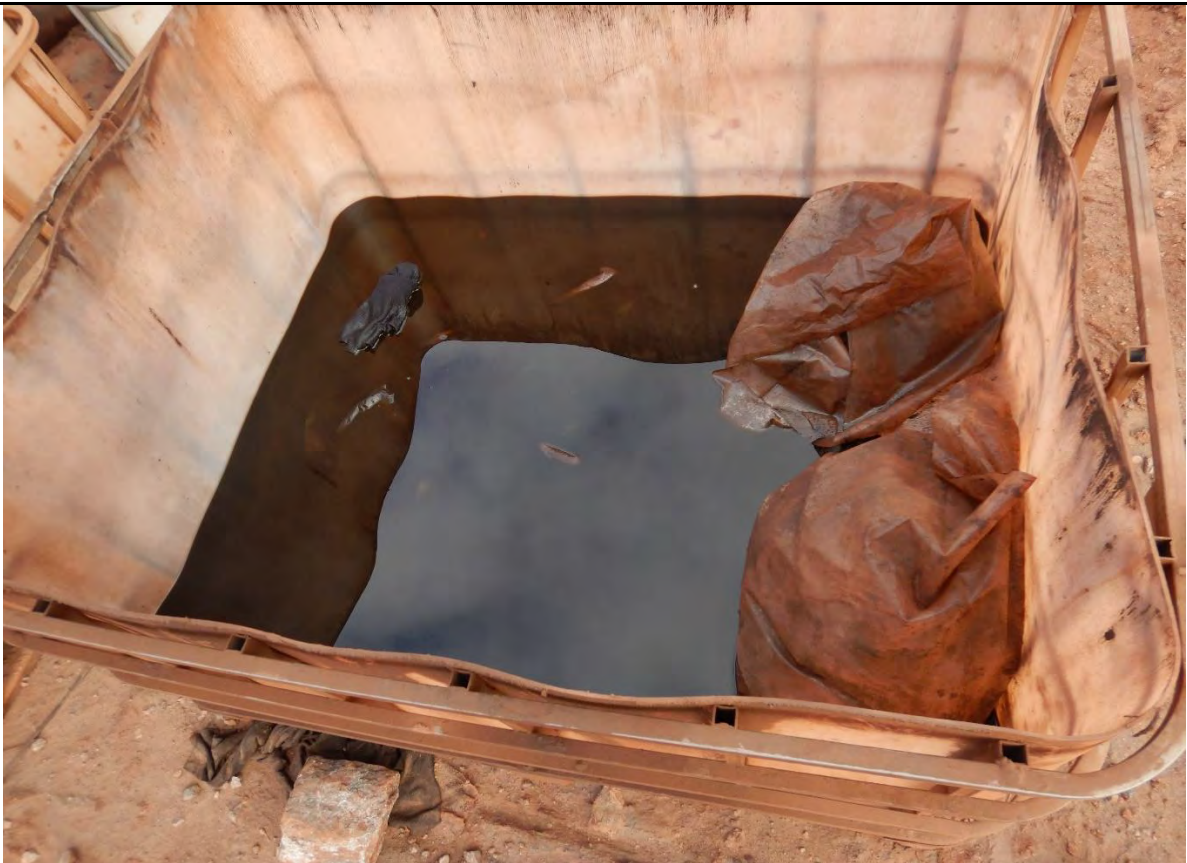
Photo 27

Description: dirty spill rags and unknown waste in open container outside of containment

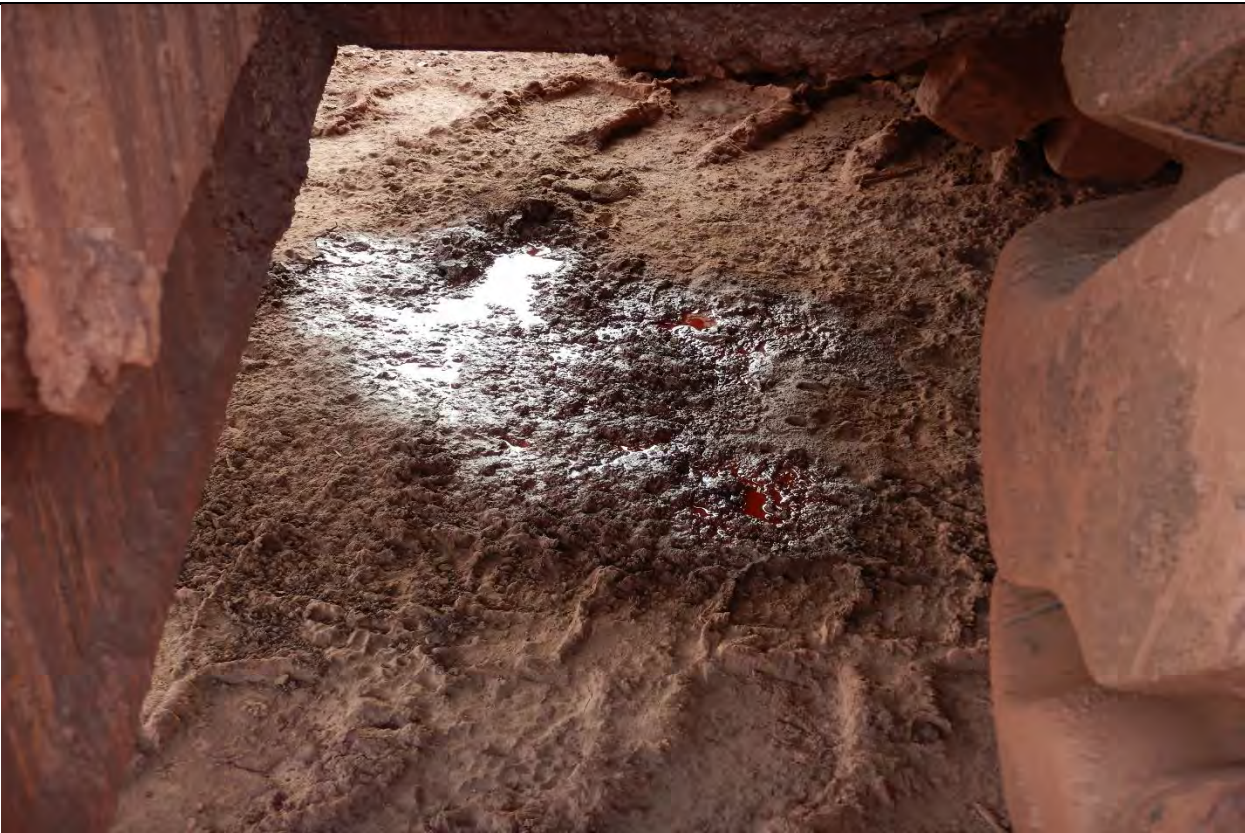
Description: fluid leaking from heavy equipment.

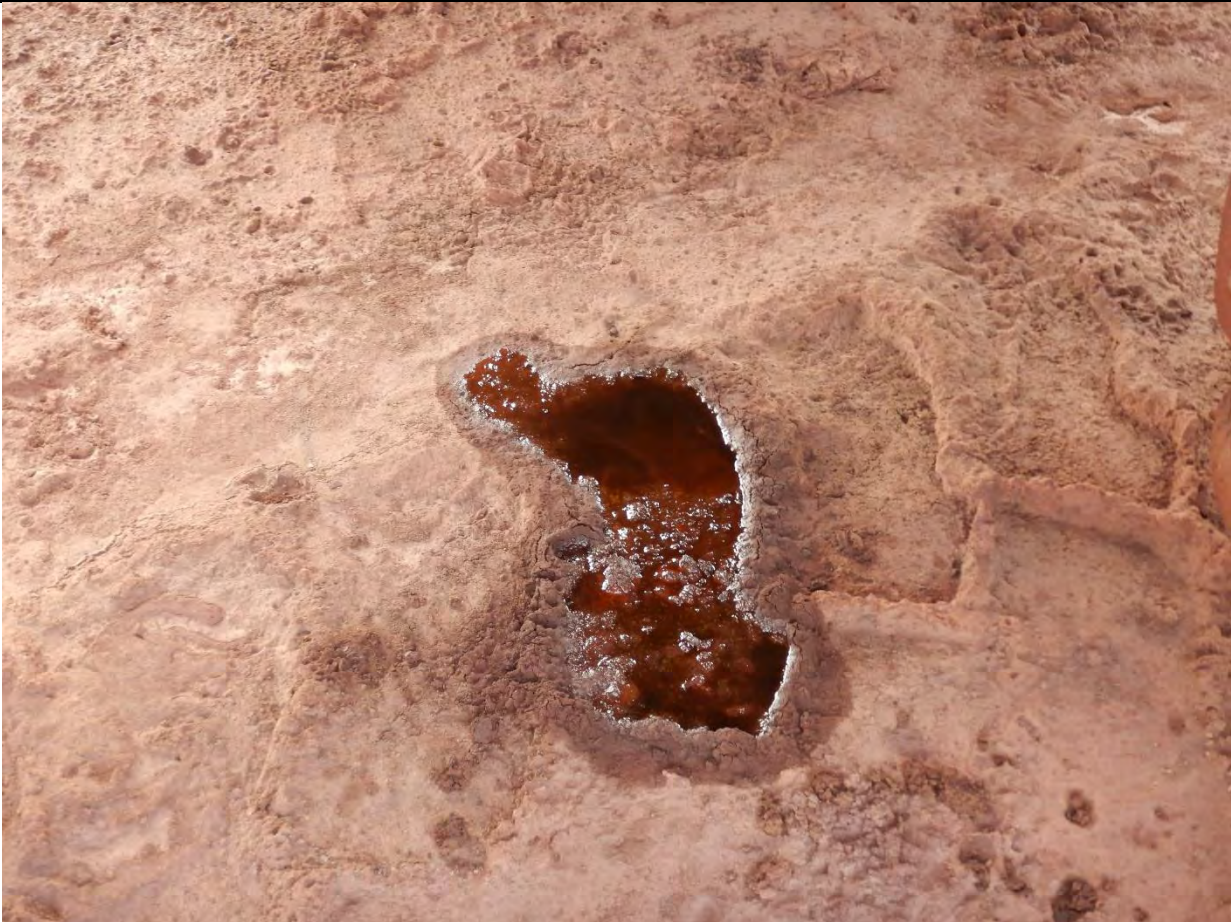
Description: fluid leaking from heavy equipment.
